Evaluation of the Quality of Civic Amenities at Rehabilitation Sites of the Sardar Sarovar Project

**Sardar Sarovar Project - Fake Sale Deeds and Rehabilitation Sites
Irregularities Inquiry Commission**

April, 2014

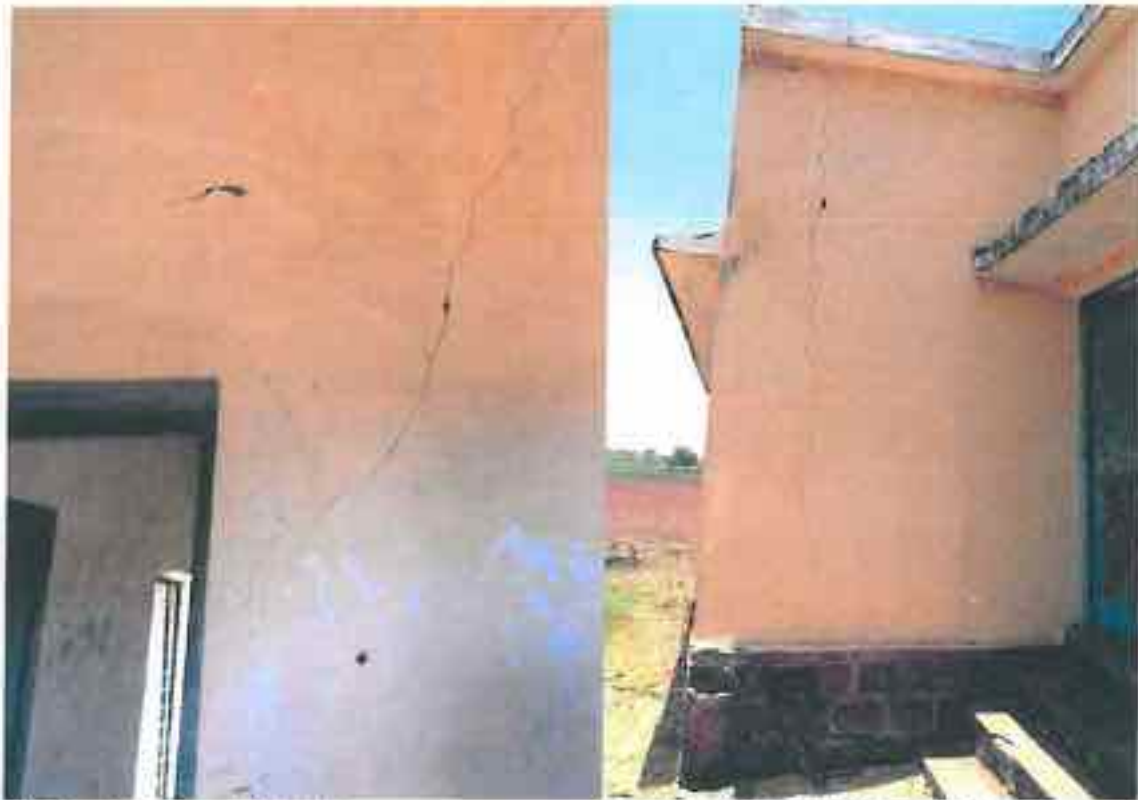
Barda :Aaganwadi Bhawan

8. However, at some R&R sites, some of the buildings have had serious issues, and were found damaged and dilapidated (Plate 2.1.1). Many structures had noticeable cracks due to foundation settlements. A few of these buildings were so highly damaged that they are no more functionally useful, and need to be dismantled immediately to avoid accidents and damage.

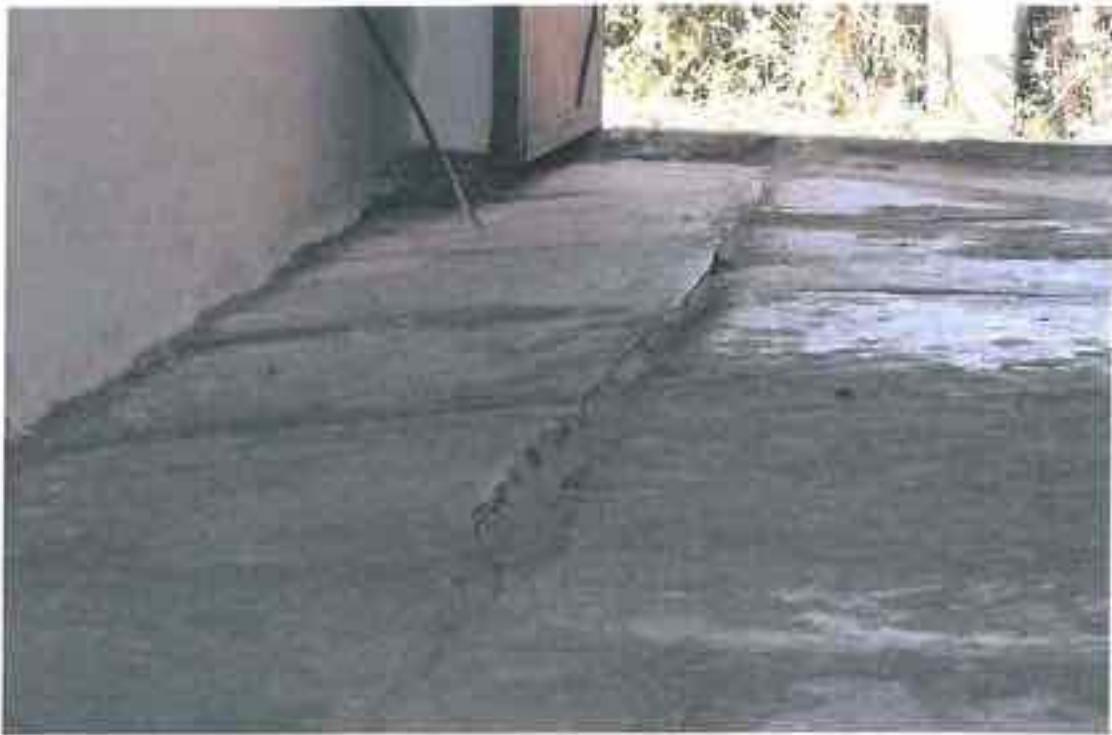
Plate 2.1.2. Typical Uneven Floors – Settlement of Foundations

9. The Flooring joints were also found very poor, and at several places uneven flooring surface was visible, indicating uneven foundation settlement (Plate 2.1.2).

Khalbujurg: Primary School floor

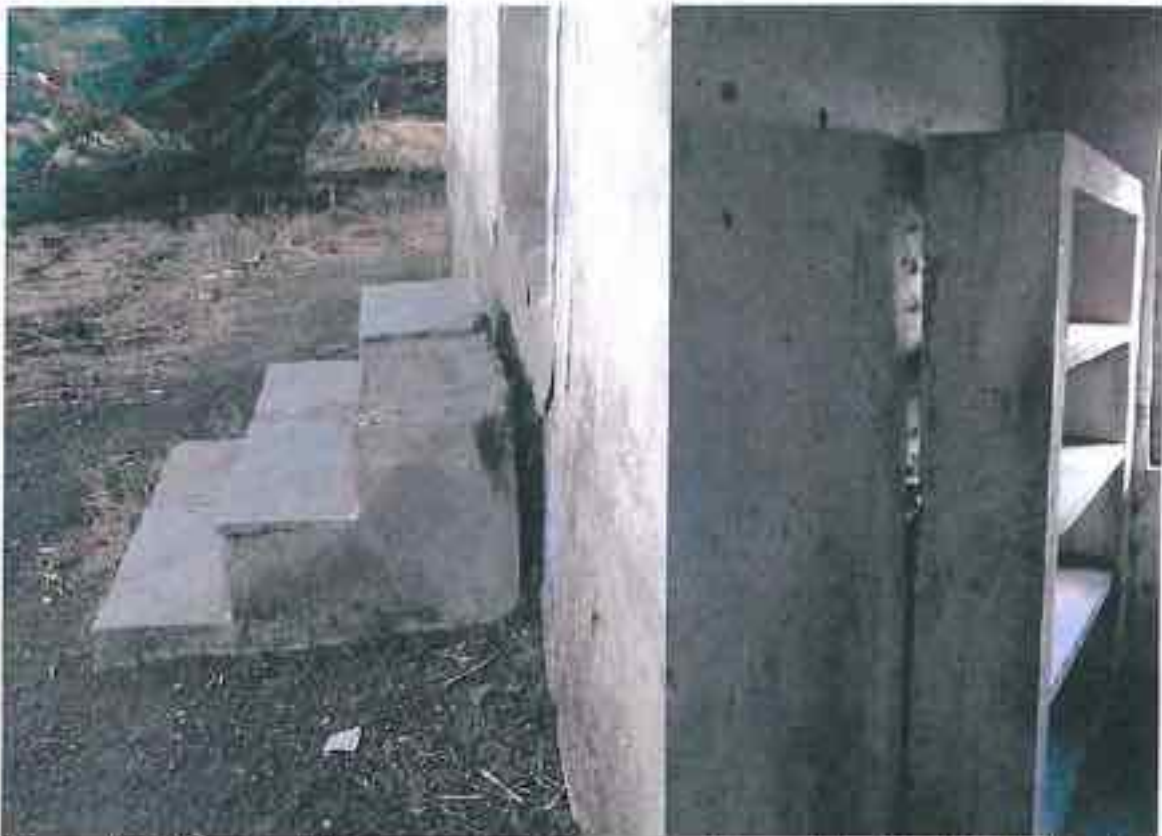
10. At a few sites, the Stairs at entry to the building had no bonding with the main building structure. Due to this, these were seen dissociated from the building structure and found displaced (Plate 2.1.3). Similarly, in few cases, the bonding was seen to be missing with the Almirah etc also (Plate 2.1.3).

Moregadhi: Dissociated Steps

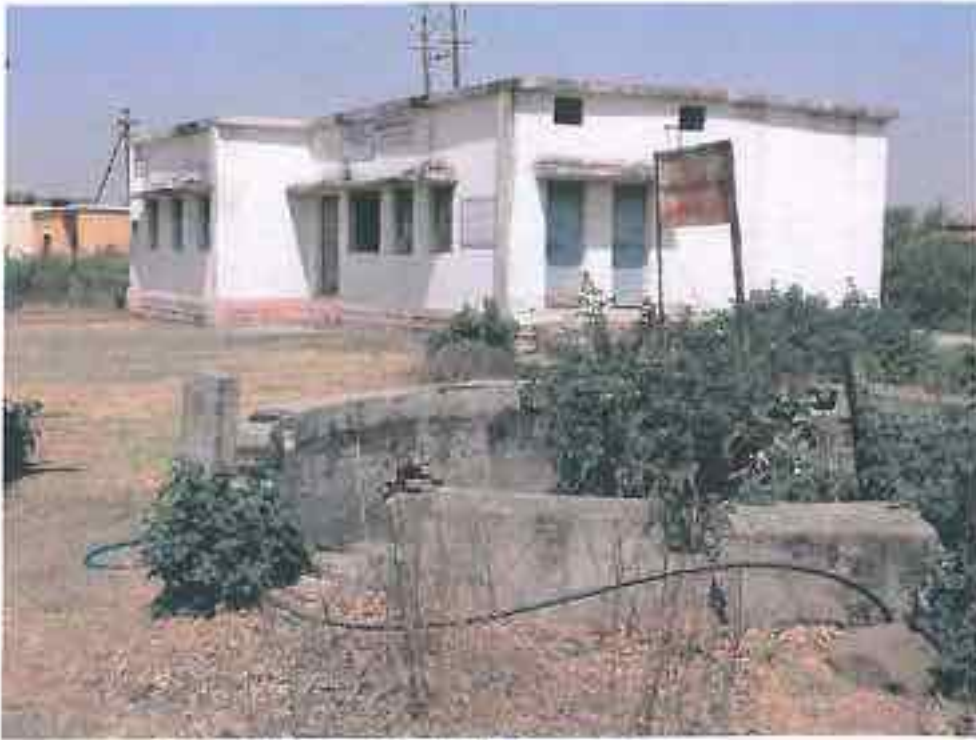
Plate 2.1.16. Compromise with safety - Insensitive Planning & Execution (Typical).

Panya: In Primary School II campus, a huge well 70-80 ft deep exists inside the school premises and fencing. The well has its boundary damaged and broken in parts, and is without fencing. This well water is being pumped by a motor inside the pumphouse located nearby and had a direct connection without any meter. Serious chances of accidents for school-children. Insensitive planning and gross negligence.

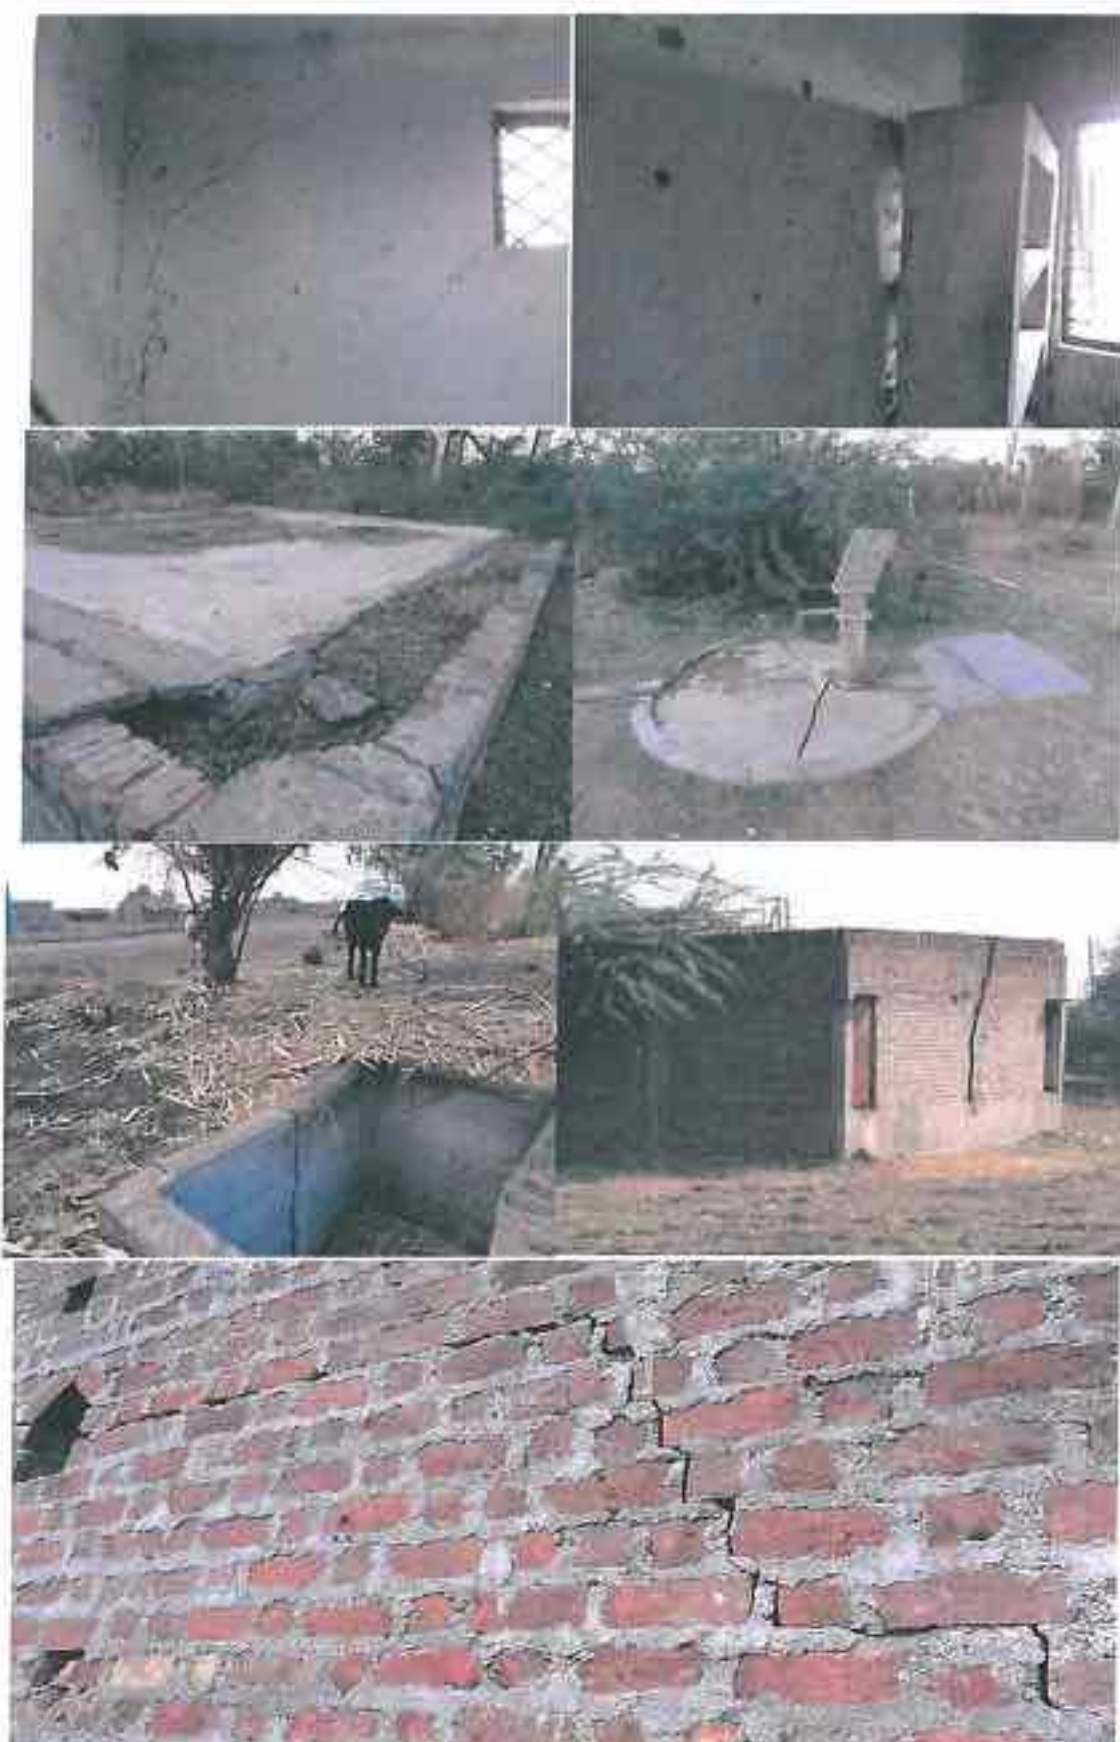
Plate 2.1.17. Construction in Prime BC Soil at Moreghadi and Khalbujurg: When the structures made by engineers have given way (top 4 photographs for Moreghadi), how will houses and structures of oustees (bottom 3 photographs) survive the onslaught of BC soil without any Technical help?

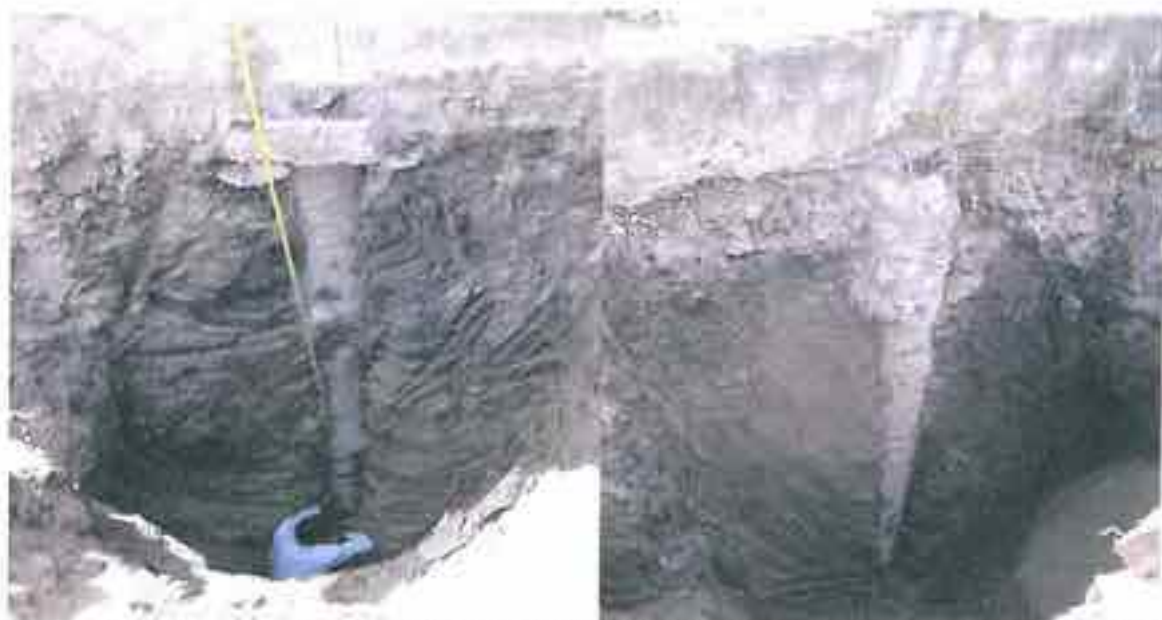
Noticeable pile eccentricity along the length (left), and shorter pile length (right) at Moreghadi Panchayat Bhawan. The depth of pile was found 20 cm short - as per MB it should have been 3.6 m, but pile measured only 3.4 m. Pile cap had a depth of 0.20 m.

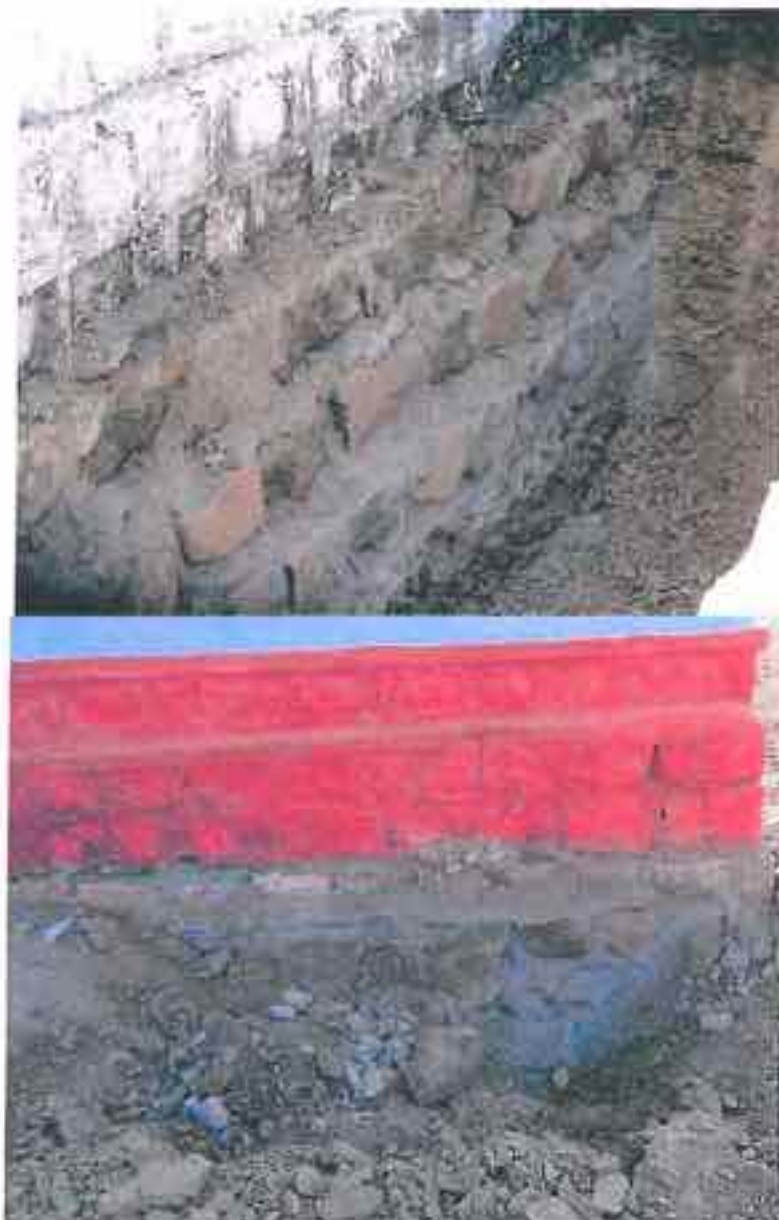
Bolai I Primary Health Centre (Top) & Morekatta School (Bottom) showing poor and thick masonry joints

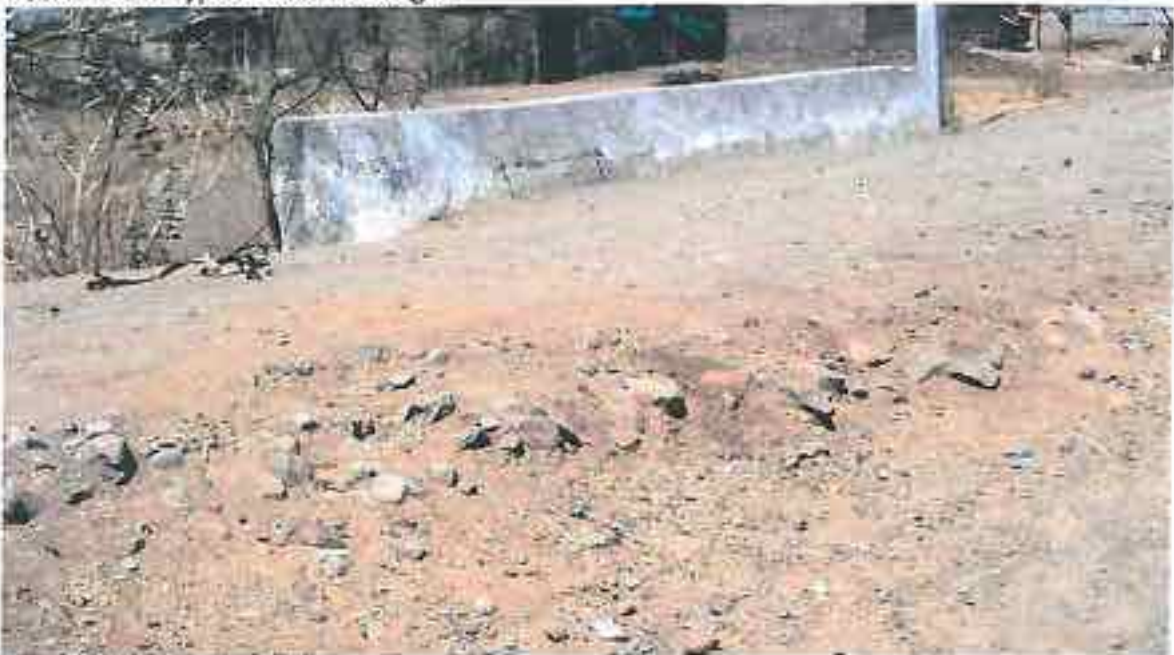
Gawla II: Typical road damages

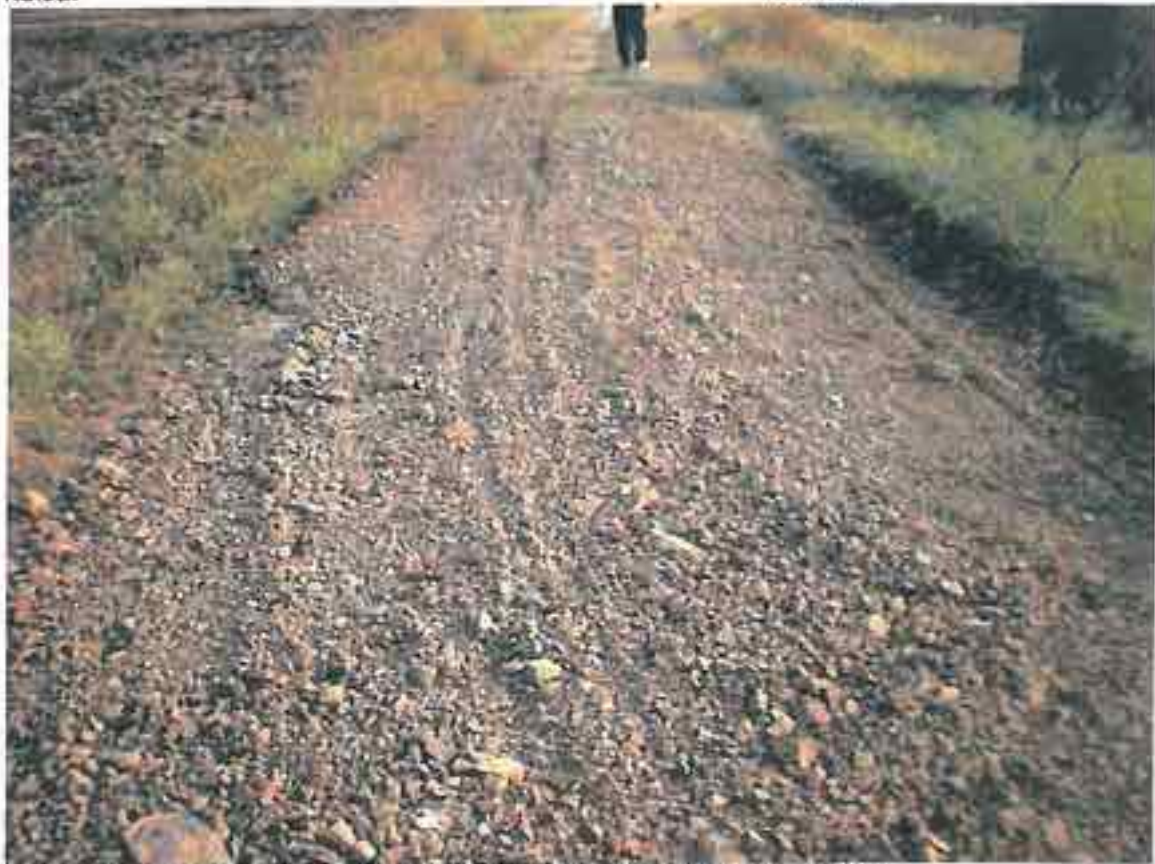
Kaisur : Loose aggregate material, shoulders infested with vegetation.

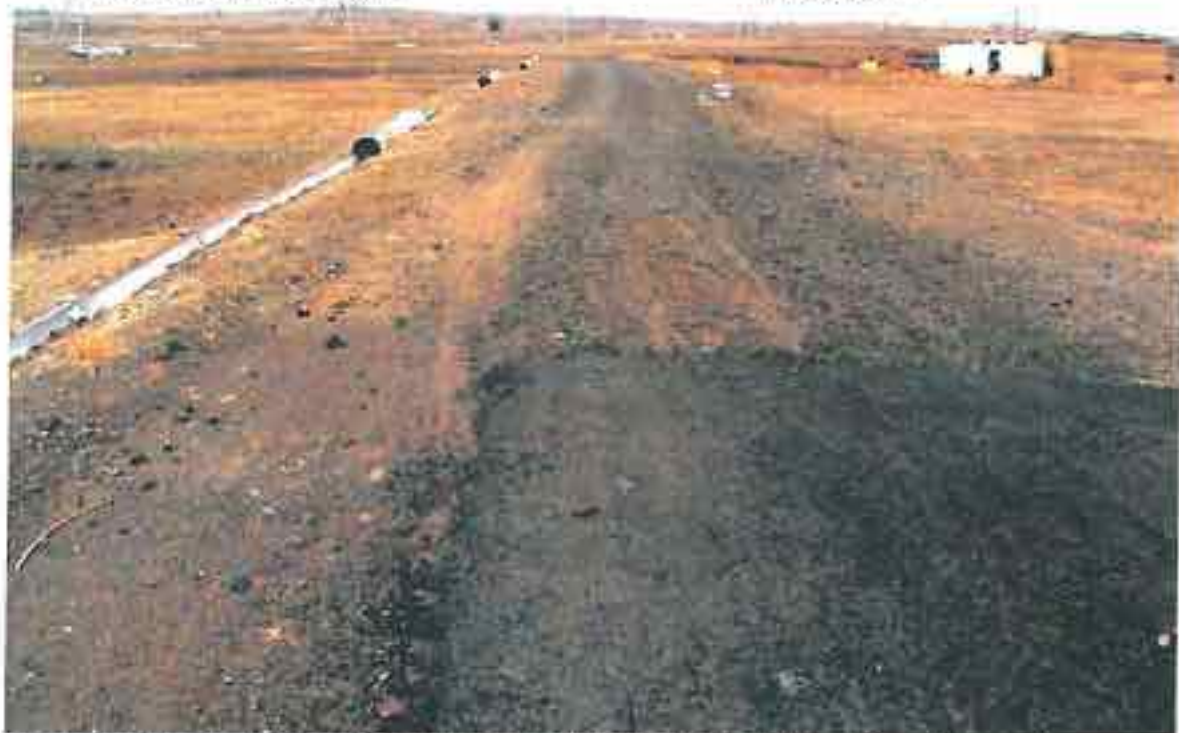
Plate 2.2.4.Damaged Bitumen Road Surfaces (Typical)

Beganda : The bitumen surface appears to have been applied partly on the road, or may have just completely eroded over large parts of the road.

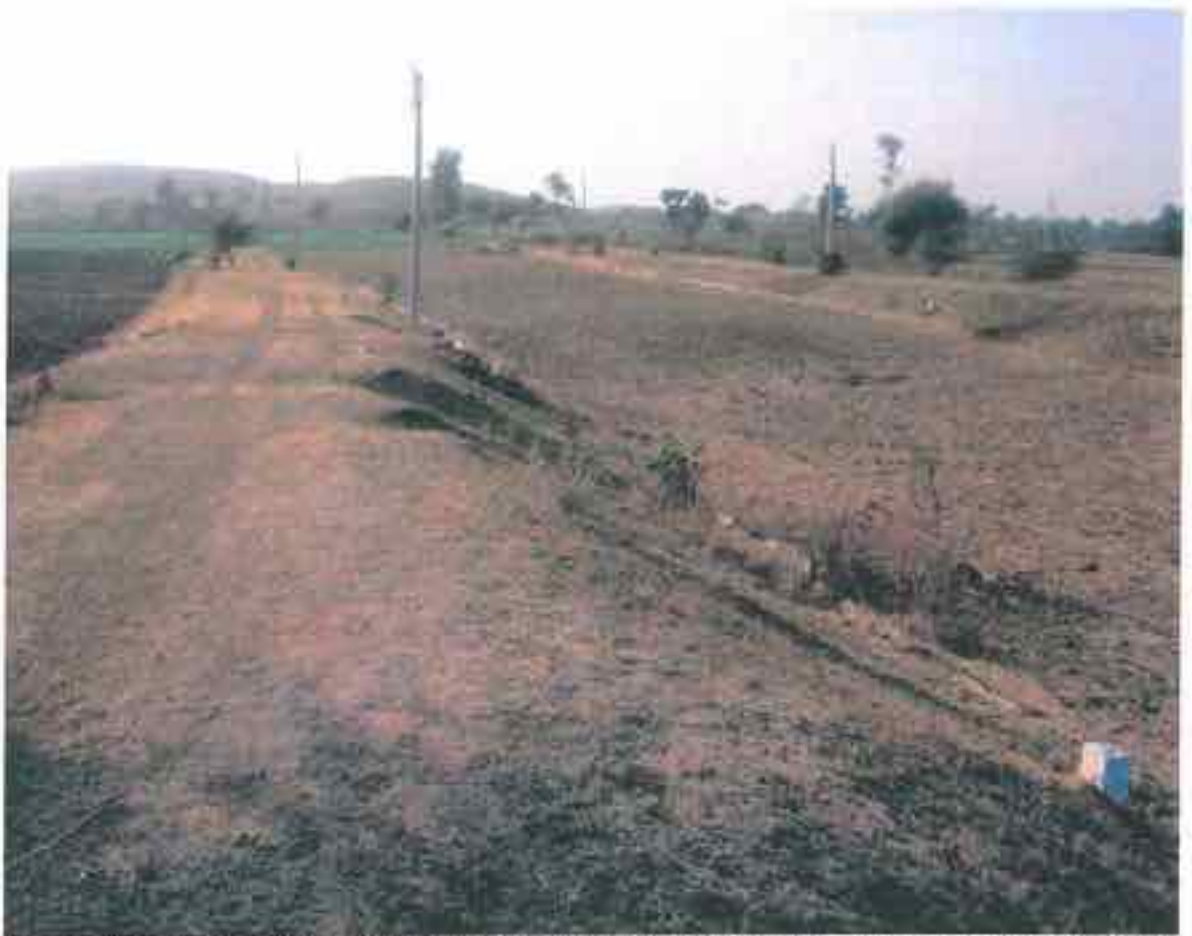
Chandankhed: Poor road condition, Poor condition of shoulders. Mark the position of the plot stone and electric pole. Note that there is no provisioning of street lights.

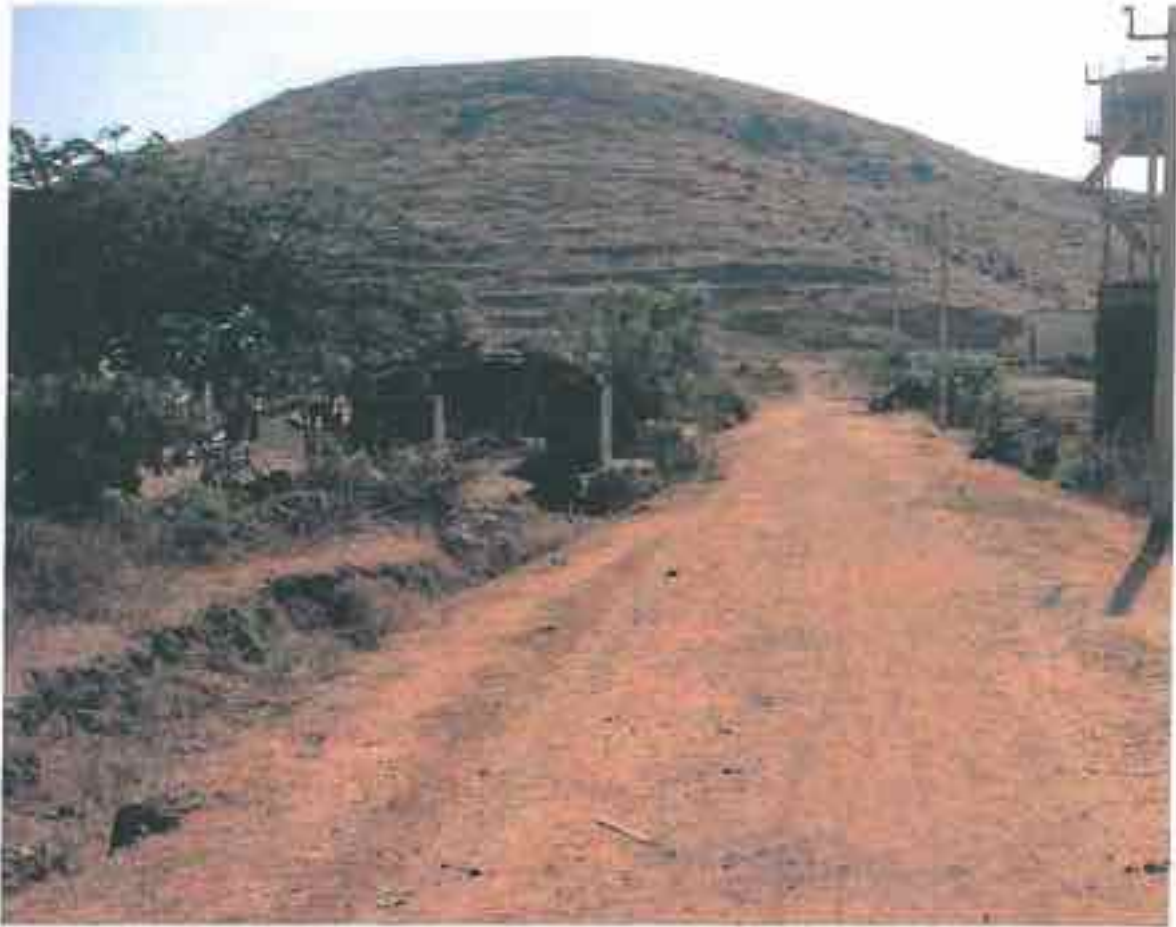
Sirsaani: Deep trenches alongside the road. Are these trenches made during construction by use of soil therein?

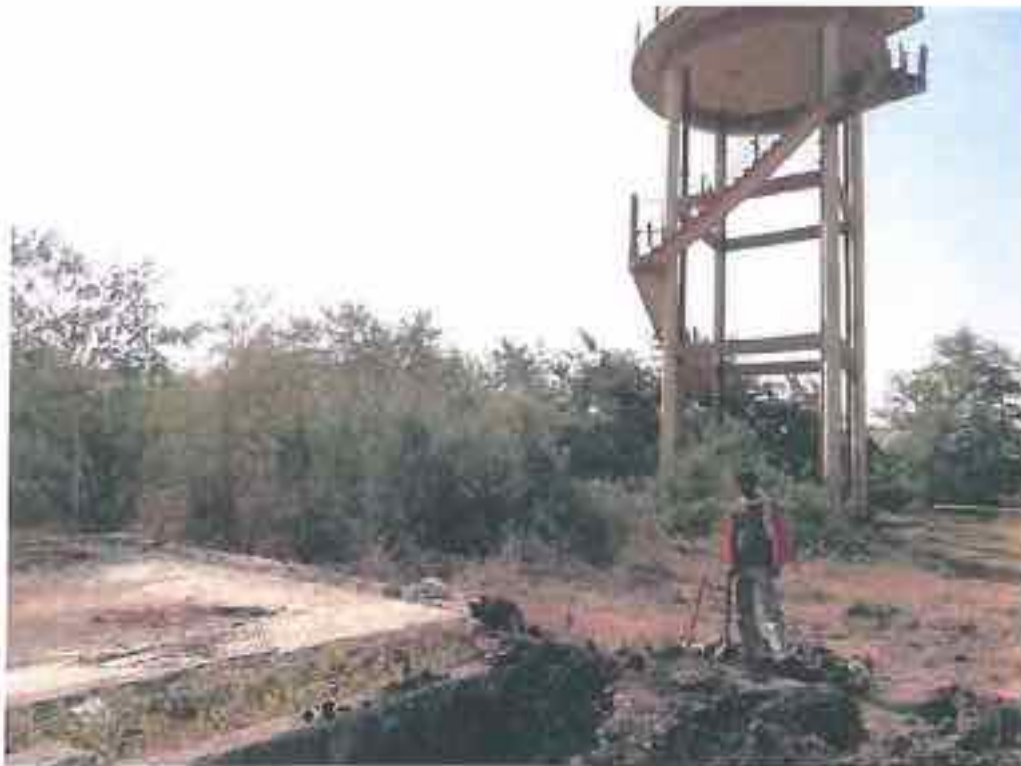
1. Top left hand corner: 3 Tree Platforms indicated by blue balloons in Building premises within nearly 50 m: Note the difference in their sizes. Also seen are the nearby located three septic tanks with blackish dots indicating that the septic tanks covers are missing.
2. On bottom right hand of satellite imagery: A platform in the overhead tank premises (Actual Photograph below).

Moreghadi: A Tree Platform in the secured, secluded Overhead Tank premises

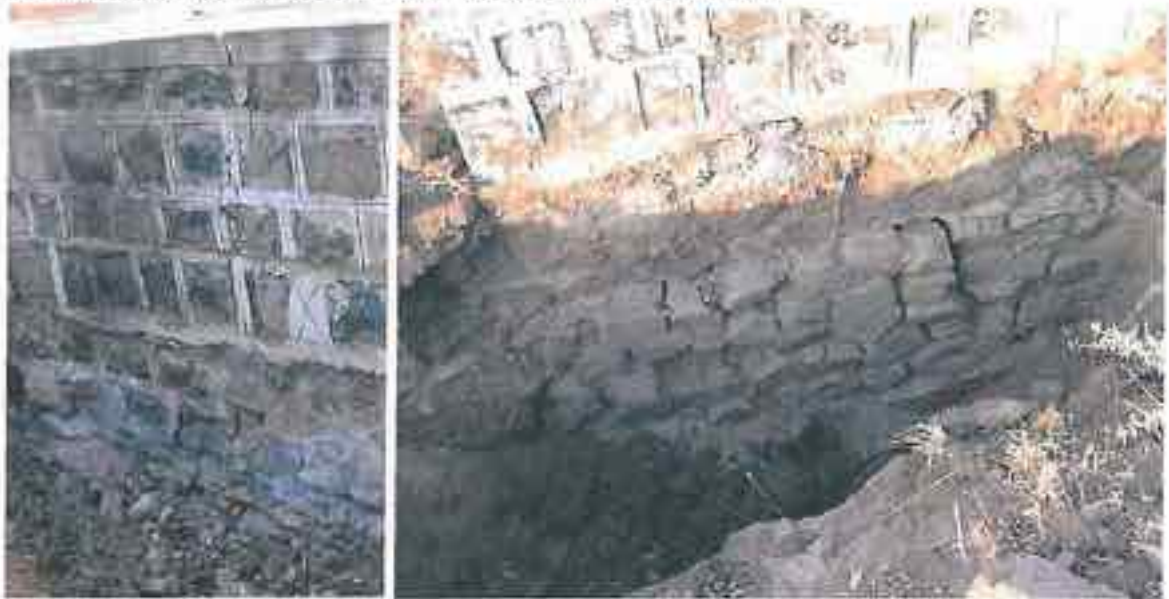
Foundation of Tree Platforms showing poor masonry joints leading to vertical cracks at Eklera(left) and poor and almost non-existent masonry joints at Khedi Bagood (right).

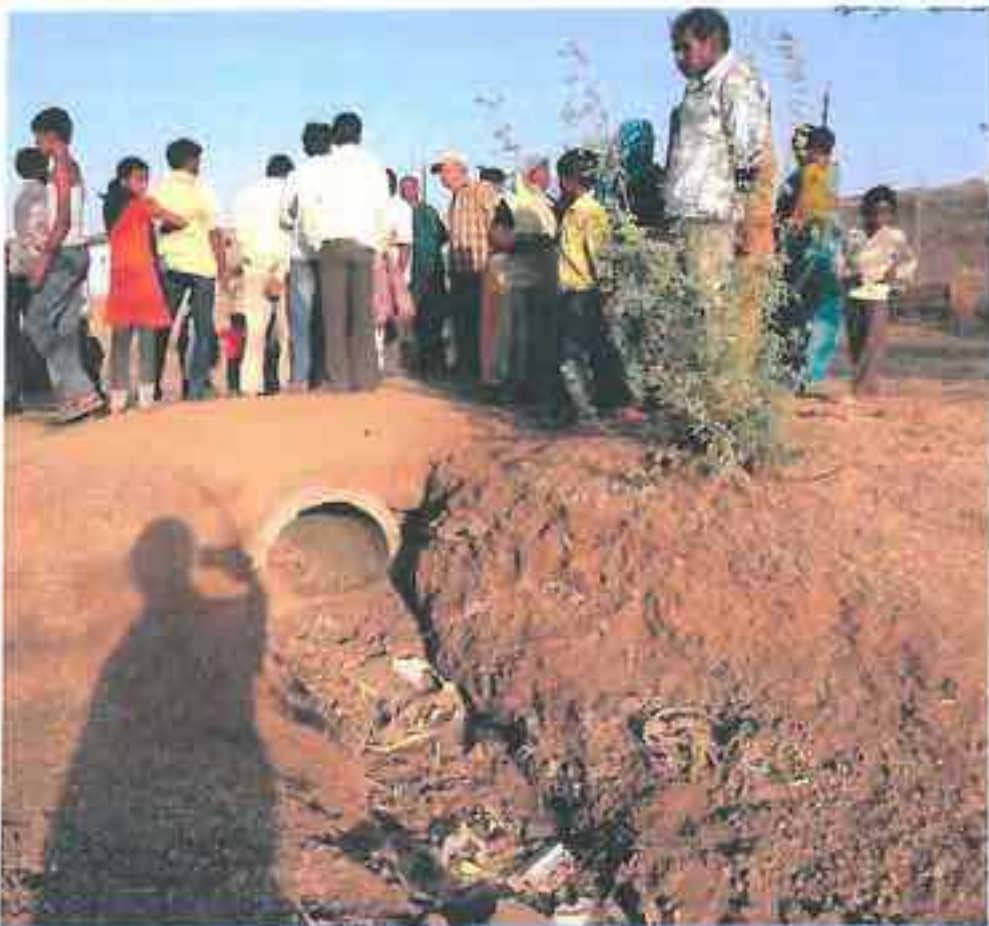
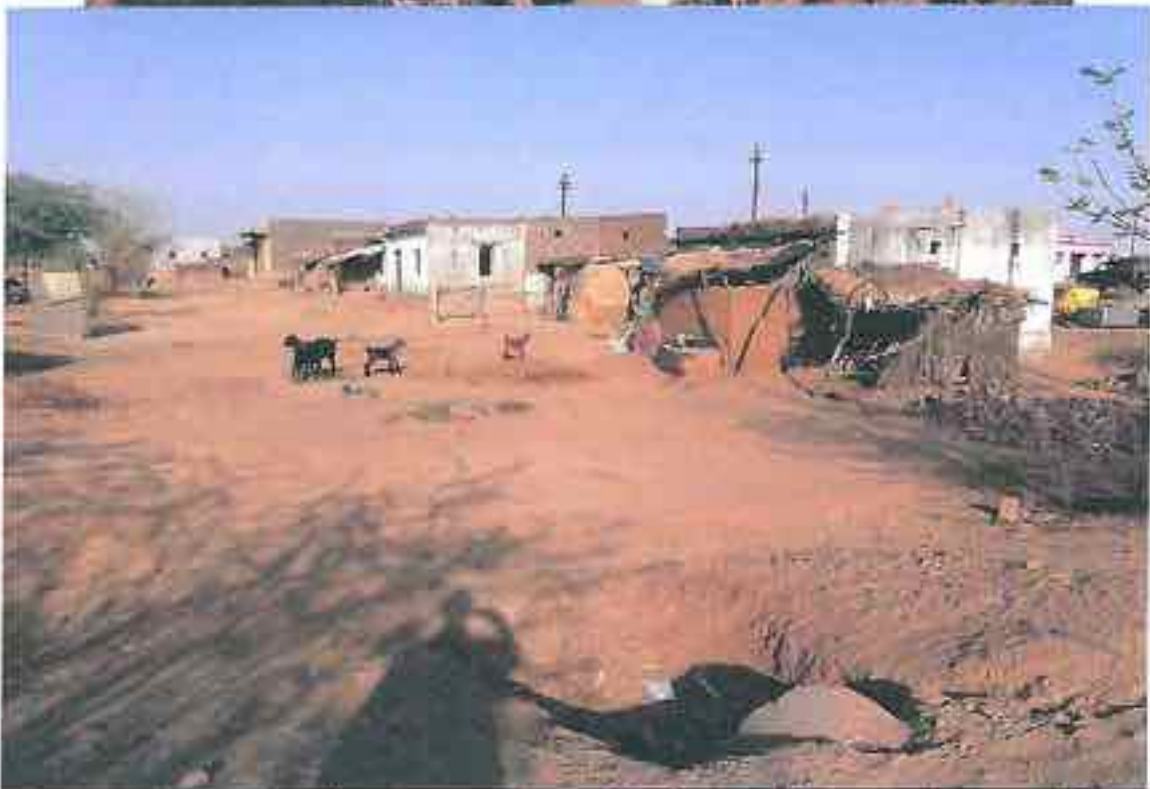
Takiapur → Pipes put in adhoc manner across roads for providing some drainage. At times this would be sufficient, at times insufficient due to inappropriate pipe diameter to drain water. Result is complaints of water not being drained and flooding of houses.

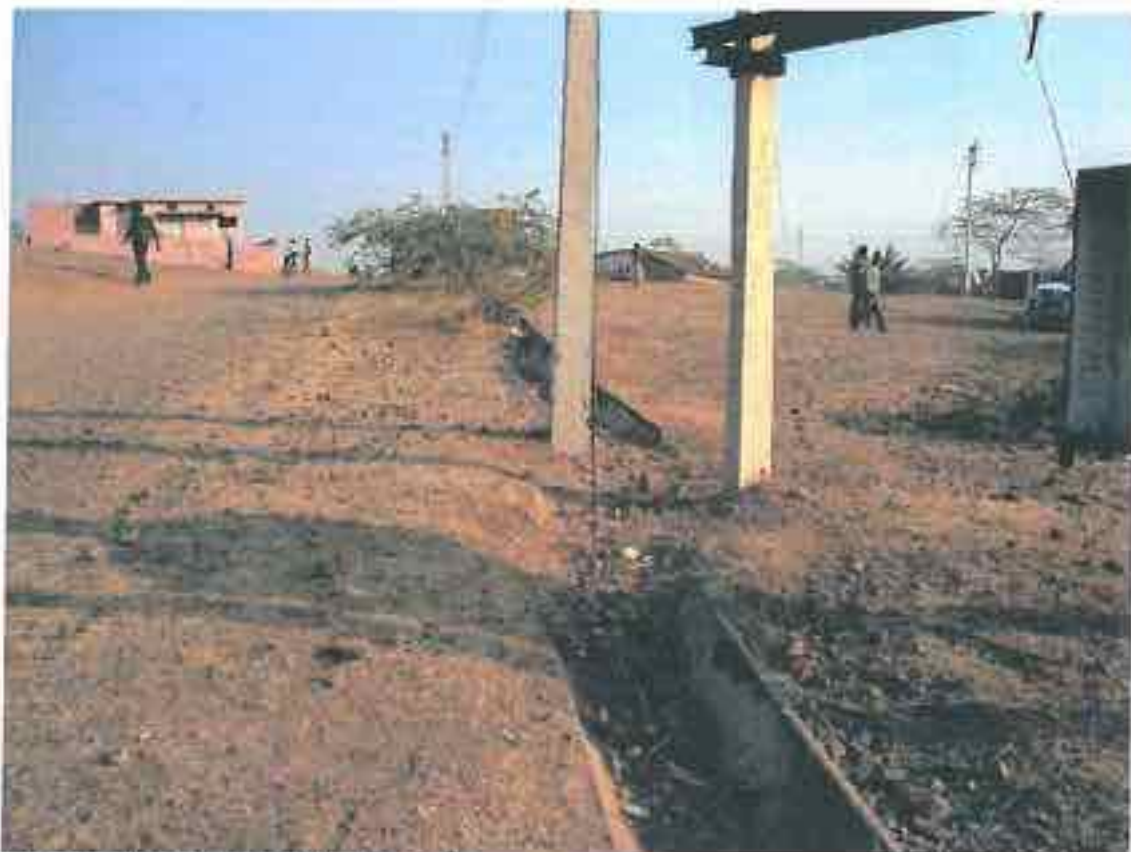
Chandankhedi: Unaligned drainage

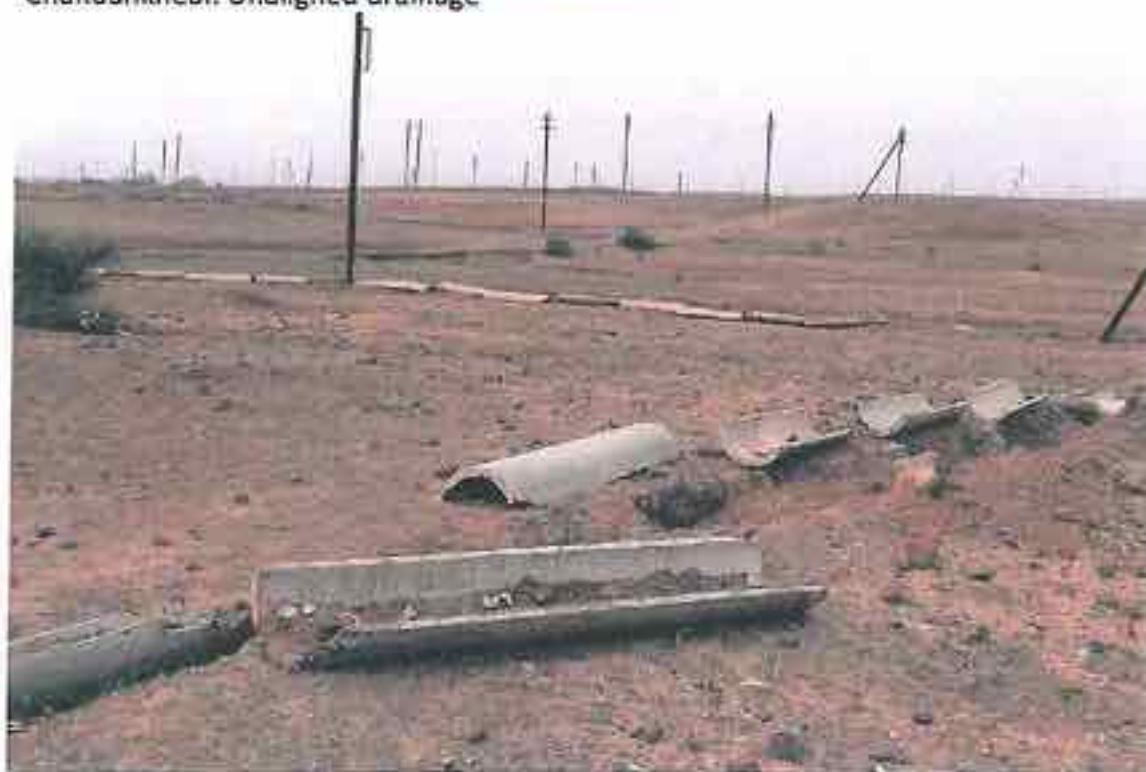
Kasrawat (Dharamपुरi): Doubtful if this drainage system was ever laid, although excavation ruts exist. On a site on which virtually no one lives, one wonders what could have possibly led to such a damaging scenario. Complete apathy and lack of interest in execution of works, or incomplete works may possibly be the reasons. Even if it is a case of incomplete work, who bears the financial damages of this wasted infrastructure?

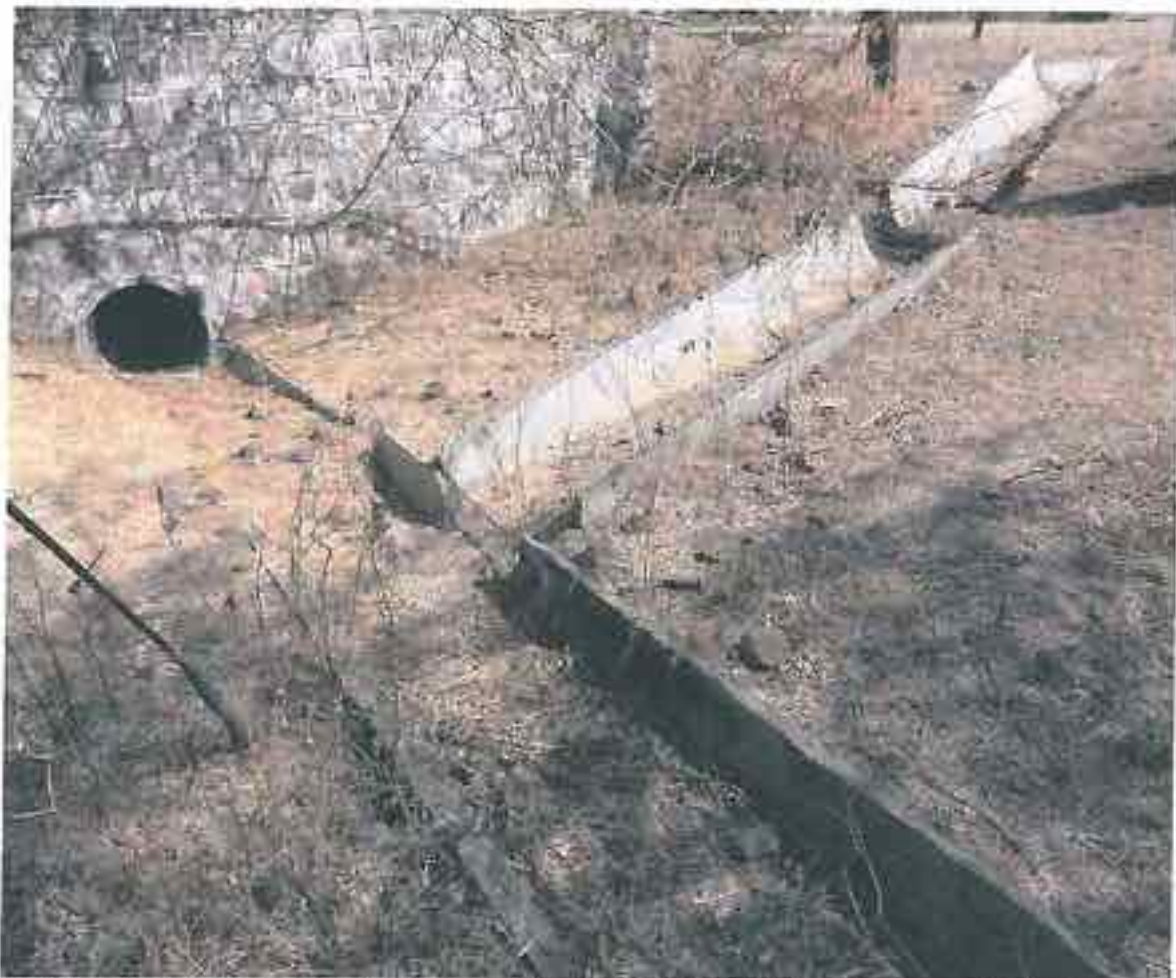
Bhawati II (Typical): Is the outgoing pipe diameter sufficient? Also seen are the broken connections at pipe joints. Two 600 mm half round pipes discharge water into another 600 mm half round pipe.

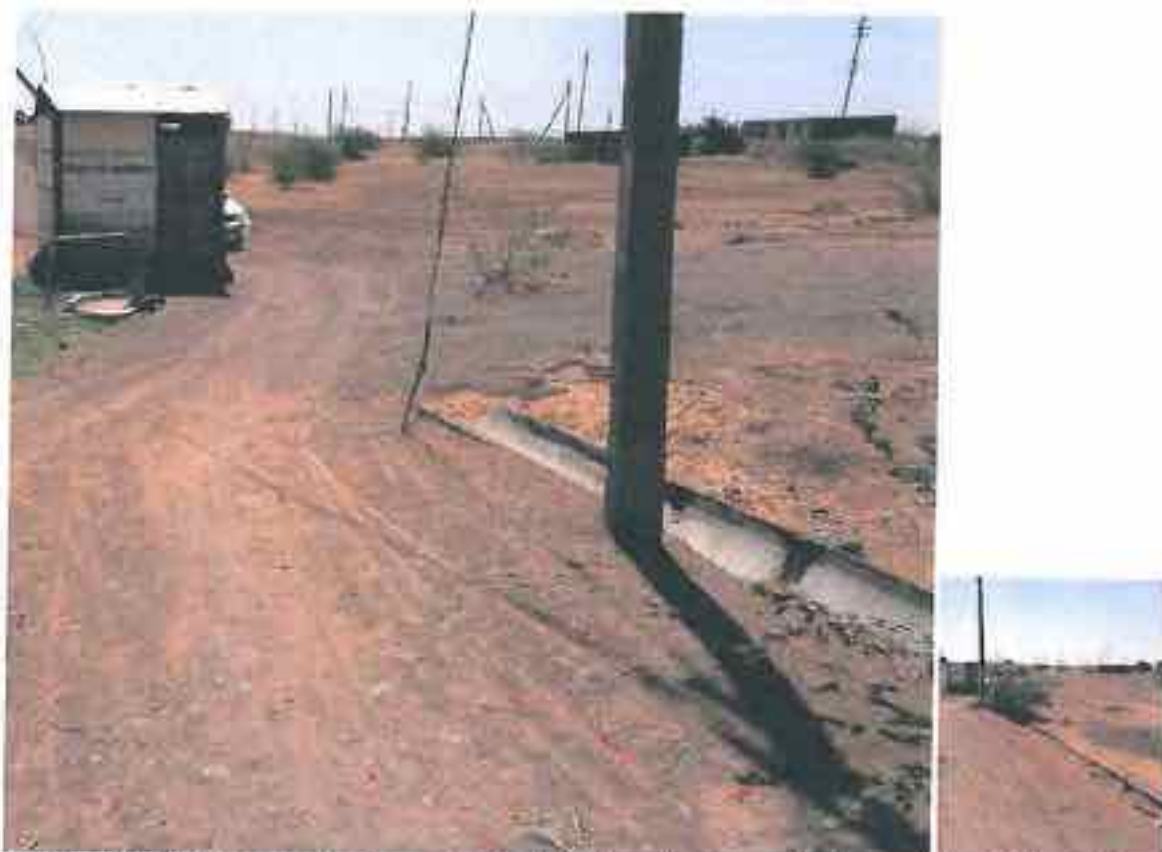
Ganpur Sirsi: Photographs of a semi-circular pipe drain coming from slope drains directly towards the Pumphouse some 6-7 m in front, posing risk of flooding of Tubewell and pumphouse during the rains.

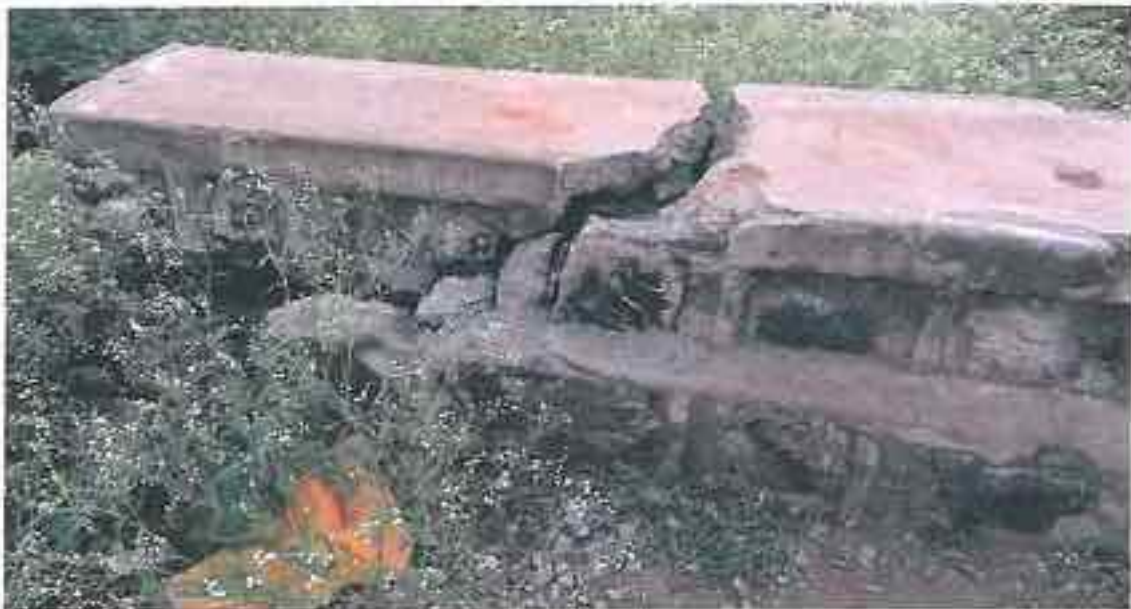
Ganpur: Foundation failure and poor workmanship of RR Masonry culvert

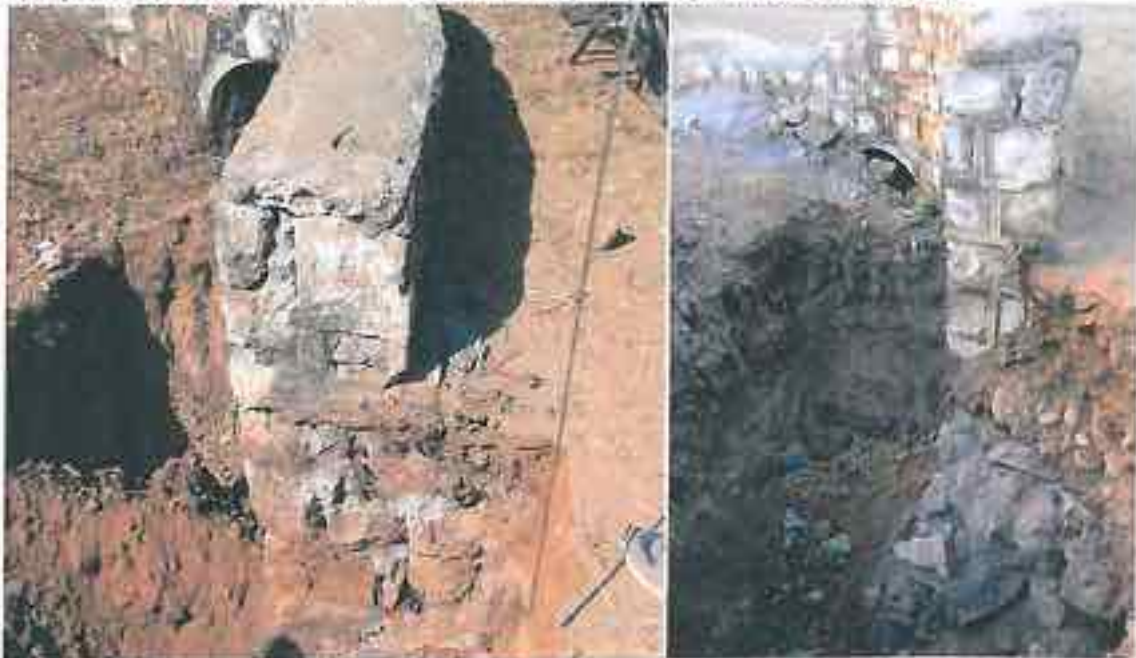
Jamda (left) and Kalyanpura (right) : RR Masonry culverts with poor quality of work

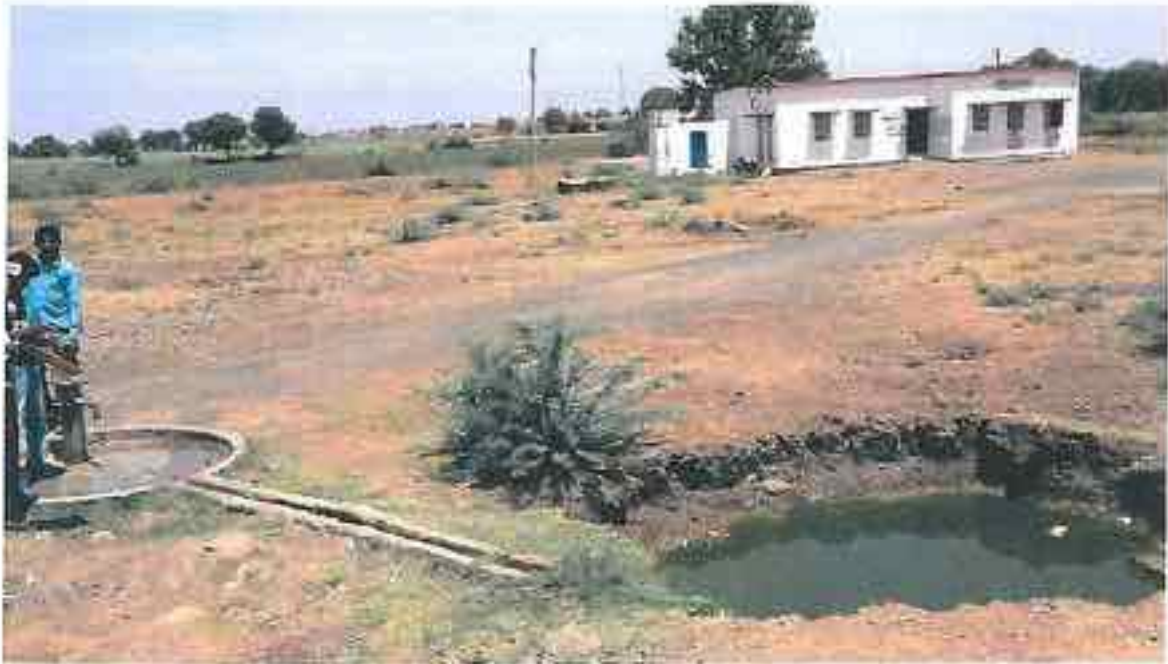
Sala (Dharampuri) : A HP near Primary School. The primary school in the background does not have any fencing and gate arrangement, giving schoolchildren ample opportunity to dwell around. HP would be a favourite place due to availability of drinking water here. But the disposal arrangement in a deep ditch for HP drainage is essentially unsafe and adhoc, and the collected water would stagnate to breed mosquitoes.
