Evaluation of the Quality of Civic Amenities at Rehabilitation Sites of the Sardar Sarovar Project

**Sardar Sarovar Project - Fake Sale Deeds and Rehabilitation Sites
Irregularities Inquiry Commission**

April, 2014

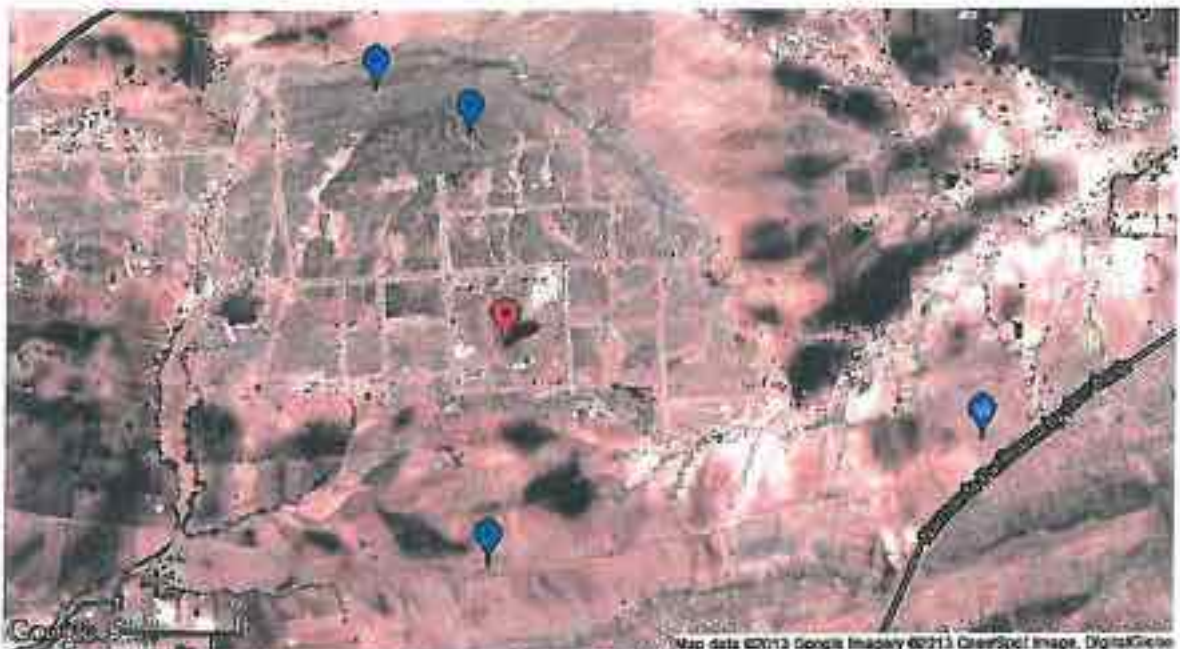
Dharamrai-Satellite imagery: Note the position of the Handpump (extreme Right-Blue mark with whitish centre) which lies more than half-a- kilometre from the nearest plots. The Centre has a Red Balloon which represents the civic buildings. On the far top the two blue balloons represent the two over-ground sumpwells, whereas the tubewell supplying them water is the bottom blue balloon in the centre.

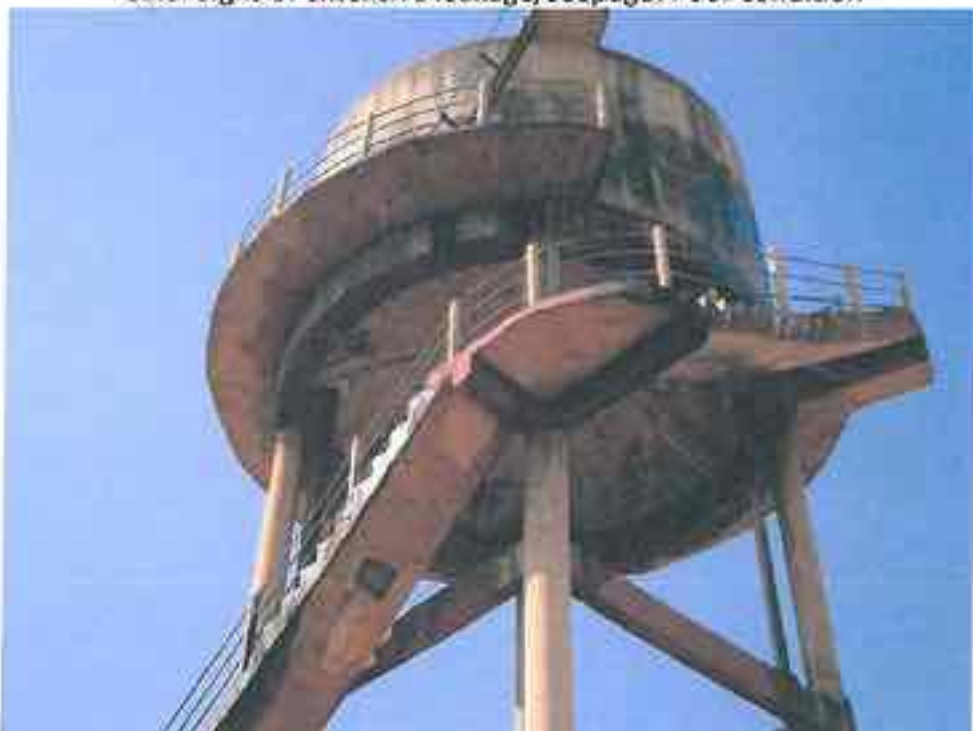
Sirsani: Extensive Seepage despite earlier efforts (whitish marks) at plugging the leakages

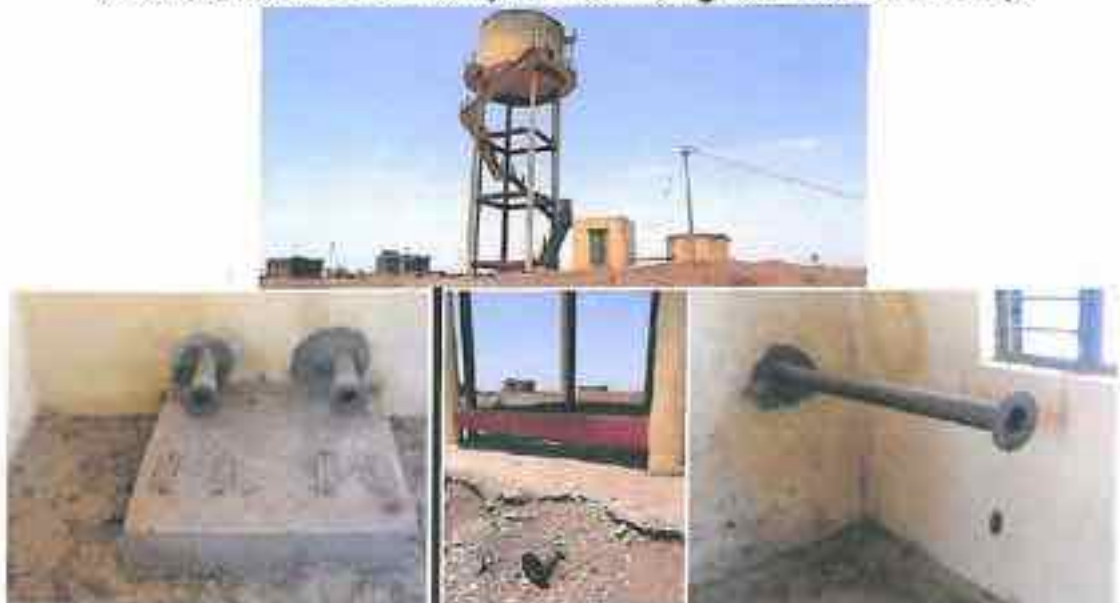
Kadmal: OHT stands tall, but missing Pumps, Connections imply defunct Infrastructure

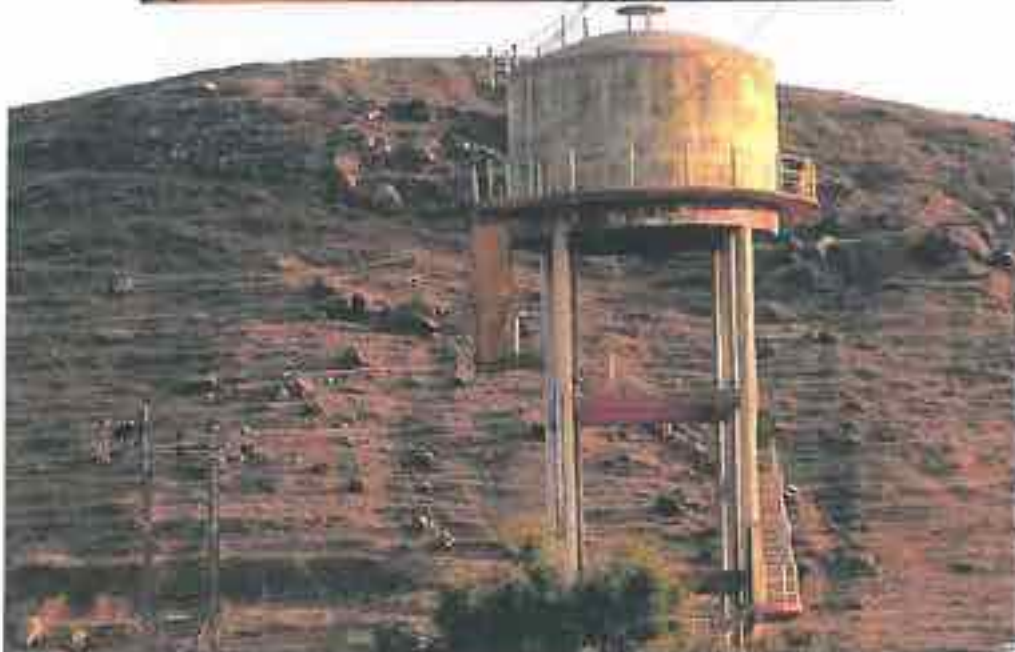
Sirsani: Missing fences, premises not marked and prohibited for public. Building lies too near. The OHT is located just below a hill where boulders lie loose, and may roll down damaging the OHT and risking the lives of people.

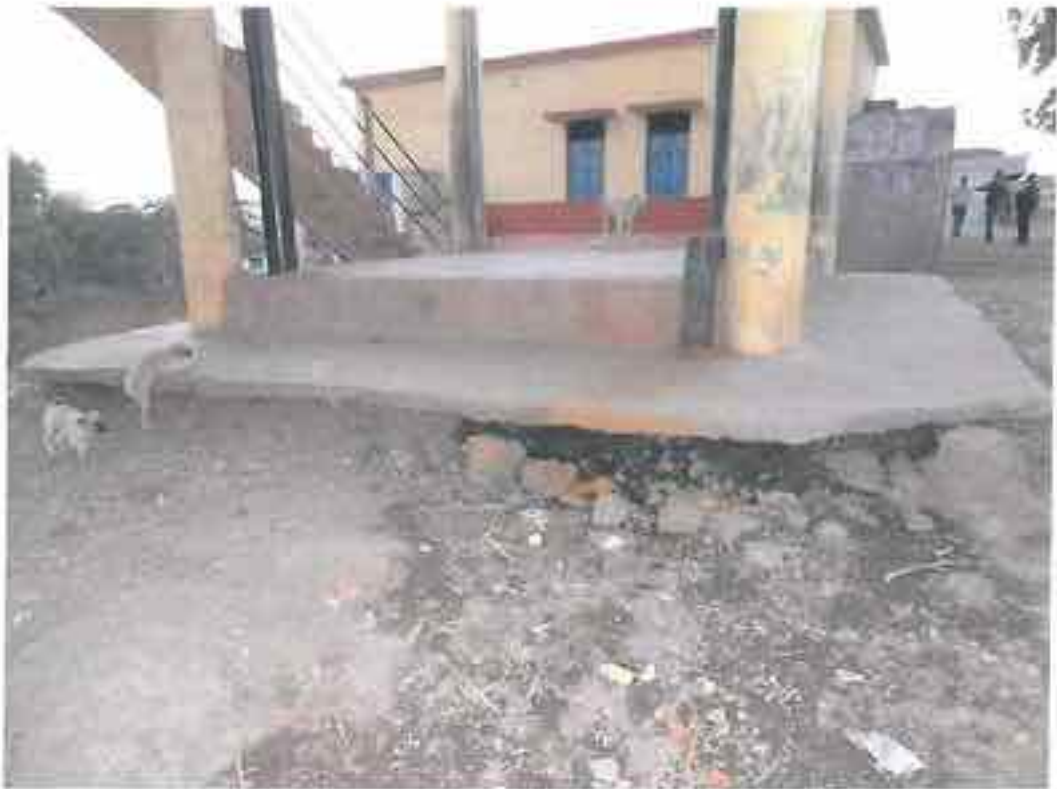
Eklera : Damaged Base Platform for an OHT located within 10 m of a Primary School (seen in the background)

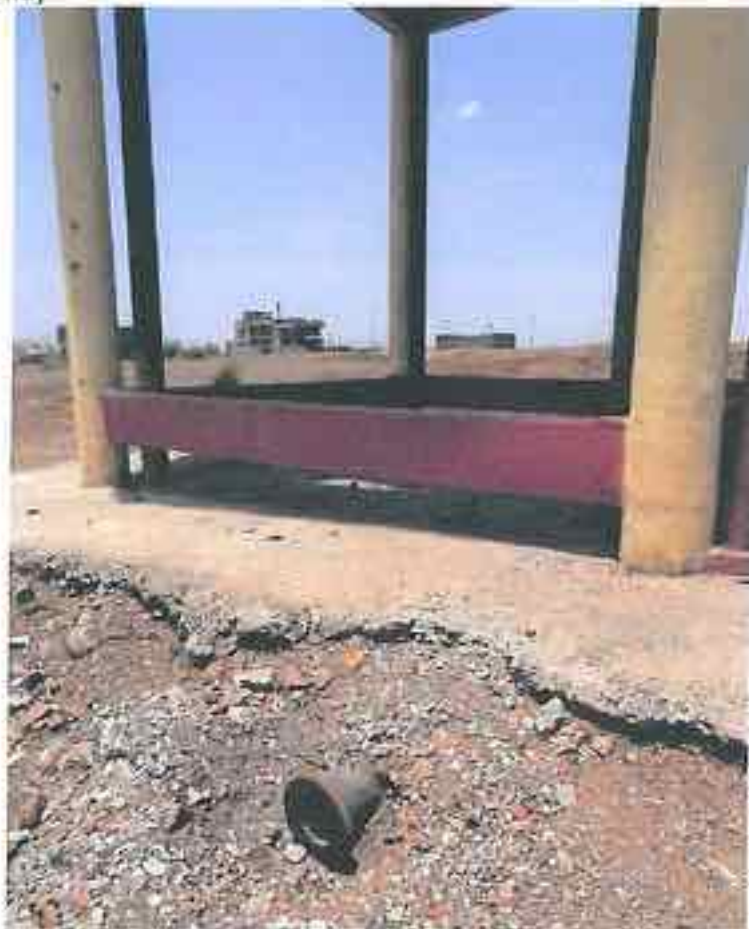
Kadmal: Base platform erosion. Also seen is an unconnected pipe indicating that the OHT is not connected with the Network, despite the structure having been built.

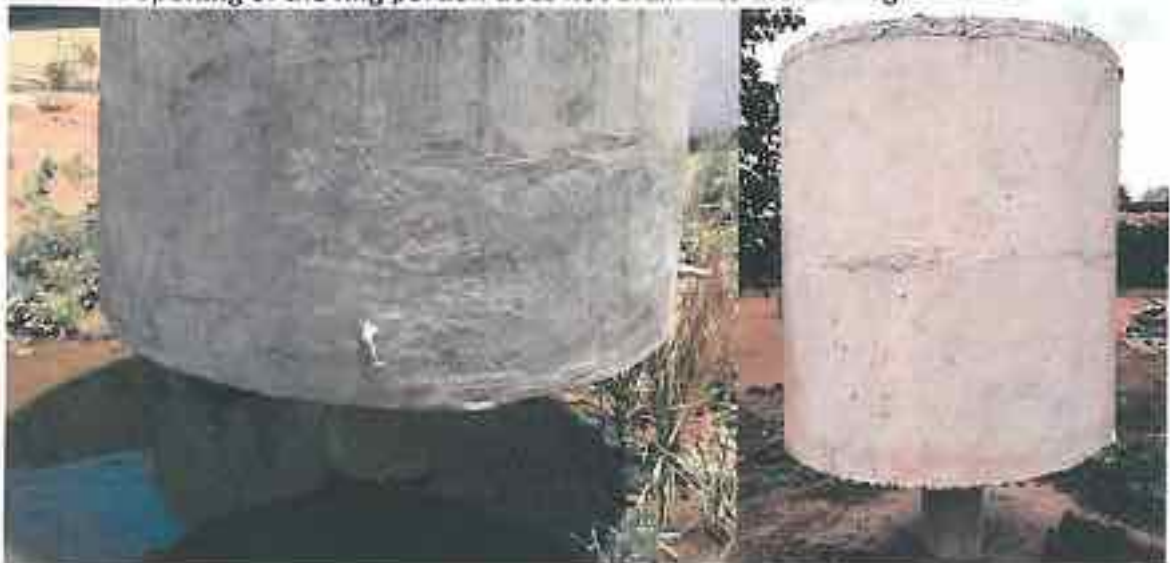
Vishwanath Kheda (Left) & Shakirpura (Right): Whitewash to hide massive cracks?

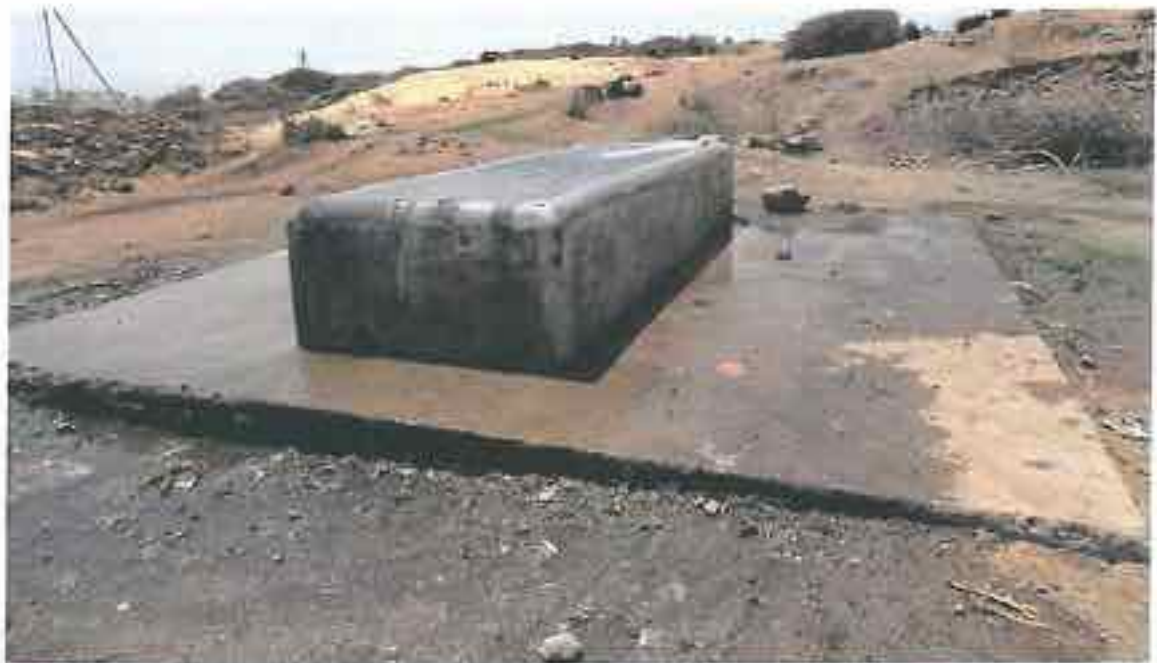
Vishwanath Kheda: Wastage of precious water
No protection mechanism against overflows

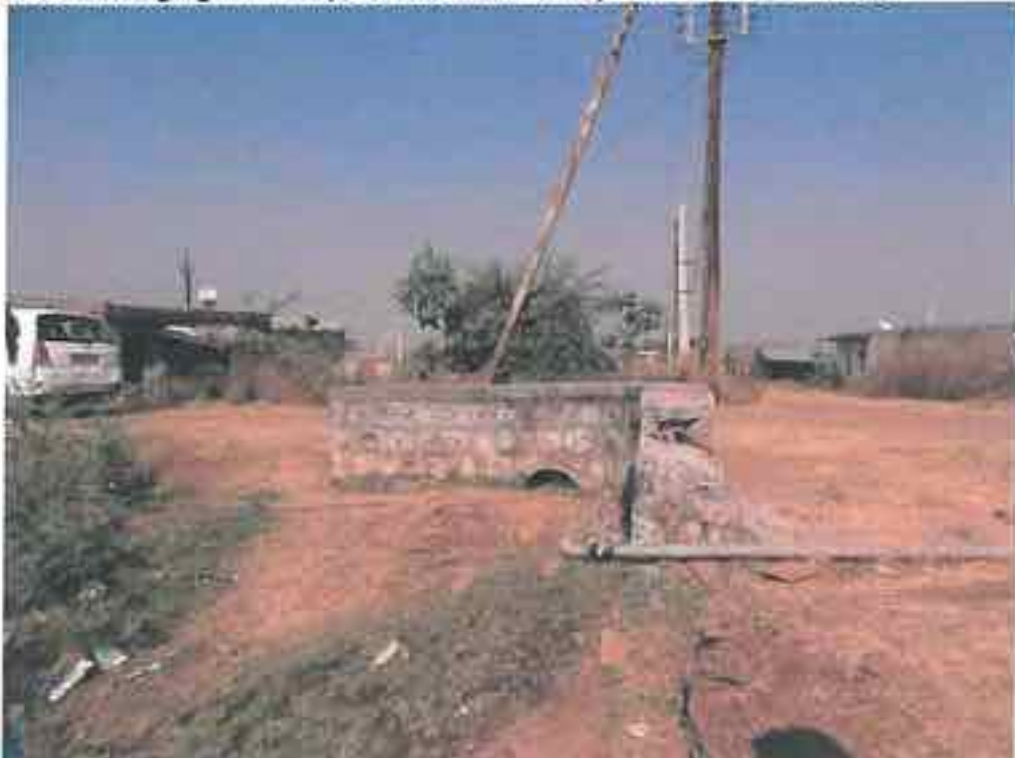
Borlai II: Pipeline laid over a culvert which is half seen as silt has deposited over the culvert drain pipe. While laying, little attention has been paid to retrieve the culvert and make it functional, and lay the pipeline over the actual ground.

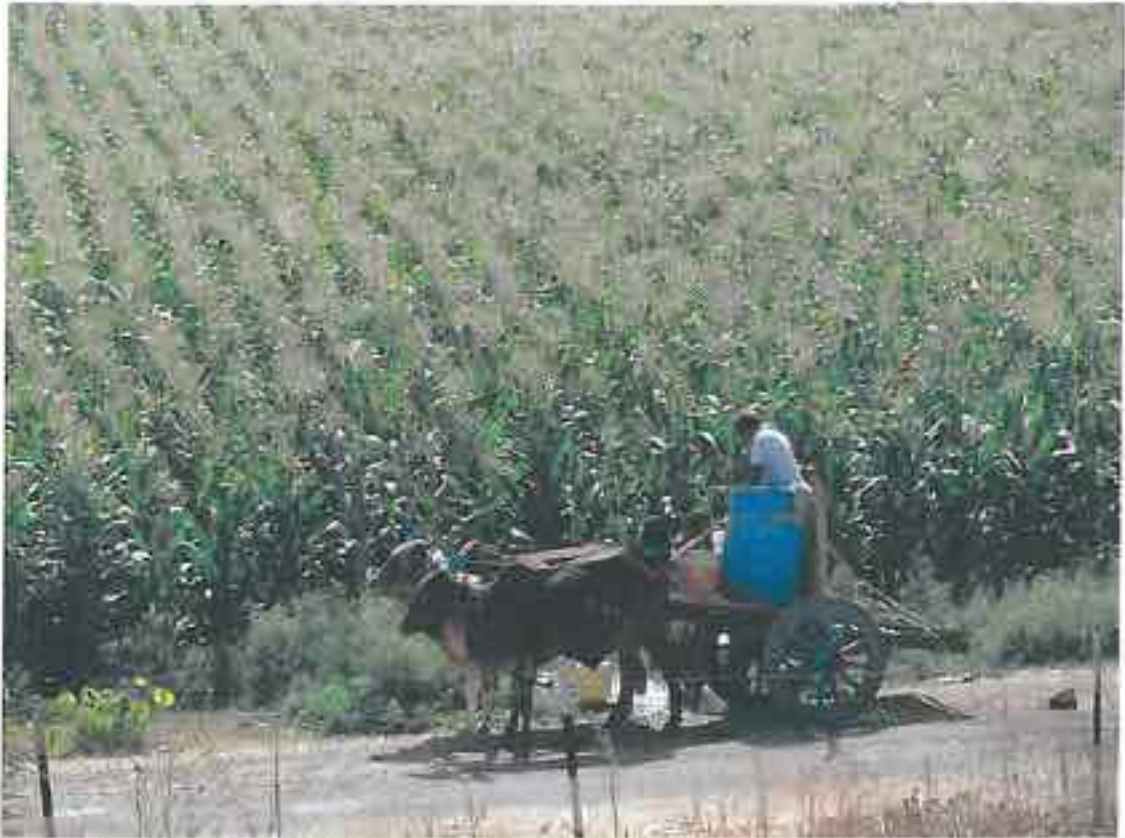
Nalvai: Water being transported by a bullock Cart from an Agricultural Tubewell as pump was out of order.

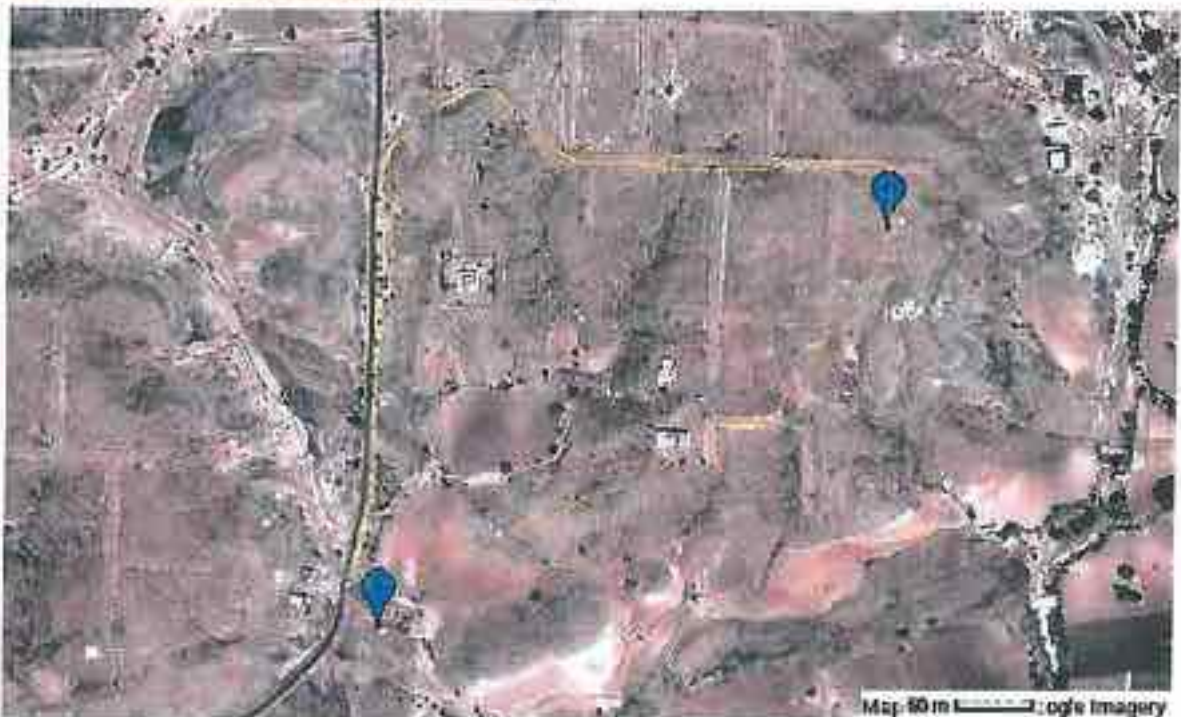
Kikarwas: Pressure pipeline laid from tubewell (bottom Blue mark-at the bottom of hillock) to Cistern (Top Right Blue Mark- on Hillock top). The yellow pipeline as laid goes around the hillock, along the road to reach Cistern. The dashed (broken) yellow line from tubewell to Cistern over the hillock could have saved a lot of capital expenditure, and with curtailed length (no more than 60% of the presently laid line) could have resulted in lesser losses, lesser pumping costs, lesser electricity bills and lesser maintenance.

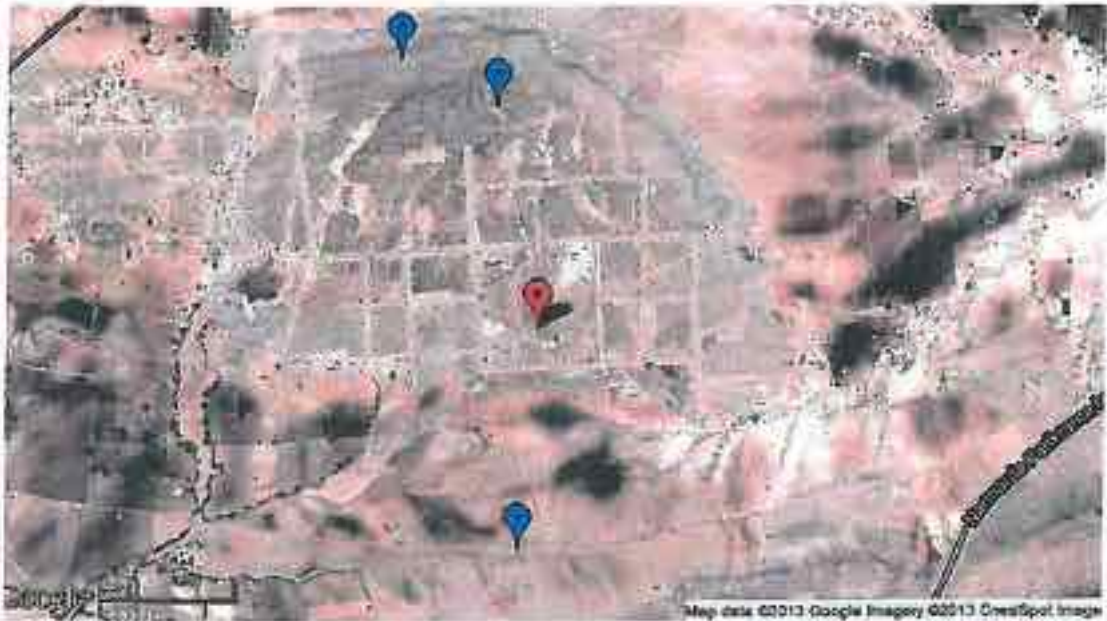
Dharamrai; The remote located tube-well (bottom Blue mark) (note the large distance from the nearest rectangular plot area-the pumphouse lies in crop fields far away from intended habitation) pumps water all the way up to the two sumps (two blue marks on top of imagery) located on another extreme end of the R&R site again outside the plot area, through pipelines laid along the roads of the central area (Red mark at centre) where buildings are located.

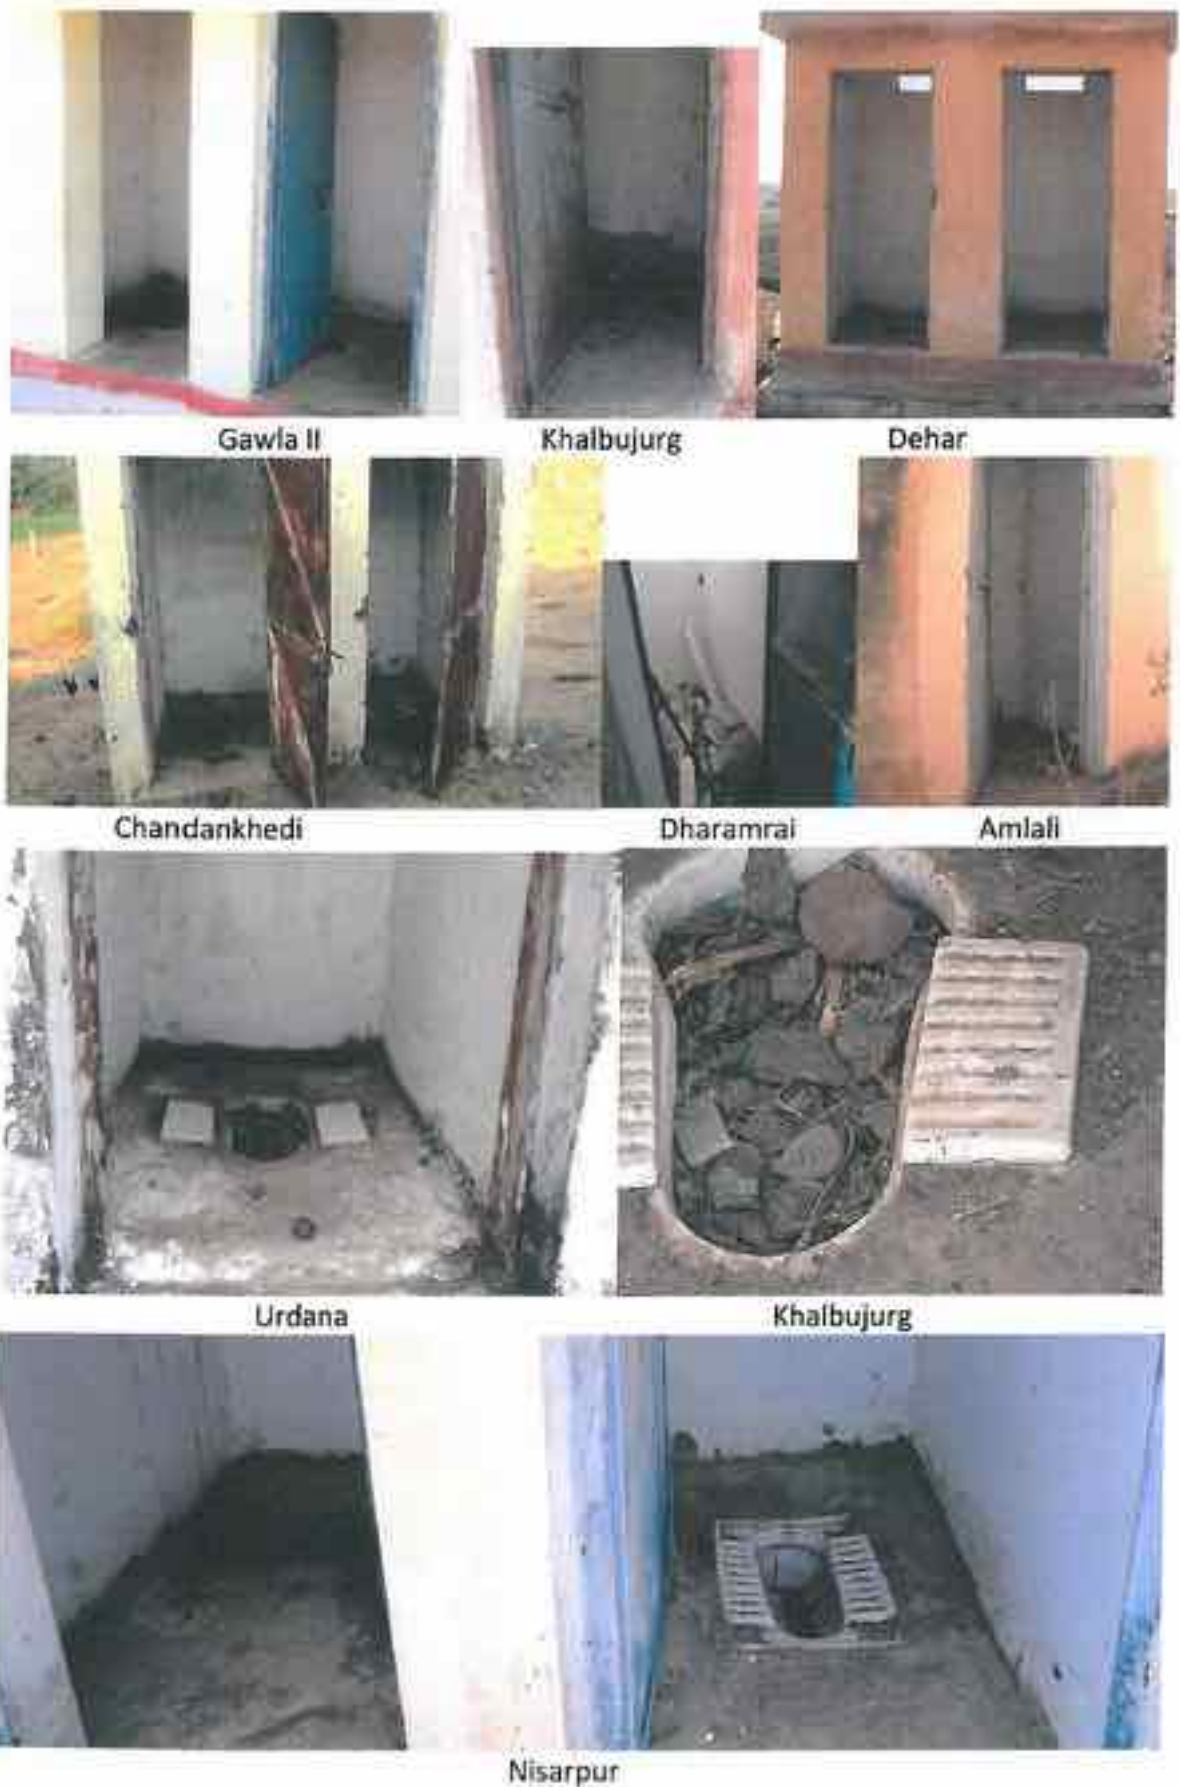
Plate 3.2.1. Dirty/stinking/unmaintained/unhygienic/defunct/out-of-use toilets without any provision of water and light. Typical for most buildings including Schools.

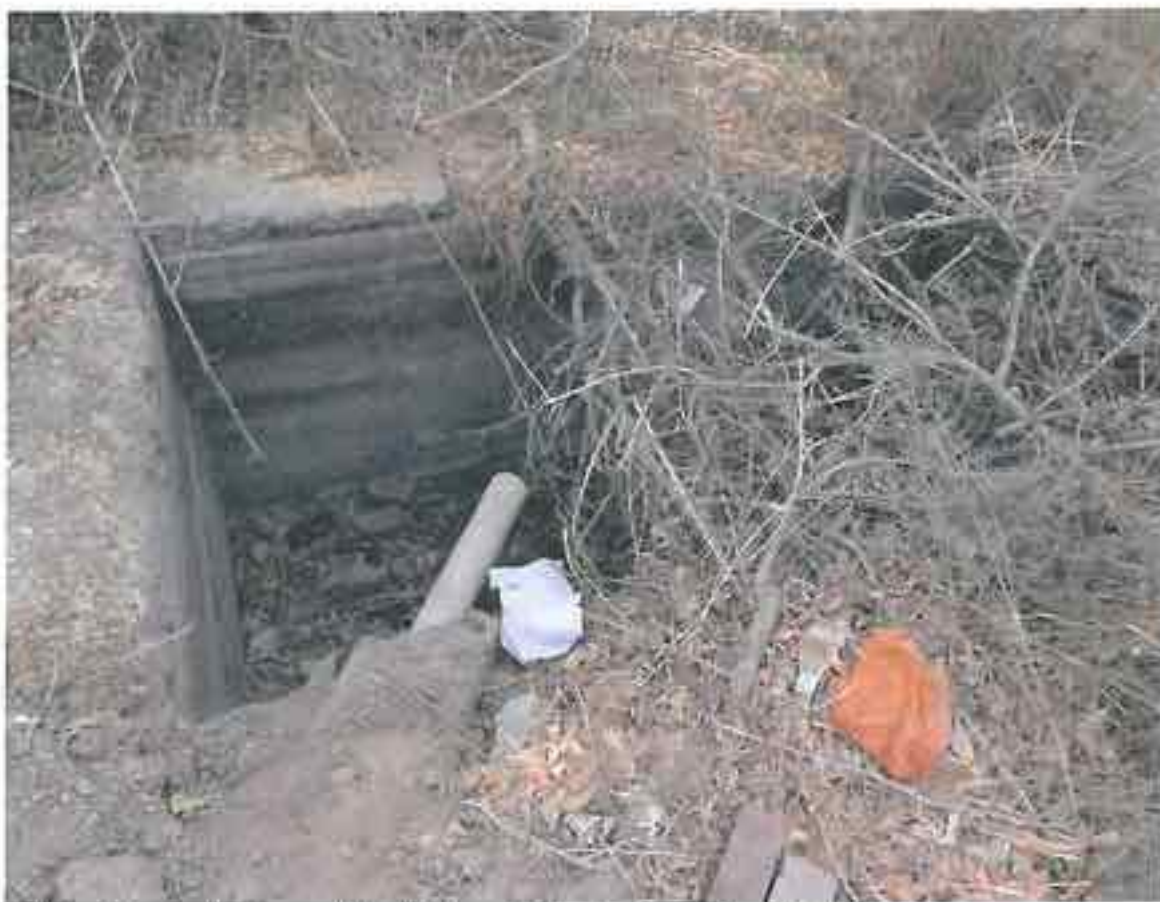
Golata: the whole upper slab of the septic tank not cast/not found

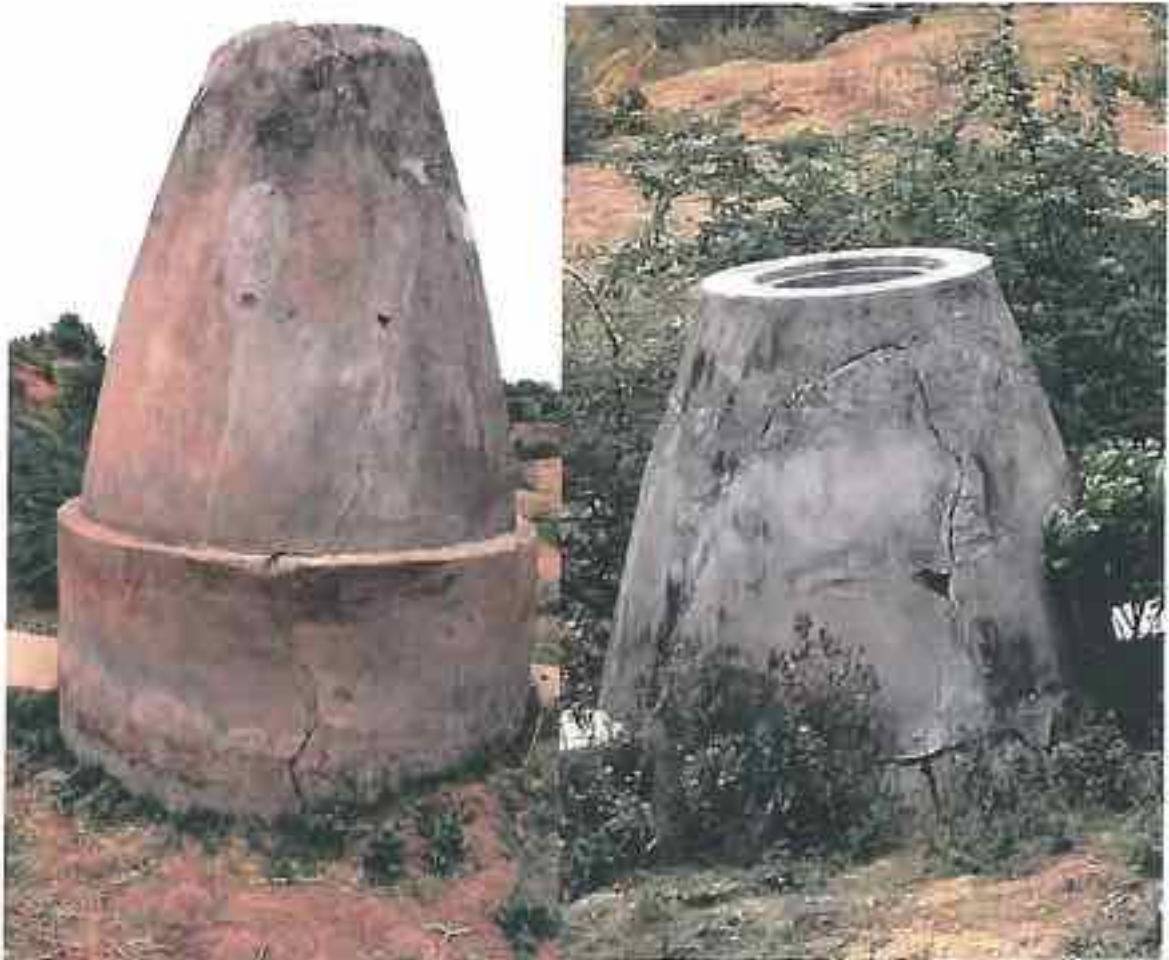
Plate 3.2.9. Dharampuri: Typical Huge sewerage manholes presumably in the low-lying area prone to flooding. Note the large Longitudinal Cracks, and extensive damage. Very poor execution and work supervision.

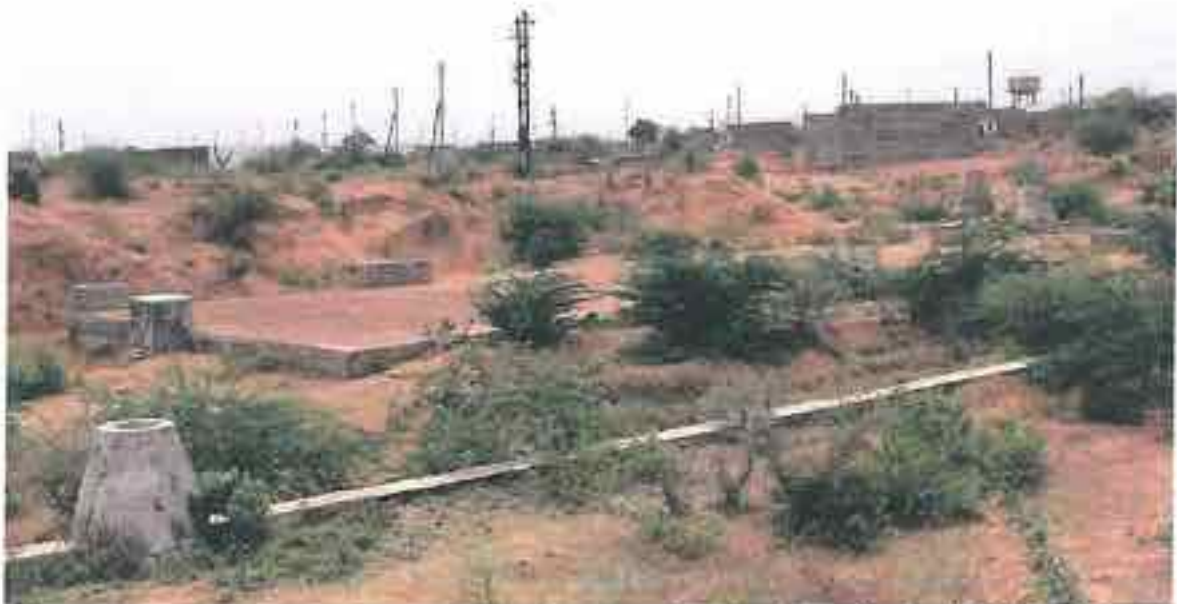
Plate 3.2.10. Dharampuri: One of the five massive septic tanks. In the front lies an encased sewerage line, and a big manhole, designed for low-lying area under flooding. If this sewer line gets flooded, it is very likely that the septic tank may also get flooded as well.

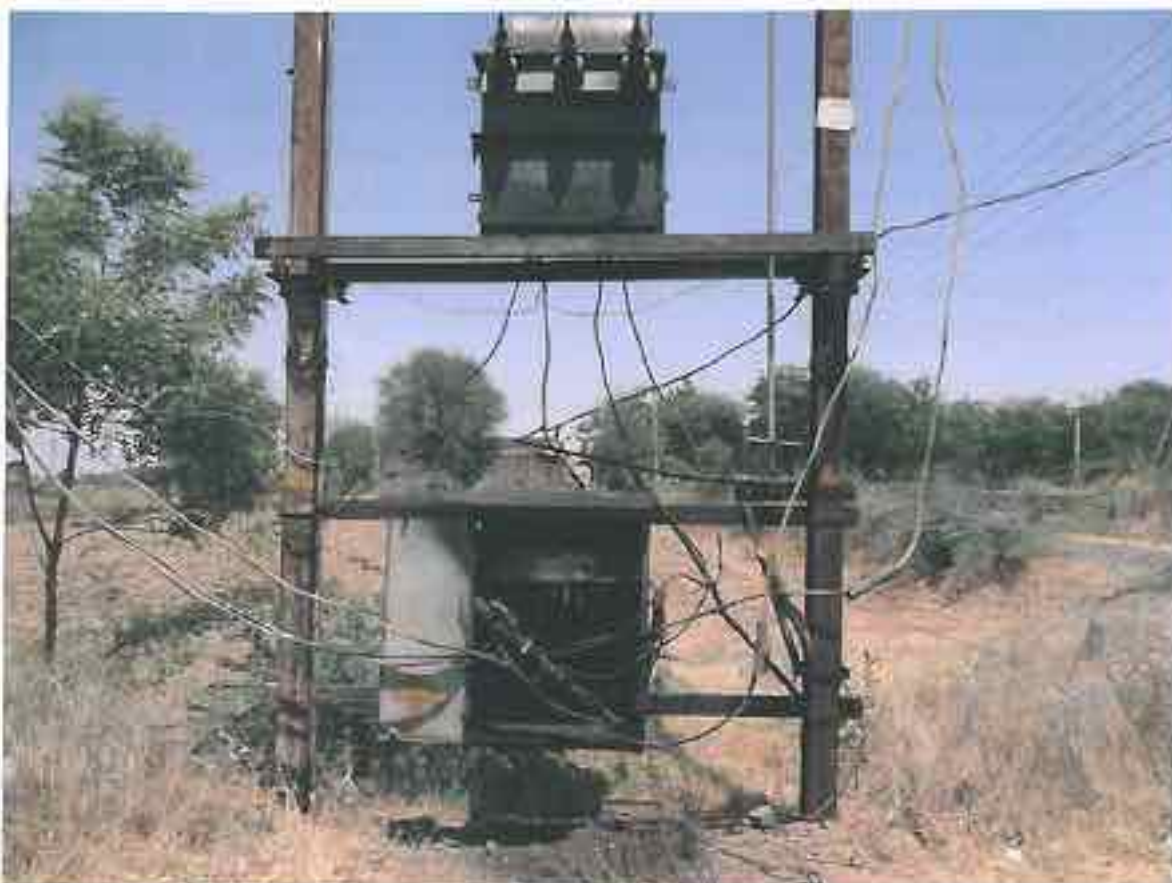
Sala: Highly dangerous and unsafe adhoc connections

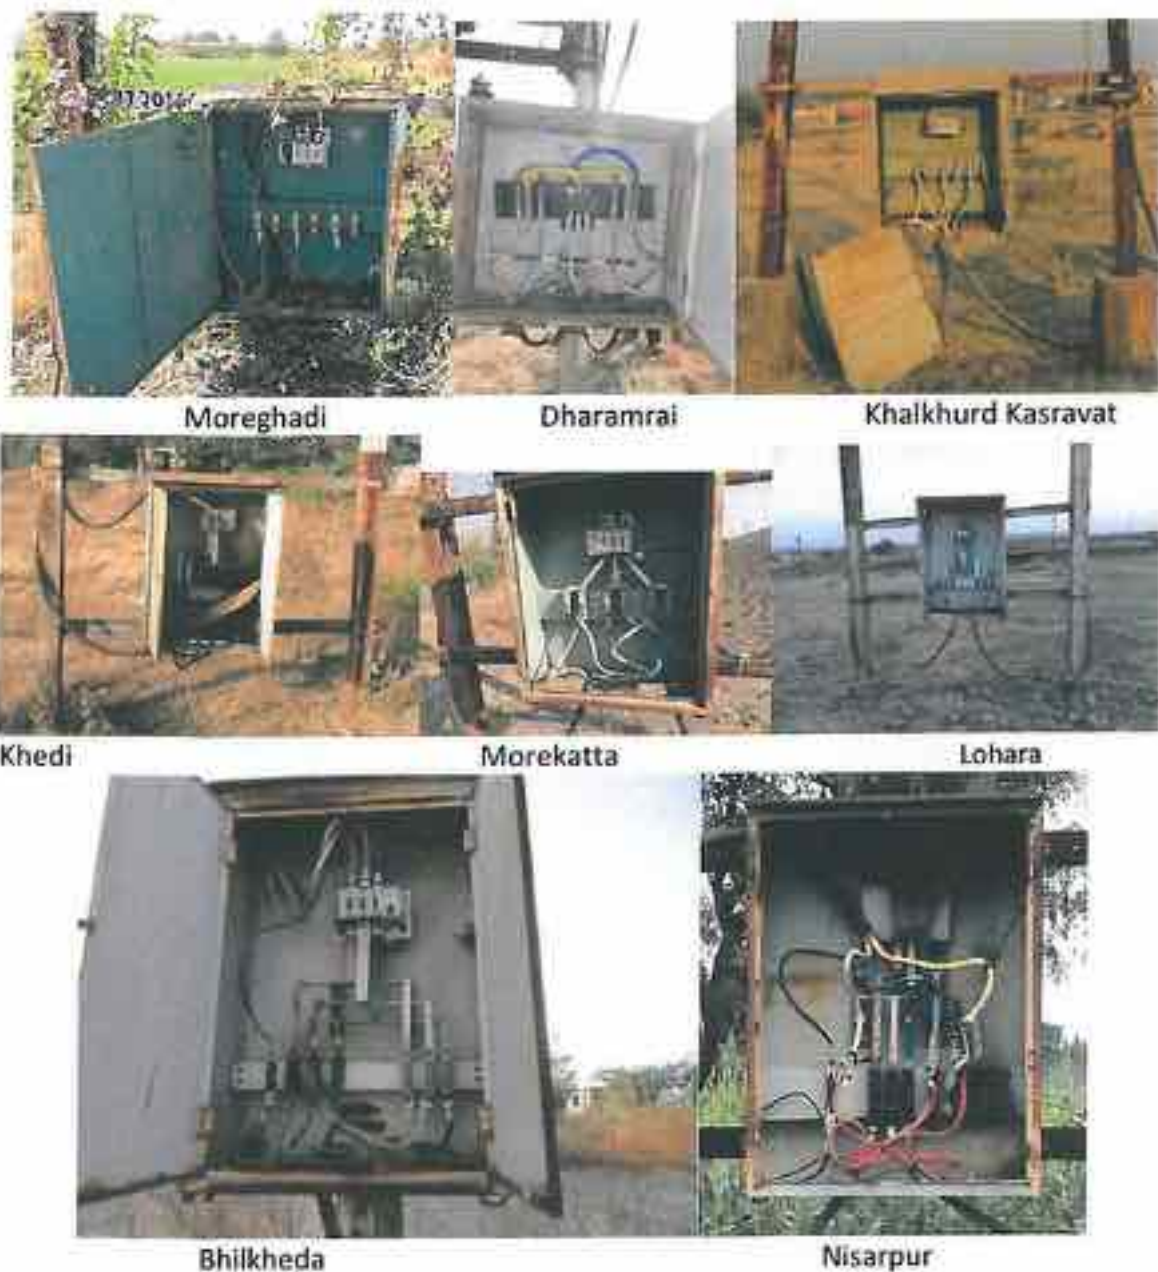
Plate 4.13: Safety Compromised: Missing Switches, Missing/unlocked covers, and Poor quality of switchgears.

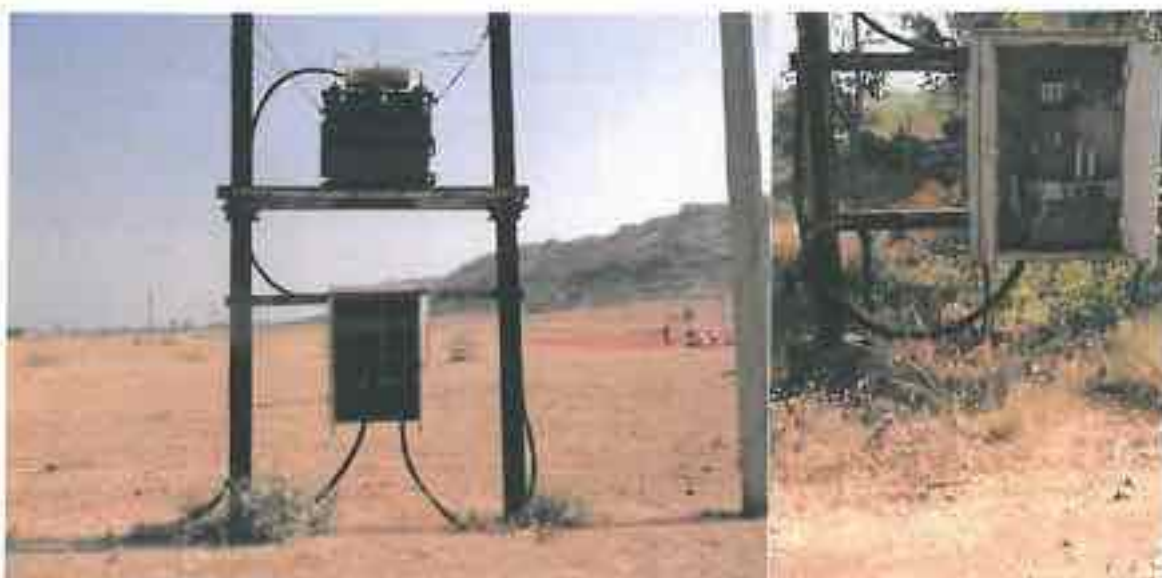
Plate 4.18. Borlai II, Phase 2: Inappropriate Ground clearances even in 2009 construction. Also seen are the missing muffings in the left photograph.

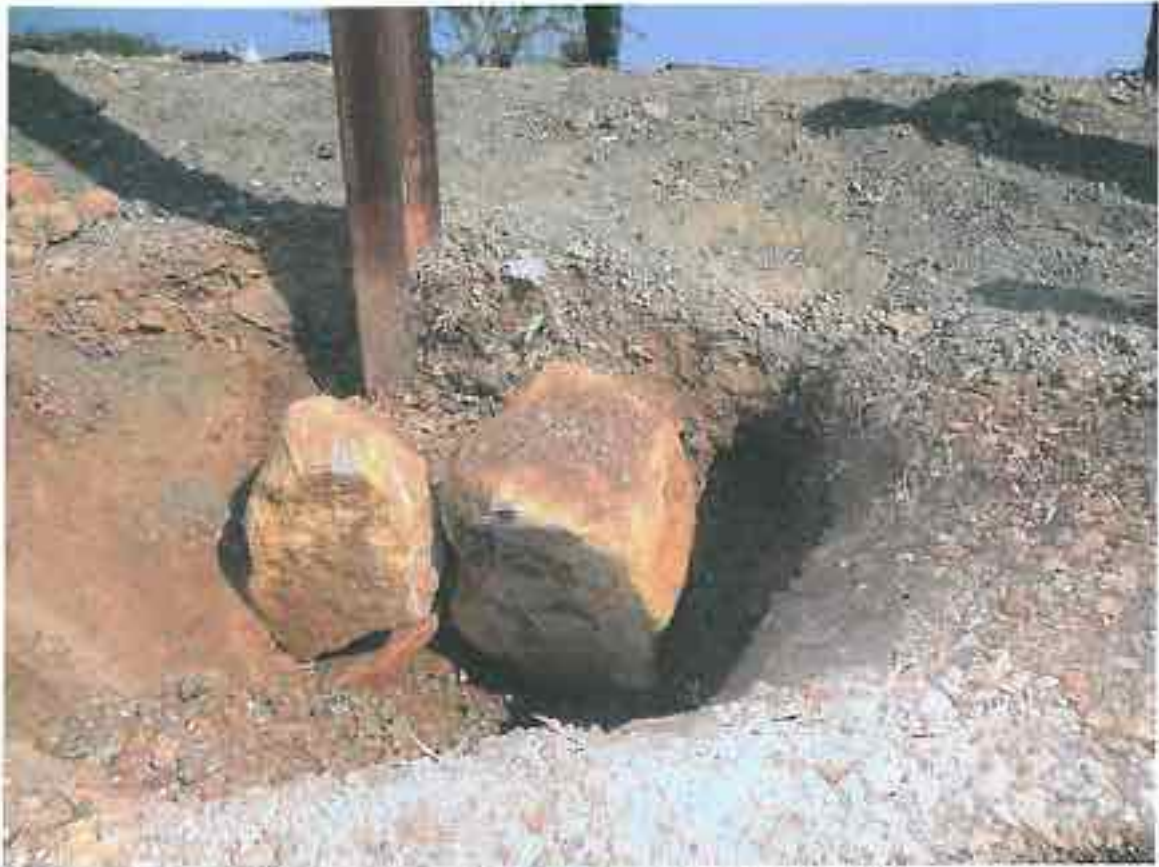
Plate 4.30. Borlai II Phase II - Metallic poles with recorded Concrete Foundations in MBs actually do not have even proper boulder foundations: Typical rampant malpractices – In some cases, muffings have been done away with (top photograph), while Cosmetic muffings provided in other cases to give an impression that concrete foundations lie underneath.

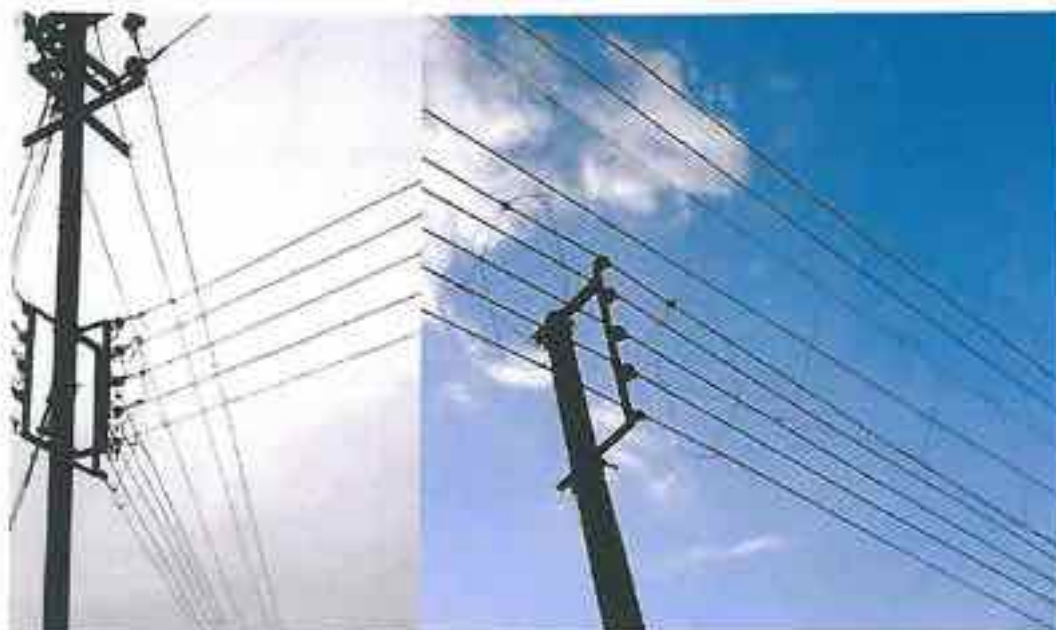
Broken Guarding wires touching LT conductors at Beganda (left) and Moreghadi (Right)

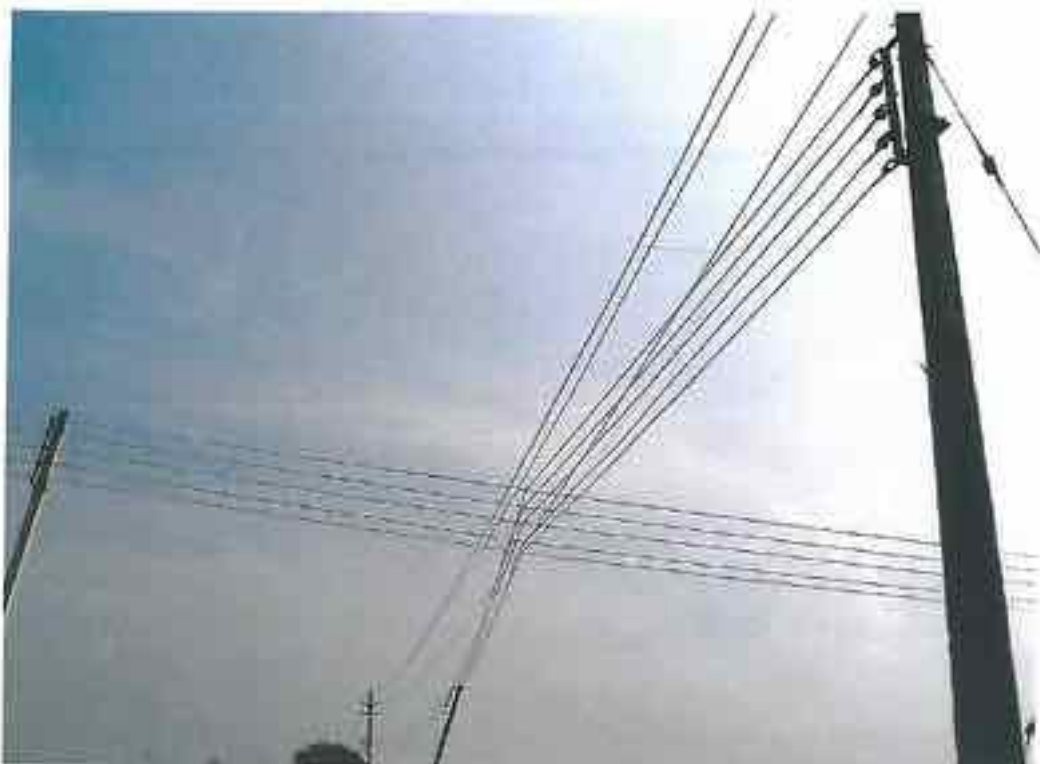
Nisarapur: Violation of Rule 87 (3) of the Indian Electricity Rules, 1956, which requires 2.44 m (at the very minimum) or more of the minimum clearance depending upon the system voltages of the line crossing each other.

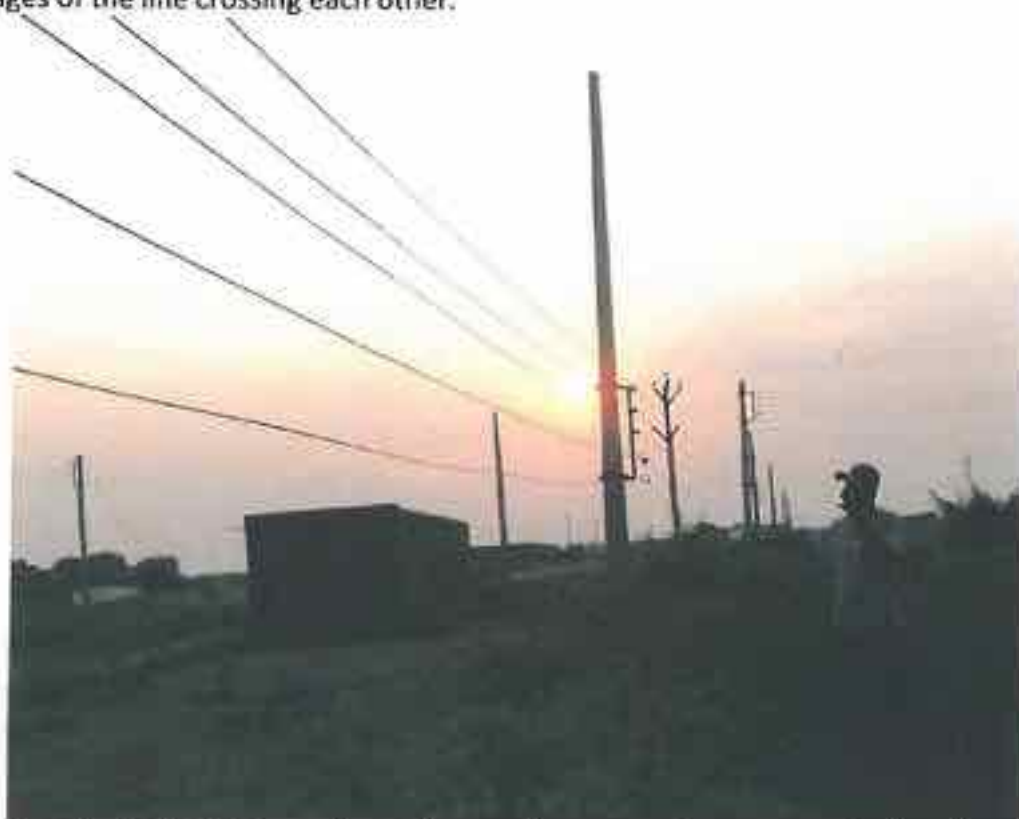
Nisarapur: Typical violation of minimum clearances above ground for the lowest conductors. Rule 77 of the Indian Electricity Rules, 1956, specifies a minimum clearance of 5.5 m for lines of medium and low voltages along any street (as is the case illustrated in photograph), 5.8 m across a street, and 4.6 m minimum for lines anywhere else.

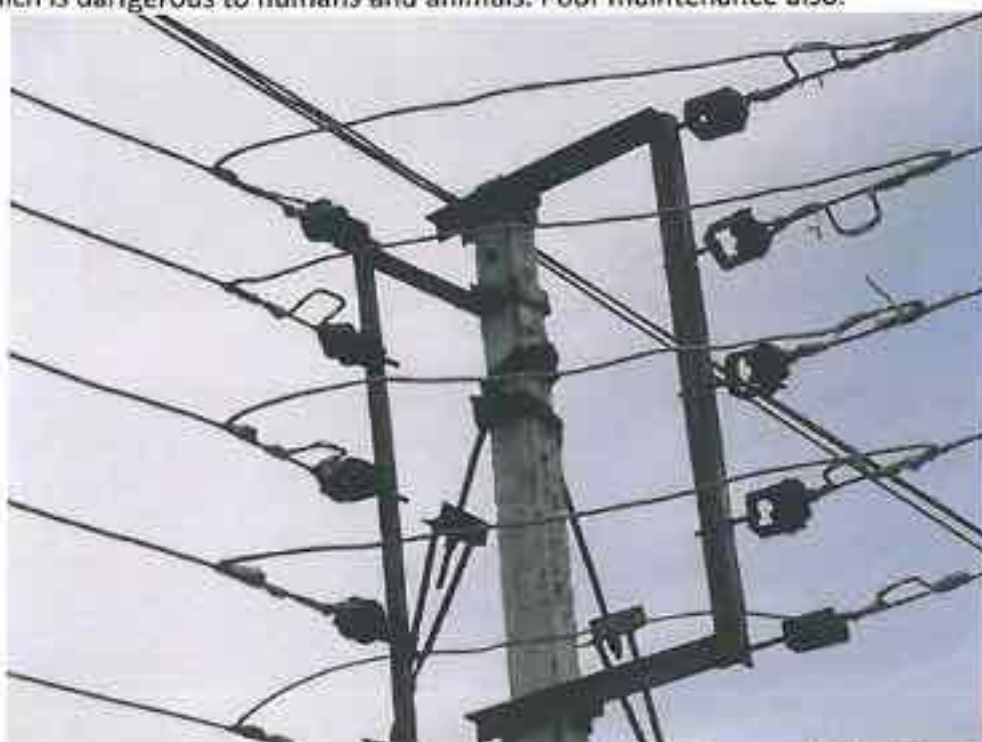
Mirzapur : Ds not used for connections, loose jumpers exist , and lack of earthing for cross arm and other metallic fittings
