Evaluation of the Quality of Civic Amenities at Rehabilitation Sites of the Sardar Sarovar Project

**Sardar Sarovar Project - Fake Sale Deeds and Rehabilitation Sites
Irregularities Inquiry Commission**

April, 2014

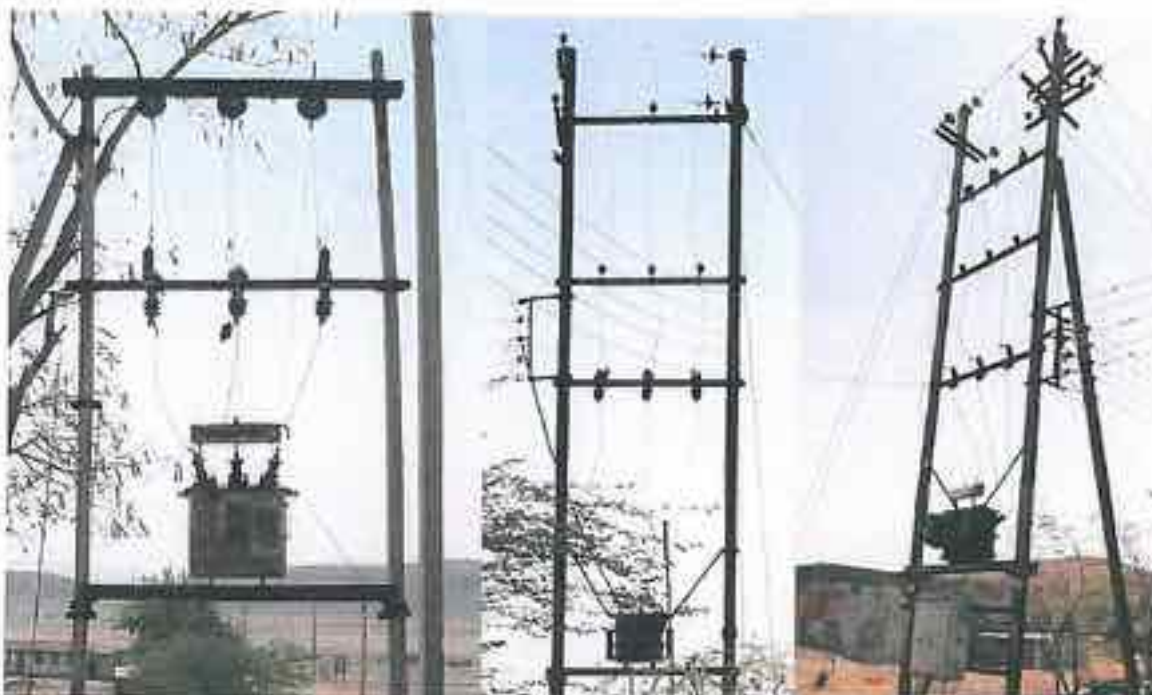
Missing Lightning Arrestors (Typical) at Dharamrai (Kukshi), Kadmal & Anjad Barda resp.

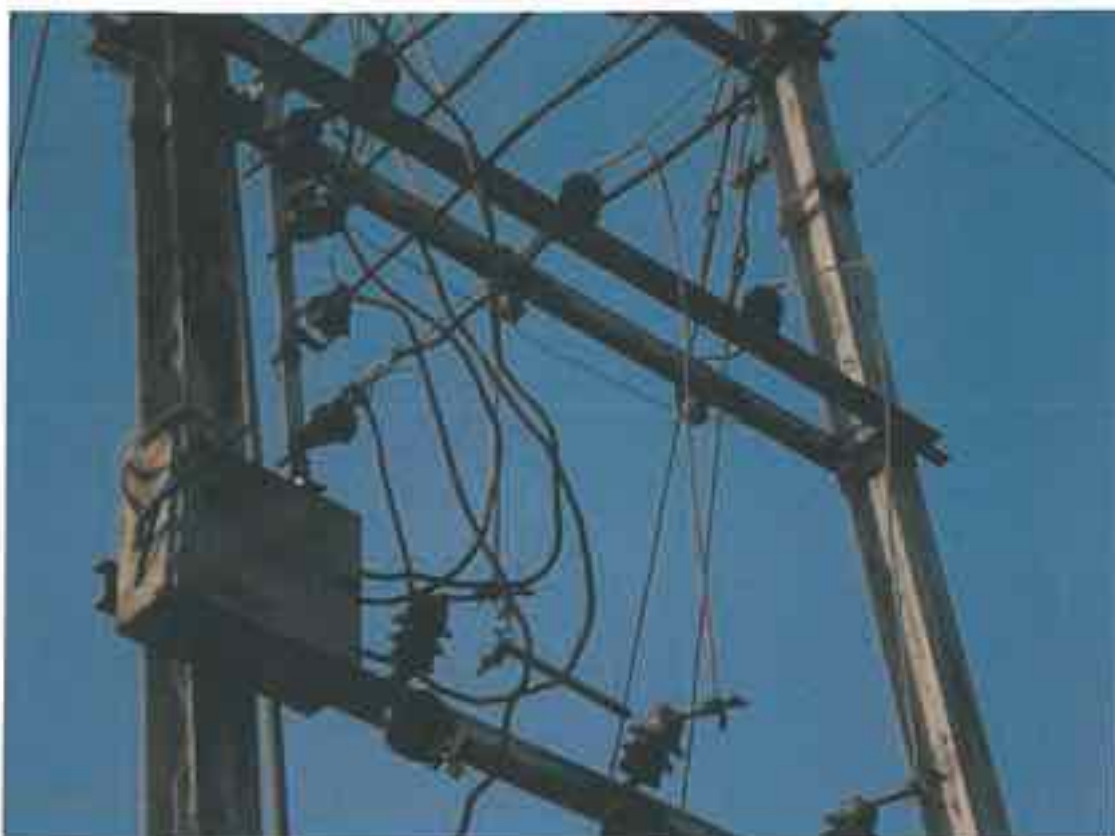
Poor execution and work quality-Clearance between conductors not as per safety norms

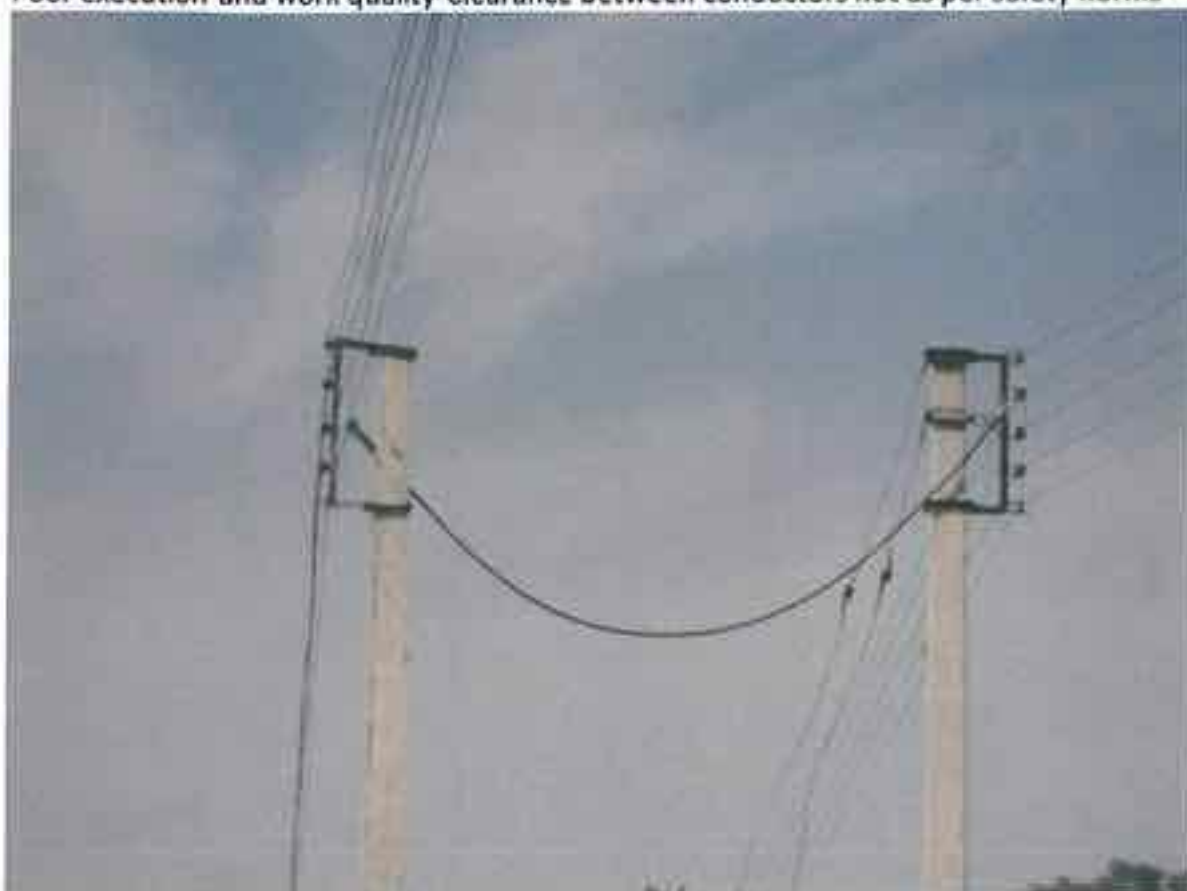
Missing Metallic Bearer wire to support cable: Poor work execution in violation of Rule 79 (2) of Indian Electricity Rules 1956

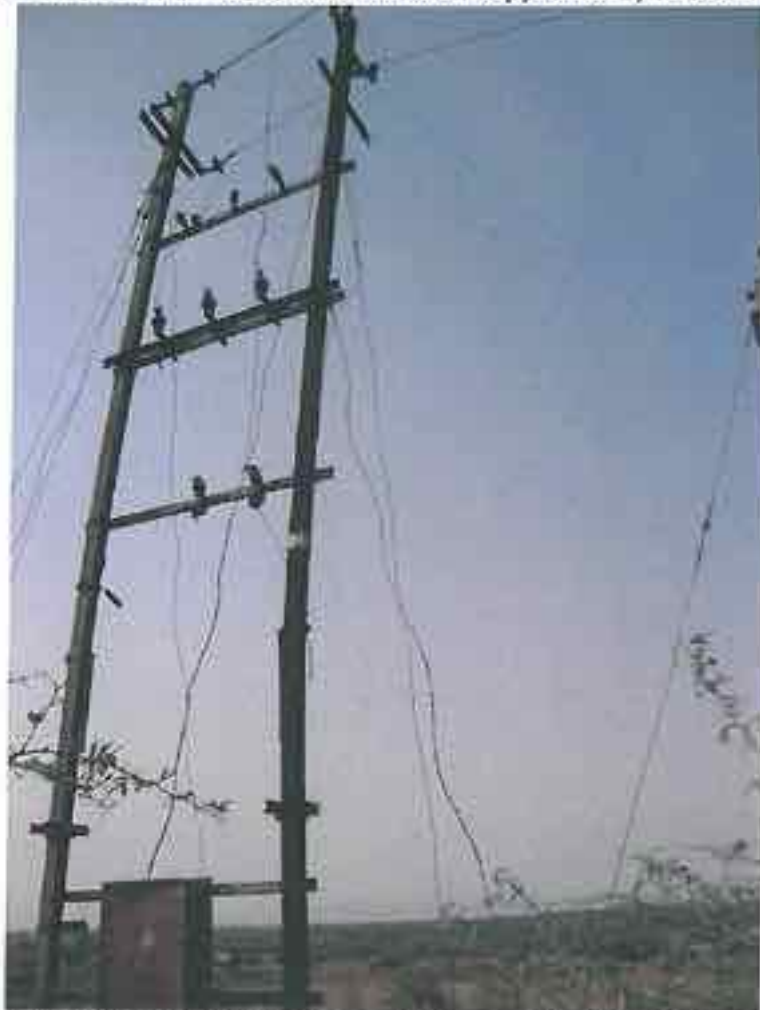
Poor mechanical strength of the Pole, Loose wires, Improper tightening of the overhead Conductors.

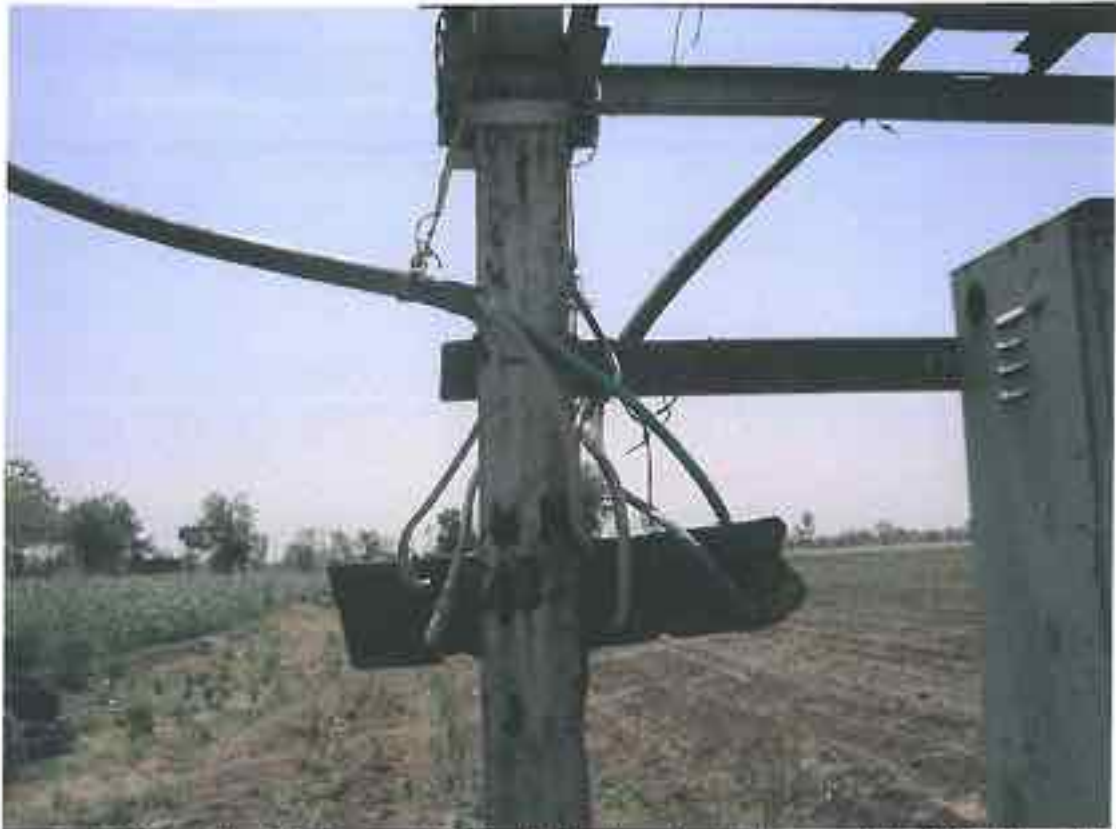
Semalda: Link Switch with Fuse and a Circuit Breaker Needed as per Rule 50 of the Indian Electricity Rules, 1956

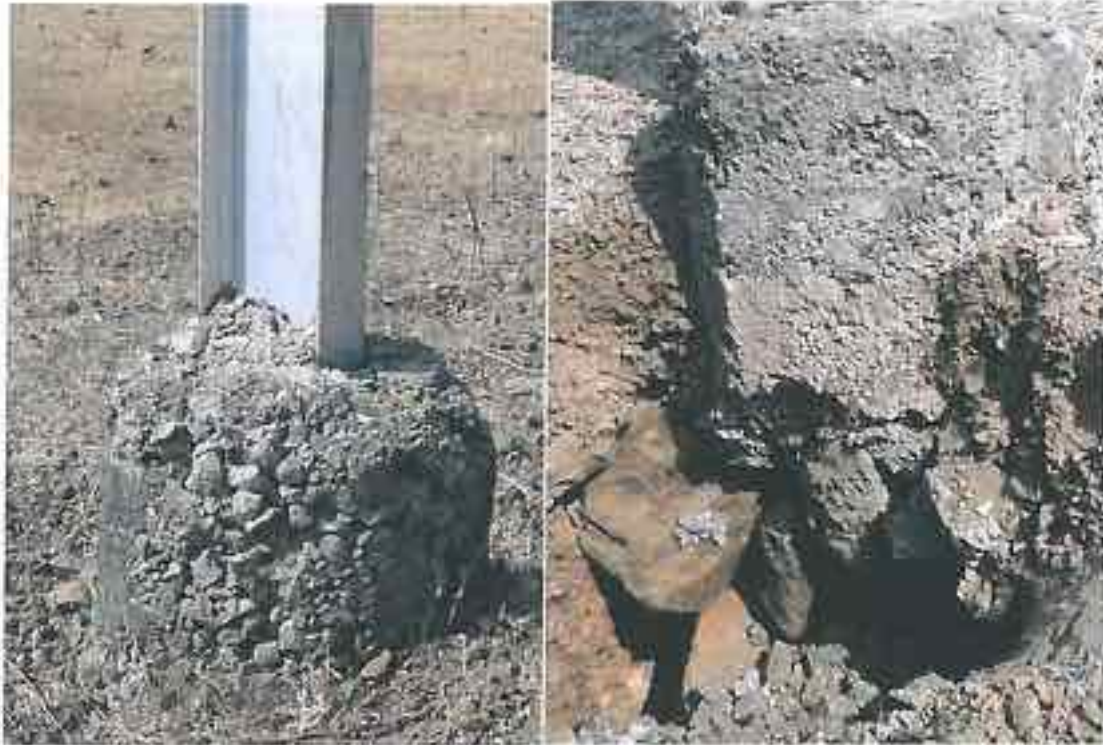
Very Poor quality of concrete in Muffings
