Evaluation of the Quality of Civic Amenities at Rehabilitation Sites of the Sardar Sarovar Project

**Sardar Sarovar Project - Fake Sale Deeds and Rehabilitation Sites
Irregularities Inquiry Commission**

April, 2014

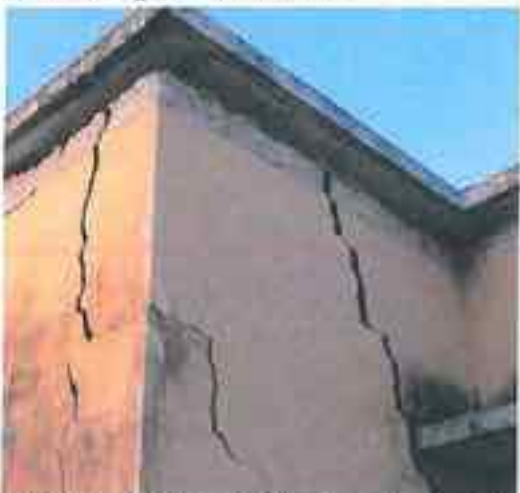
Semalda: Primary School No 4

Lakhangaon : Post office Building Khalbujurg: Prominent Cracks Inside School Building.
Plate 2.1.1 Typical Damaged buildings at various R&R Sitescont....

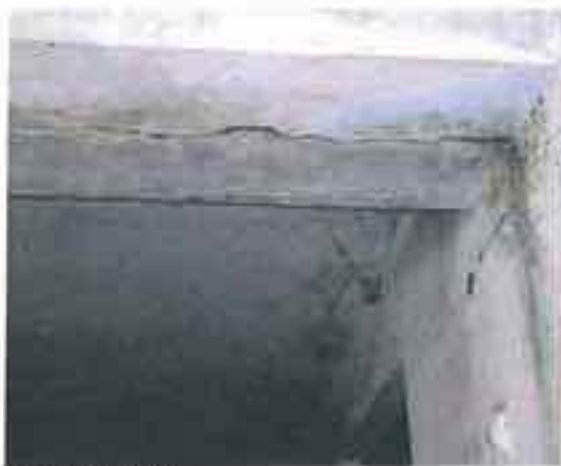
Khedi : Hostel

Plate 2.1.1. Typical Damaged buildings at various R&R Sitescont..

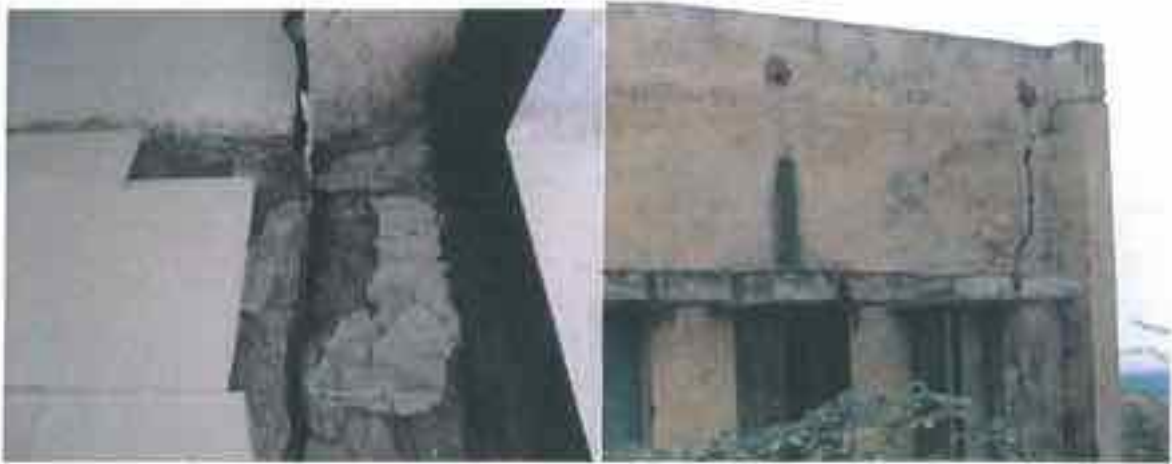
Nisarpur: Men's toilet in Hospital and Primary School building

Plate 2.1.1. Typical Damaged buildings at various R&R Sites

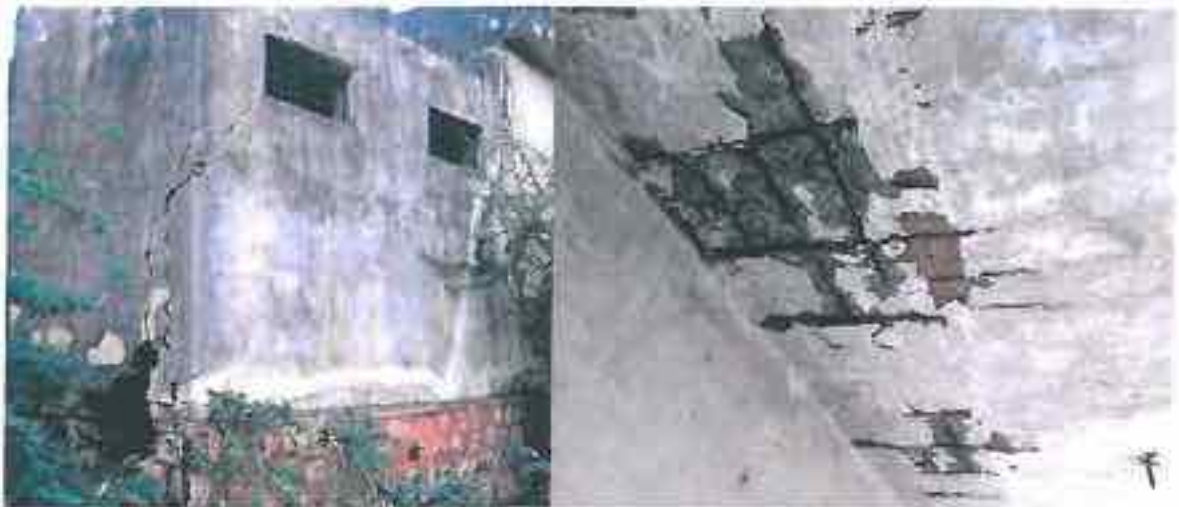
Nisarpur Yatri Pratikshalay

Khalkurd Kasrawat: Primary School ceiling:
Reinforcement with Inadequate Cover:
Exposed & corroded

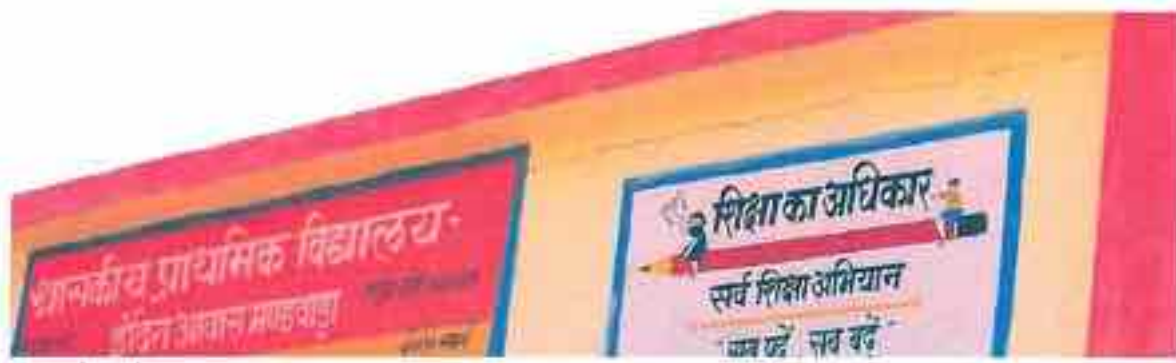
Mandwada

Plate 2.1.4. Typical horizontal cracks in the buildings at select R&R sites

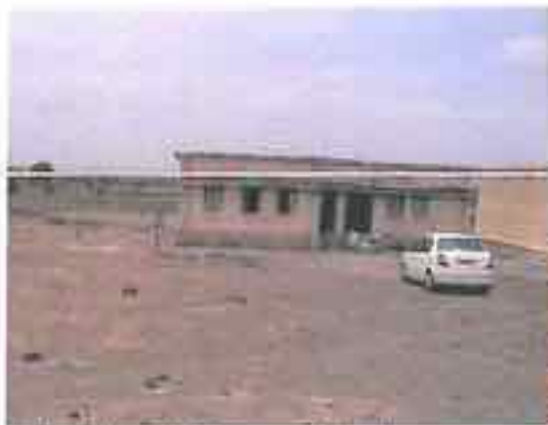
Talwai Khurd: Primary School

Plate 2.1.5: Typical Missing Fences, Gates and Pillars at some sites

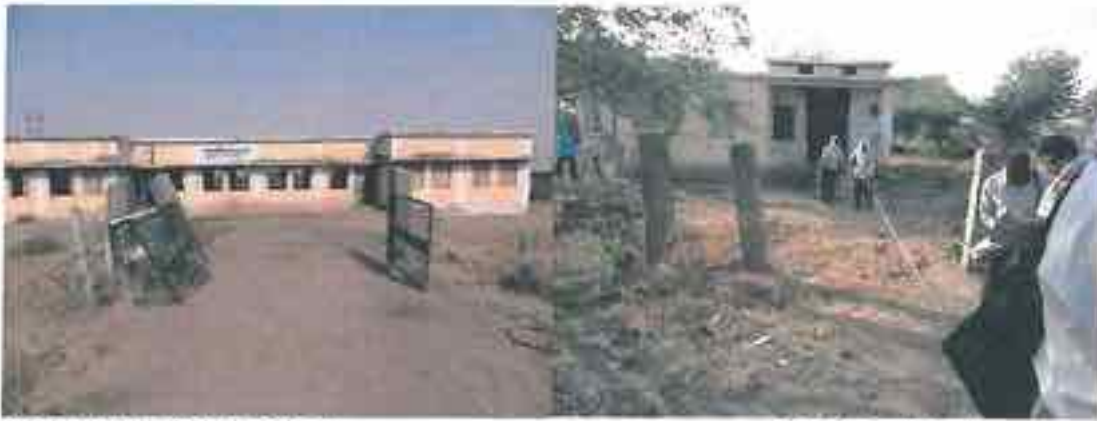
Plate 2.1.6: Typical Damaged gates, Pillars, Fencing--A common Occurrence

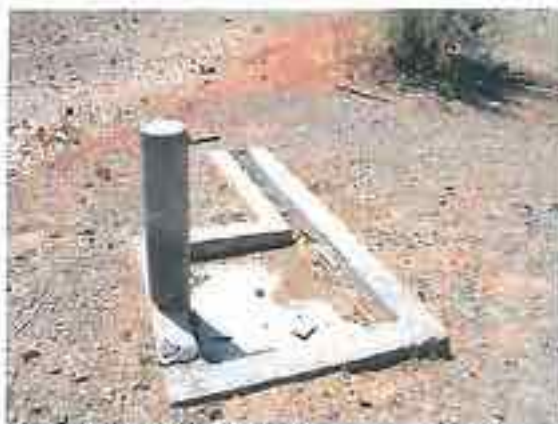
Semalda Middle School

Plate 2.1.7. Typical handposts : Missing taps, missing pipes, defunct at several sites , even in Schools

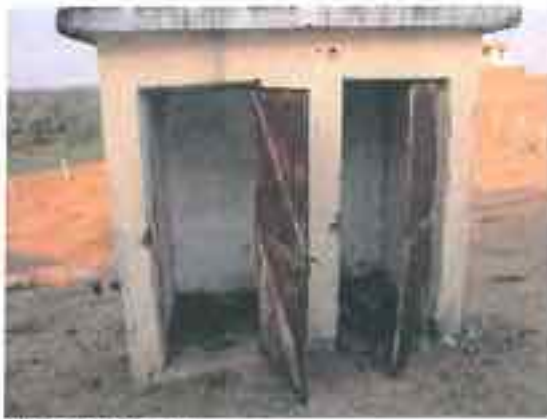
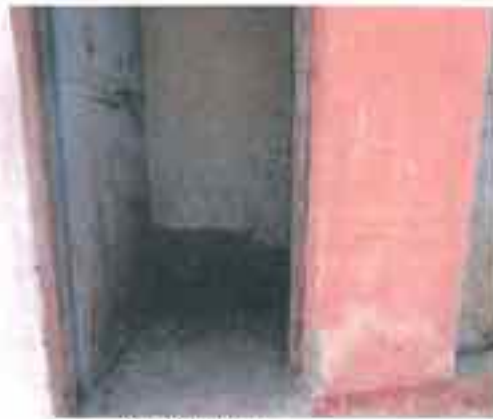
15. Similarly, the toilets were inadequate and essentially unhygienic (Plate 2.1.8) because of no provision of water made in the toilets, and also because of lack of appropriate maintenance. Lack of water again ensured that whatever sewage ensued from these rather defunct toilets was too meagre to travel all the way to septic tanks, which were invariably defunct for a vast majority of cases. Even the planning and execution of these septic tanks was not upto mark: septic tanks constructions and connections were of poor quality, the effluent of septic tanks was left to flow overground (Plate 2.1.9), Connections to Septic tanks were often missing/damaged so that sewage could not flow to septic tanks, and the fact that these were all defunct saved the school, Panchayat premises etc from foul overflows. Even as defunct constructs these septic tanks continue to remain as safety hazards, with most of the not having covers, even inside the Primary School premises where children can easily fall down (Plate 2.1.10). The construction quality of these septic tanks was also not upto mark at some sites (Plate 2.1.11).

Plate 2.1.8. Typical Toilets: mostly defunct even inside Schools, unhygienic, stinking, dirty, without water and light. Poor maintenance.

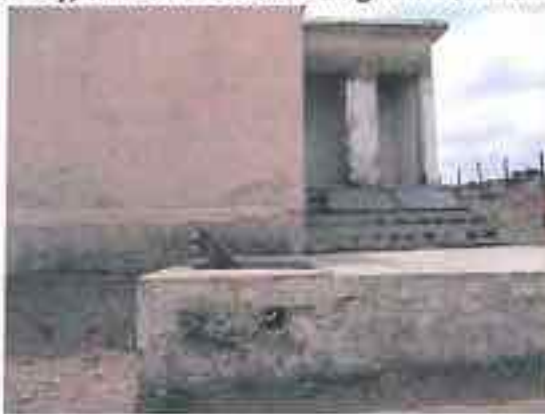
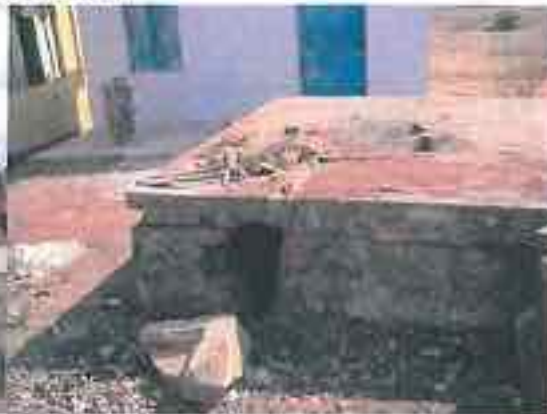
Plate 2.1.9. Septic tanks built to discharge on surface (Typical)

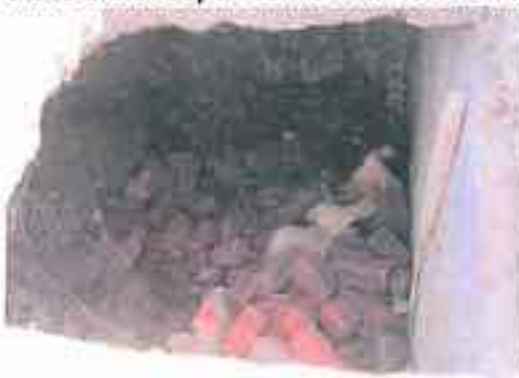
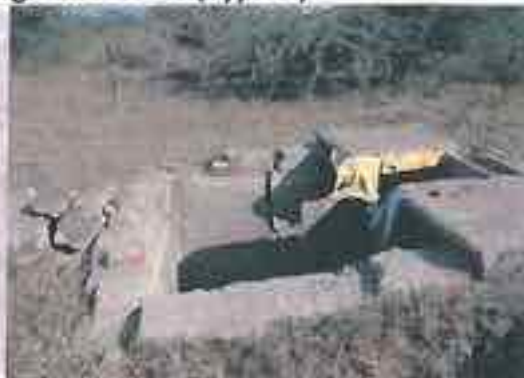
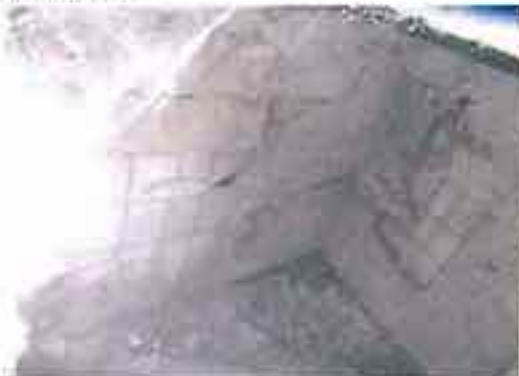
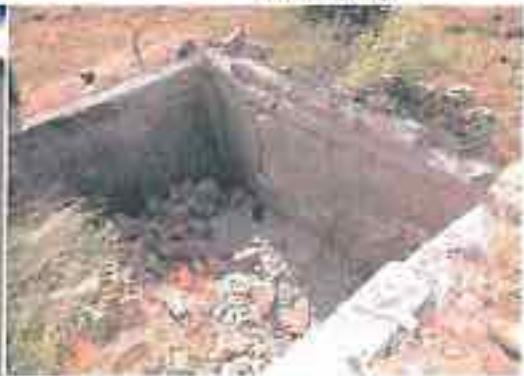
Plate 2.1.10. Poor construction quality of septic tanks at some sites (Typical)

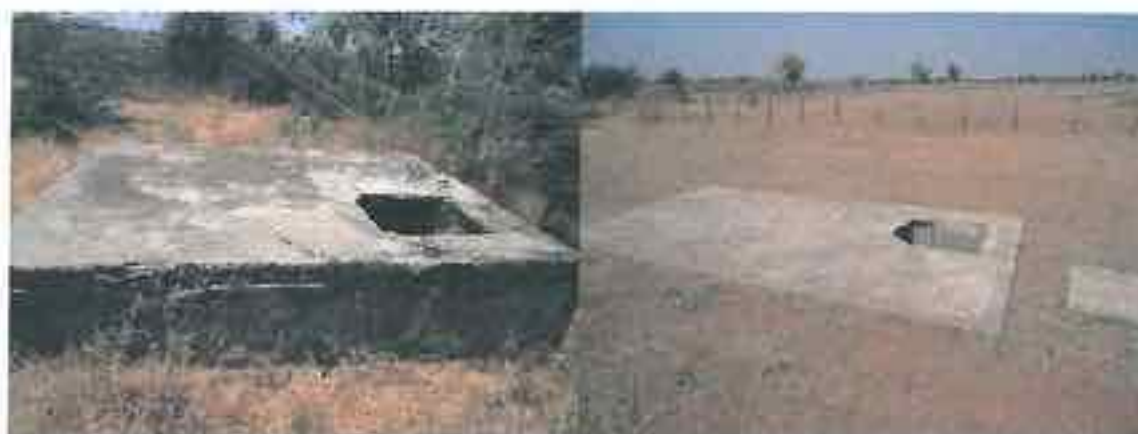
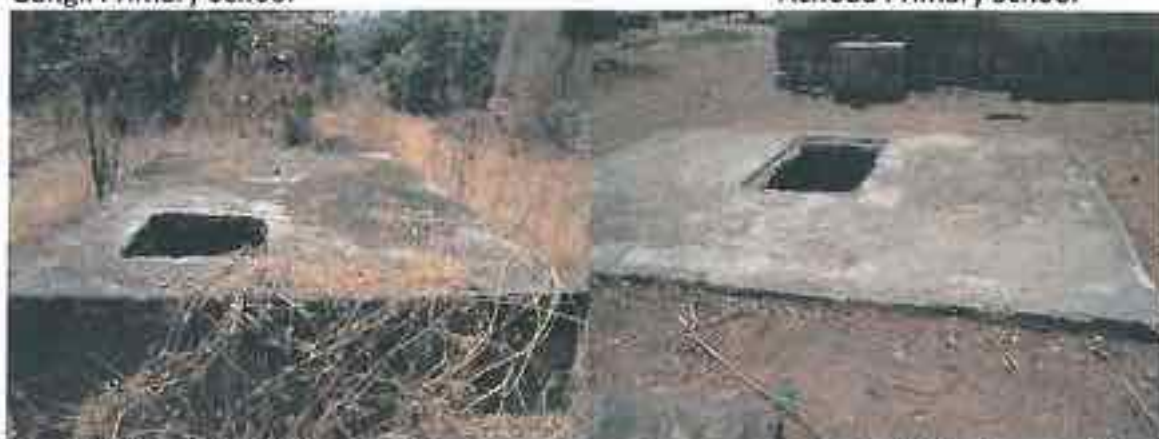
Plate 2.1.11. Typical septic tanks associated with building works: almost invariably Defunct, missing connections, missing gas pipes, and Covers mostly missing - Safety Compromised.

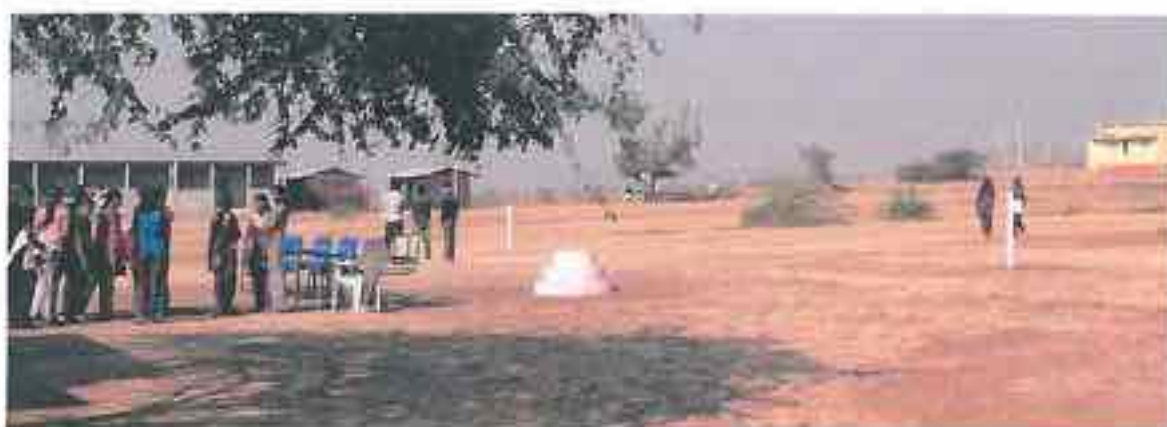
16. Other ancillary provisions such as playground in Schools were also completely missing in a vast majority of cases. In fact, it was in rare case such as Dharamrai (Kukshi) (Plate 2.1.12) where a playground could be seen. The School grounds were often inadequate and sometimes portions of open ground were intruded by stagnated water around hand pumps/handposts, or open septic tanks at the back or sides. Drainage considerations were also almost absent.

Plate 2.1.12. Dharamrai: Proper space in the school premises for use as a playground

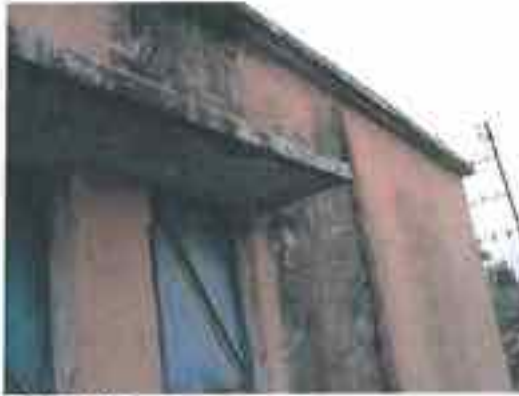
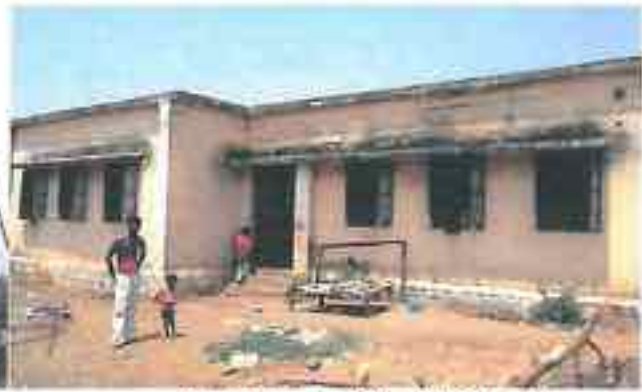
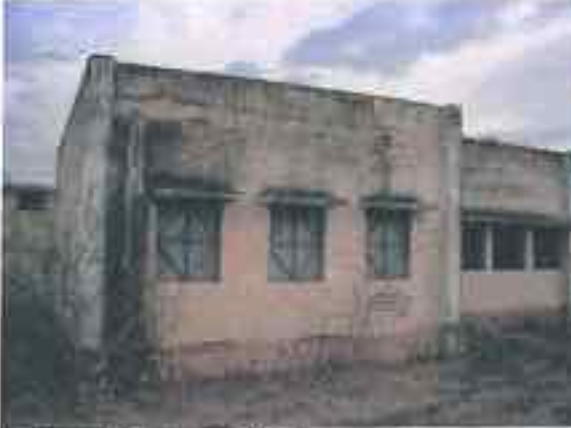
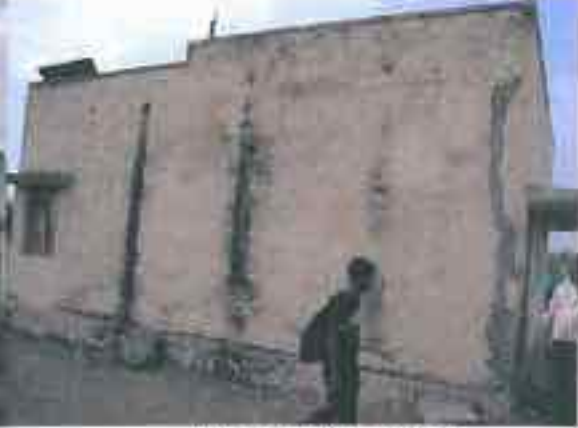
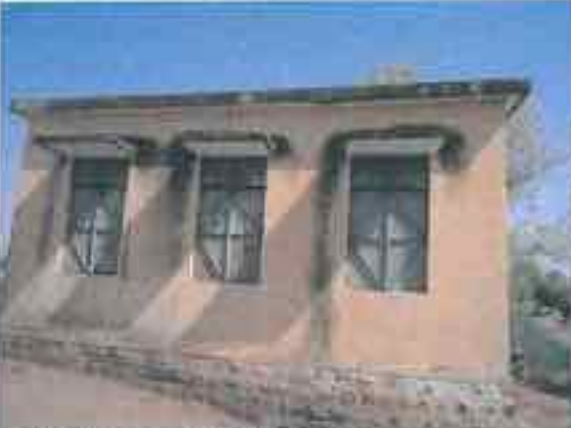
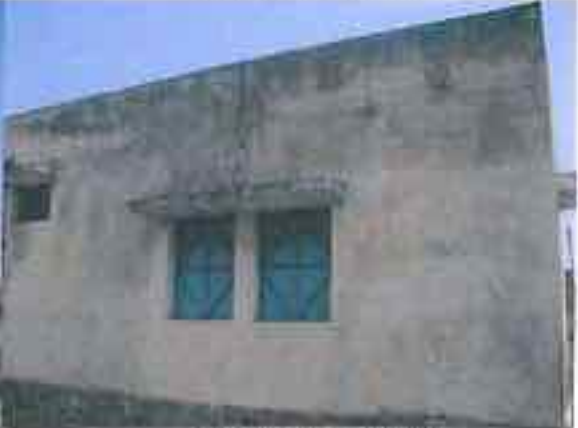
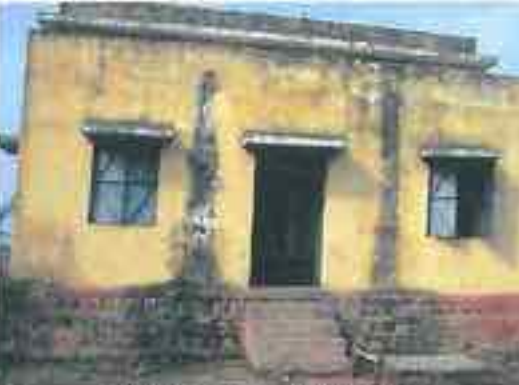
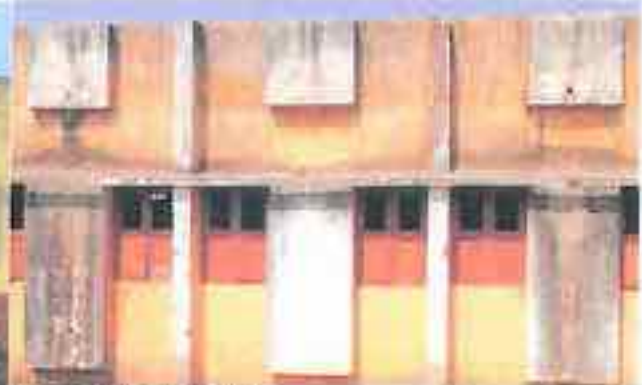
18. The drainage from building roof tops was not planned. Roof drainage was missing at most places. Drainage pipes were conspicuous by absence, as the roofs did not have parapets at several R&R sites. Drain holes were provided, but were sometimes seen discharging on chajjas (which would eventually make them weak leading to collapse), and in some cases even on building entry door/steps. Blackish exterior marks (erosion of exterior paint) indicated, that the roof slopes were not provided right, and the rooftop water would either drain from anywhere, or would stagnate on roof top leading to seepage on roof and walls (Plate 2.1.13).

Plate 2.1.13. Typical impact of inadequate/inappropriate drainage of roof water on Building exteriors. Note the darkish exterior marks made by water.

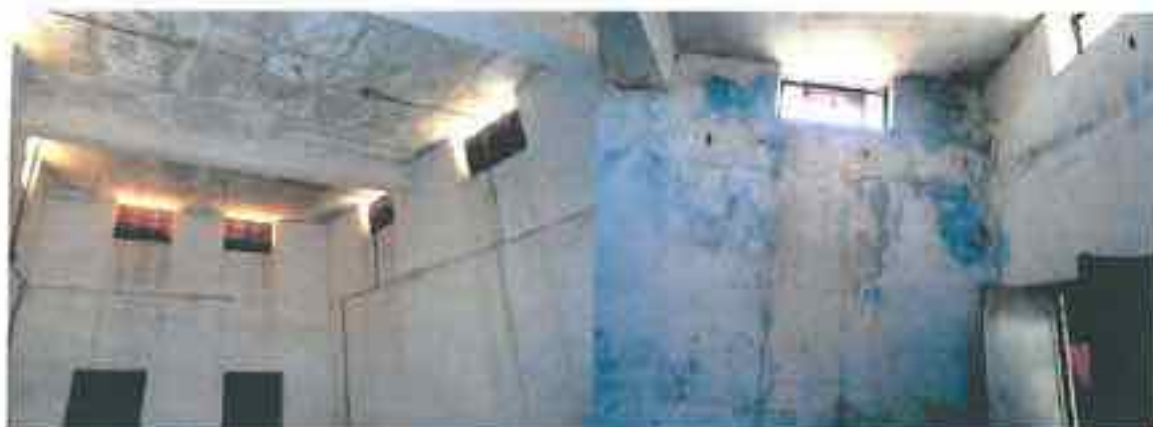
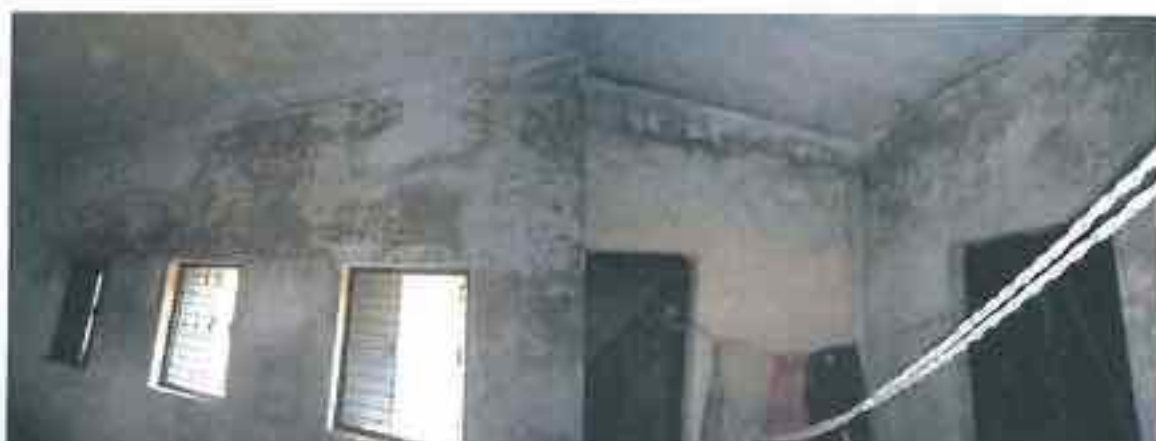
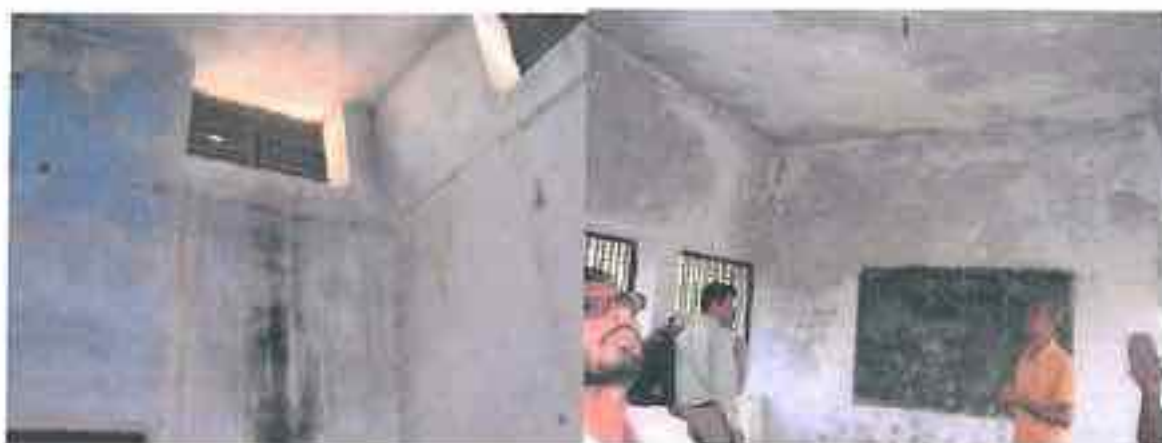
19. The supposed free flow of roof-top rain water would be hampered sometimes due to inadequate slopes of roof, thereby creating build-up of dampness due to prolonged wetting, signs of which were often evident on the internal walls and roofs in several cases even in the peak summers just before monsoon. The ventilators often had no chajjas to protect the ingress of rains inside, implying that

Plate 2.1.14. Inside of Buildings: Dampness prevalent even in dry season (Typical).

Note: All photographs taken during peak summer season April-June 2012, before the onset of monsoon when dampness would be minimal.

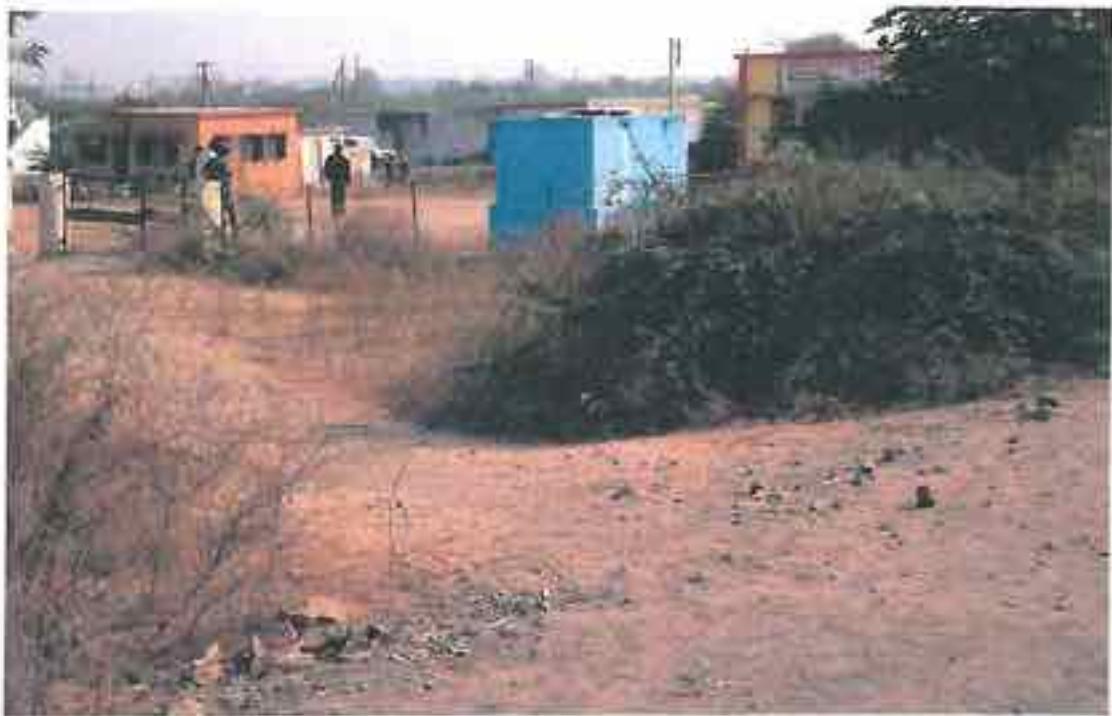
20. Approach/Entry to the buildings, including sometimes even to the schools, was not always smooth. In several cases, the road was not extended to the building or engineered approach to the amenities was not provided resulting in poor approach (Plate 2.1.15). In other cases, the building premises were not levelled or raised appropriately relative to the top road formation and large differences in plot level and road formation was the reason behind problem of smooth entry (Plate 2.1.15). Where the building premises near the entrance to these buildings, including the school premises, were found much lower than road formation, there would be a risk of flooding of the access during rains, and as the local resident reported, the school children would be forced to walk barefooted without shoes & socks/footwear up to school building from the roads.

Kukra: Lack of smooth entry to the buildings. The road could have been extended a few meters to reach the gate (or better till the school building), but this small patch has been left undeveloped without considering likely problems during Rains.

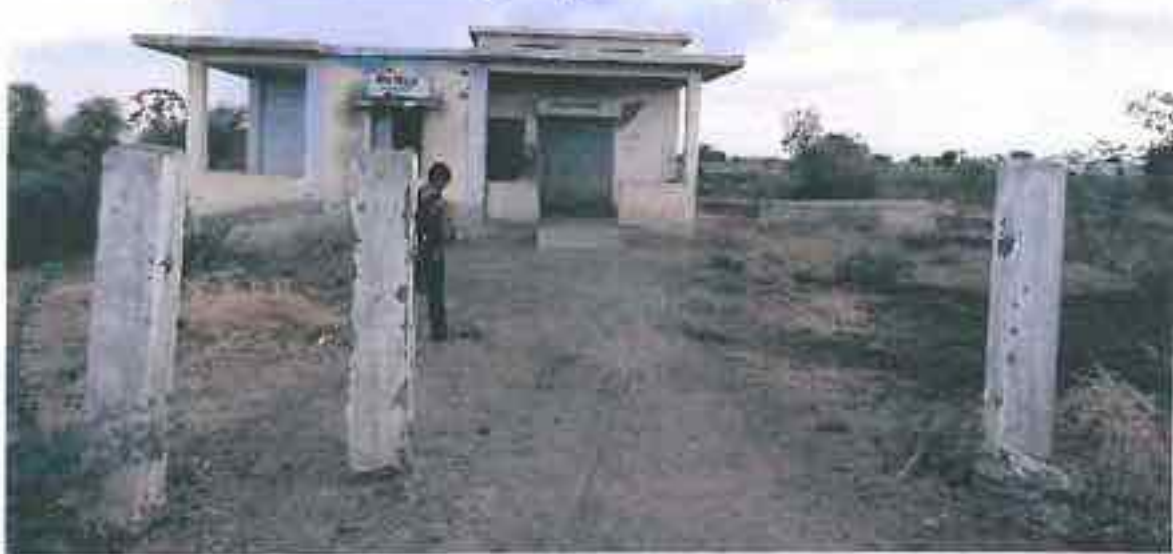
Moreghadi: Seed Godown- The access is higher, but the open area around the building has not been levelled, implying water will pool up during monsoons.

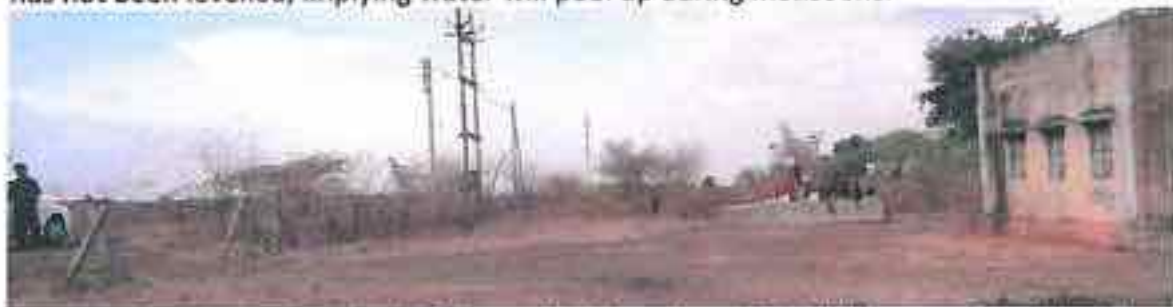
Moreghadhi: The road at the left is much higher than the building premises. Plinth has not been raised appropriately relative to road formation.

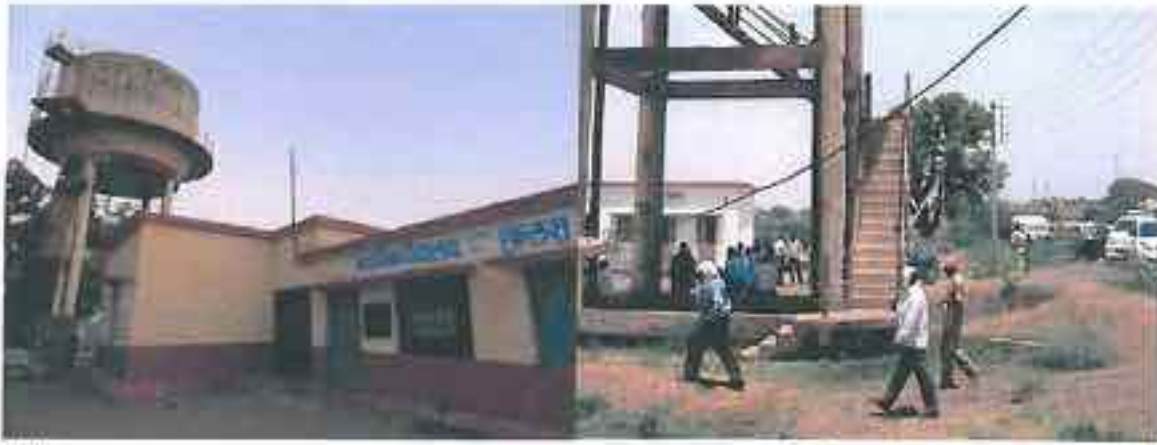
21. The buildings were also sometimes located disregarding safety issues (Plate 2.1.16). One could see even Schools located right next to Overhead tanks, awaiting a tragedy that may befall in unfortunate event of a tank collapse, and giving the schoolchildren unlimited opportunity to scale the tank heights as even the premises were not fenced. At Gangli, one could see a large ditch in front of a Primary School. At Panya, one could see a huge open well, very deep (70-80 ft) within the school premises whose boundary was damaged and broken, and without an inkling of any warning signboard fencing and isolation. Such instances reflect poorly on the sensitivity with which planning and execution have been carried out.

Overhead Tanks located in the proximity of Primary Schools. What if the tank collapses? Also an absence of fencing and isolation present the school children free access to scale the tank heights.

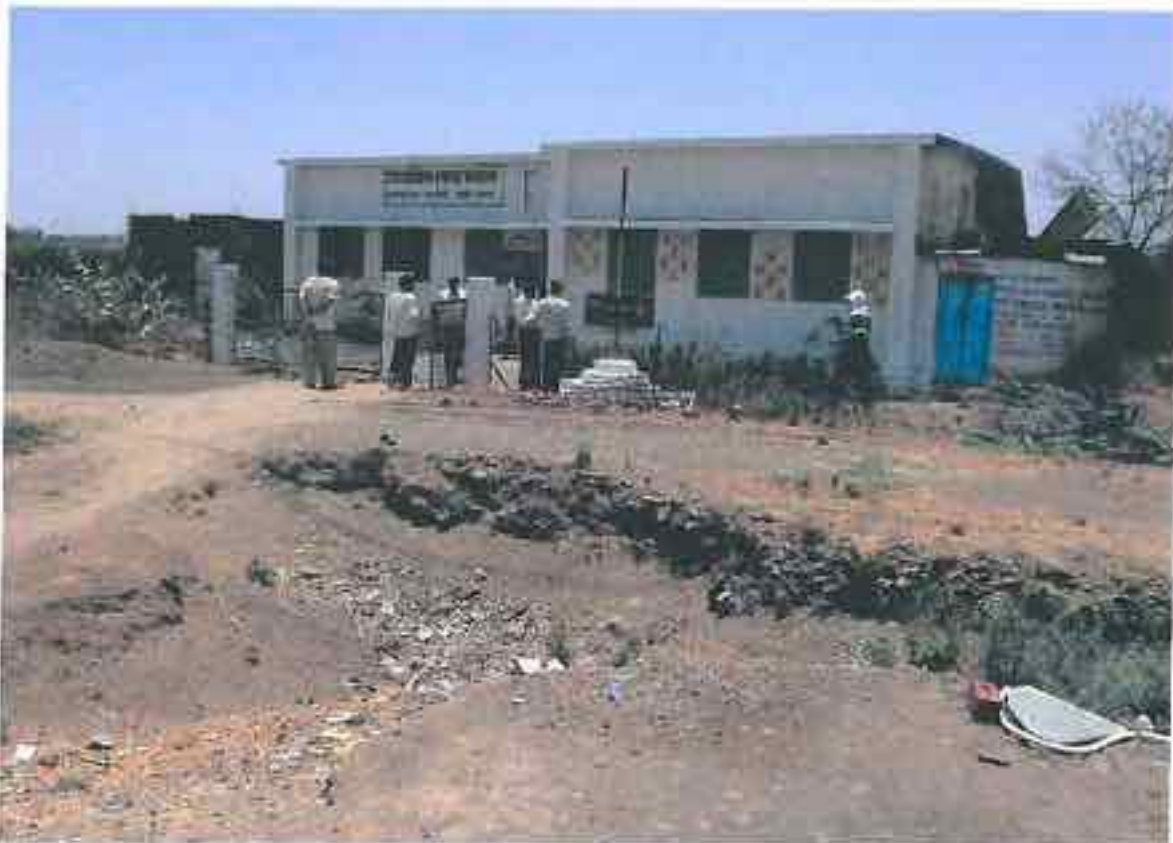
Gangli: In front of Primary School a large ditch which would fill up in the rains, increasing chances of serious accidents, more so because the school is in the vicinity—Poor planning, and insensitive finishing of construction activities undertaken at the R&R site, accentuating and strengthening the public perception of lack of proper facilities and related insecurities.

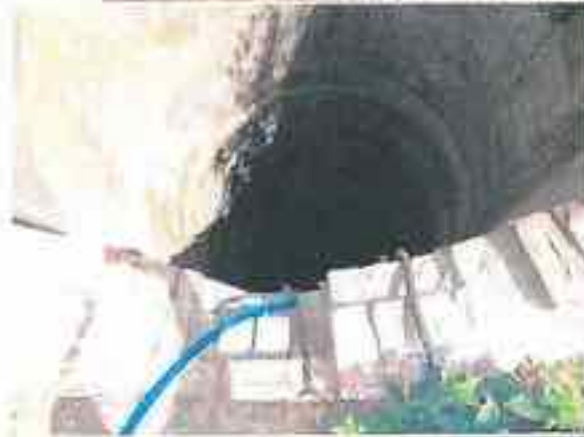
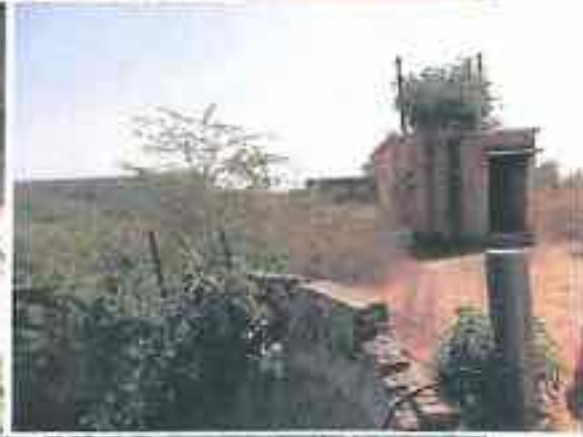
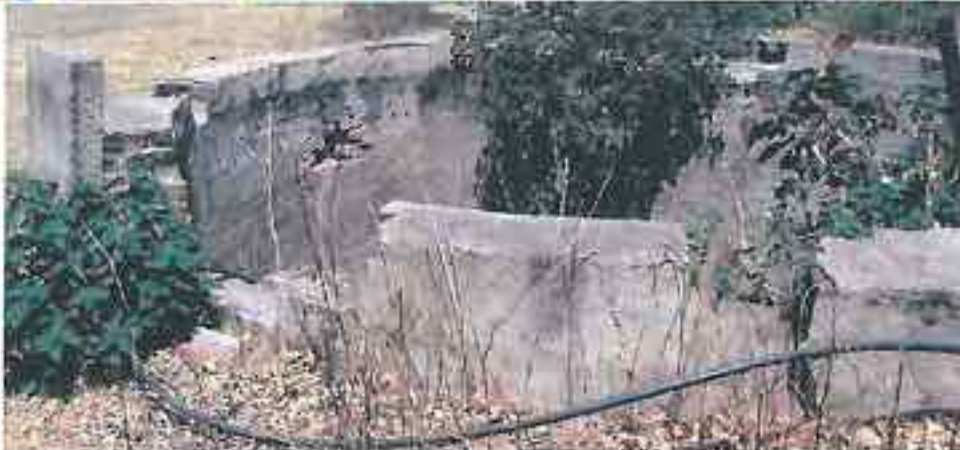
Panya: In Primary School II campus, a huge well 70-80 ft deep exists inside the school premises and fencing. The well has its boundary damaged and broken in parts, and is without fencing. This well water is being pumped by a motor inside the pumphouse located nearby and had a direct connection without any meter. Serious chances of accidents for school-children. Insensitive planning and gross negligence.

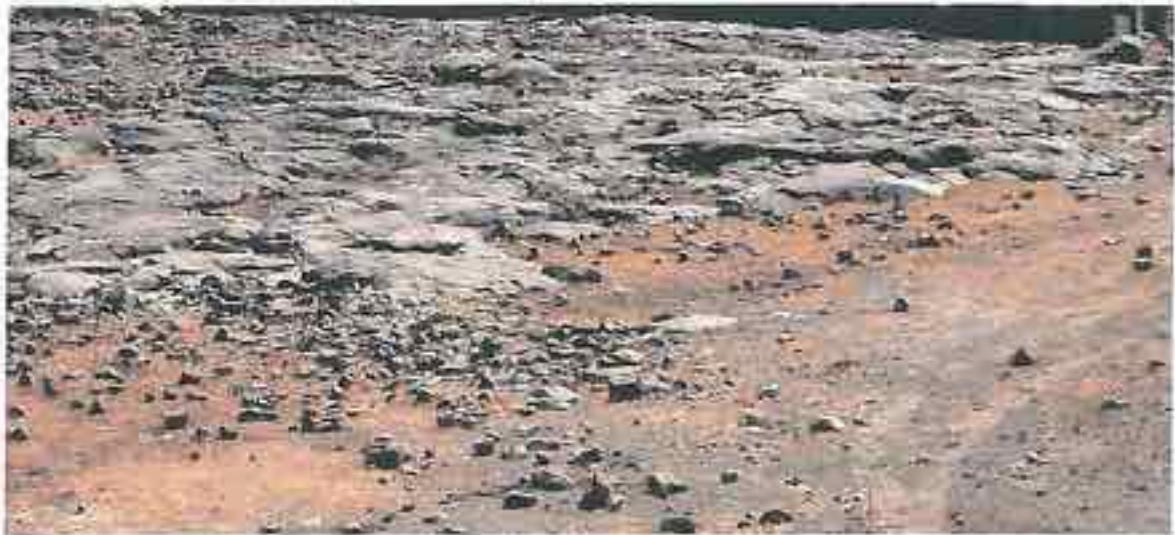
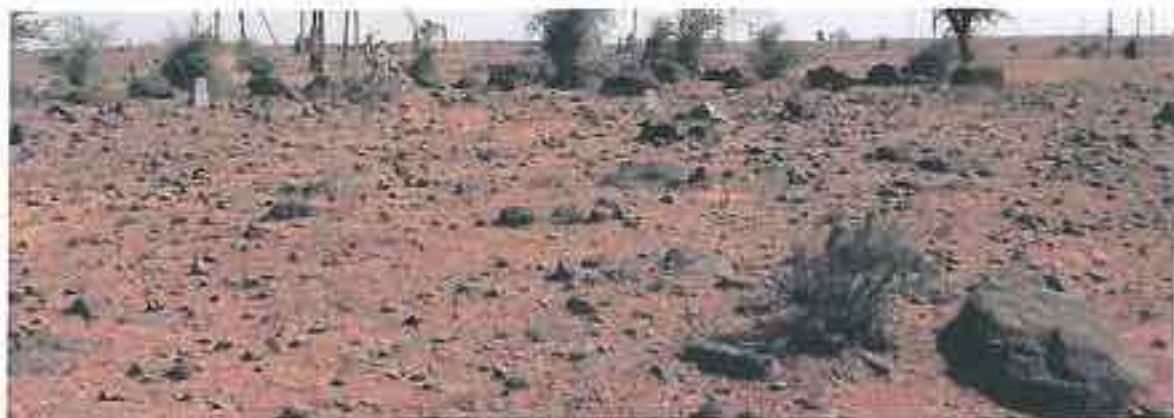
23. Similar siting issues pertaining to planning lapses occur at other sites like Brahmangaon (Theekri) where the underlying strata is extremely hard in parts (Plate 2.1.18), and even mild blasting may be required to construct houses with minimal foundations. Even if blasting is not permissible for safety reasons, the cost of excavations will be significant for chiselling. Will the oustees be able to bear this extra cost of construction? Is it fair to ask them to do so, just because they have been allotted this particular site? These are relevant questions that needed honest soul searching at the time of site planning.

Plate 2.1.18. Brahmanaon (Theekri) : Very Hard strata implies difficult construction (Typical)

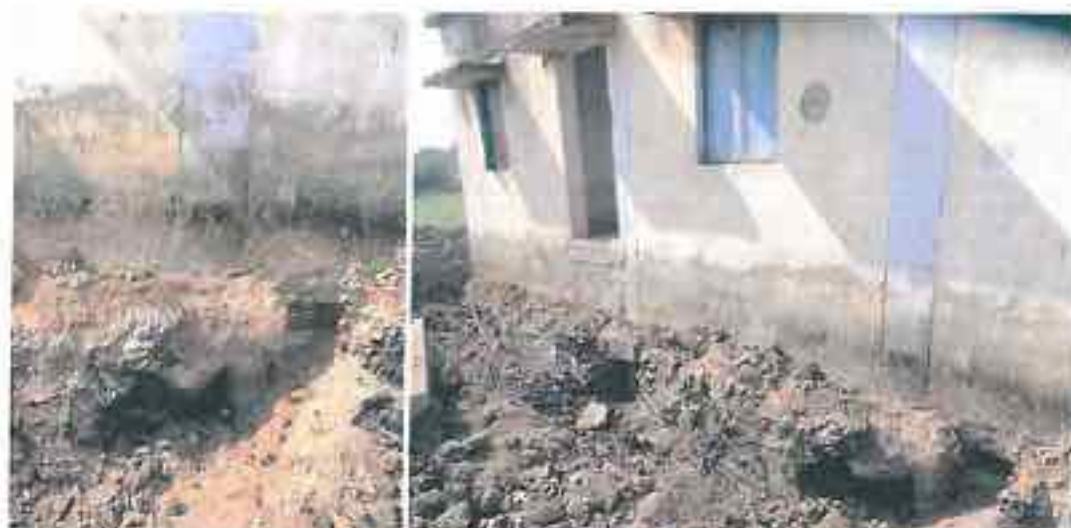
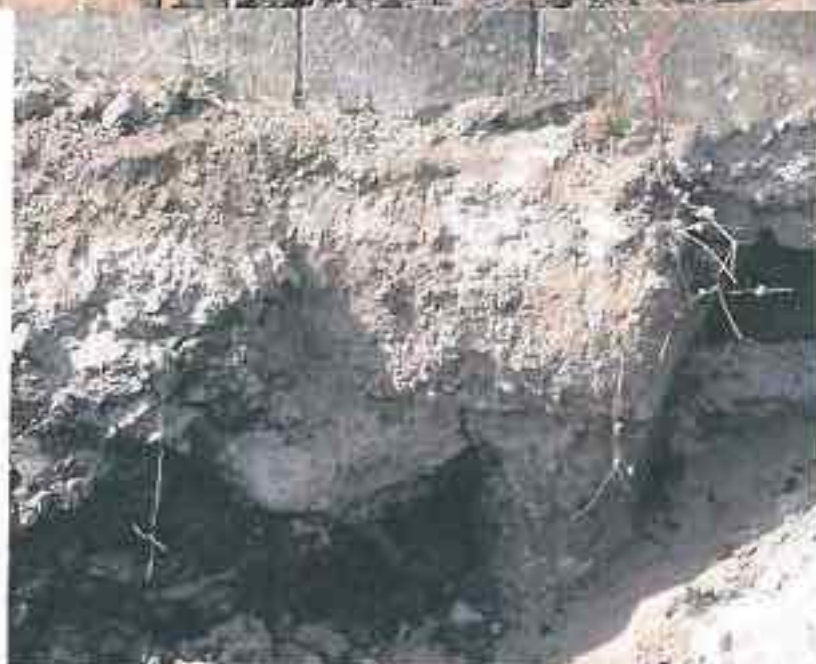
25. At two sites, Khalbujurg and Moreghadi, the buildings had foundations on piles, and yet there were extensive damages to the building superstructures. Reasons for such damages could possibly be the larger spacing between piles (> 10 feet), and/or poor workmanship, material and supervision. The piles were also not always seen located exactly below the columns indicating a lop-sided transfer of superstructure weight to the underlying strata or in some cases few piles were not aligned completely vertical (Plate 2.1.19). The workmanship was poor, and no Dummy piles were provided in any of the structures. The result was that at both these sites, the building structures had elaborate cracks, and Almirah etc. had become disjointed from the walls as illustrated in Plate 2.1.19, and floors had uneven settlement (Plate 2.1.2). The pile investigated at Khalbujurg was found to be short by 20 cm, and apparently pile cap of 20 cm was also assumed to be included in the pile length. At Moreghadi, however, the pile length shortfall was 27 cm, and even with pile cap included the pile length fell short of recordings in MBs (Table 2.1.1)

Lop-sided location of the Pile : Moregadhi Panchayat Bhawan - Pile not located below the weight carrying column, but rather displaced on one side.

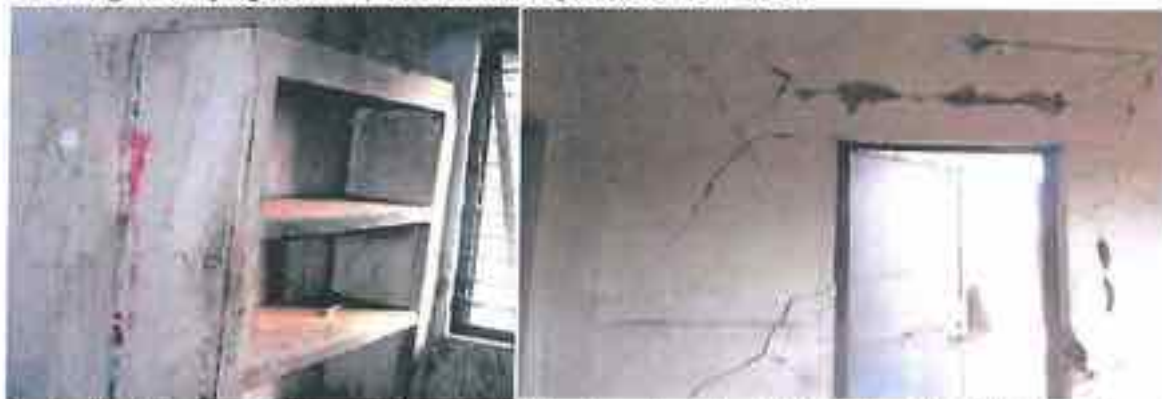
Typical settlement failure between Almirah and wall at Moreghadi (Left), & cracks at Khalbujurg Seed Godown (right). At both places, spacing between piles measured > 3 m. No dummy piles were provided in between main piles. Hence, such failures were inevitable in poor strata.

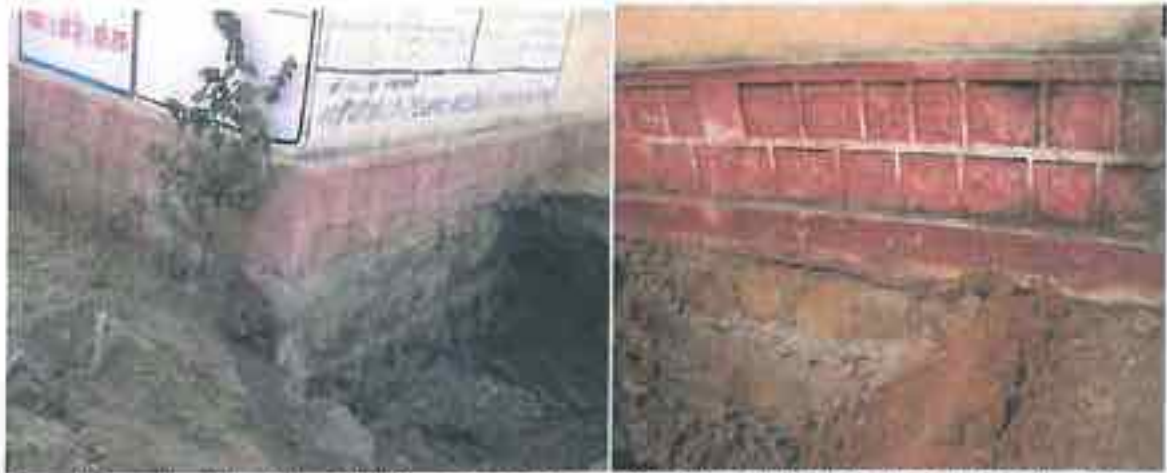
Foundation depth at Borlai II Panchayat Bhavan (left) with foundation depth 34 - 86 cm whereas at Kikarwas Primary School (right) foundation depth in similar strata was found 49-52 cm only.

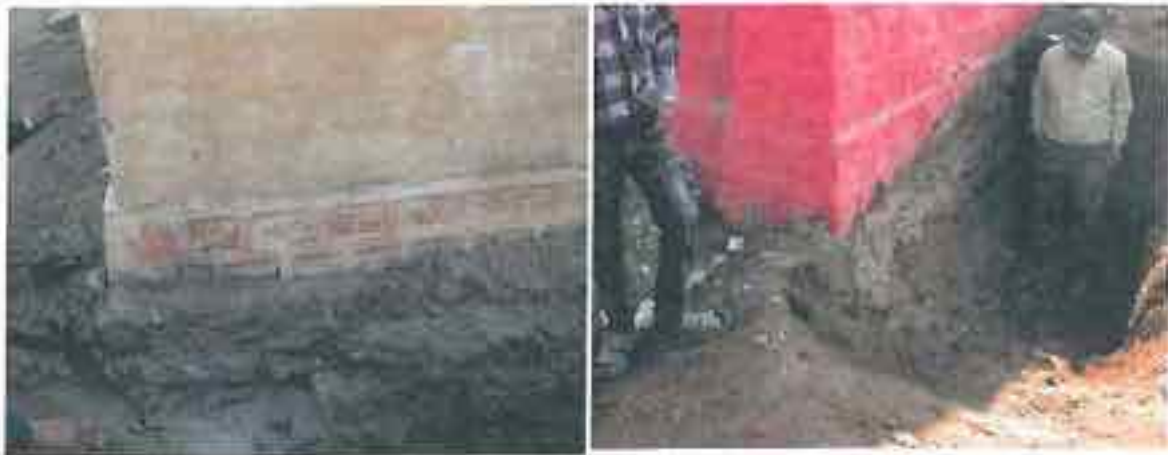
Bijasan: Aanganwadi located on sloping ground (left) had foundation depth 91-191 cm, whereas in similar sloping land, at the same site, the depth of foundation at Middle School (right) measured 76- 145 cm only.

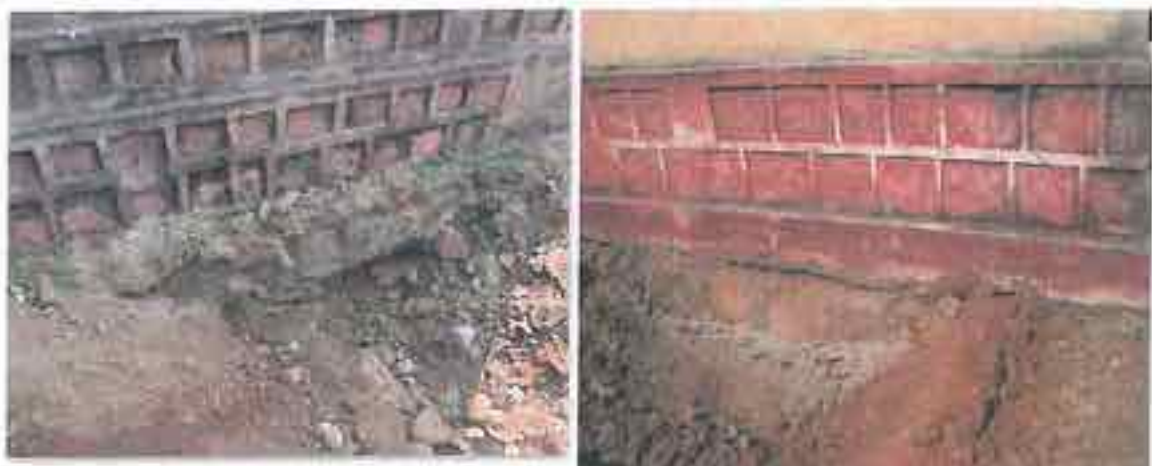
26. At all other remaining sites, the buildings had open foundations. However, it was rather bizarre that the foundation depths varied considerably from building to building and from site to site even for cases when the strata remained similar (Table 2.1.1), (Plate 2.1.20). This indicated to the possibility that the building foundations were not designed and were laid on adhoc basis, a fact confirmed later from the records made available (refer Section 2.7 for details).

Foundation of Middle School Building had only 40-61 cms depth at Nisarpur I (left), whereas in similar strata at Primary School Kikarwas (right) 49-52 cm deep foundation was provided.

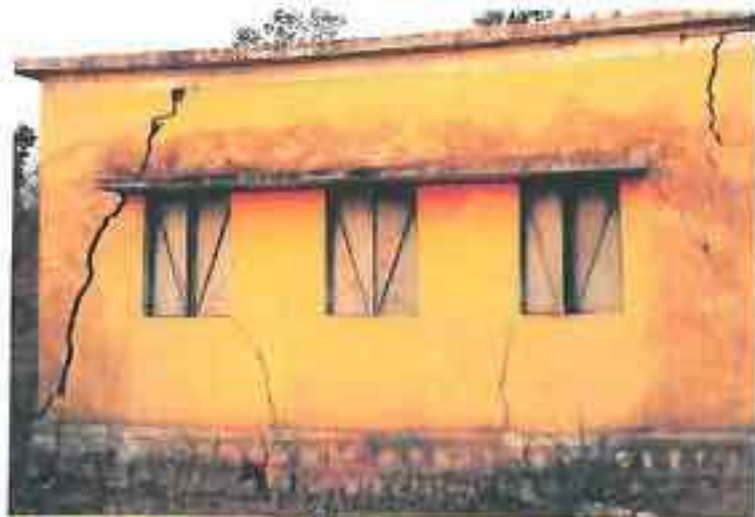
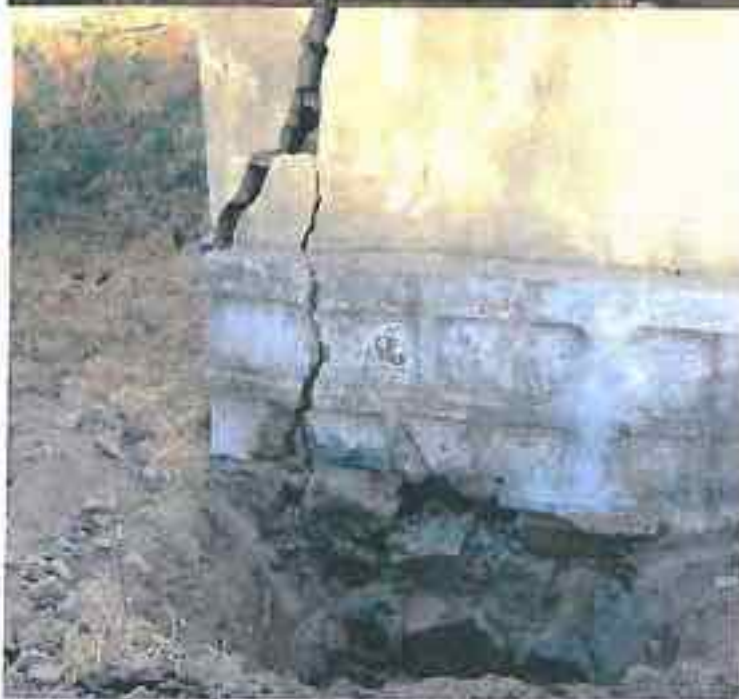
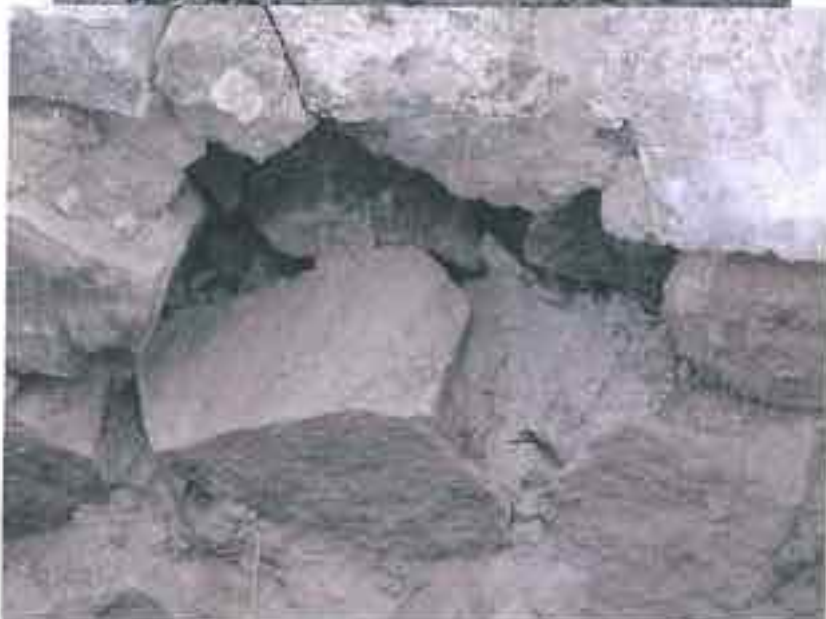
Chikalda: Primary School Building (left) showing typical foundation failure.
Plate 2.1.21. Typical Foundation Failure
