Evaluation of the Quality of Civic Amenities at Rehabilitation Sites of the Sardar Sarovar Project

**Sardar Sarovar Project - Fake Sale Deeds and Rehabilitation Sites
Irregularities Inquiry Commission**

April, 2014

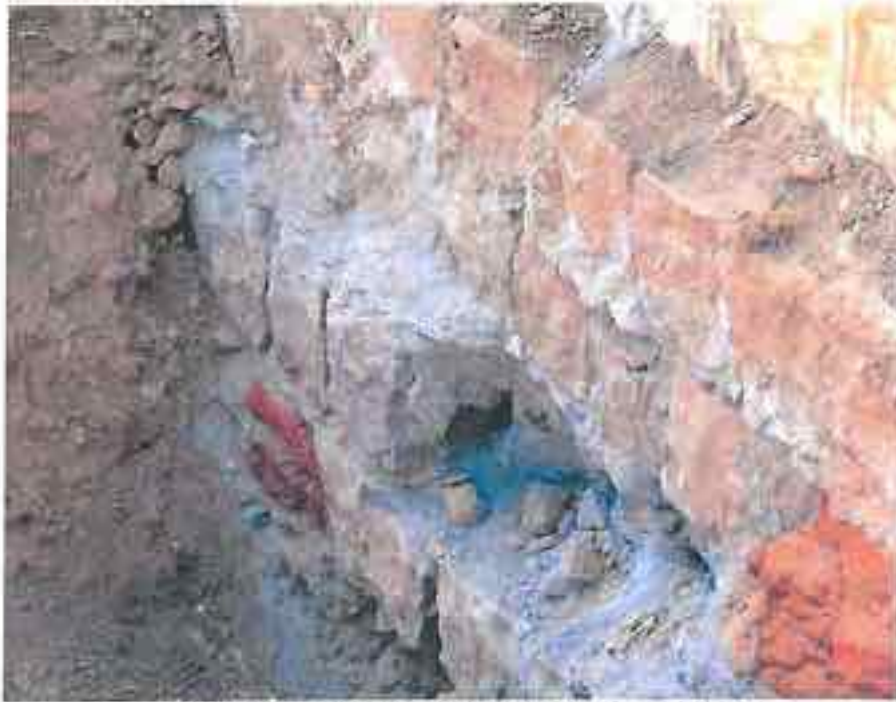
Amlali: Foundation of Panchayat Bhawan- Poor joints

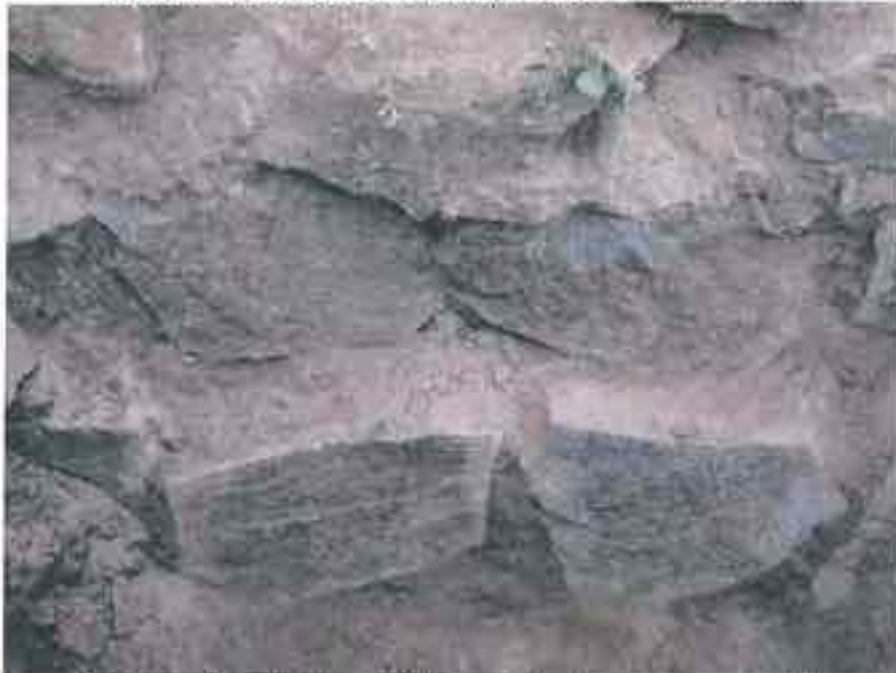
Nisarpur: Foundation at Primary School-poor wormanship

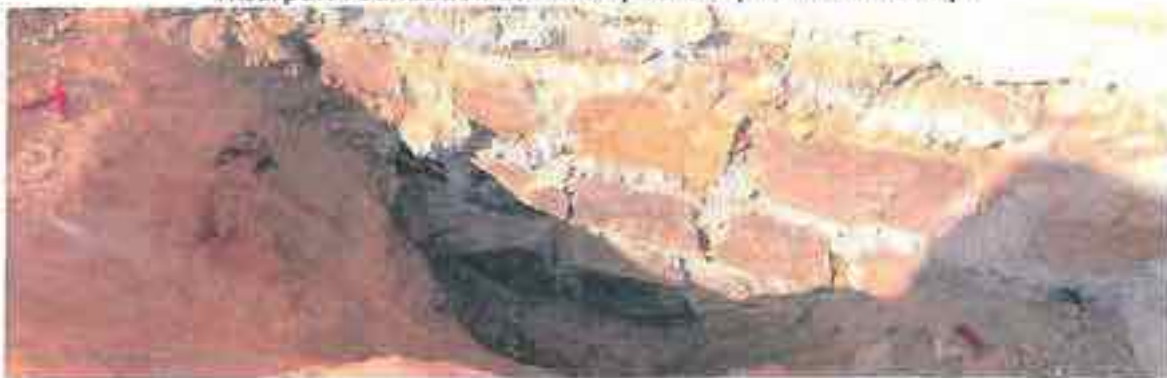
Chikalda-Panchayat Bhawan: Poor and thick joints-poor workmanship

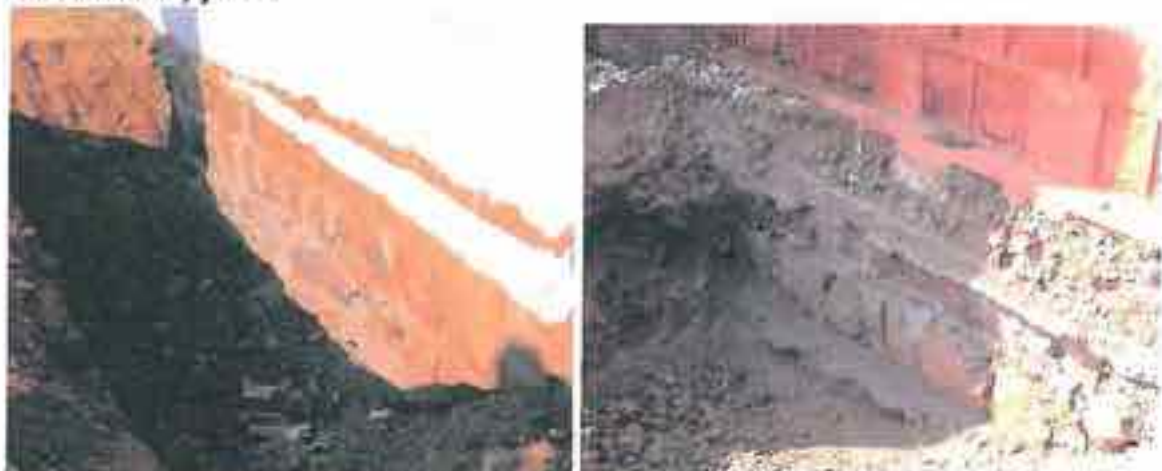
Poor masonry joints at Primary School Khedi (left) and Government High School, Dharamrai (right)

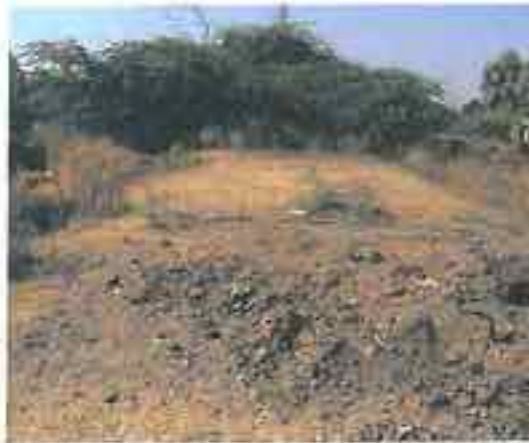
Jangarwa

22. However, at certain sites some layers components were found missing in some roads indicating that the grading was inappropriate in such cases from the time of construction itself. Plate 2.2.1 illustrates some such cases.

Plate 2.2.1. Improper grading and Missing Component layers

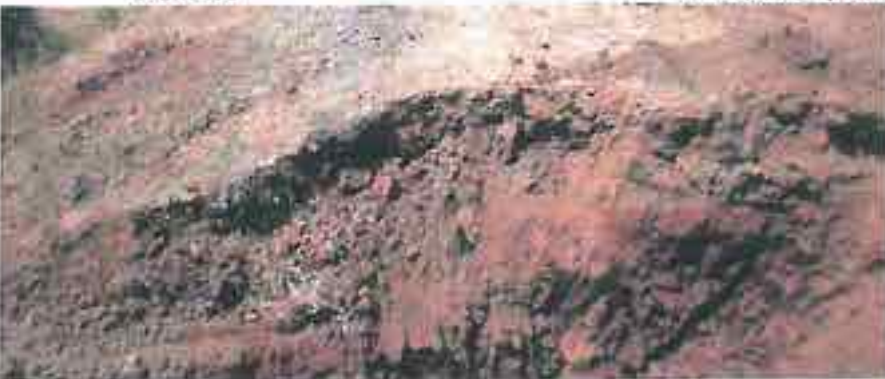
Jalkoti : A road cross section at a road collapse

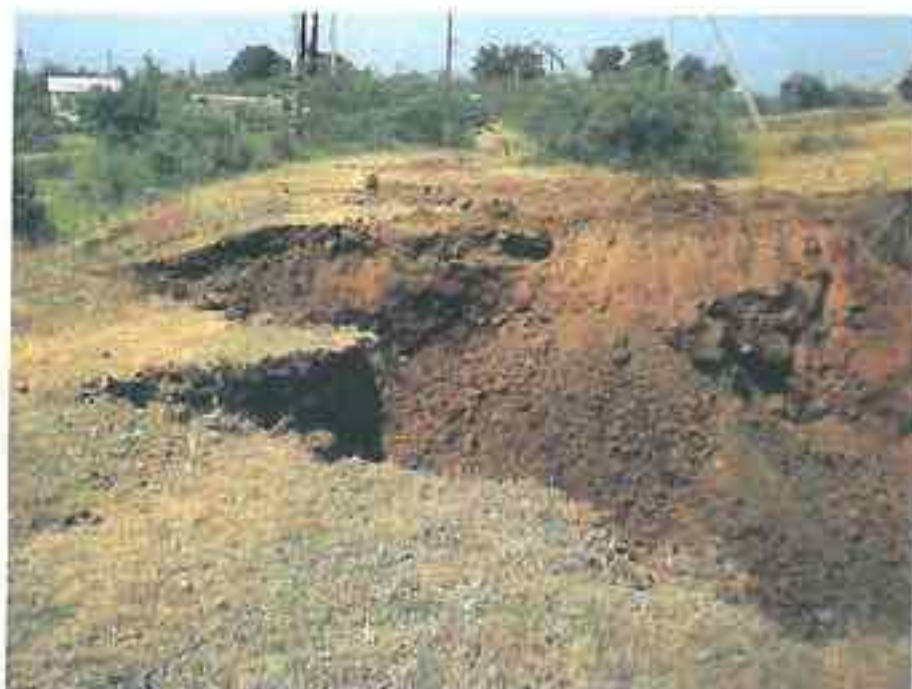
Jalkoti: A collapsed road section

Plate 2.2.2: Collapsed/Malformed Road sections (Typical)

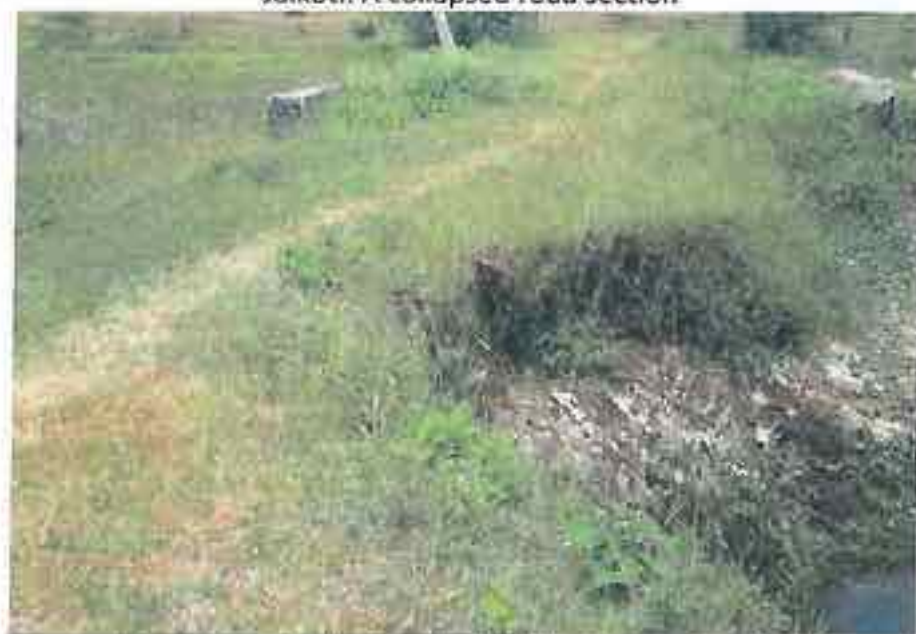
Moosapura: A damaged and collapsed road section.

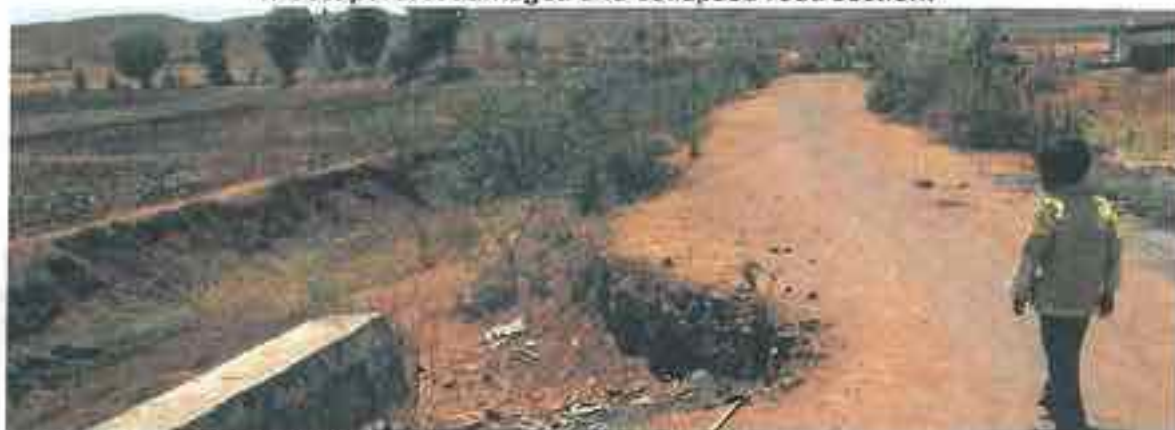
Chenpura: Typical Road damages

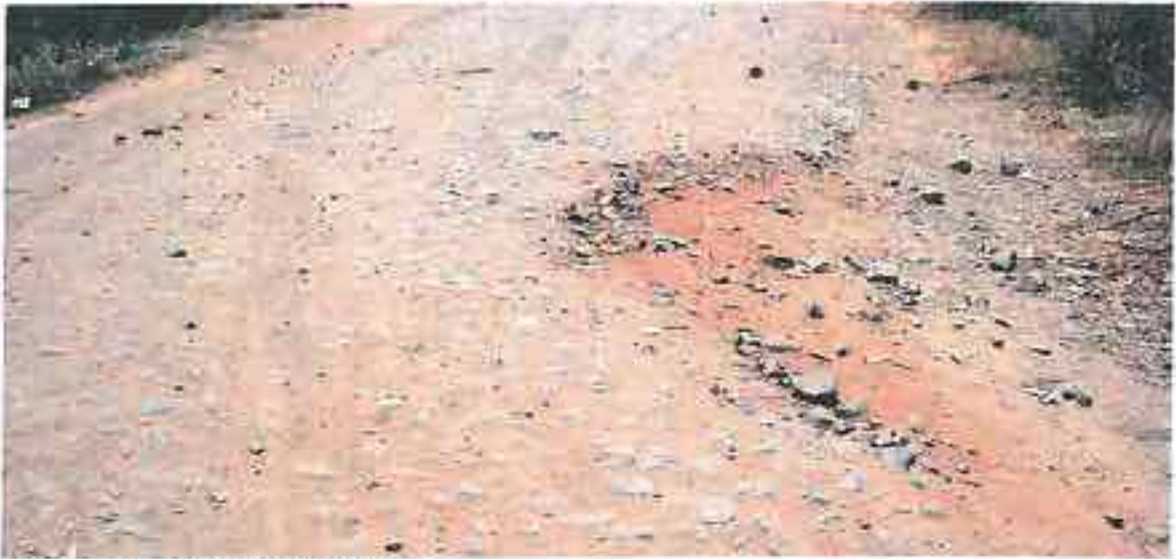
Raswa Deb: Typical Road damages

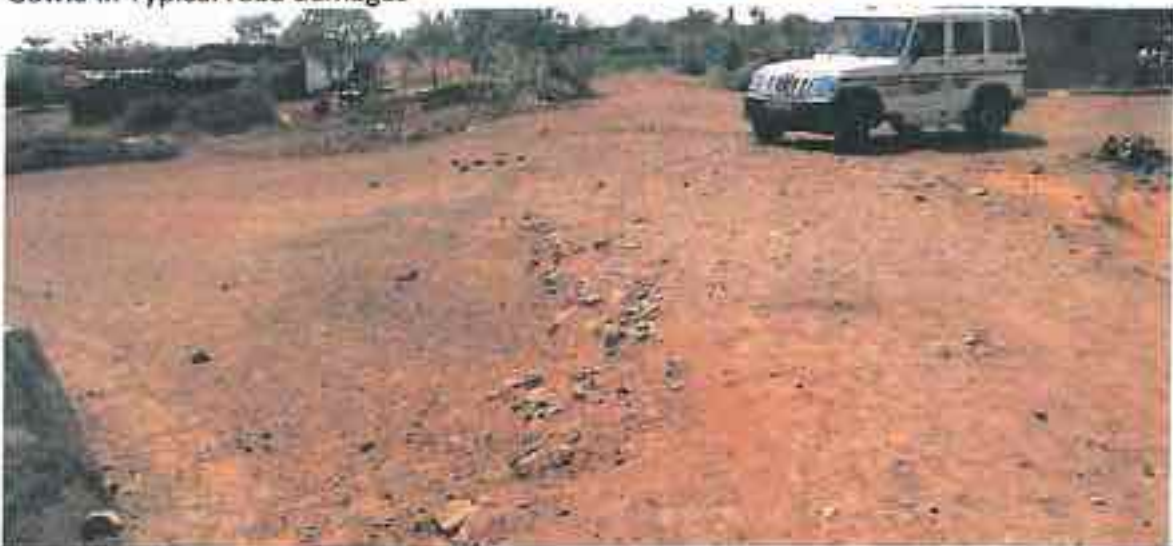
Gawla I

23. Some of these roads have outlived their lives or are on the verge, and have had poor maintenance, and need urgent repairs although they have not seen much traffic as several of the R&R sites are not fully habitated as of now. The damaged roads patches include complete collapse in sections (Plate 2.2.2) to wearing, loosening of the aggregate etc of the roads (Plate 2.2.3).

Plate 2.2.3: Poor Road Conditions and road damages (Typical).....cont.

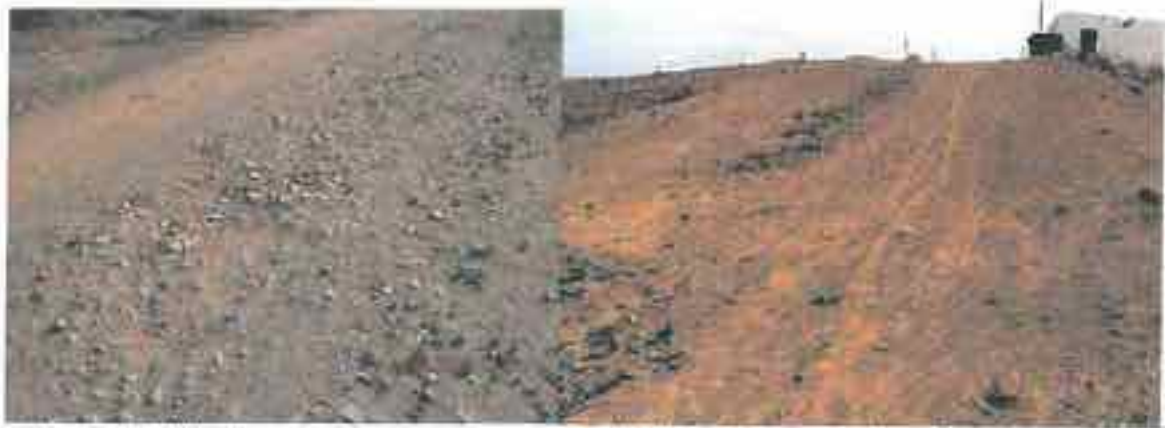
Jalanpur Dhalkheda

Tawlai Khurd: Poor quality of road & shoulders

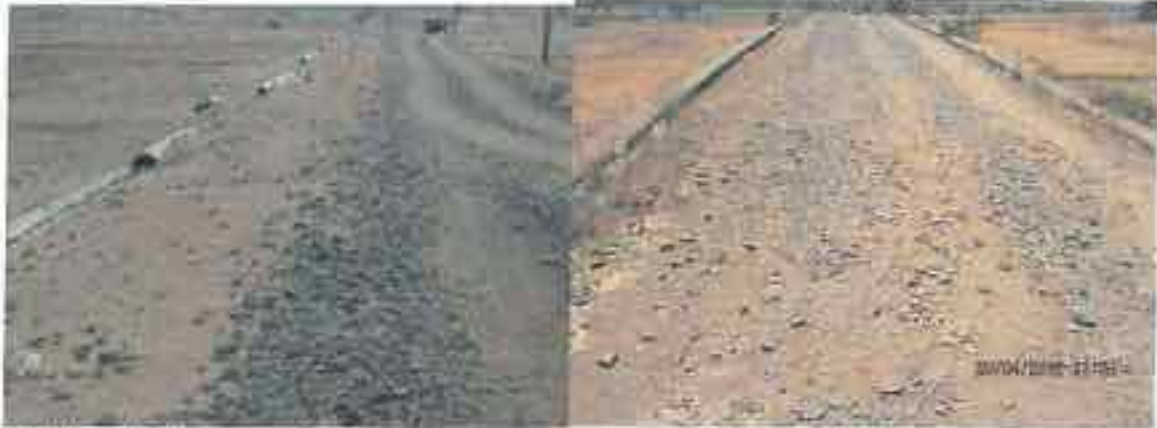
Khalkhurd, Dharampuri

Plate 2.2.3: Poor Road Conditions and road damages (Typical).....cont.

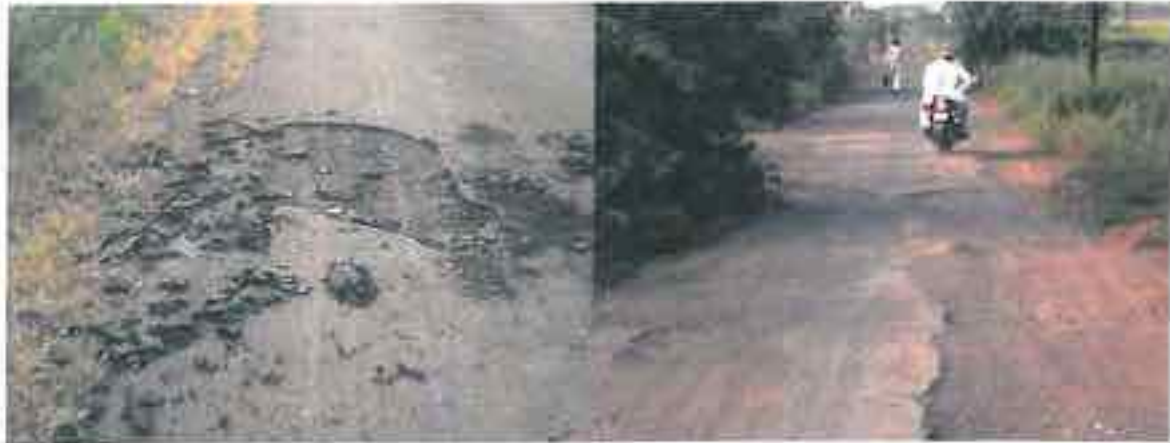
Nisrapur II/III: Poor roads, vegetation infested shoulders.

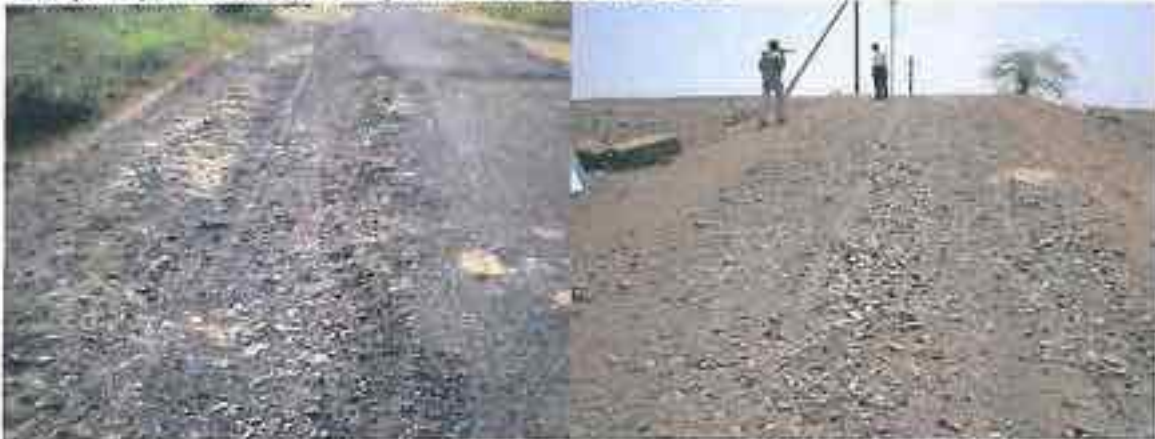
Kaisur

Plate 2.2.3: Poor Road Conditions and road damages (Typical)

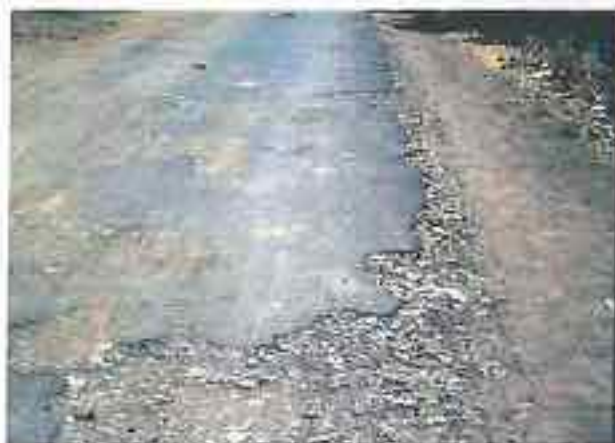
Perkhad

24. Where roads were bituminous, the bitumen thickness was approximately 20 mm. However, the bituminous concrete mix coat was found damaged in patches at several sites (Plate 2.2.4) sites including the approach roads at Brahmangaon, Khedi etc. It also exhibited cracks at places (Plate 2.2.5).

Plate 2.2.4.Damaged Bitumen Road Surfaces (Typical)

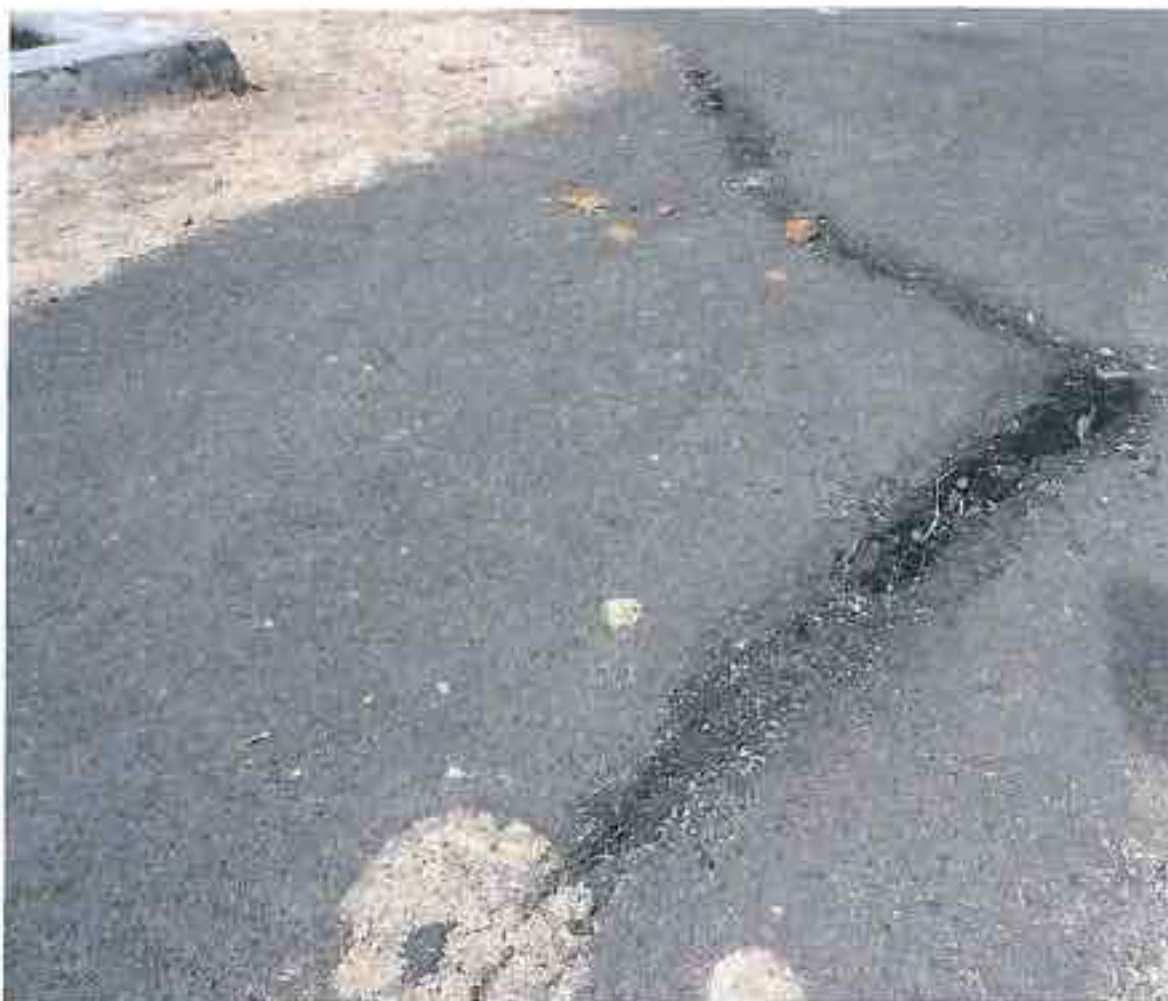
Khalbujurg

Plate 2.2.5. Cracks on Black Top BT Road surfaces (Typical)

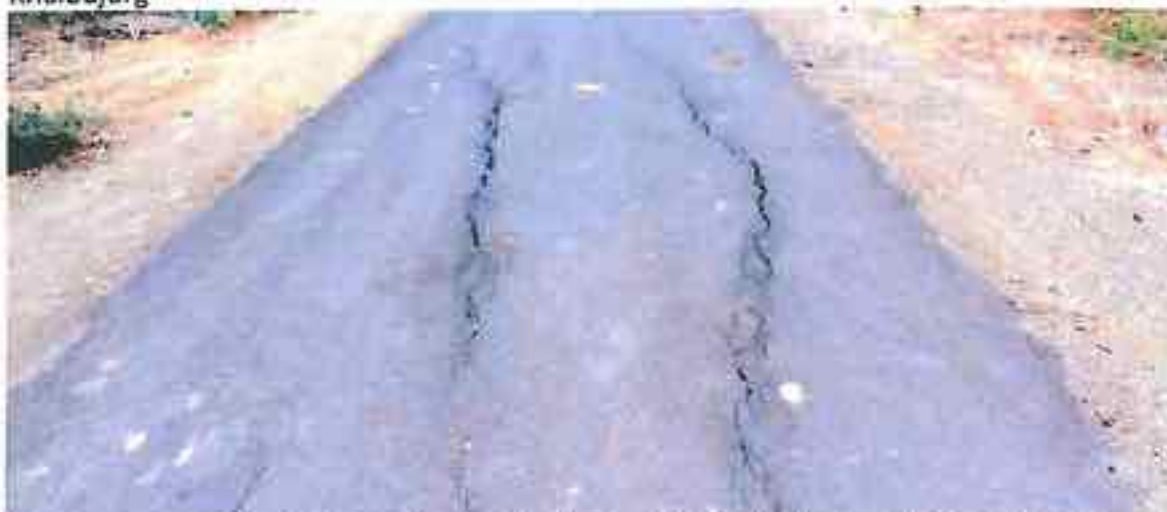
Dharampuri: Longitudinal cracks on Black Top BT Road- Typical of longitudinal crest failure and may be due to poor compaction in layers. Such cracks are also due to poor CBR of sub-surface and other layer material.

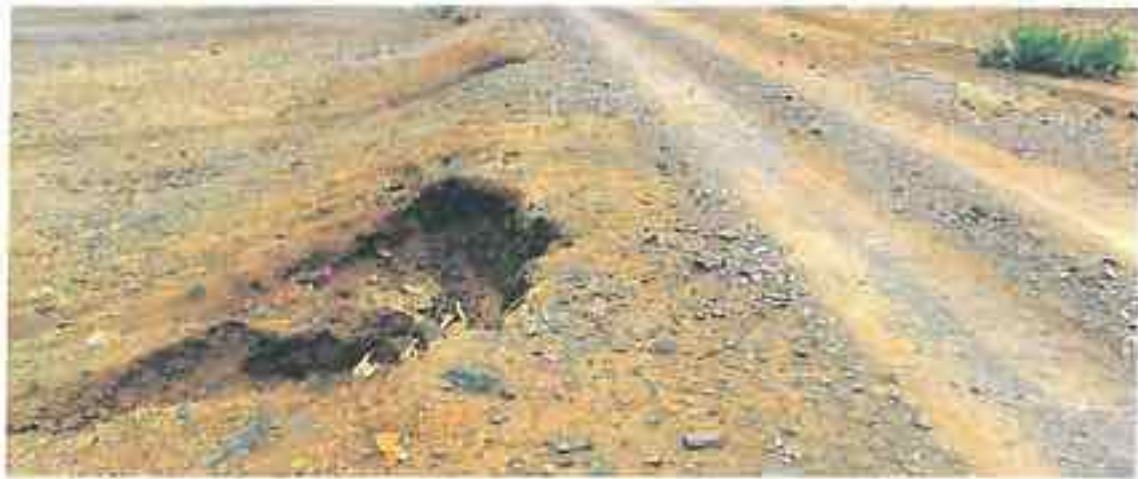
Barda, Manavar

25. The condition of hard shoulders was often found poor at most sites (Plate 2.2.6). This problem was endemic and poor road shoulders, including edge drops, erosion and wearing of shoulder material, cuts, loose material etc. were often seen, despite hardly any traffic flow at most of the R&R sites.

Plate 2.2.6: Poor Road Shoulders (Typical)

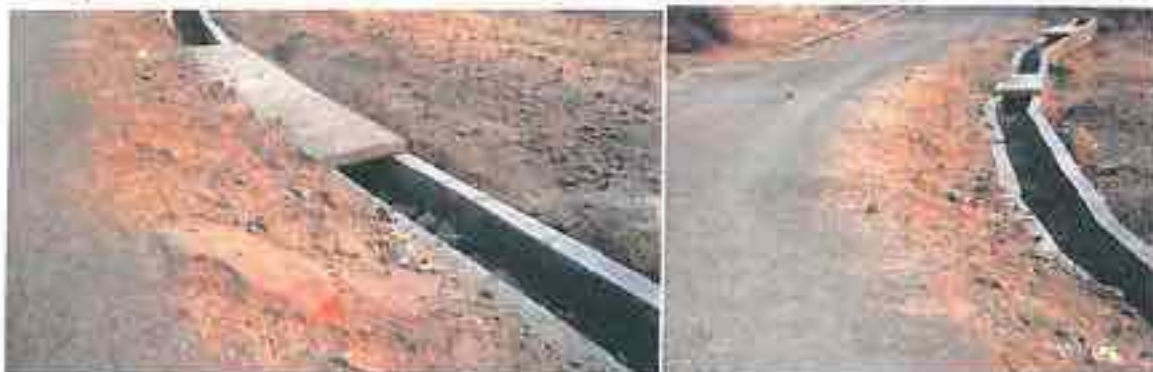
Mohipura: Boulder protruding (left)&Poor Road shoulders with wave-like drainage (Right)

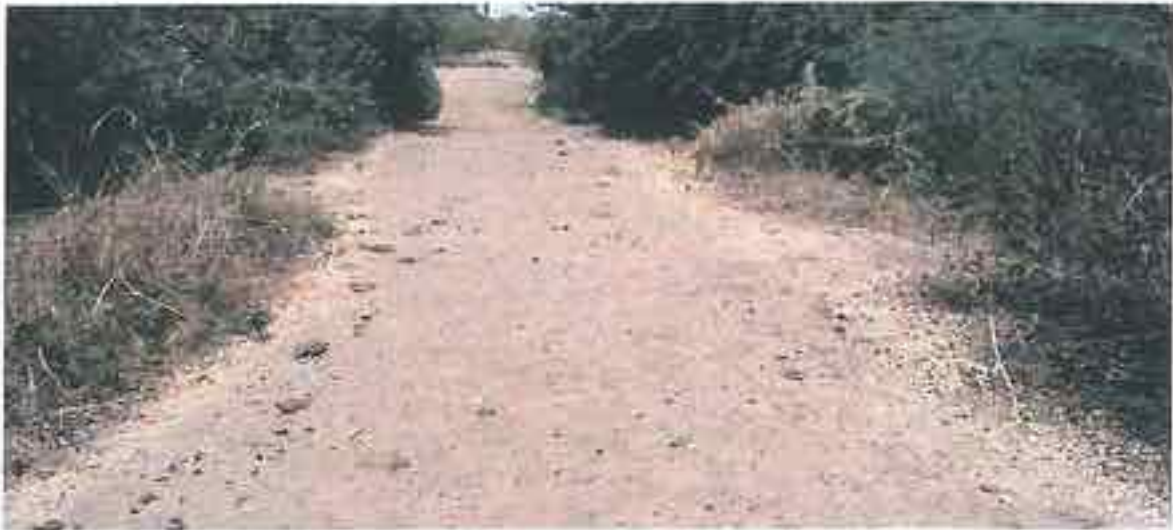
Mehgaon

26. Growth of vegetation including grass and bushes etc. on road shoulders was a familiar site (Plate 2.2.7), indicating inappropriate maintenance. The need for proper maintenance and repair therefore exists at a wide majority of R&R sites.

Plate 2.2.7.: Road Shoulders lost to Vegetation (Typical).....cont

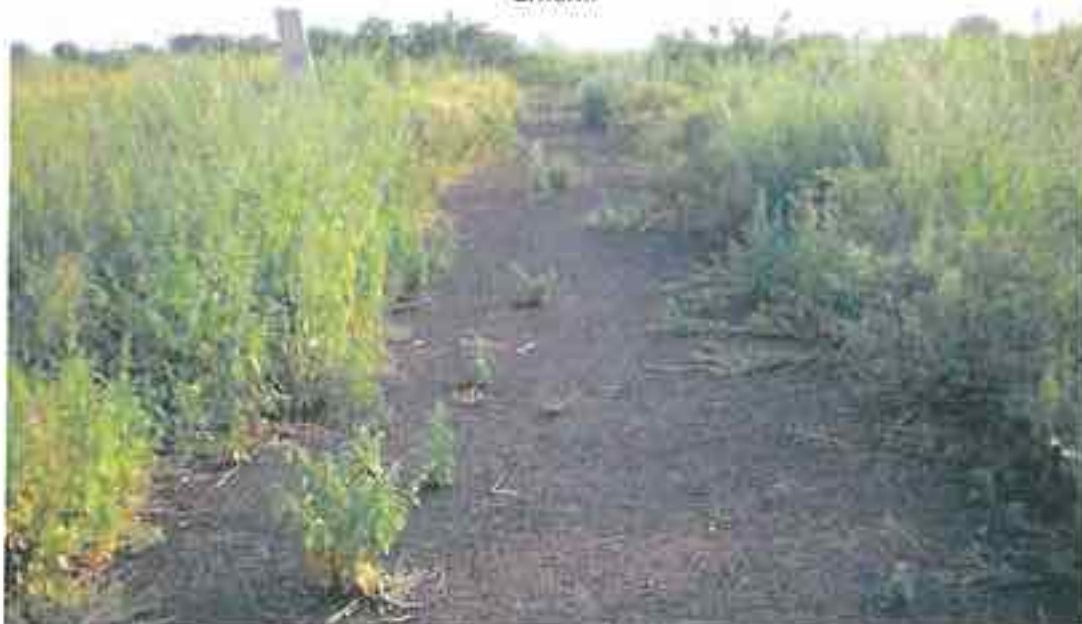
Nisarpur II/III

Plate 2.2.7.: Road Shoulders lost to Vegetation (Typical)

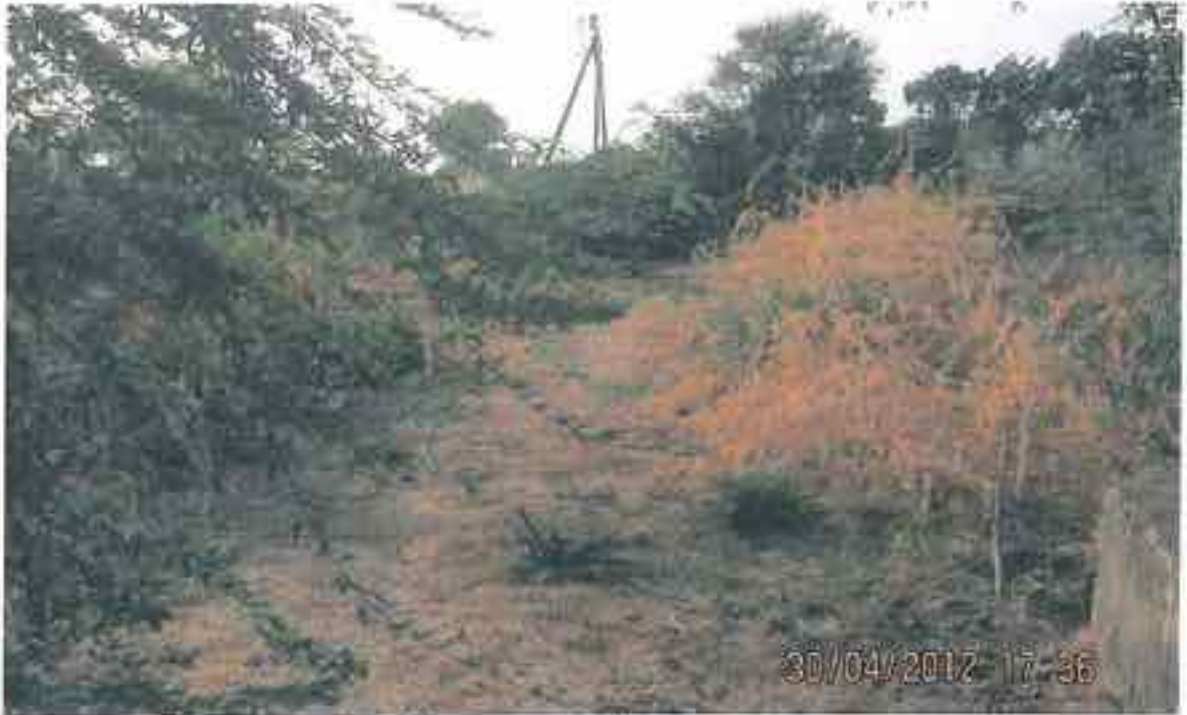
Saita: A road almost completely lost to vegetation

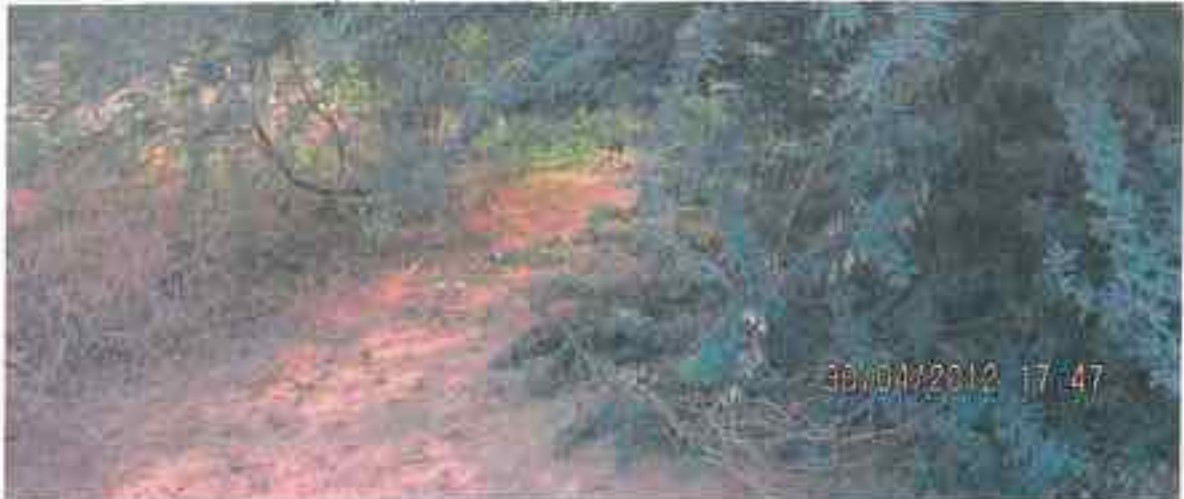
Saita: Another road lost to vegetation

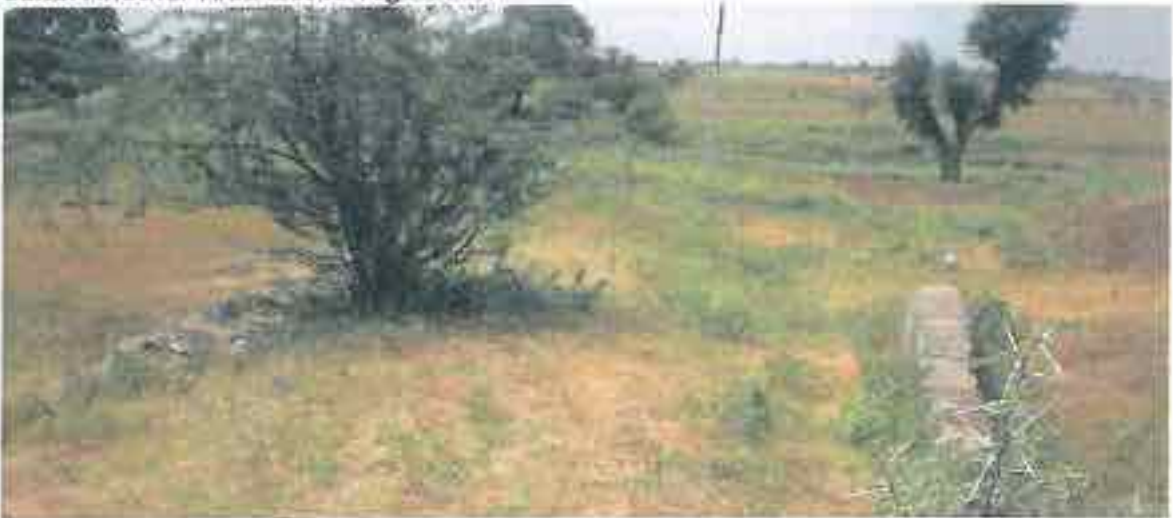
Moosapura: road lost amongst vegetation

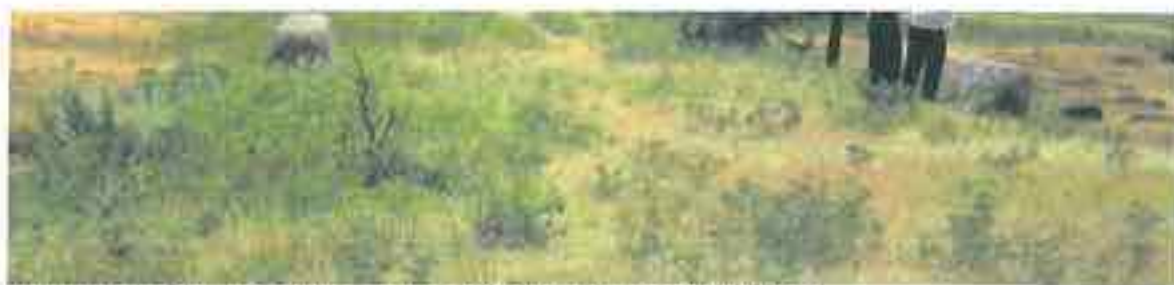
Moosapura: But for culvers, it was difficult to identify this road

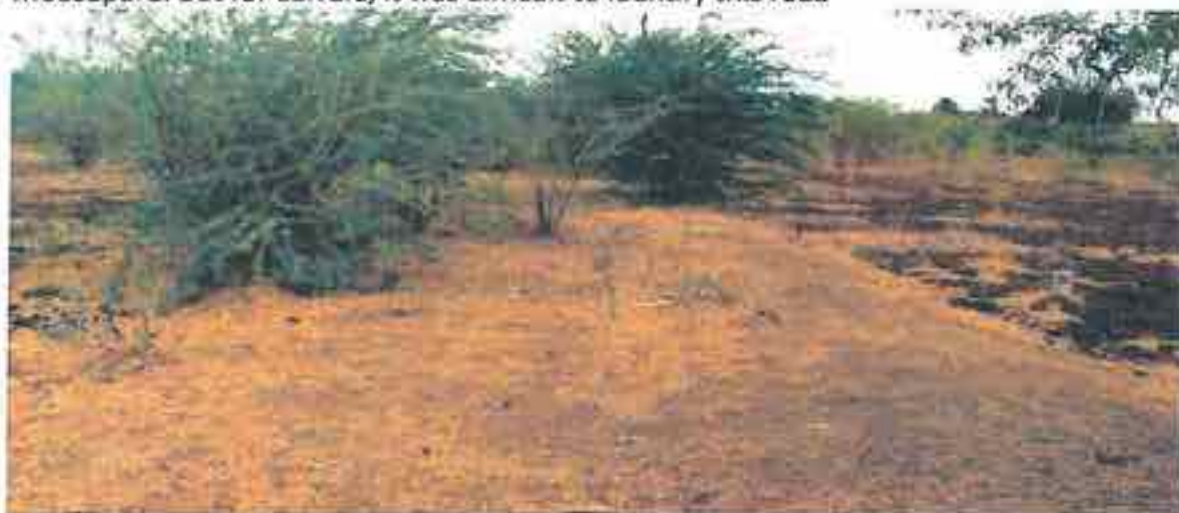
Urdana: Road lost to vegetation: Poor upkeep and maintenance

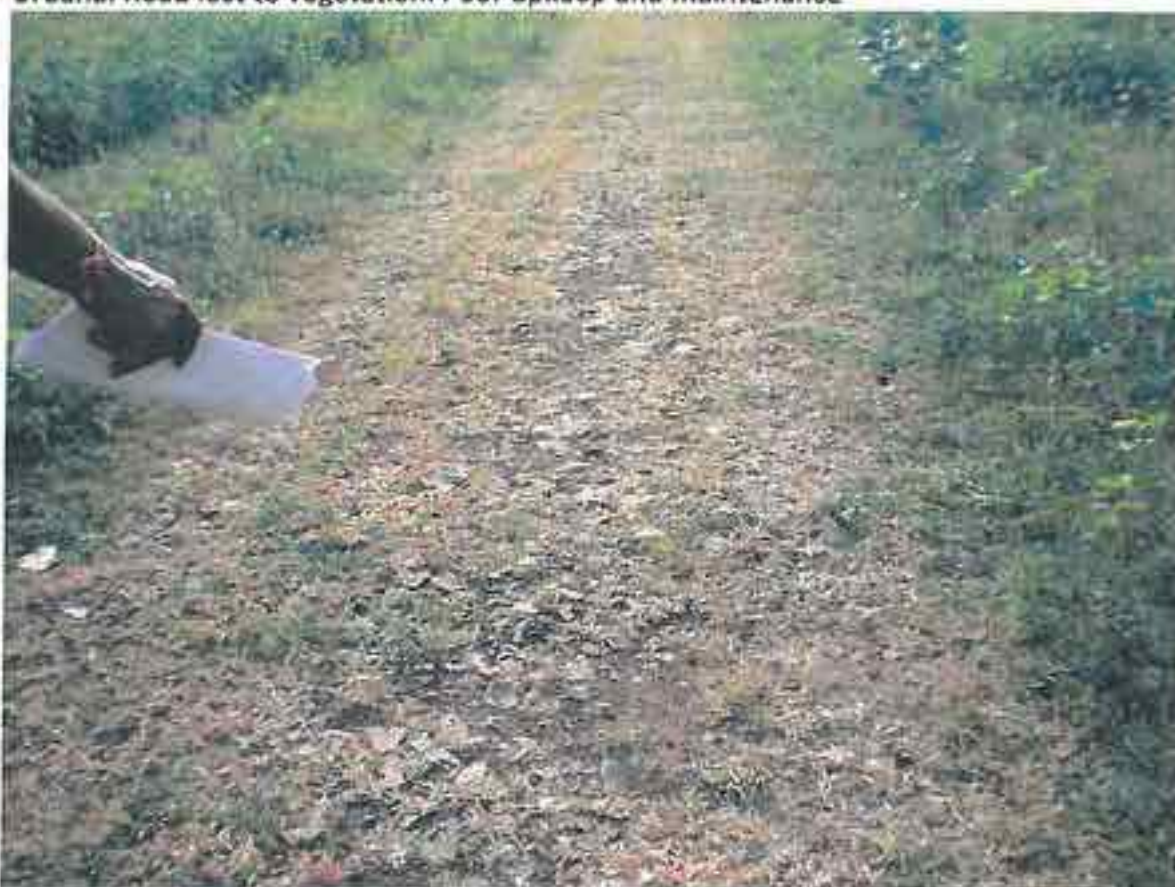
Khajuri, Jhabua: Road lost to grass and vegetation

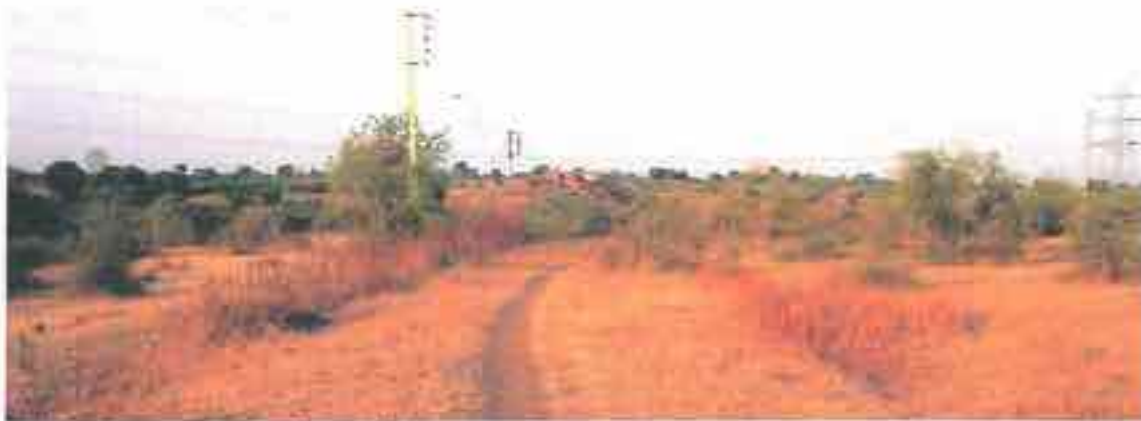
Balkhad : Remnants of a road

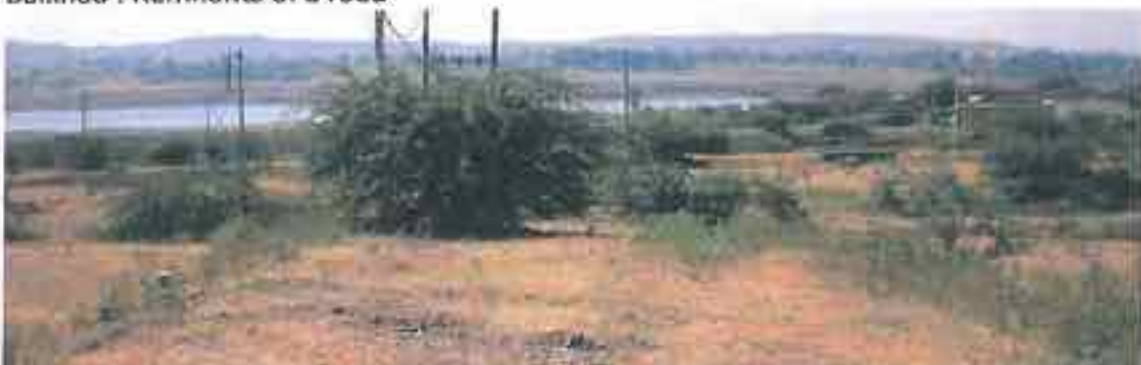
Jalkoti

Plate 2.2.8. Extensive Vegetation on Road (Typical)

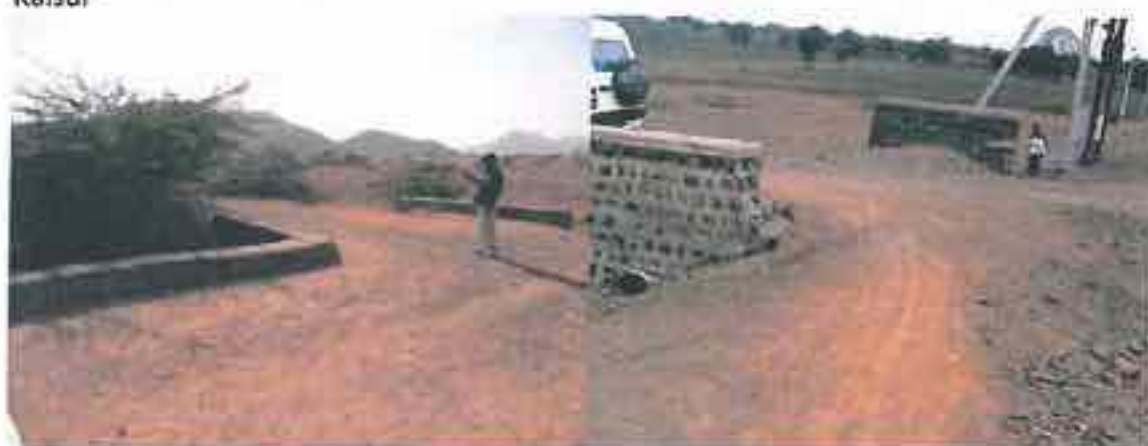
Awalda

Plate 2.2.9. Sharp Turnings: Inappropriate design and execution (Typical)

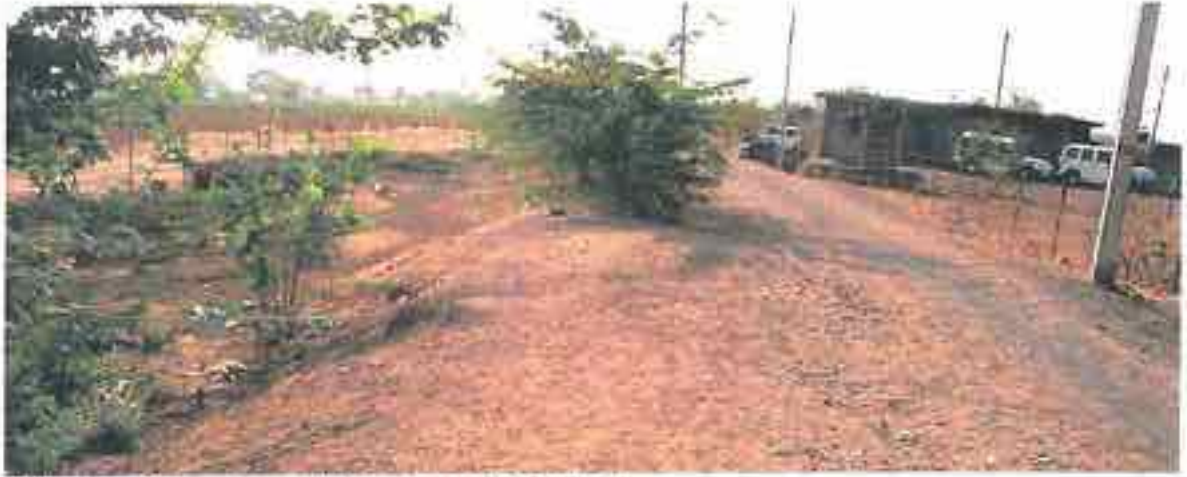
Takiapur: Pole and vegetation on road shoulders

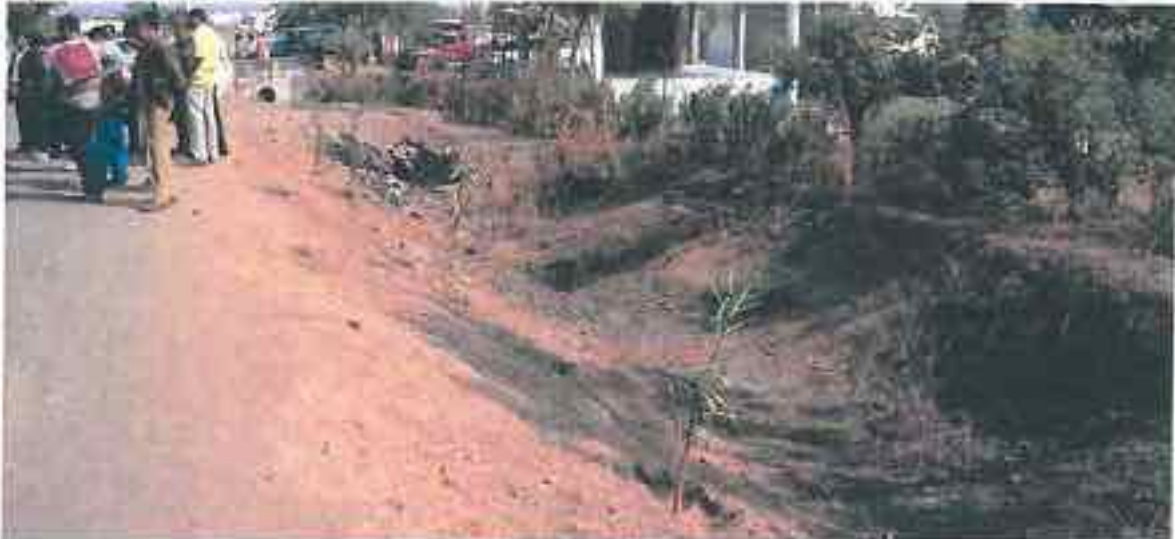
Kukra: Deep trenches upto 6 ft on both sides of the main approach road. Road safety jeopardised, more so as engineered side drains are non-existent (though culverts are present, but these are susceptible to silting and chocking up as engineered drainage is not present). What would happen in rains when ditches this deep stand filled up, and driver does not know where the road edge lies?

Plate: 2.2.11. Road Safety Compromised: Deep Trenches alongside the Road (Typical)

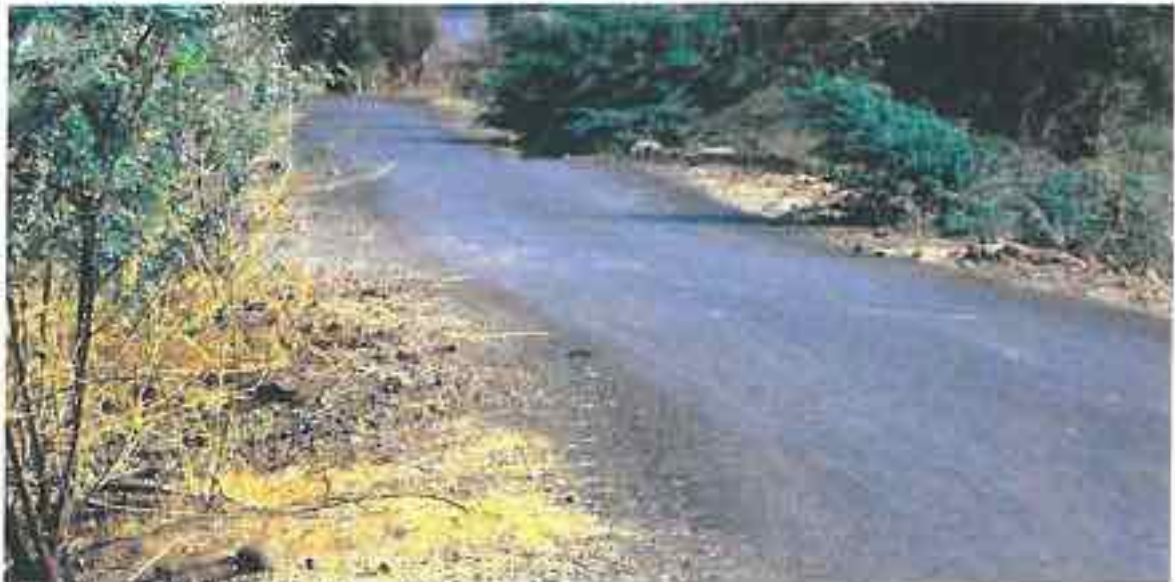
Moreghadi: Undulating, Wavy Road Surface.

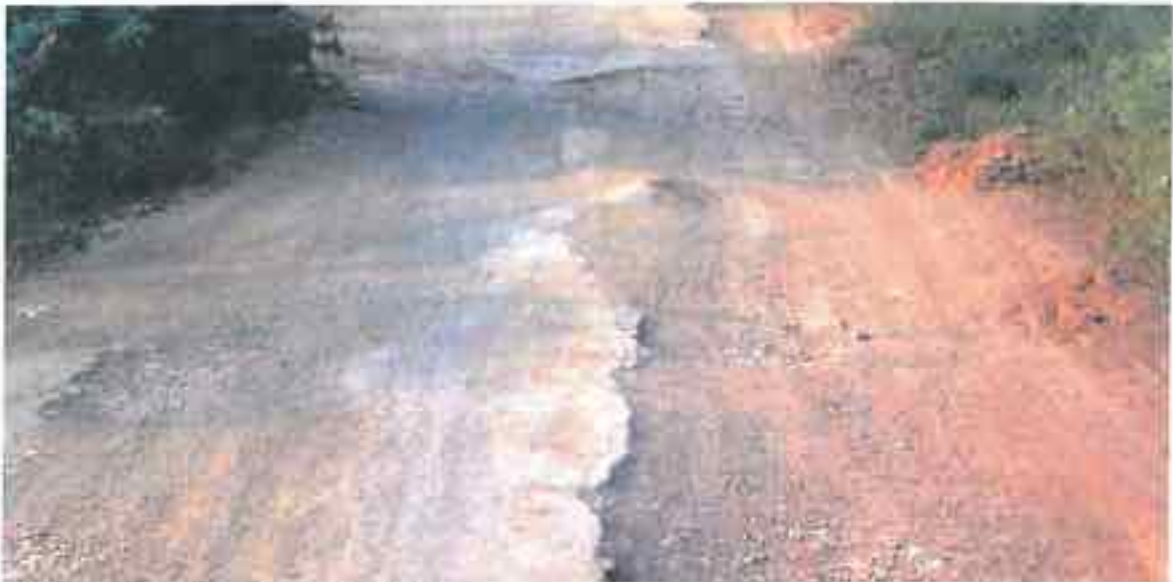
Nisarapur II/III: Distorted road surface

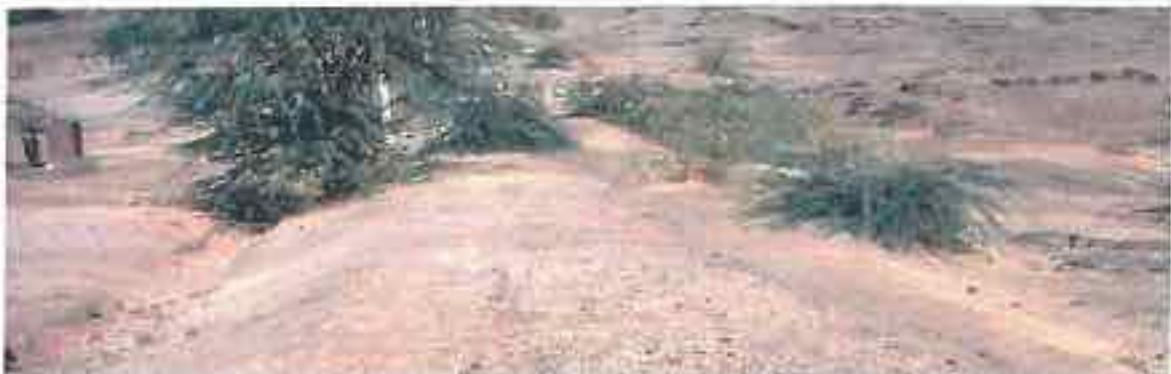
Morekatta: Poor roads, dilapidated shoulders, and lack of maintenance of roads indicated by growth of bushes.

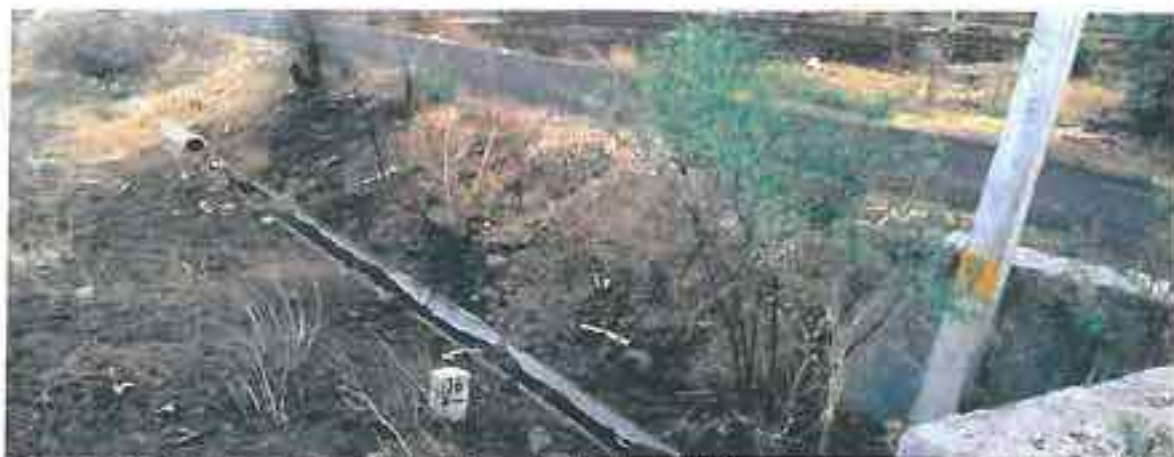
Moreghadi: Damaged shoulders. Also note the level difference between road top and the plot.

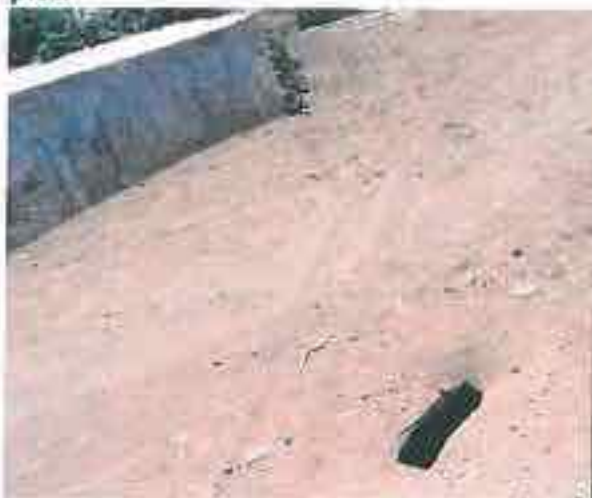
Anjad Barda

Holes on middle of roads
