Evaluation of the Quality of Civic Amenities at Rehabilitation Sites of the Sardar Sarovar Project

**Sardar Sarovar Project - Fake Sale Deeds and Rehabilitation Sites
Irregularities Inquiry Commission**

April, 2014

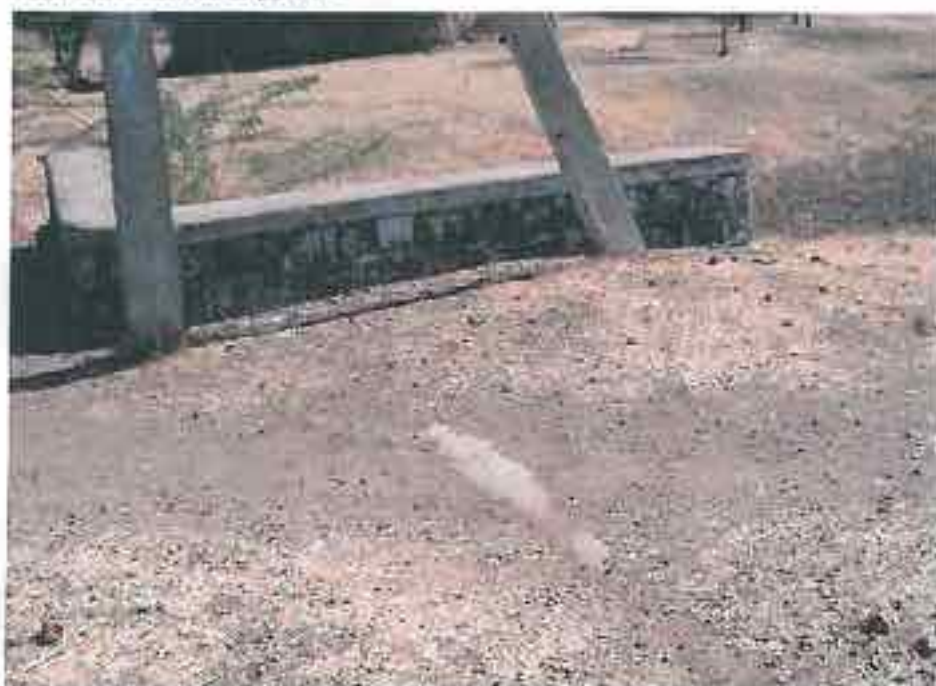
Borlai I: Cross drain pipes visible over roads: Inadequate covers on pipes

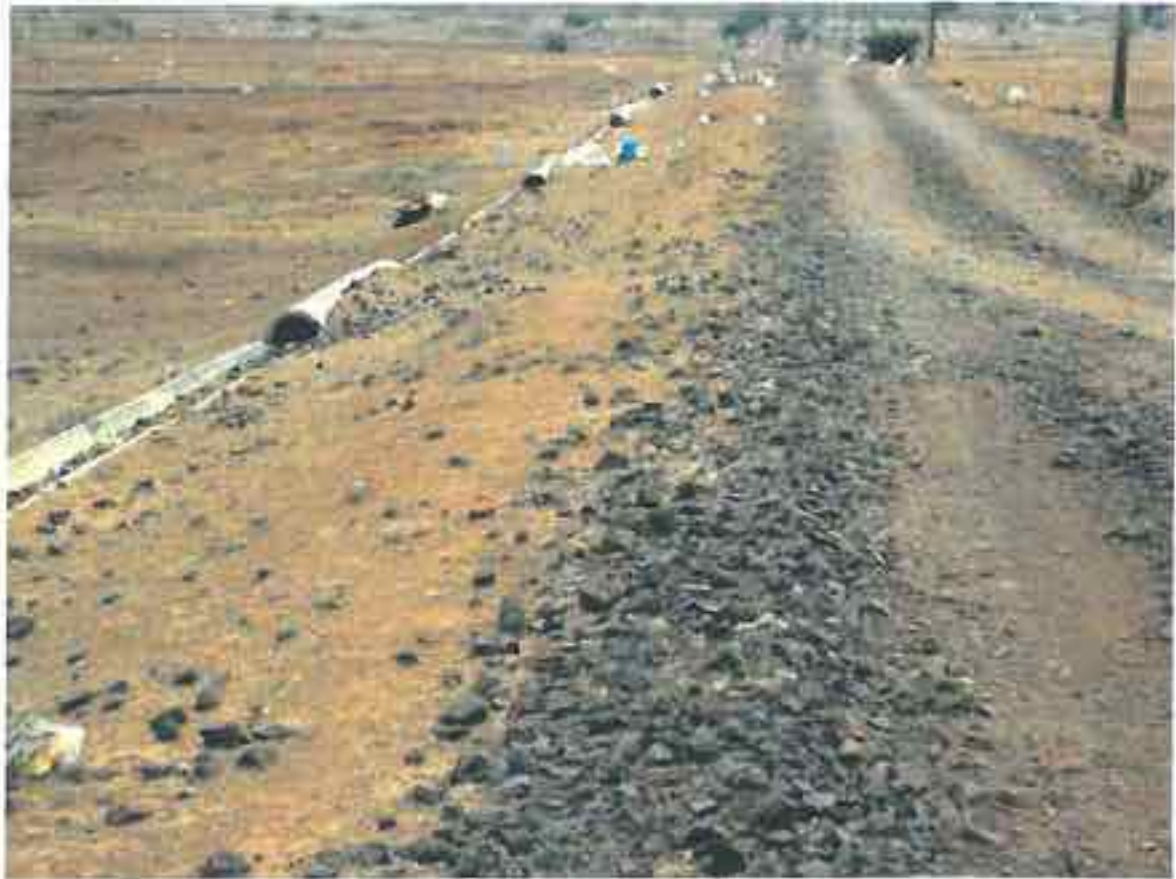
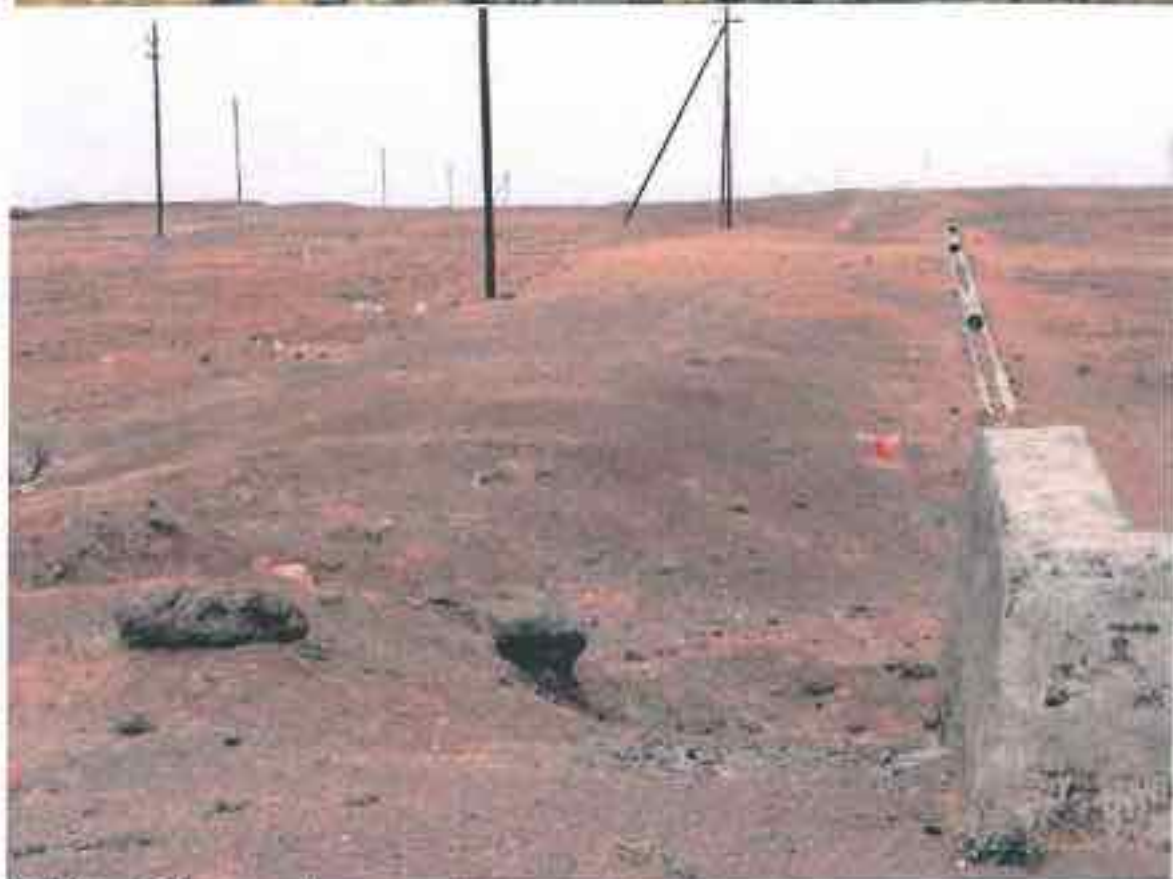
Khalkhurd, Dharampuri

Plate 2.2.13: Incomplete appearing road works (Typical)

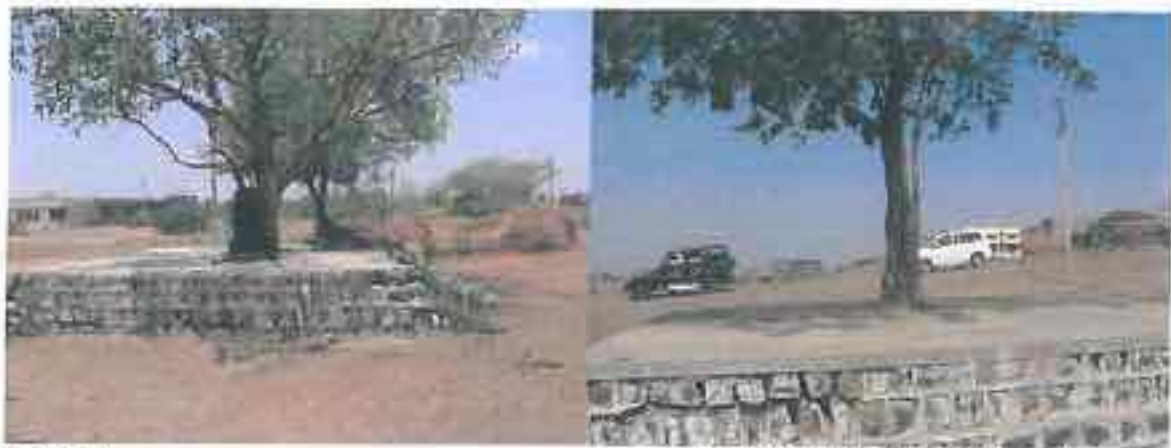
Semalda

Achoda : Neem and Peepal

Plate 2.3.1. Typical Inappropriate choices for Tree varieties planted on Platforms – Elaborate root system will damage platforms in a few years.

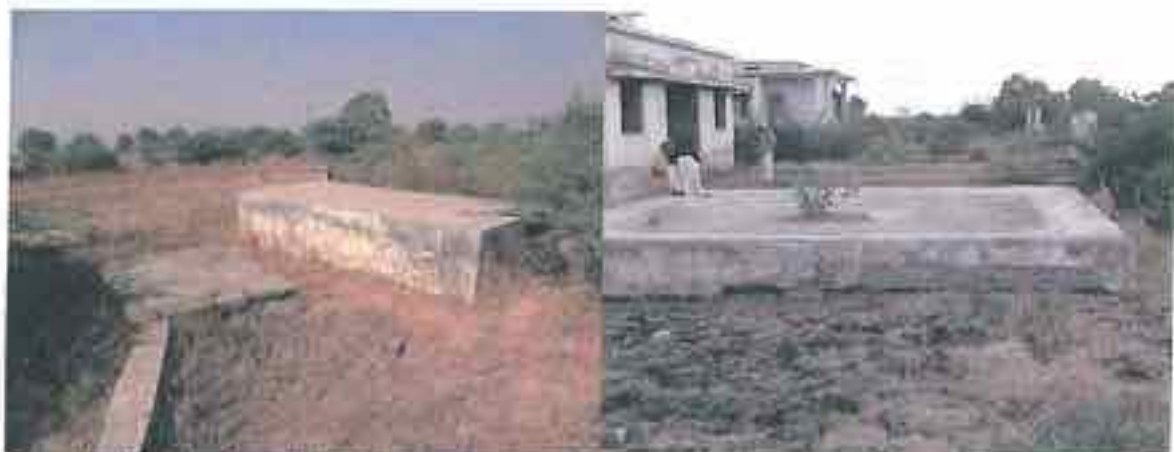
Moreghadi: A platform built next to septic tank

Moreghadi: A larger than standard platform

Plate 2.3.3. Typical Variations in Platform sizes: Two Platforms at the same site barely a few meters apart (Illustrative, lesser variations were more common at some R&R sites).

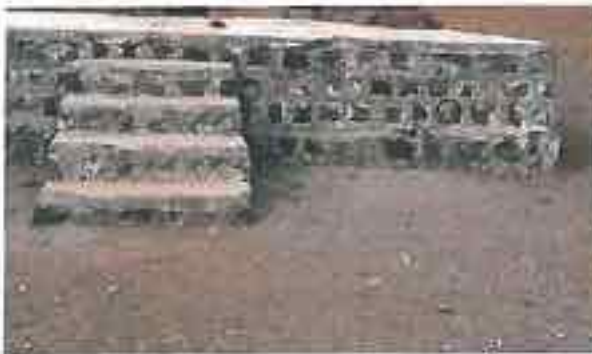
Beganda

5. Tree Platform heights were also not found standardised. There were significant variations in heights above ground level (Plate 2.3.4). For example, the heights had a range of 0.41 m (Khajuri) - 0.45 m (Kaisur and Nisarpur I), to all the way upto

Plate 2.3.4. Typical Variations in Platform Heights.

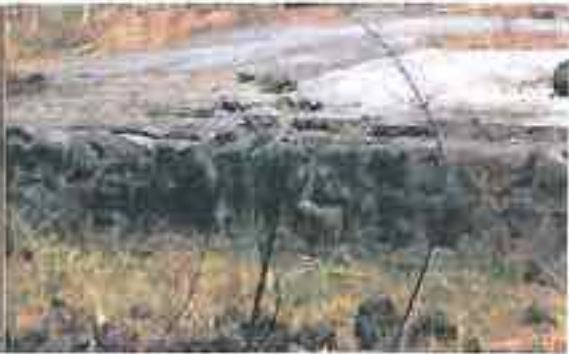
Sala (no steps seen)

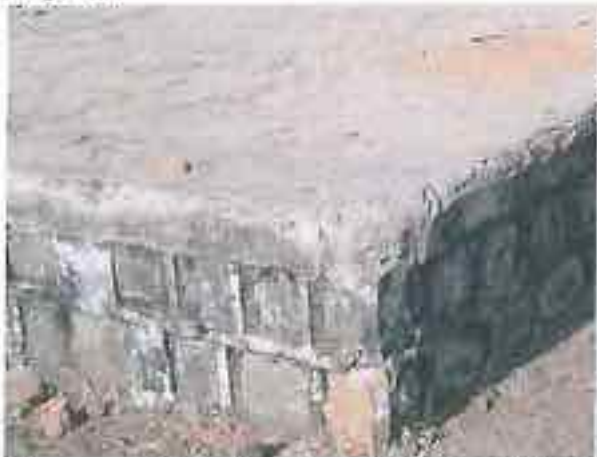
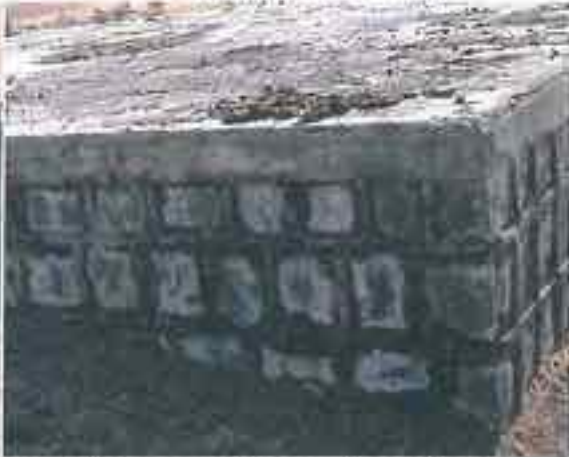
Jalanpur Dhalkheda: Two platforms : Note the variation in numbers of stones at corners (Two in left photograph vs Three in the Right)

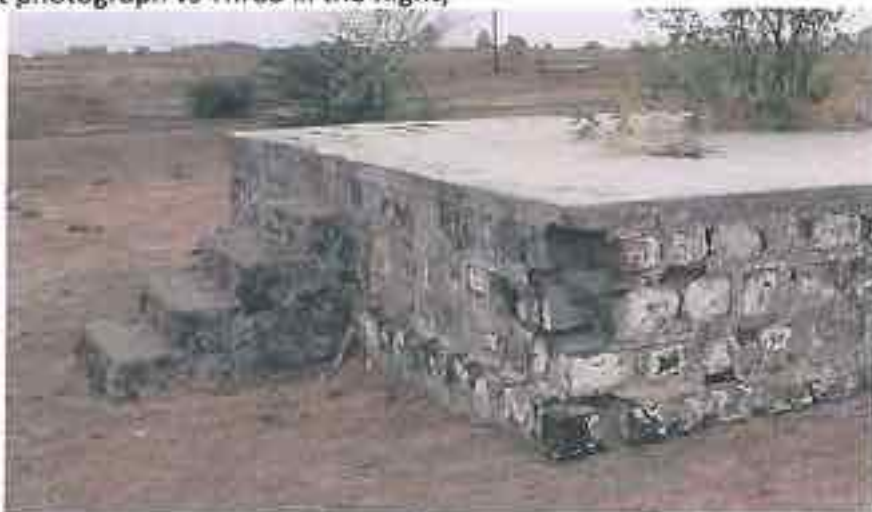
Beganda : Number of stones at corners is Four.

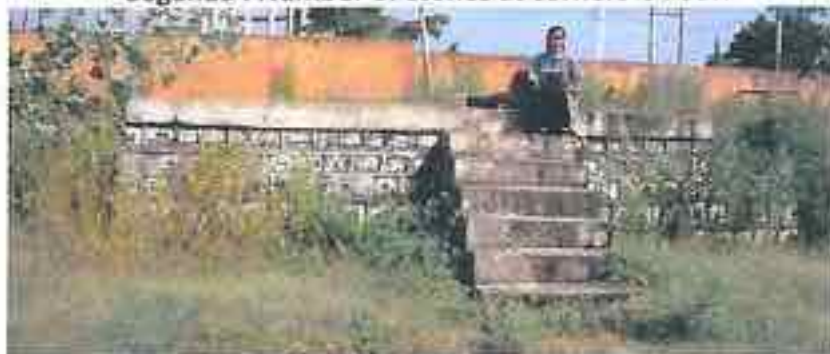
Nisarpur: Number of steps equal to six

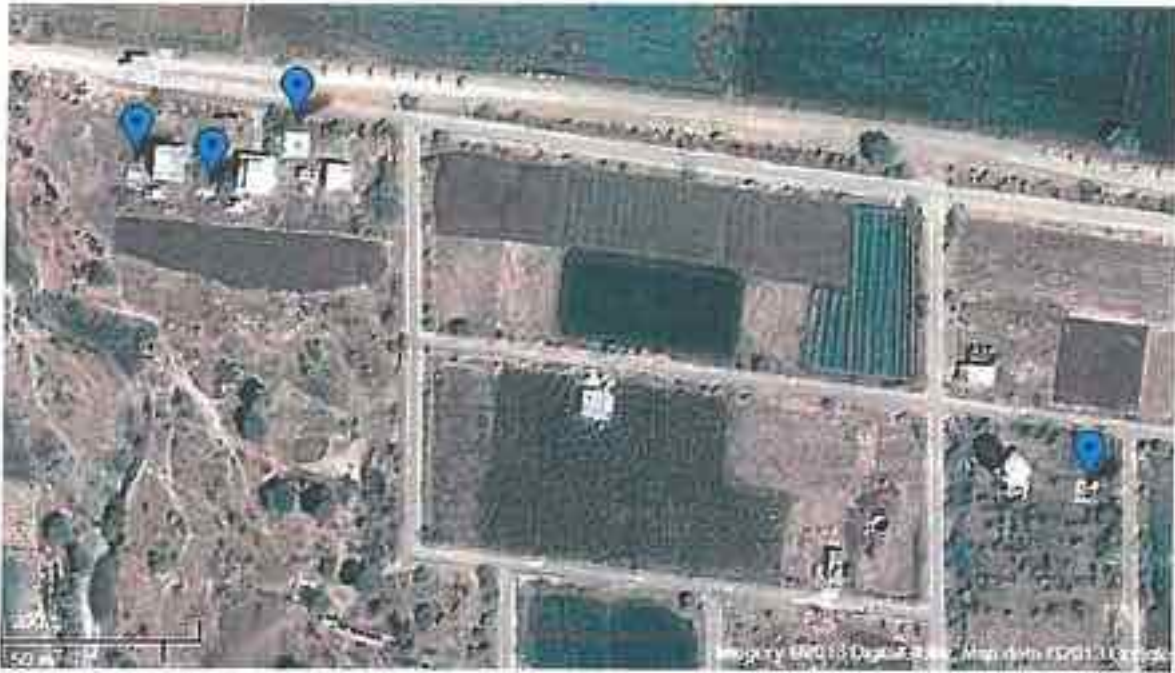
Moreghadi : A Satellite view

9. Then there were site-specific planning issues pertaining to locations of tree platforms, though the lessons would be generic (Plate 2.3.5). For example, at Moreghadi, a large spread-out site, in a distance of nearly 50 m as many as 3 platforms were found located near Panchayat Building, Seed Godown building and Primary health centre. If the provisioning is justified on the ground that people will gather near these buildings, then this argument should have applied to all other R&R sites.

1. Top left hand corner: 3 Tree Platforms indicated by blue balloons in Building premises within nearly 50 m: Note the difference in their sizes. Also seen are the nearby located three septic tanks with blackish dots indicating that the septic tanks covers are missing.
2. On bottom right hand of satellite imagery: A platform in the overhead tank premises (Actual Photograph below).

Plate 2.3.5. Typical Planning Issues.

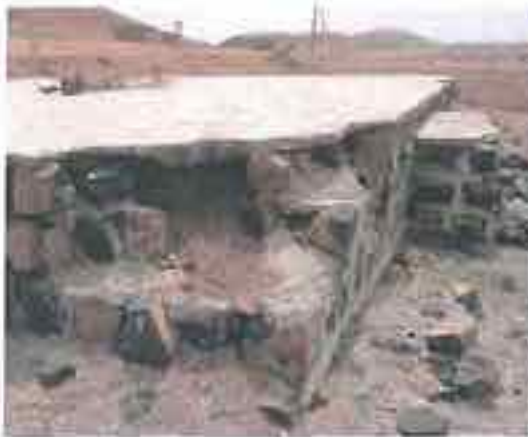
Barda Manavar

11. Large number of tree platforms across the R&R sites were found damaged; some of them were extensively damaged (Plate 2.3.6).

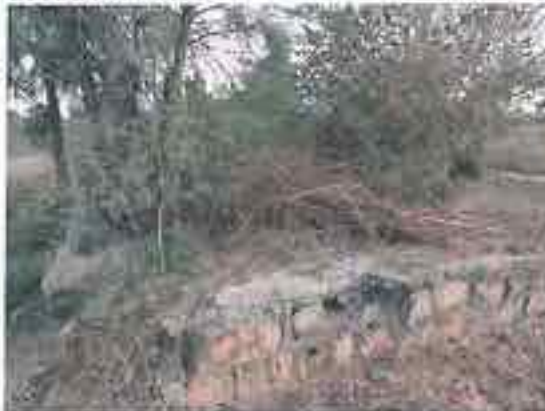
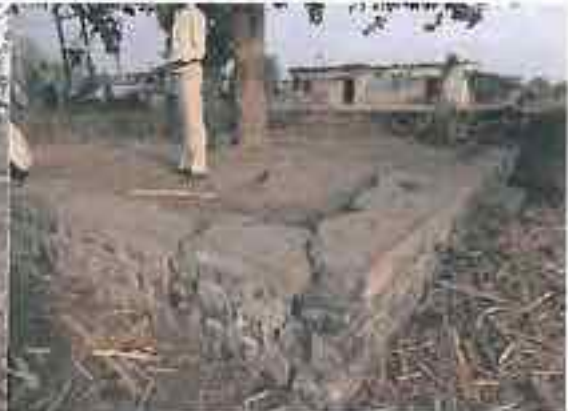
12. It was also common to find several tree platforms having vegetation sprouting from different parts of the structures, contributing to further structural damage (Some of the photographs in 2.3.6). Thus apparently, little or no efforts were being made to maintain the built Chabutras.

Ratwa: Two platforms, one with lots of vegetation and shrubs: Improper filling, poor maintenance; another has a damaged structure with wide cracks.

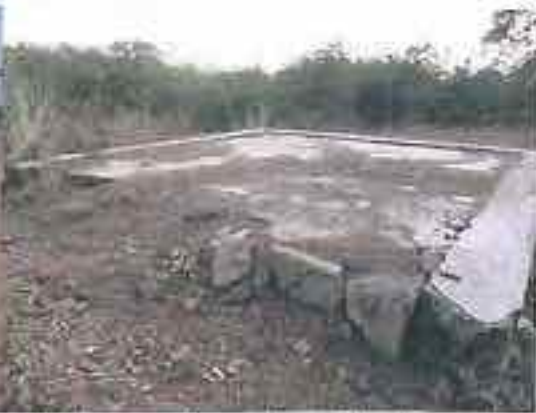
Semalda

Plate 2.3.6. Typical Damaged Tree Platforms.....Cont..

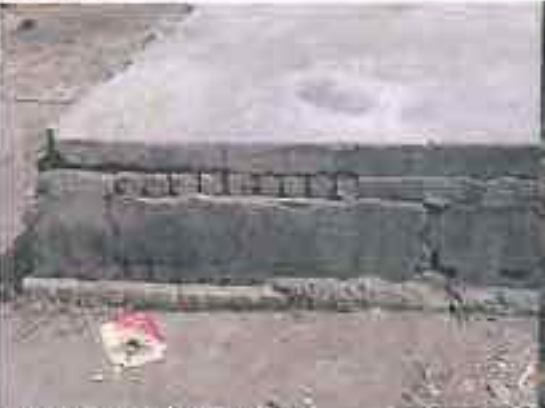
Kathora: platform extensively damaged

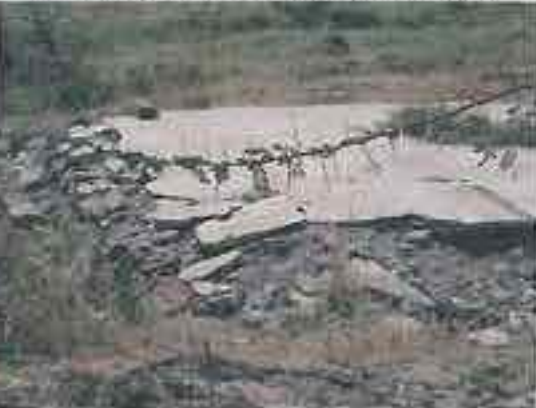
Khalbujurg: Two Platforms

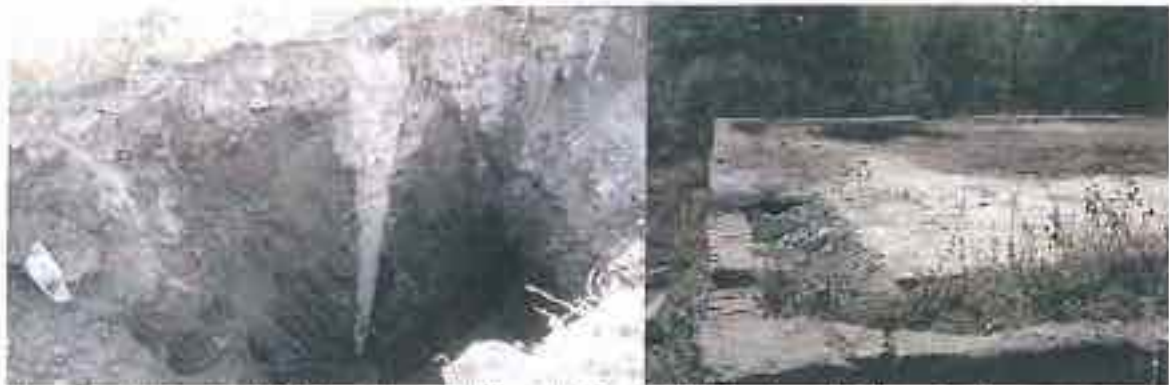
Moreghadi: Typical 2.77 m deep pile foundation (left) for tree platform in the premise of overhead tank. This platform was seen in very poor state (right). The pile depth of 2.77 m had no design basis. The quality of work was also very poor.

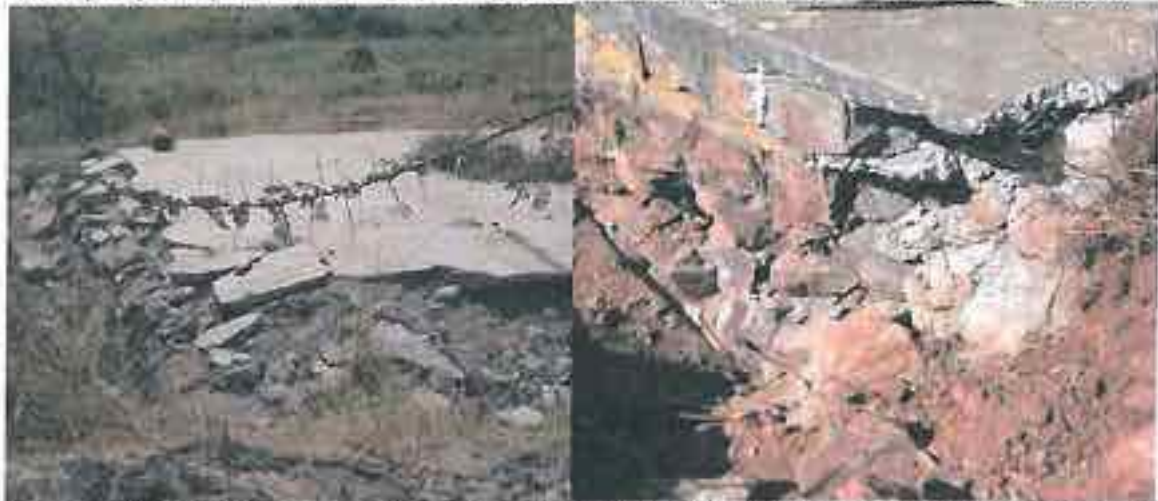
Poor quality and collapse of Tree Platform at Khalbujurg (left). Poor masonry joints and vertical cracks at a tree platform at Amlali.

Plate 2.3.7. Poor Platform Foundations (Typical) and their impacts.

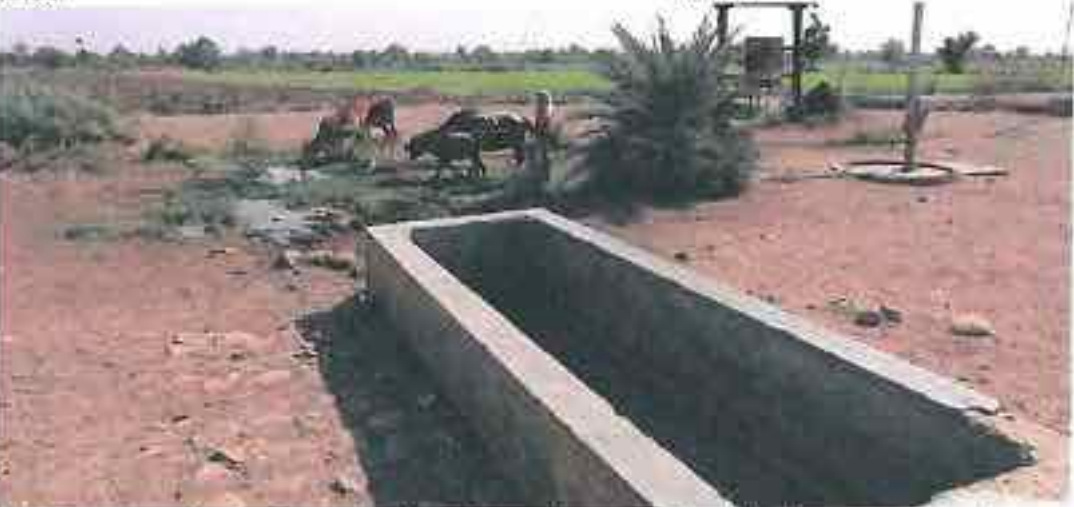
Chichli: Dry Halaos forces animals to depend upon pooled drainage from handpump spills.
Plate 2.4.1. Dry Halaos - Infrastructure rendered defunct.

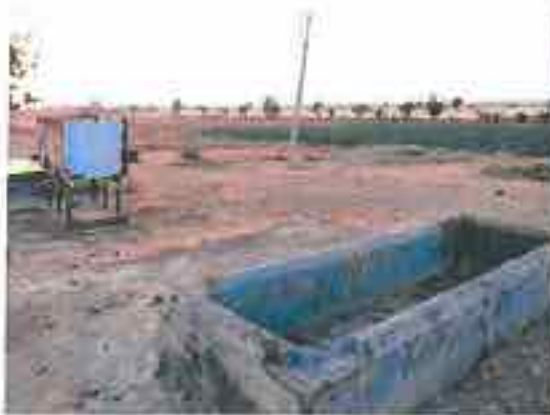
Mohipura :Defunct Cistern nearby

Plate 2.4.2. Dry Halaos - Neither the Cisterns, nor the nearby halaos have any water/ Missing Inlet connections render the infrastructure defunct.

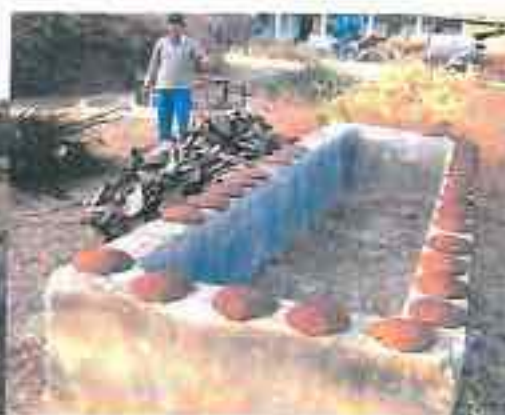
Bhilkheda: Nearby Cistern Platform remains but Cistern is missing

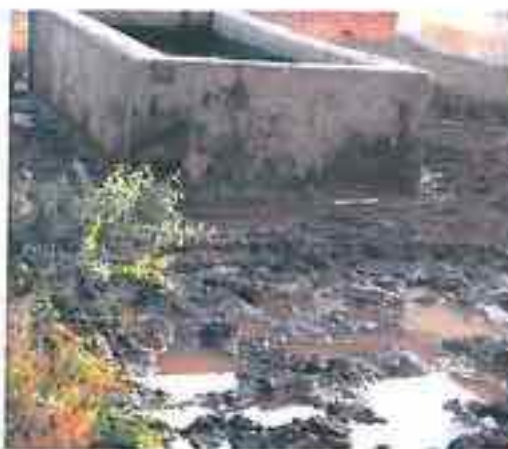
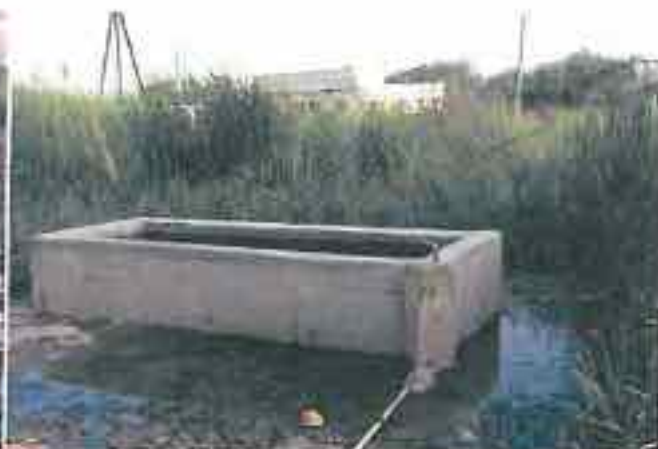
8. While the inlet arrangements/connections were often missing, so were the outlet arrangements. The drainage from halaos was mostly not in place, no provisions were made to drain the water to nearest drains in an engineered fashion (Plate 2.4.2), and the water could flow on roads, plots, or just pool around depending upon the local topography. As of now, the functional halaos already have heavy waterlogging around them in a number of cases, more so because BC soils were present at several sites and drained water would not easily soak in under such conditions (Plate 2.4.3).

Plate 2.4.3. Result of universal non-existent outlet drainage and complete absence of a stop mechanism when full: This would be a common scenario across R&R sites if halaos were in working state and had water inlet connections and water availability (Typical).

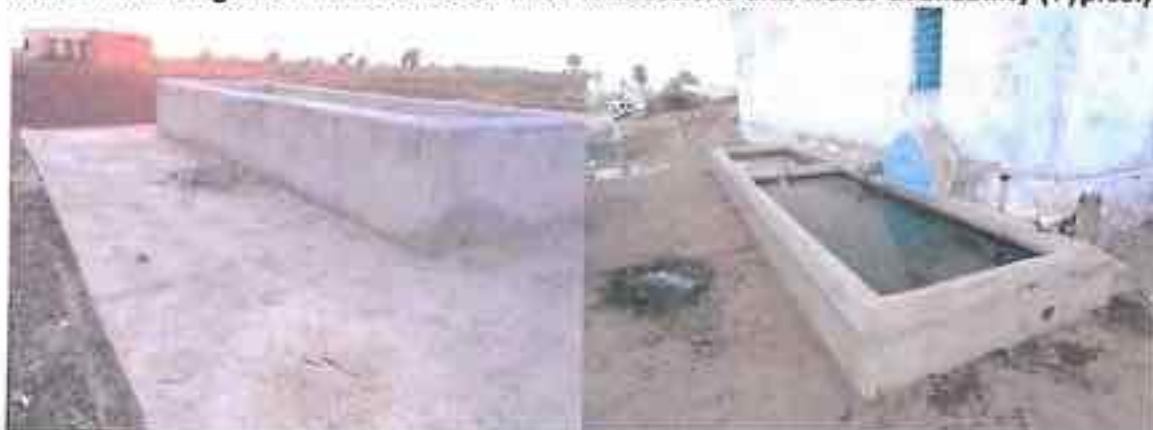
Plate 2.4.4. Ekalwara (Manawar Tehsil): Case of two Halaos : A sarkari Halao (L) vs a Private One (R)

The halao at left has height 75 cm above platform, implying smaller animals cannot drink water comfortably unless water is filled to sufficient depth. Goats, Calves etc may not be able to drink at all. Contrast this with a nearby private Halao 40 cm above ground, neatly made, and in use for past 20 years or so. No elaborate concrete platform required, correct comfortable height for cattle to drink water, and cost-effective as well.

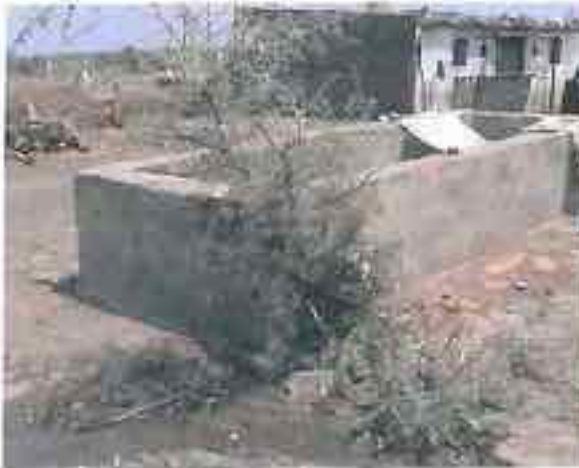
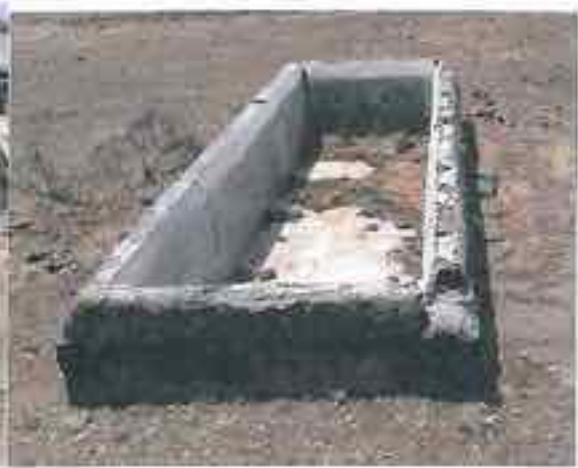
13. The halao heights over the Platform level were found to vary significantly, and were on the higher side many times. Though in several cases, the halao heights were limited to the range 45 cm to 60 cm which would be acceptable; in a wide majority of cases the halaos had a height of 60-70 cm. In still other cases, halao heights exceeded 70 cm (Sala, Lakhangaon, Kathora, Borlai II, Bhilkheda), and even seen at 75-80 cm (Saita, Achoda, Vishwanath Kheda, Khedi, Ganpur (Sirsi), Mehgaon), At Chainpura, Balkhad, Rekti, Manavar and Ekalwara, for one or more halaos, the heights exceeded 80 cms. In case of one halao at Jalanpur Dhalkheda, and another at Chichli (Kasrawad) the heights exceeded 85 cms. In case of another halao at Chichli (Kasrawad) the height even exceeded 1 m.

Rekti: Case of two halaoas at the same site

Plate 2.4.6. Variations in halao heights even at the same site (Typical)

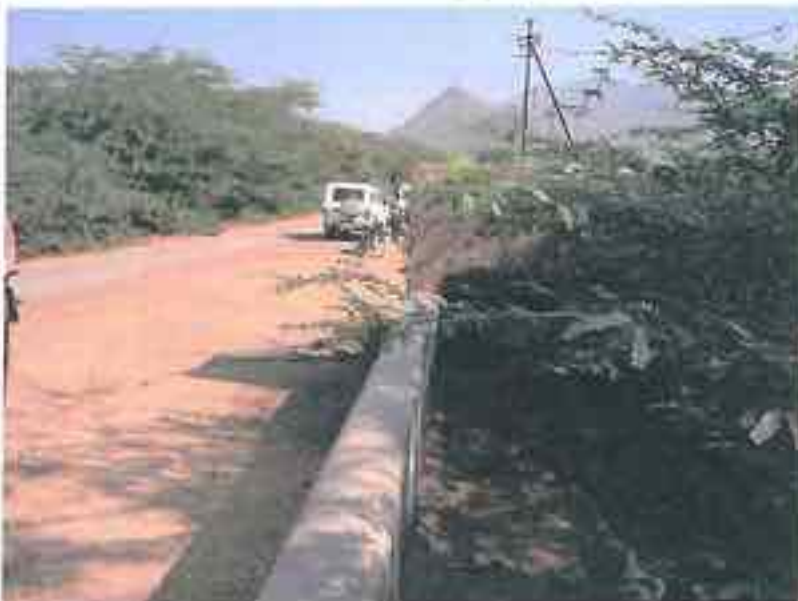
20. Further, sometimes the halaos have been located very close to the main roads (Plate 2.4.7). This is poor planning as it not only would often restrict and hinder the traffic on road, but would make such zones accident prone. The halaos should not have been located near the highways/main Approach roads. In some other cases halaos were close to individual plots, implying inappropriate undesirable siting as this would either create nuisance and insanitary conditions for plot owners. Sometimes these were located in low lying areas and near the culverts and may become unusable during monsoons as well as create insanitary conditions due to mixing of animal sewage with drain water.

Plate 2.4.7. Bijasan: Halao (thankfully defunct) on the Main Approach road

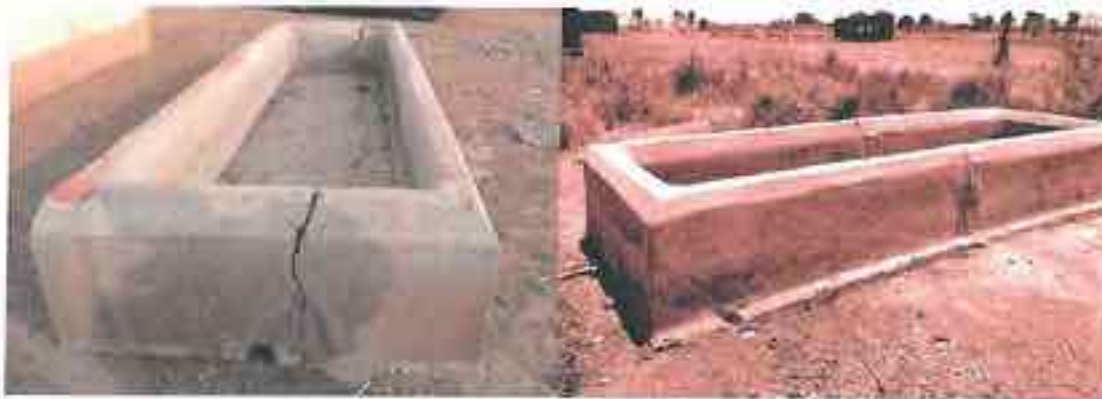
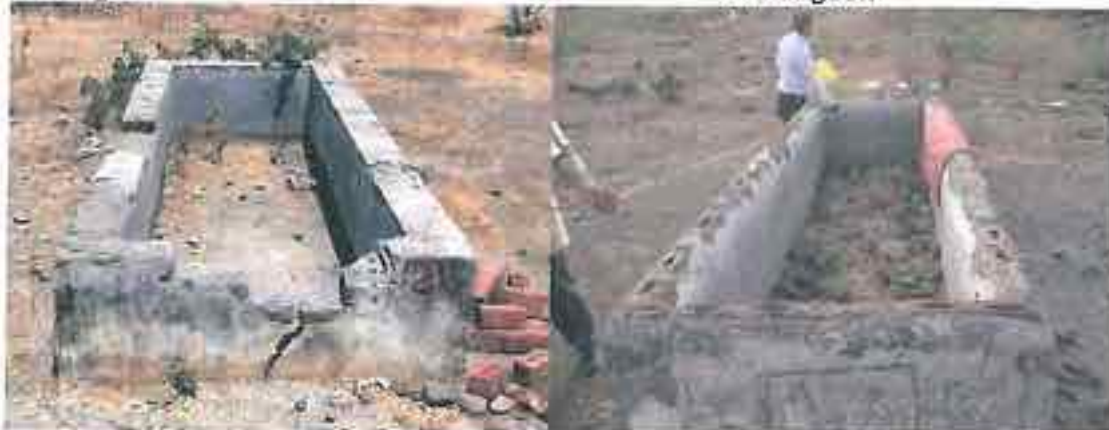
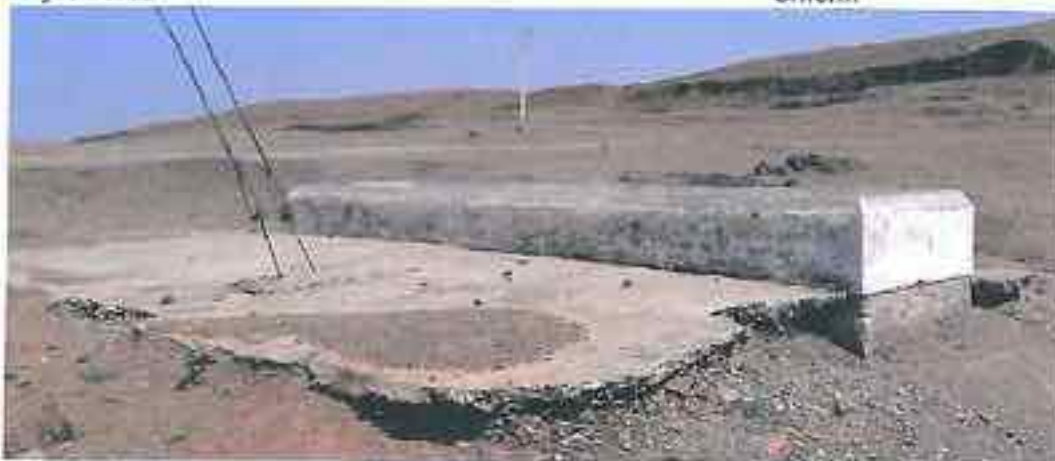
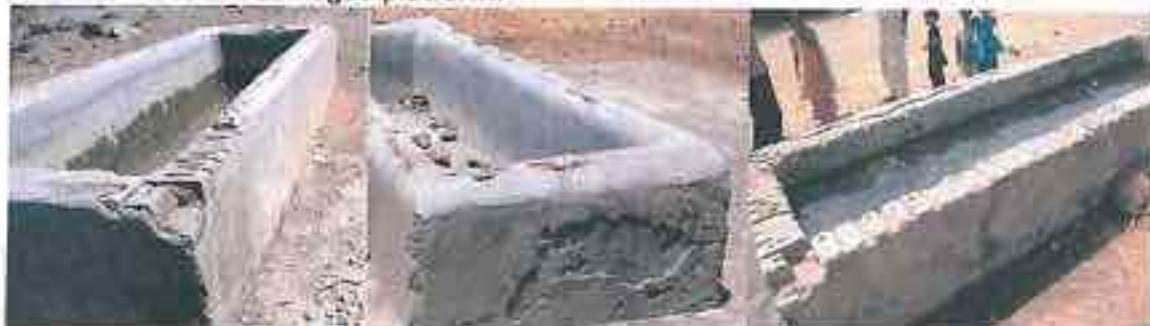
21. Some of these halaos had structural issues including wide transverse/longitudinal cracks (Plate 2.4.8) which may have been caused due to differential settlement behaviour when located in Black-Cotton soil. But in sandy/gravel soils there exists little explanation and all fingers point out to the poor quality joints etc indicating poor workmanship, lack of supervision, and possibly poor construction material used. It may be noted that no test results were found available for bricks, concrete etc employed in the construction of halaos, raising the suspicion of poor quality of material used.

22. Other defects existed such as the Plaster found peeled off sometimes, and bricks found exposed (some photographs in Plate 2.4.8), and at some halaos the platforms were found damaged indicating poor workmanship and lack of proper supervision.

Achoda: Note the damaged platform.

Plate 2.4.8. Typical Damaged/Poor Halaos: Sometimes even when the soil is sandy, (and not at all the universal villain Black-cotton), Halaos lie damaged. Most of these do not have inlet/outlet connections also. Poor workmanship and supervision.

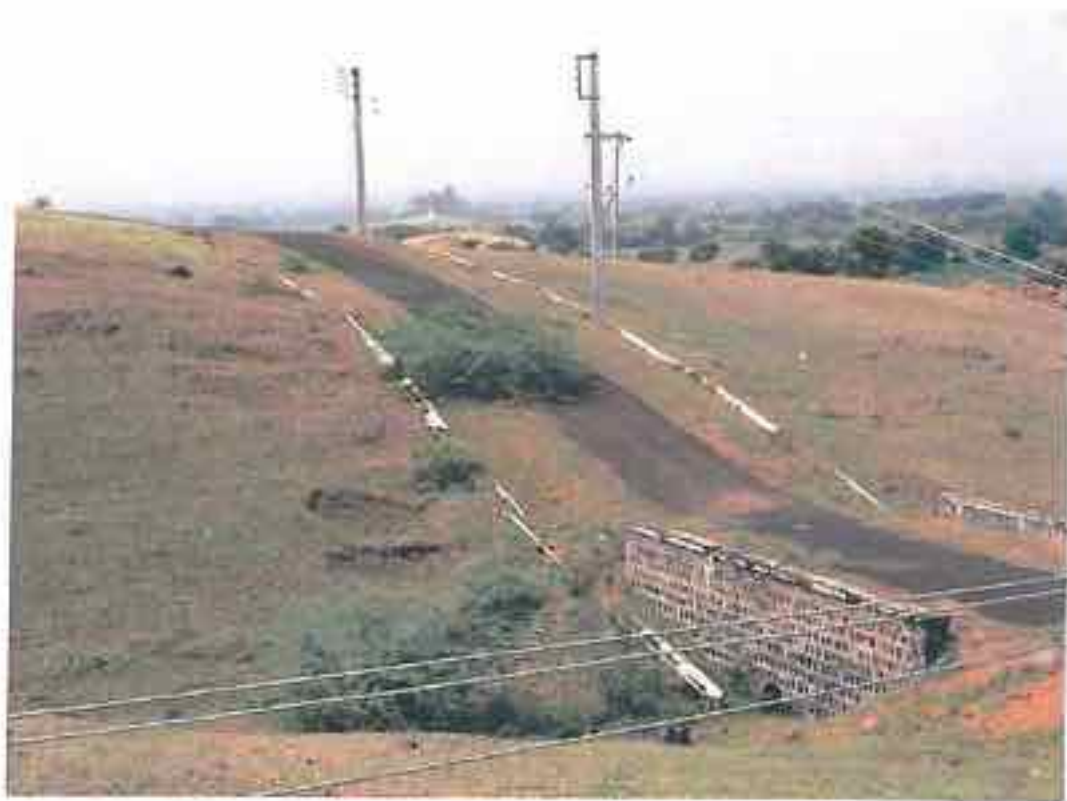
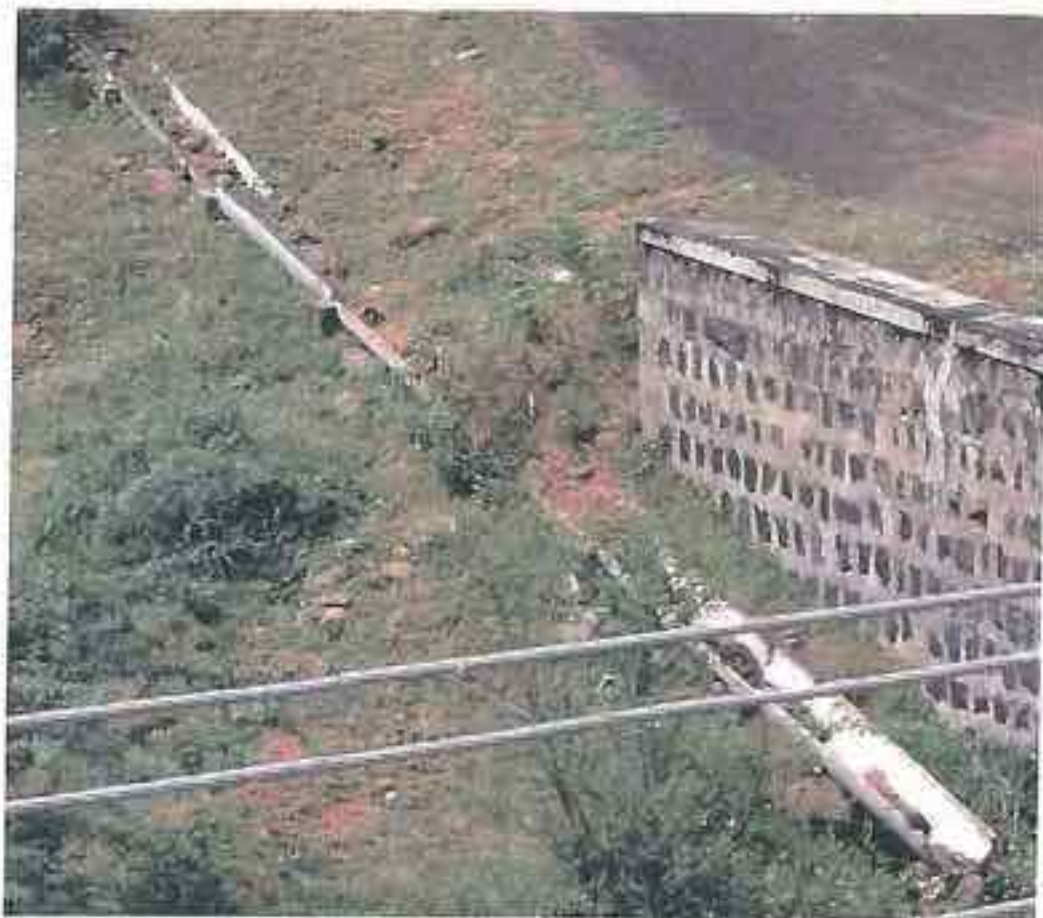
Nisarpur: Too steep profiles for pipe drains to work. The pipes joints are gone, and pipes are misaligned.

Plate 2.5.2. Typical steep Slopes for half round piped drains

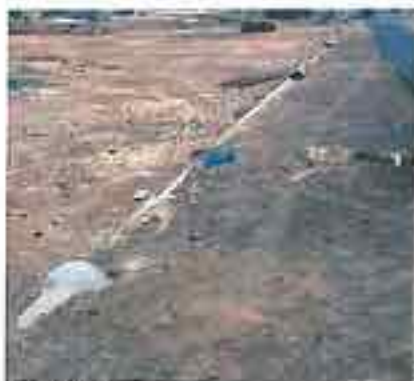
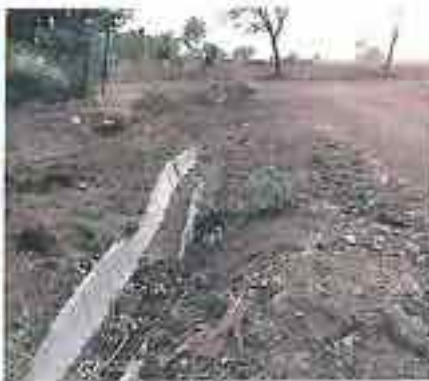
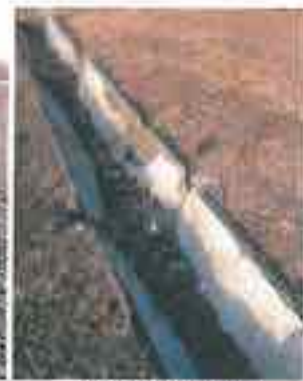
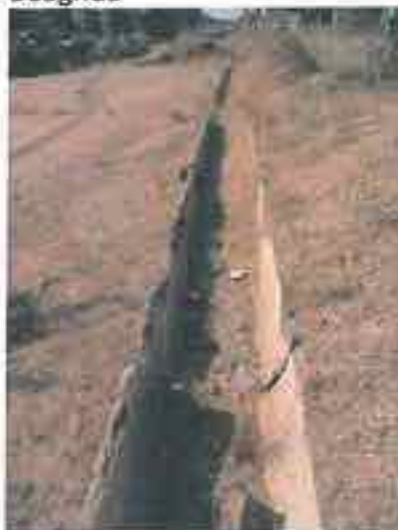
Plate 2.5.3. Typical Defunct/damaged drainage pipes

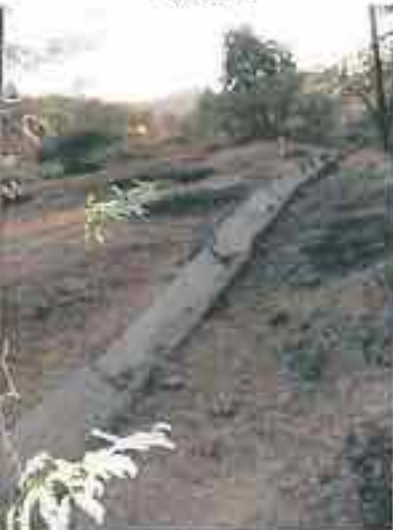
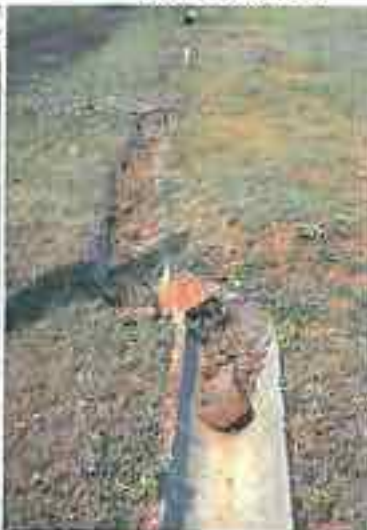
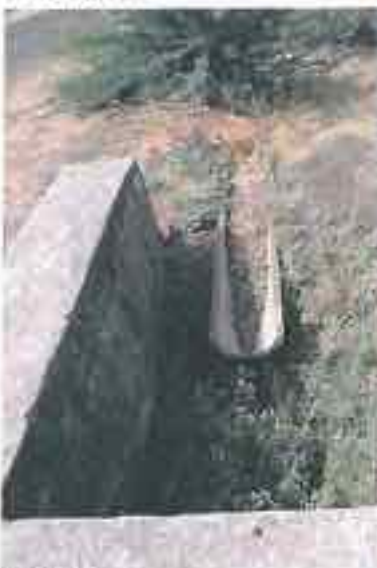
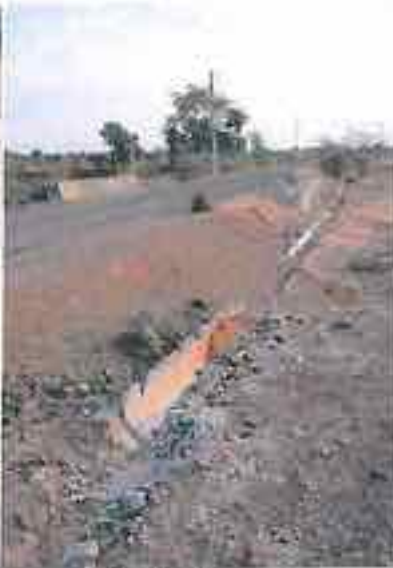
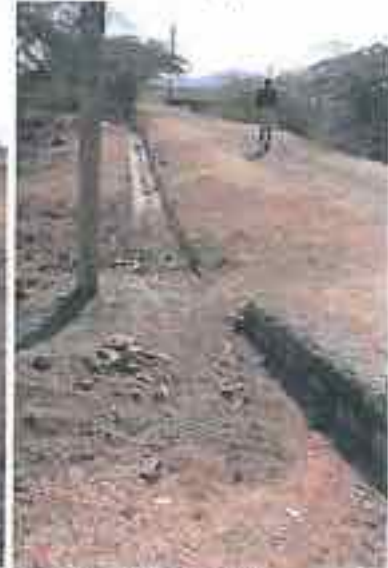
Typical misaligned, chocked, defunct drain pipes, sometimes hanging and protruding in air, at other times grounded in the present day topography, sometimes left to discharge some distance away from the nearby culvert mouth. Also seen were broken/damaged joints. Even this has been provided only at select R&R sites, and wherever drainage system exists, it is mostly dysfunctional.

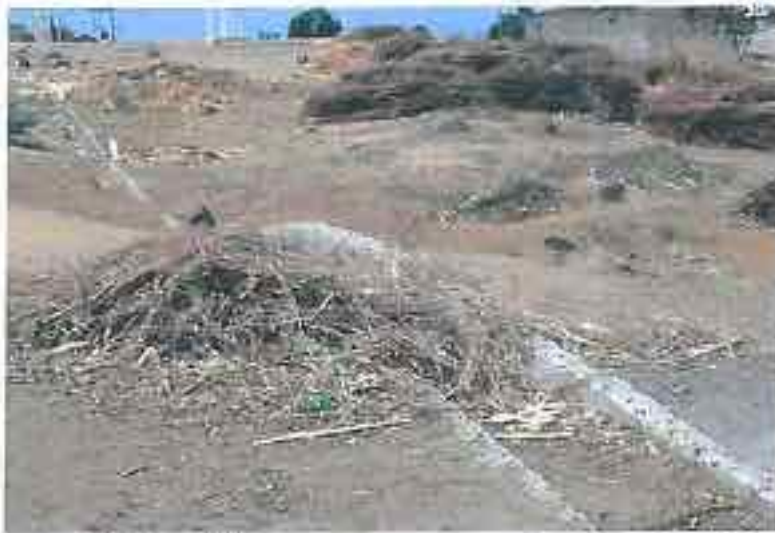
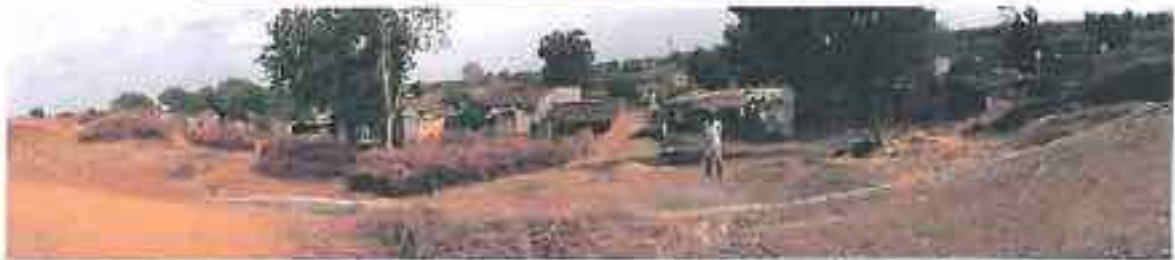
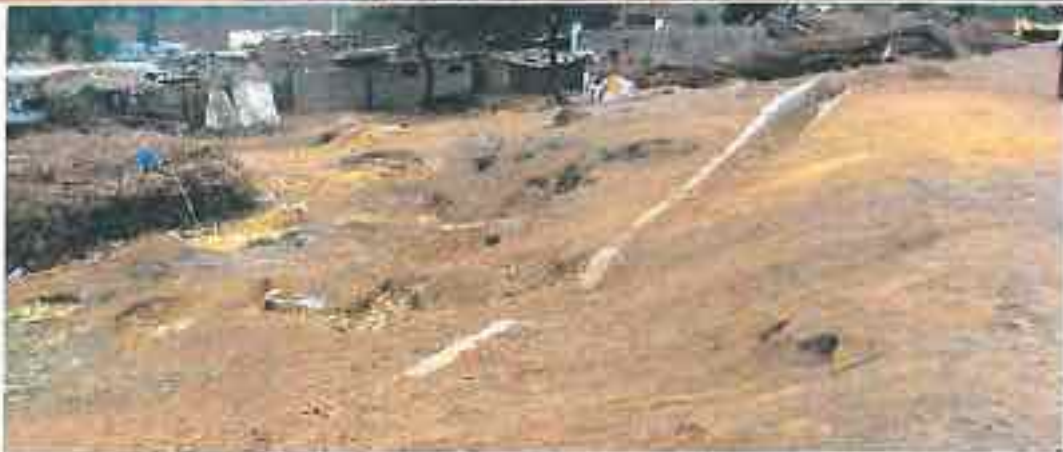
Plate 2.5.4. Poor Construction, Execution and Supervision

Mirzapur: Trapezoidal water drain slopes in middle from both sides (Top 2 photographs). A cut in the middle at lowest point (Bottom photograph) ensures that collected water spreads transversely and gushes out freely unplanned into a habitated area.

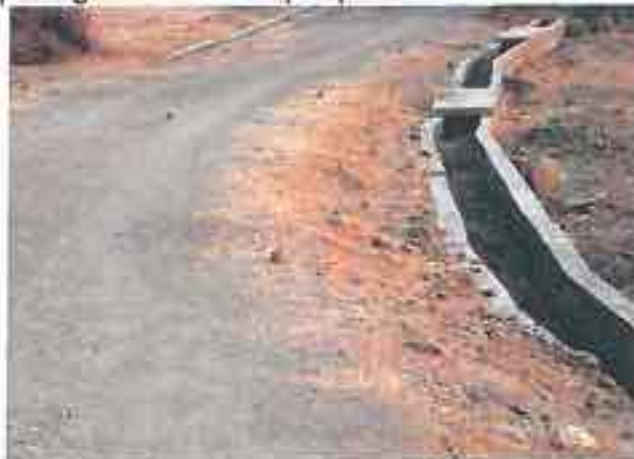
Plate 2.5.5. Poor Construction, Execution and Supervision for RCC Drains

Mohipura: Poor construction and execution

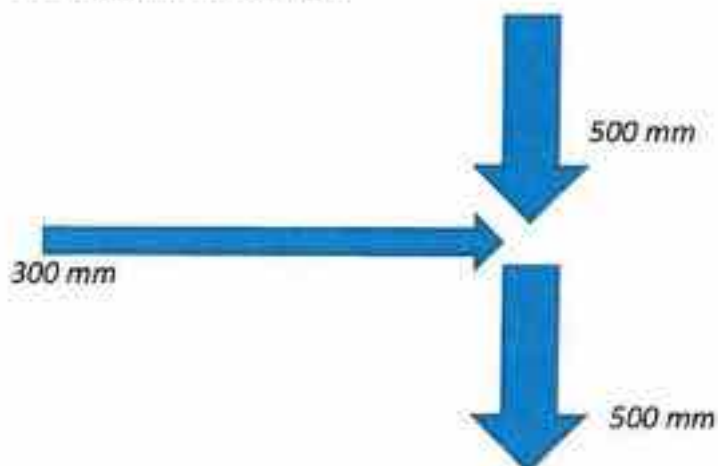
Diameter of this pipe draining 500 mm and 300 mm pipes is still 500 mm

Moreghadi (Typical)

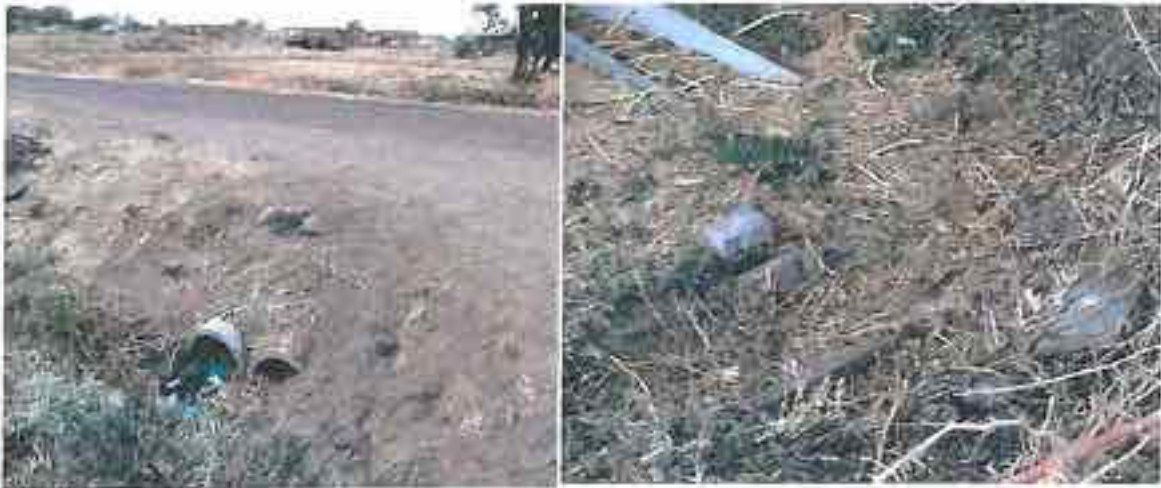
Khujhawan

Two drain Pipes passing through the road. Pipes of 300 mm diameter each discharging from plot 256 (upstream of pipe) on one side of the road to the Polt 283 on the other side of the road. No culvert constructed here, the pipe cover below the road here is less than 0.5 m. Adhoc drainage arrangement to supplement existing drainage system at site.

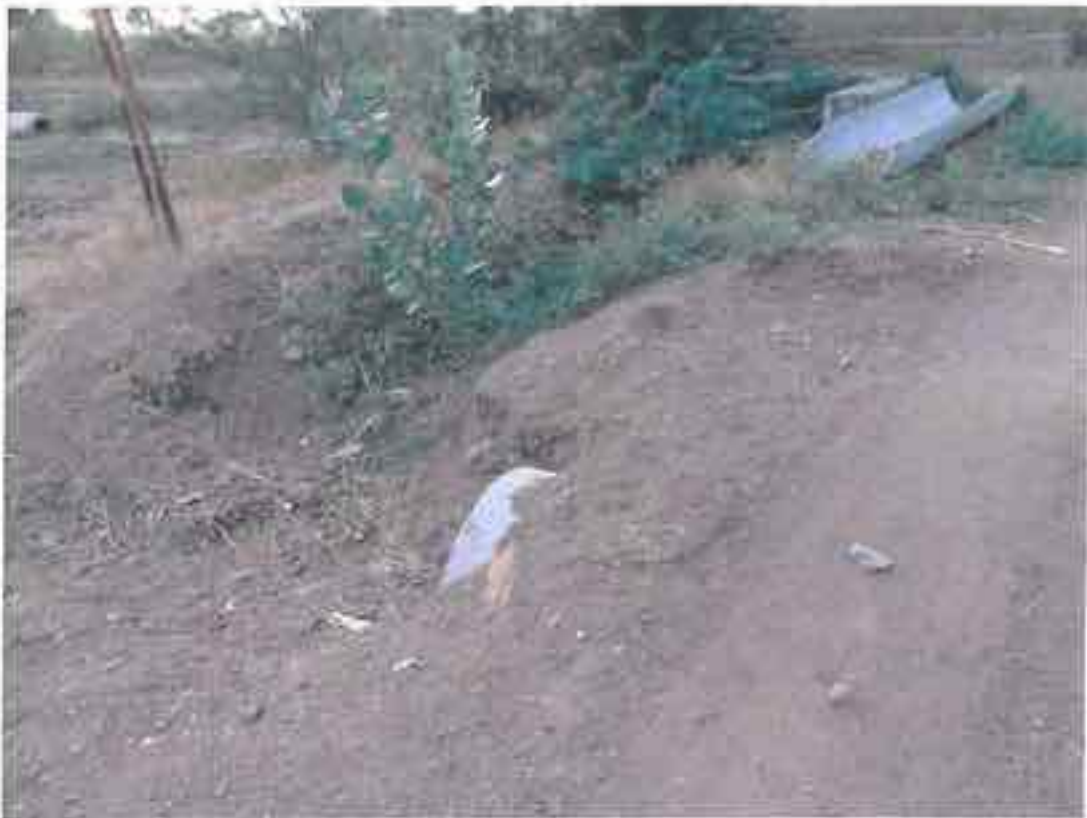
Plate 2.5.7. Inadequate drainage systems at Sites - Lack of micro-planning.

Ratwa –Adhoc pipe laid across the road for drainage with hardly any cover

Note: At some sites, some of these adhoc cross drainage pipes may have been laid by private persons or the community, but nevertheless it reflects the insufficiency of the drainage infrastructure officially created and provided at R&R sites.
