Evaluation of the Quality of Civic Amenities at Rehabilitation Sites of the Sardar Sarovar Project

**Sardar Sarovar Project - Fake Sale Deeds and Rehabilitation Sites
Irregularities Inquiry Commission**

April, 2014

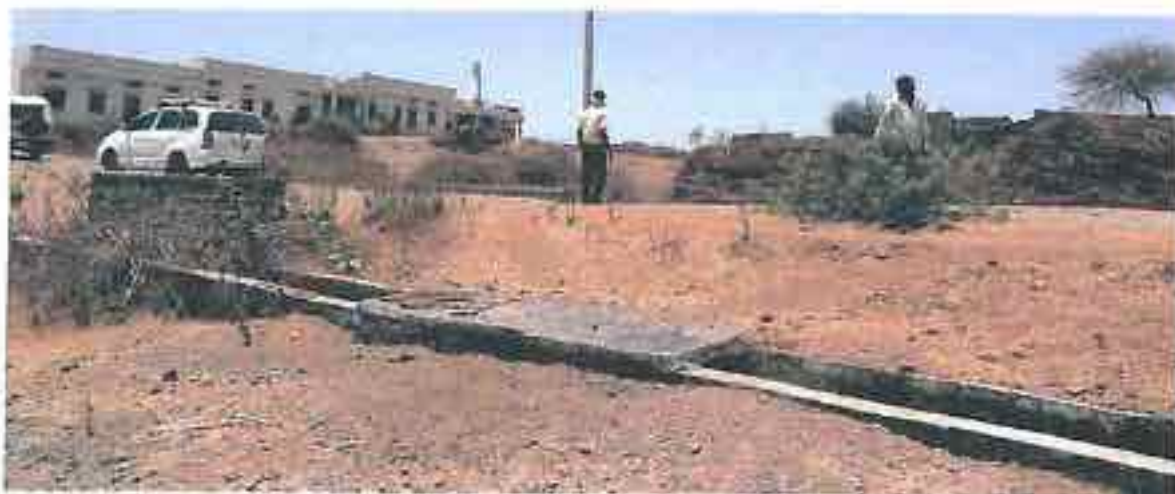
Plate 2.5.8. Poor Planning at R&R sites (Typical)

Chenpura: Drainage provided in parts only on one side of the road, and towards the lower side (building located on the higher elevation on other side of the road): This implies that the flowing water from higher slope is collected by the drainage system only after it crosses the road, and hence the road remains unprotected from the lateral flow of water flowing rapidly down the slope.

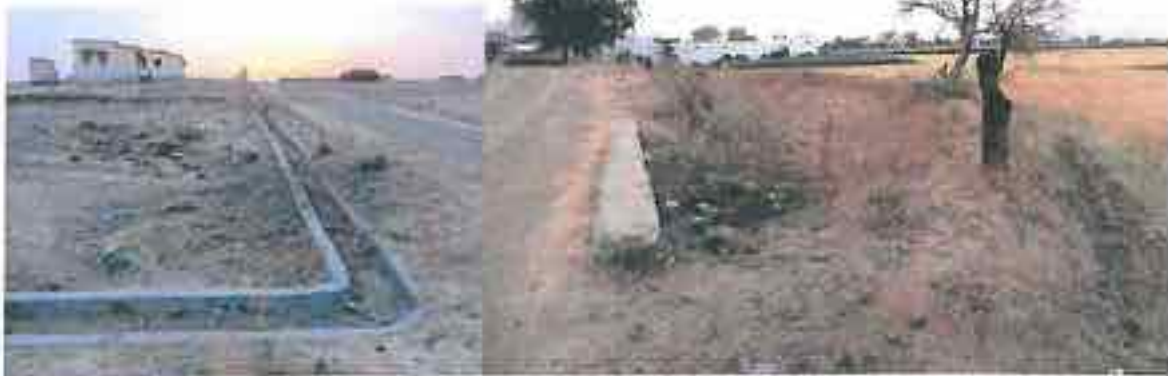
Mohipura

The Site has cemented side drains (Left) in a part which drains water from the hillock where buildings are located. At stretches, the drain is on one side of the road only, and at other stretches on both sides. The drained water forms a pool crossing the road through culvert (Right), and then overflows damaging the crops around. Lack of plan for final disposal of drained water: a typical problem across R&R sites with drainage system.

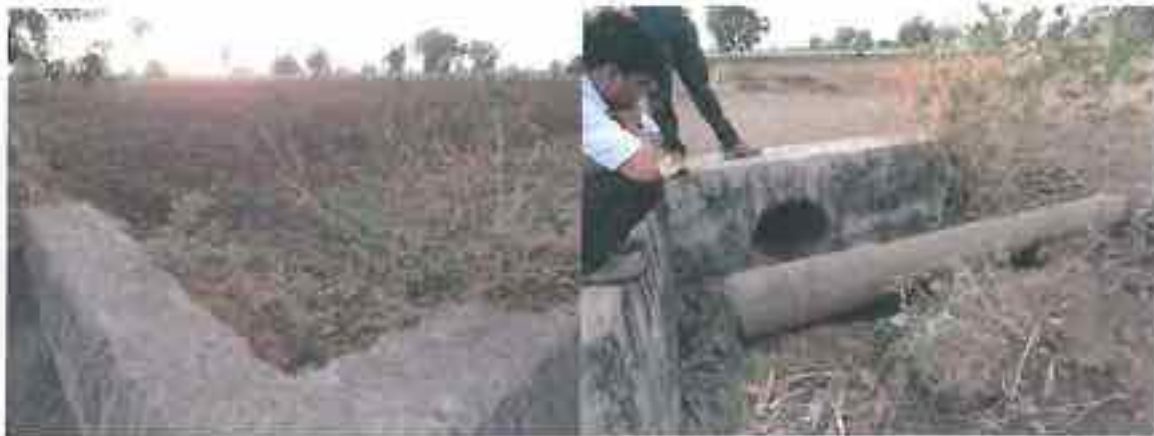
Plate 2.5.9. Planning lacunae - Final Disposal of Drained water into crops.....cont..

Ratwa: the case of drainage system becoming a liability for some

At Ratwa, the ultimate disposal of drainage water is into private agricultural fields. To prevent crop damage and erosion of top soil, the farmers ensure that the surface drain are choked and culverts blocked by putting Stones etc. But, if farmers stop the flow of accumulated drained water in their fields during the rains, the site gets submerged with water entering homes.

Note: Earlier to the construction of drainage system also this water would enter the crops due to natural slopes, but now there are limited designed point sources that discharge heavily as the drainage is no more now distributed and spread over a larger area.

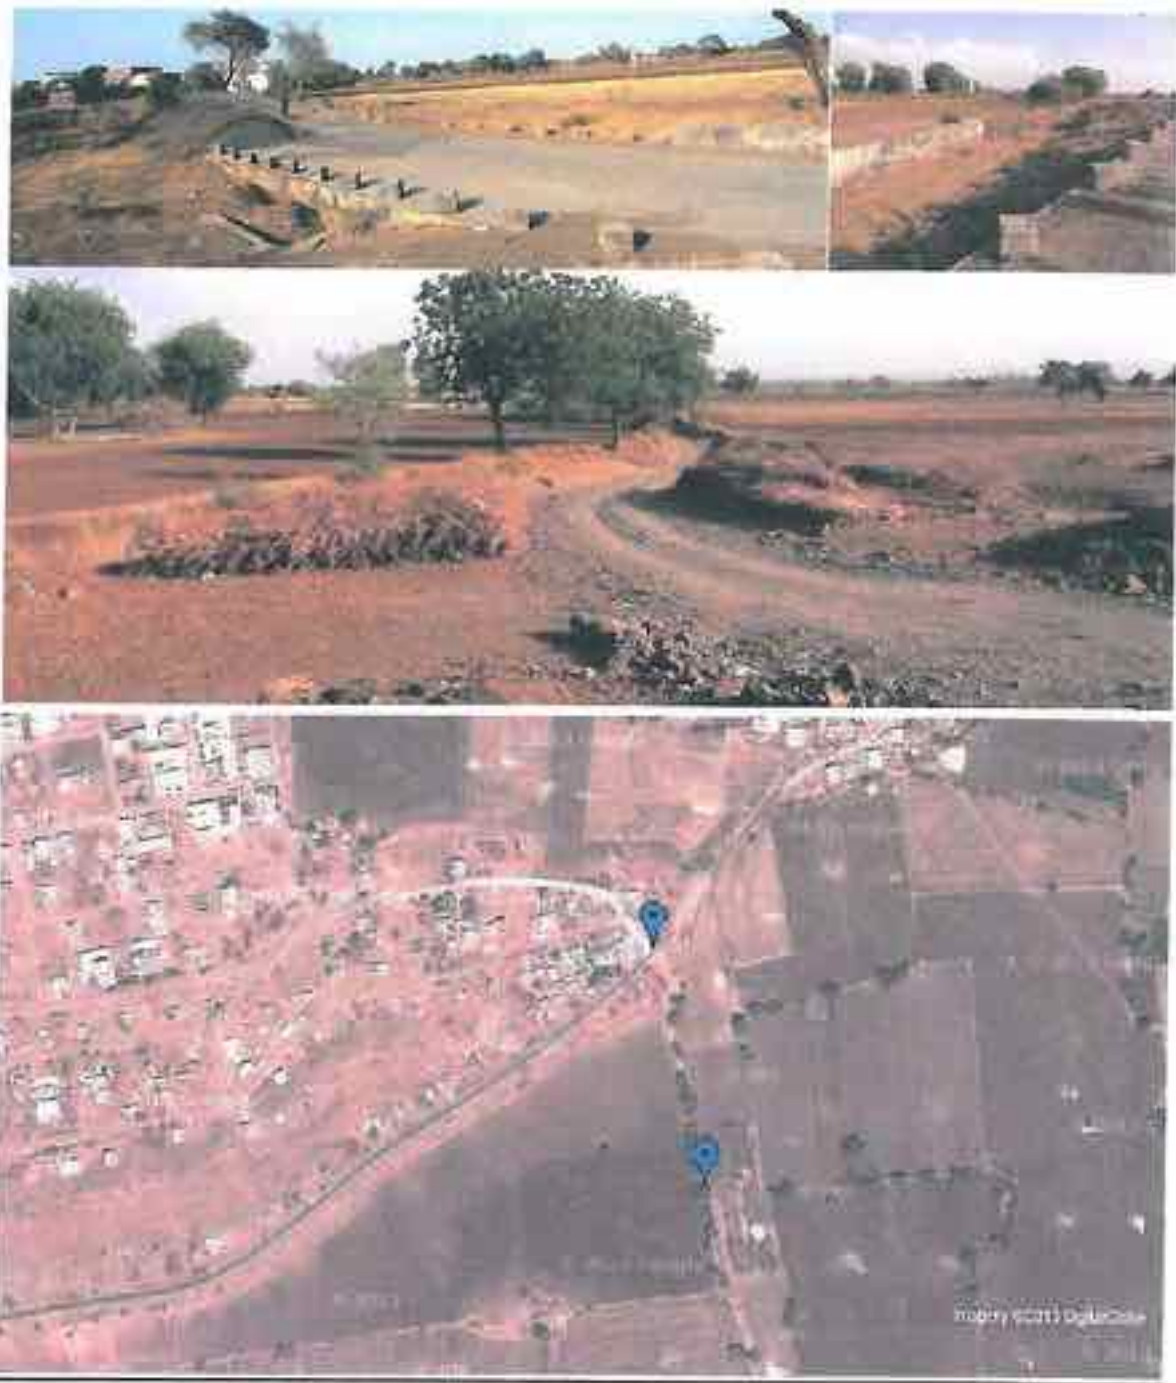
Plate 2.5.9. Planning lacunae - Final Disposal of Drained water into crops

Kavanthi: The entire collected stormwater from the R&R site and a hillock drains through a Rapta at Main road (Manavar Ganpur road) (Top Photos, and satellite imagery white line of deposited silt above the top blue mark) takes a curve, and goes into a drain to a road (Middle Photo, and satellite imagery bottom blue mark), where inhabitants have their agriculture fields which are not under submergence. This road is in the form of a channel as seen from satellite imagery, and gets flooded to become completely unserviceable for 4 months during and after rains due to BC soil all along. Accidents are likely to be common, as it is the only road connecting the fields. Thus, the water finally drains into crop-fields and is a major issue of contention.

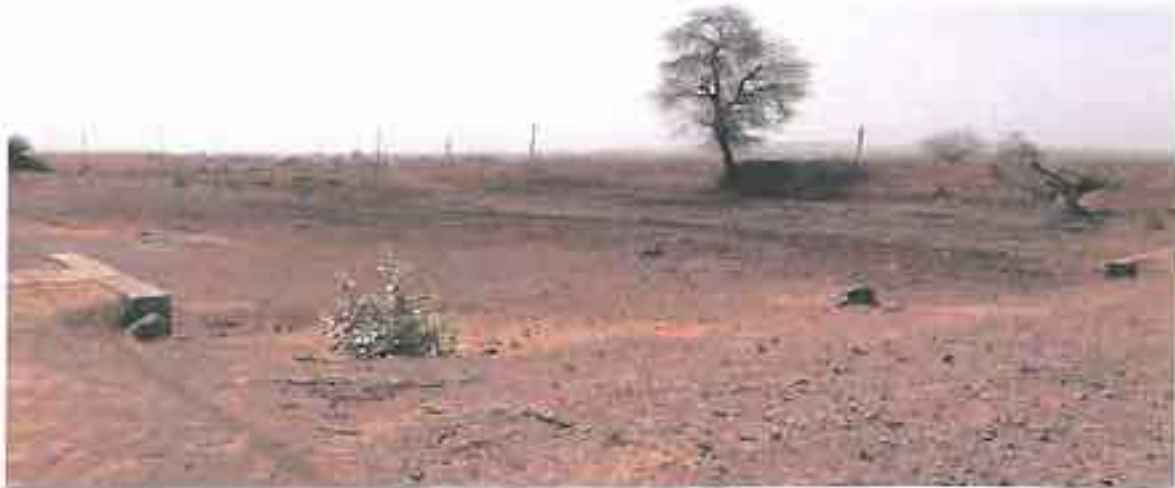
Plate 2.5.10. An opportunity lost in haphazard planning- Case of Brahmangaon

Brahmangaon (Theekri): Two Culverts discharging water at right angles into an area that has higher elevation all around with no place for water outlet. This could have formed an example for other sites, had a proper pond been constructed here making use of the situation, and the ponded water could have recharged groundwater as well as acted as storage for improved aesthetics and for miscellaneous uses.

A centralised planning process with specific provisions to be provided at R&R sites could not have made such site-specific provisions that could have contributed in a big way in all-round development of R&R sites. Decentralised micro-planning was necessary with flexibility to introduce limited site specific interventions, and that has been missed sorely.

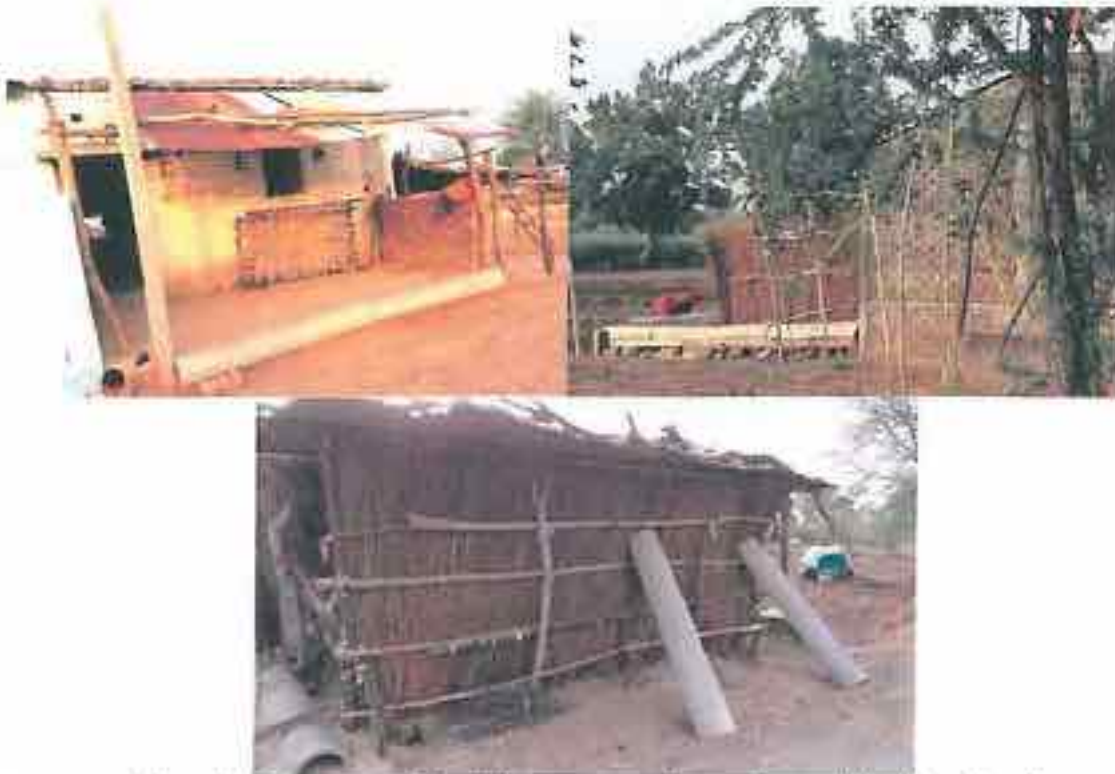
Plate 2.5.11. Public Disenchantment with Drainage Infrastructure

Ratwa : Although private use of public resources is condemnable, lack of maintenance and a not so functional infrastructure, has led the locals to use drain pipes that are otherwise lying defunct and waste.

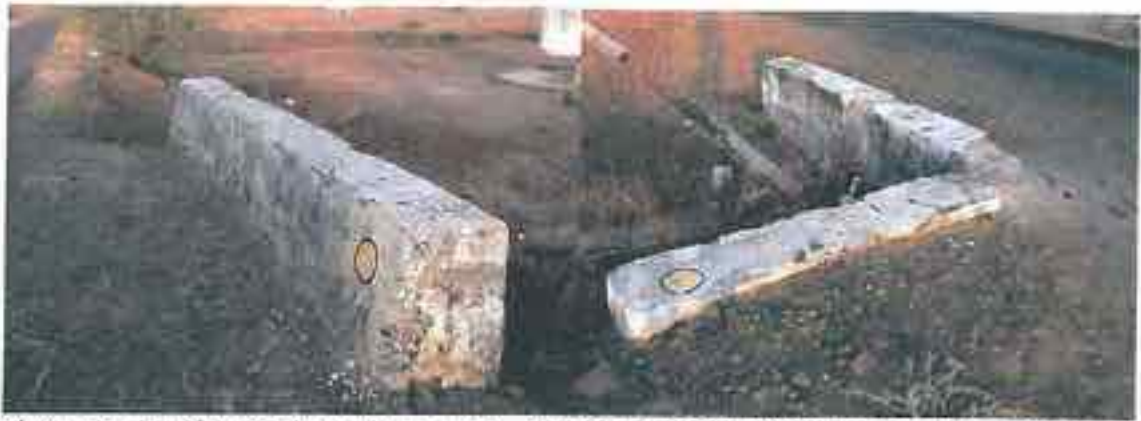
Plate 2.6.1. No standardisation of culvert headwall heights (Typical)

Balwara: Case of 2 nearby culverts nos. 12 and 13 barely a few meters apart. Culvert No 12 has headwall height 50-60 cms above road. Nearby Culvert No. 13 is almost flush with the road.

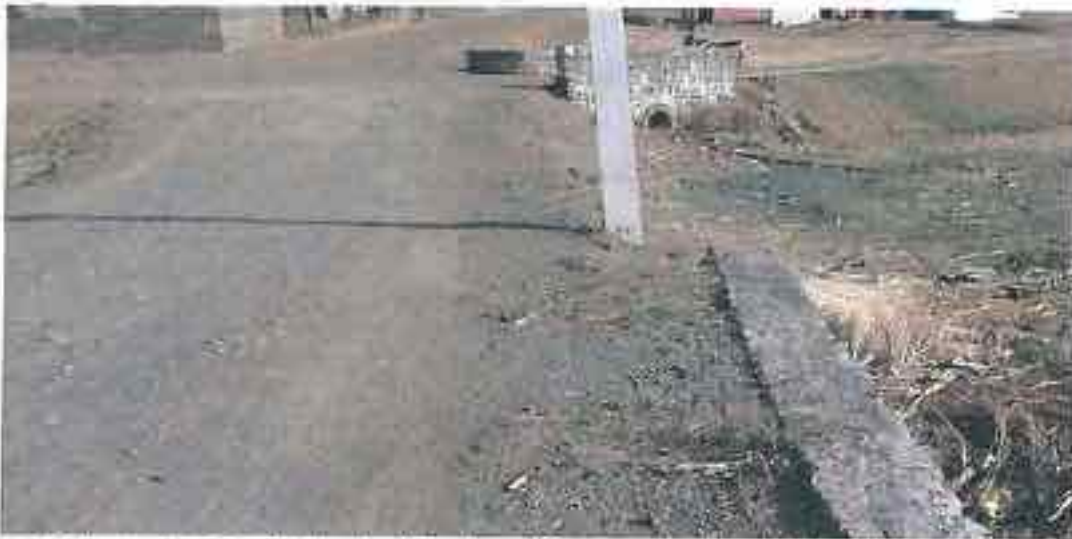
Kavanthi: Two adjoining Culverts. Note the difference in their heights (almost 70 cms). Culverts ranged from being flushed to 70-80 cms above ground level at this site.

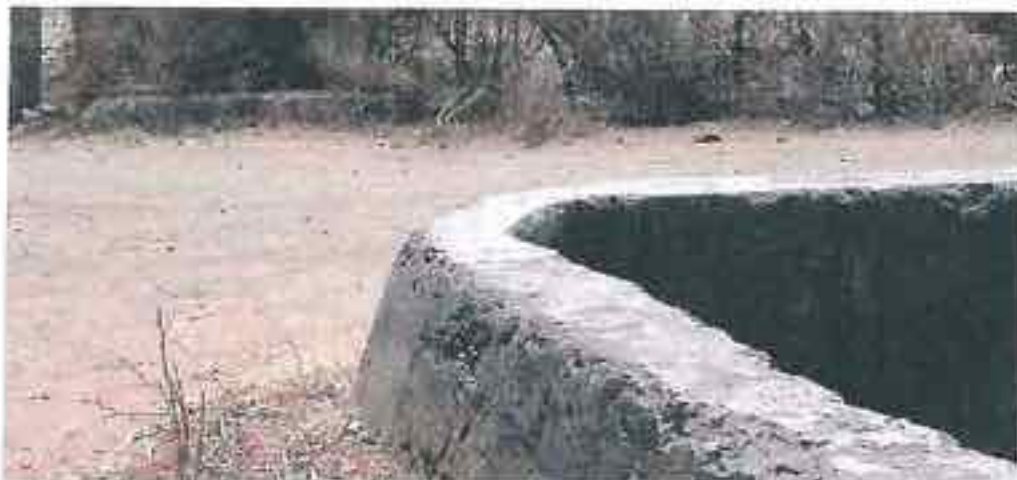
Plate 2.6.2. Variations in headwall heights for the same culvert (Typical)

12. Even if one forgets about uniformity in various culverts as regard to observance of similar heights of headwalls above ground, variations were even seen in the same culvert: the two walls across the road were not found at the same level in some cases (Plate 2.6.2) indicating poor execution and supervision.

Vishwanath Kheda: The far away headwall on upstream side has 25-30 mm height, whereas the nearer wall on downstream side was 55 cm from Ground level.

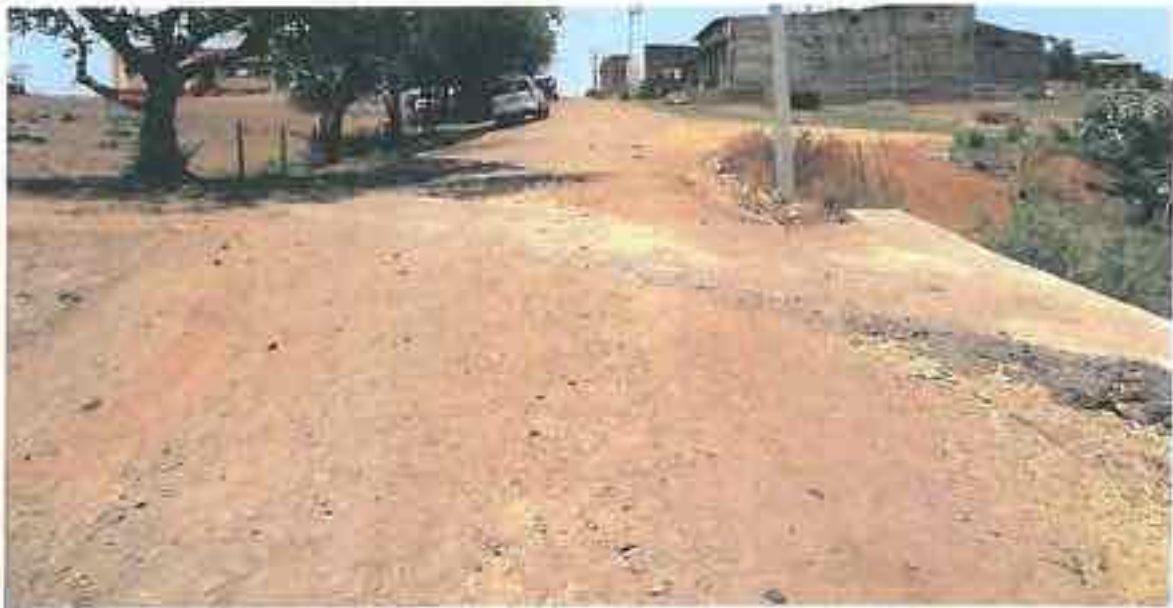
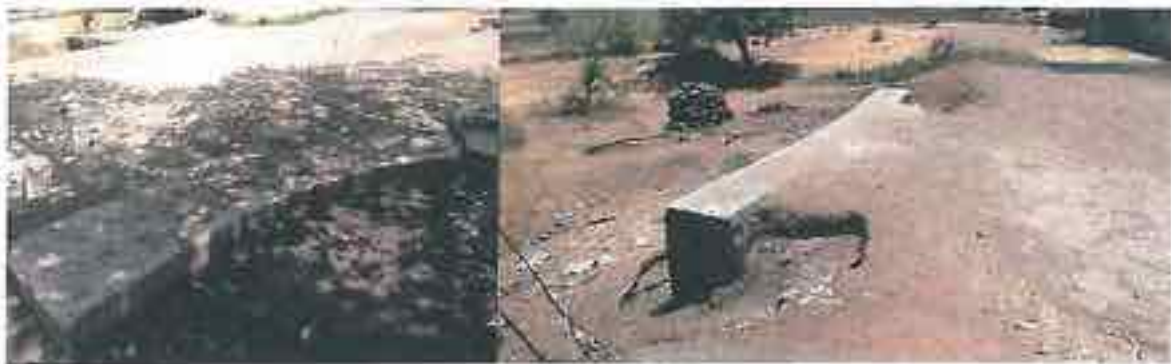
Plate 2.6.3. Typical Poor Planning, execution and safety issues—Case of Chenpura.

Top Photograph: The road slopes longitudinally, and has no camber so that the water will mostly flow longitudinally along the road damaging it, rather than across the roads to side drains (which have not been provided).

Also note the lack of safety measures: There is an abrupt end of the road which makes it risky and accident prone: a vehicle may easily fall down off the road into the ditch. Either the headwall had to be raised above the top formation of the road, or at least wheelguards could have been provided to save the vehicles from falling over. Safety has often not command the much necessary priority.

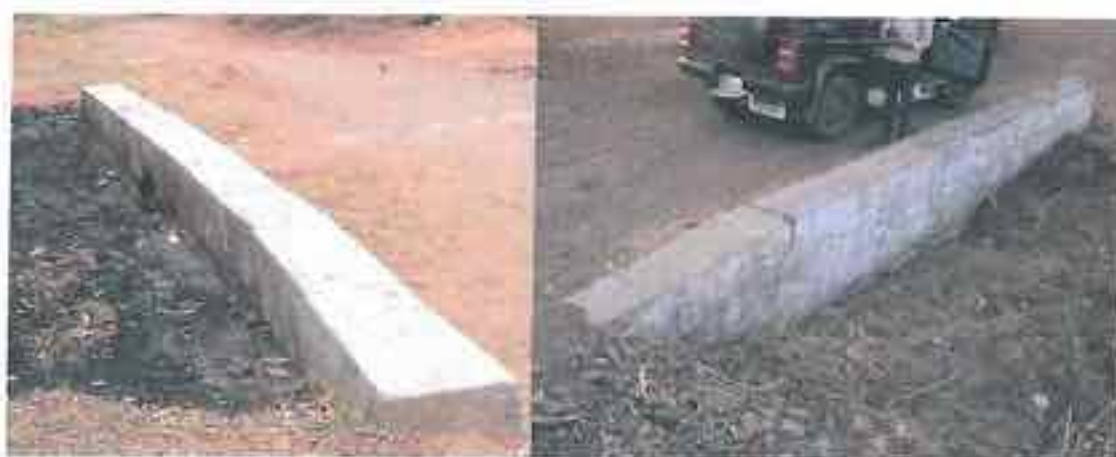
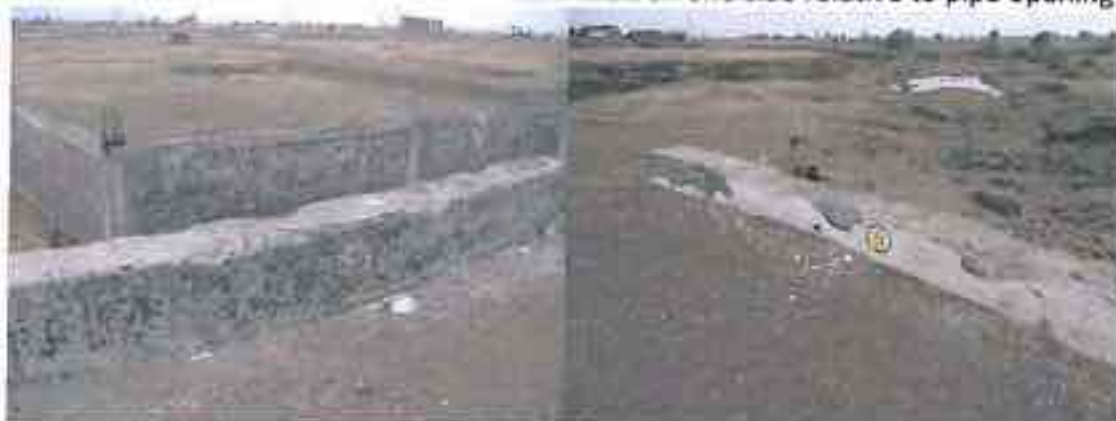
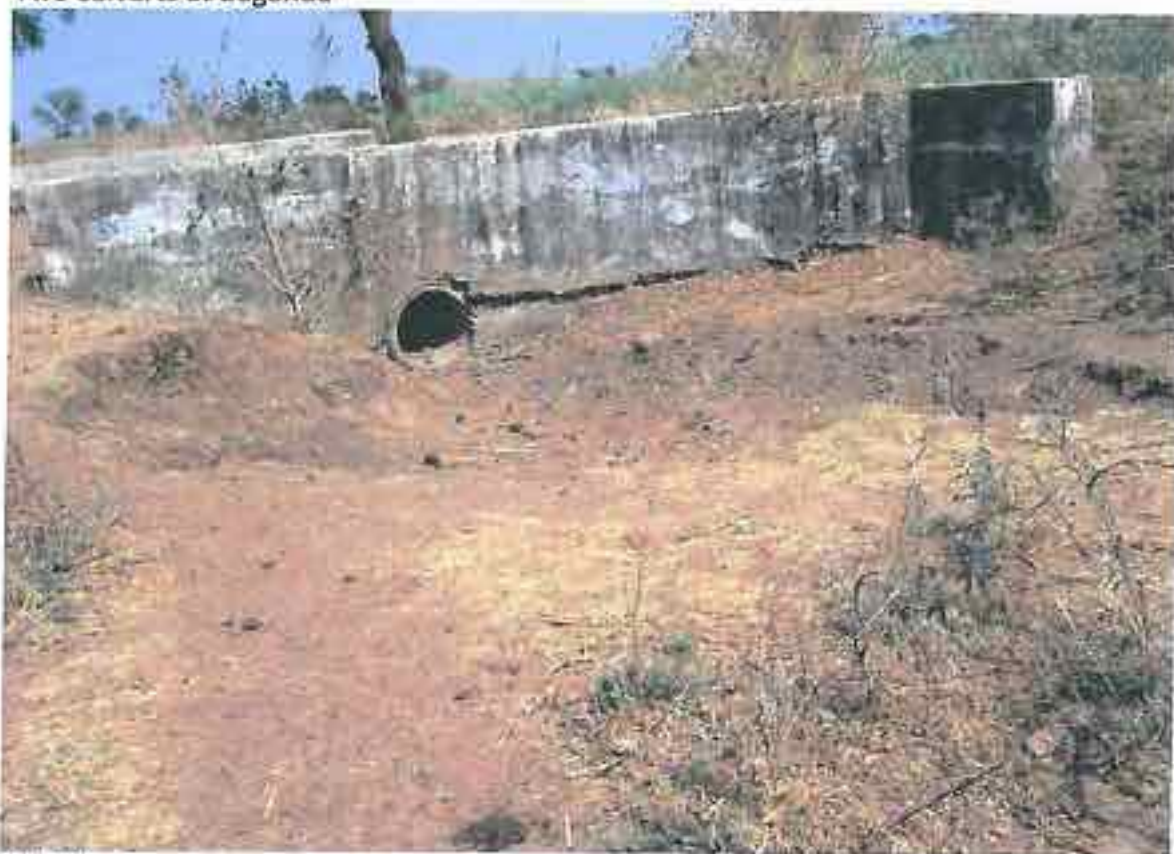
Plate 2.6.4. Excessively long Culvert headwalls (Typical).

14. Similarly, there was no standardisation with regard to culvert headwall lengths. The Culvert headwalls were sometimes excessively long (Plate 2.6.4). Shorter walls could have been equally useful, and would have been less prone to damages, besides being economical in terms of initial costs and maintenance thereafter.

Ekalwara: Size relative to Jeep, Notice also the extension on one side relative to pipe opening

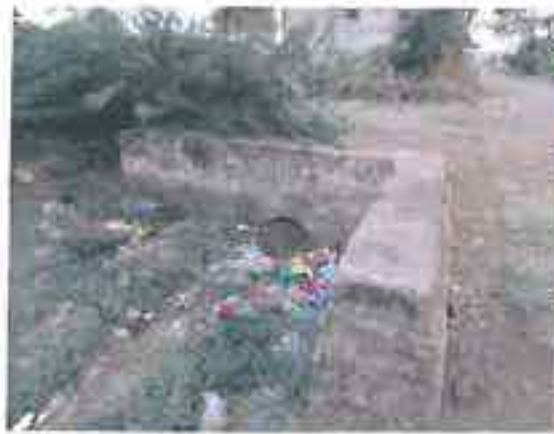
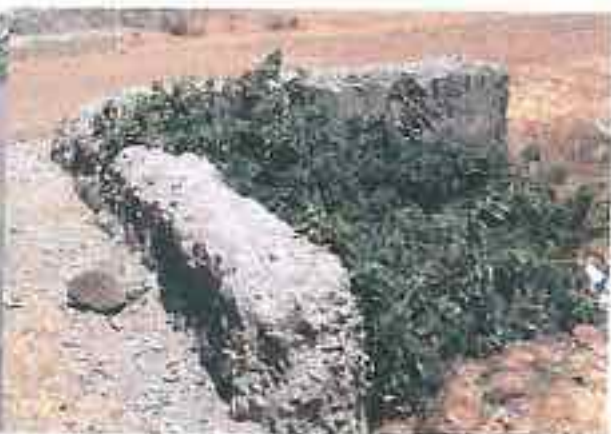
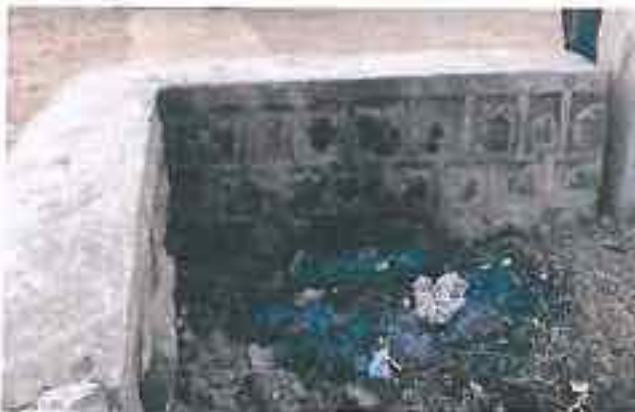
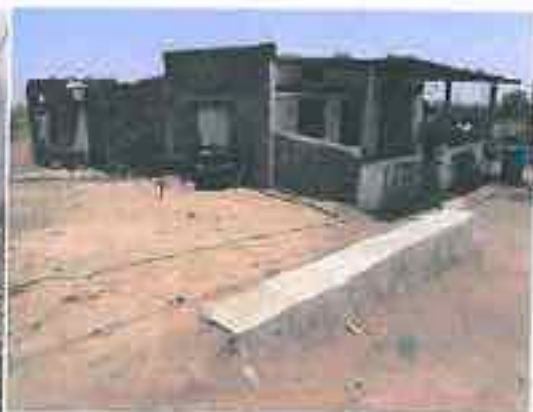
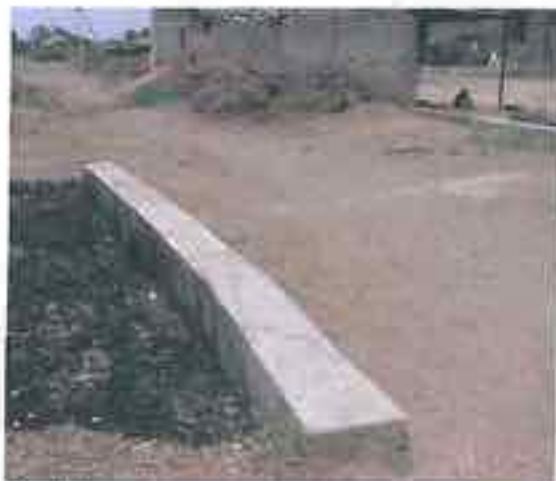
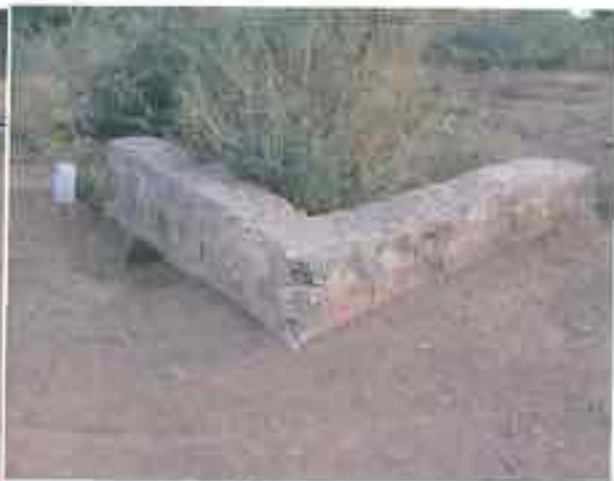
Plate 2.6.6. : Clogged defunct culverts. Waterways not properly made or channelized. Poor Maintenance (Typical)

17. It was not uncommon to find chocked/clogged defunct culverts (Plate 2.6.6). With side protections missing, and waterways not constructed, topography having altered over years due to construction activities, and all this coupled with lack of maintenance and regular cleaning, has ensured that culverts have often become completely defunct due to clogging.

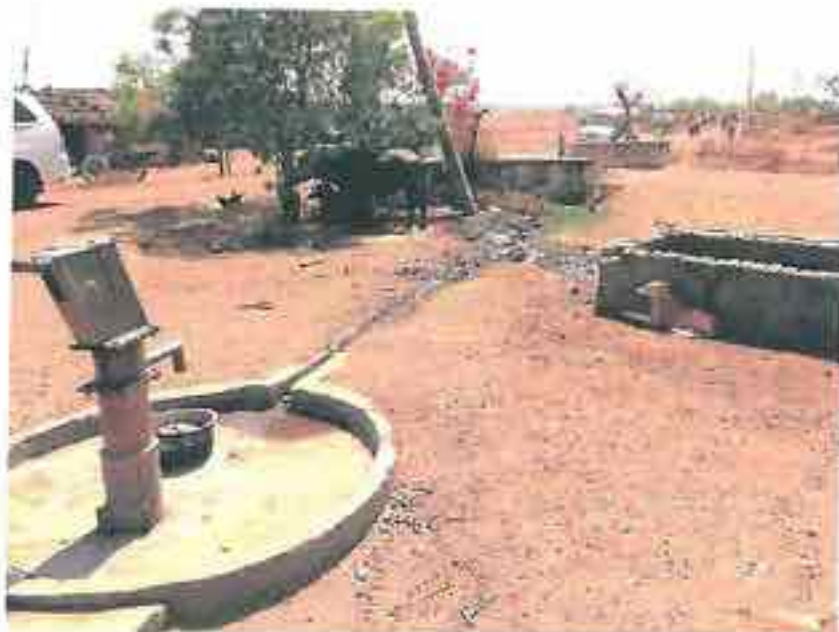
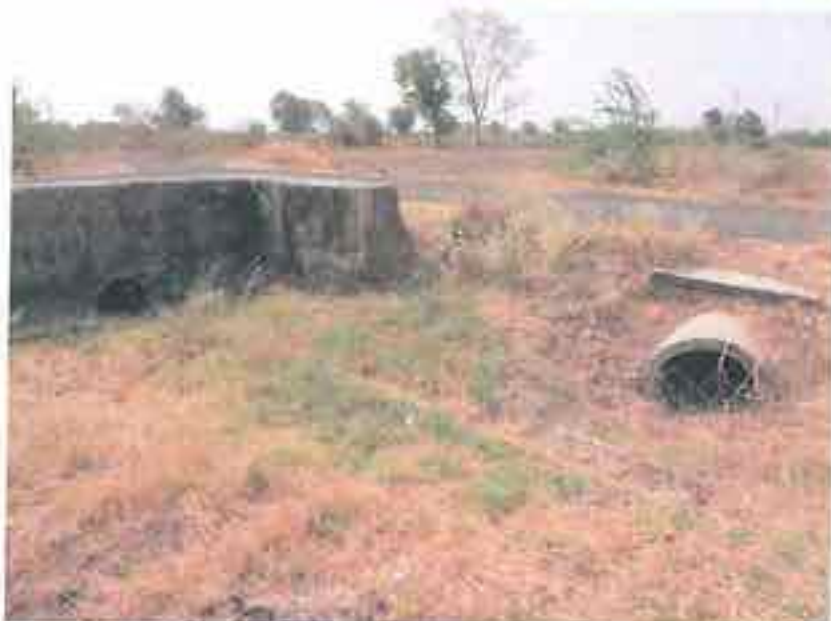
Gawla II: Poor drainage for Handpump and halao etc. The unengineered and undesigned drainage from these would drag mud that would invariably choke culverts (Typical)

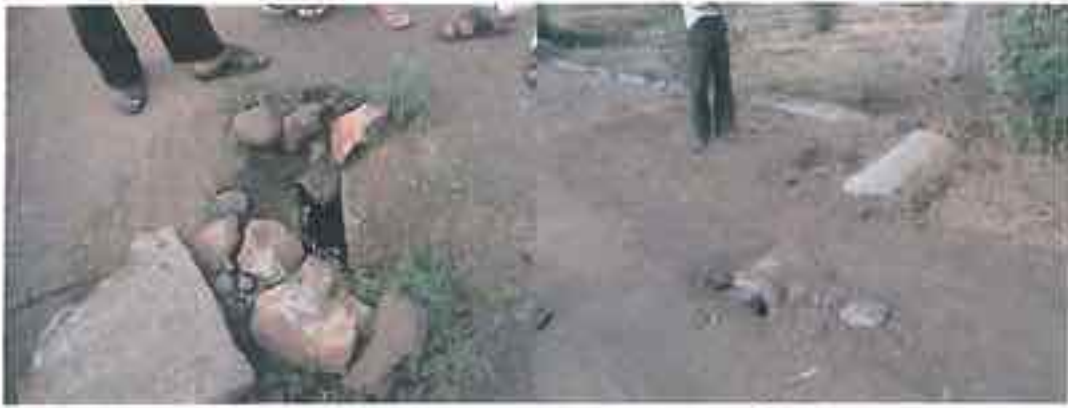
Nisarapur

Plate 2.6.8. Poor Execution and Supervision (Typical)

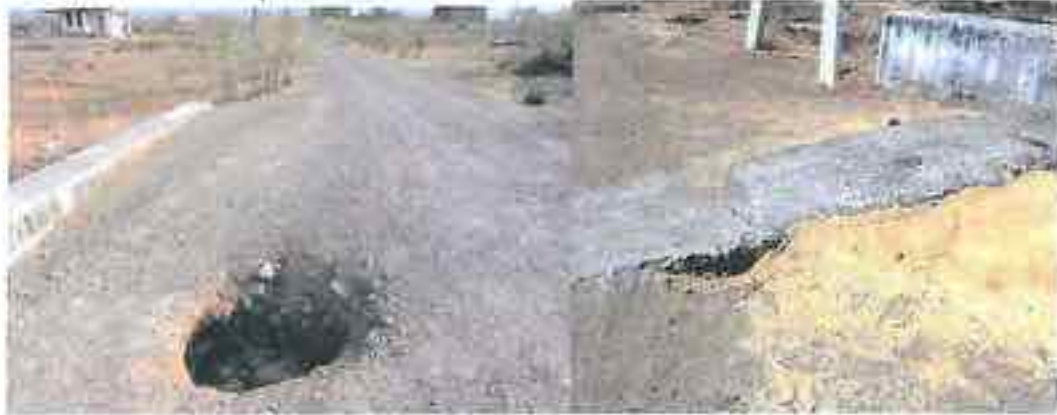
Chichli Kasravad :Massive piping even in hard soil

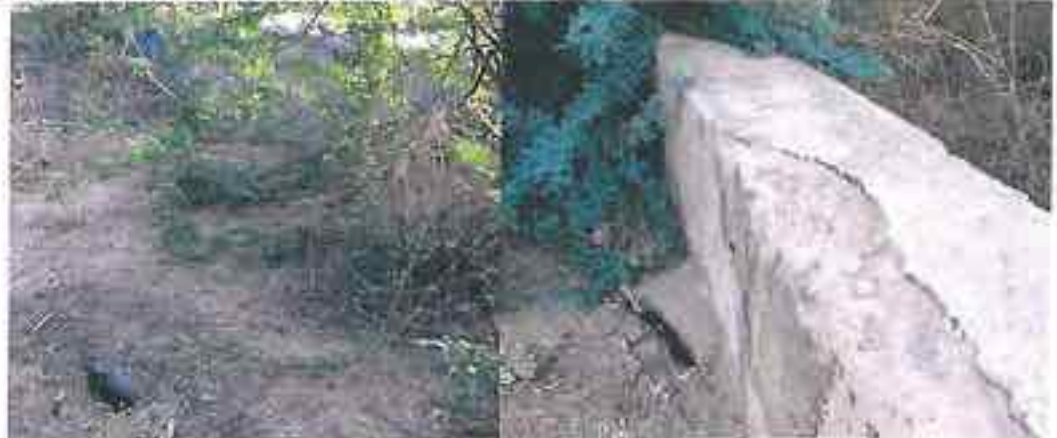
Saita (Kasravat) : 2 different Culverts with inadequate cover, if any.

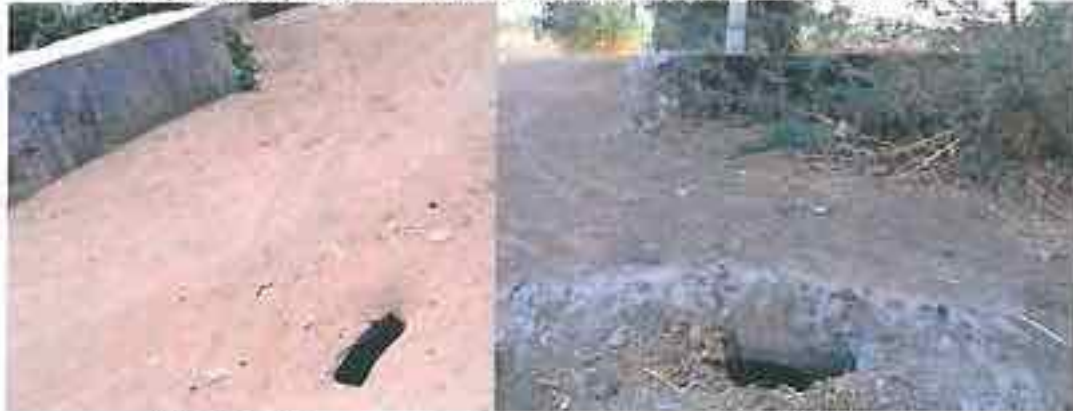
Plate 2.6.9. Cross drain Pipes not connected, Inadequate Pipe covers on Road, Roads caving in (Typical): Poor Execution.

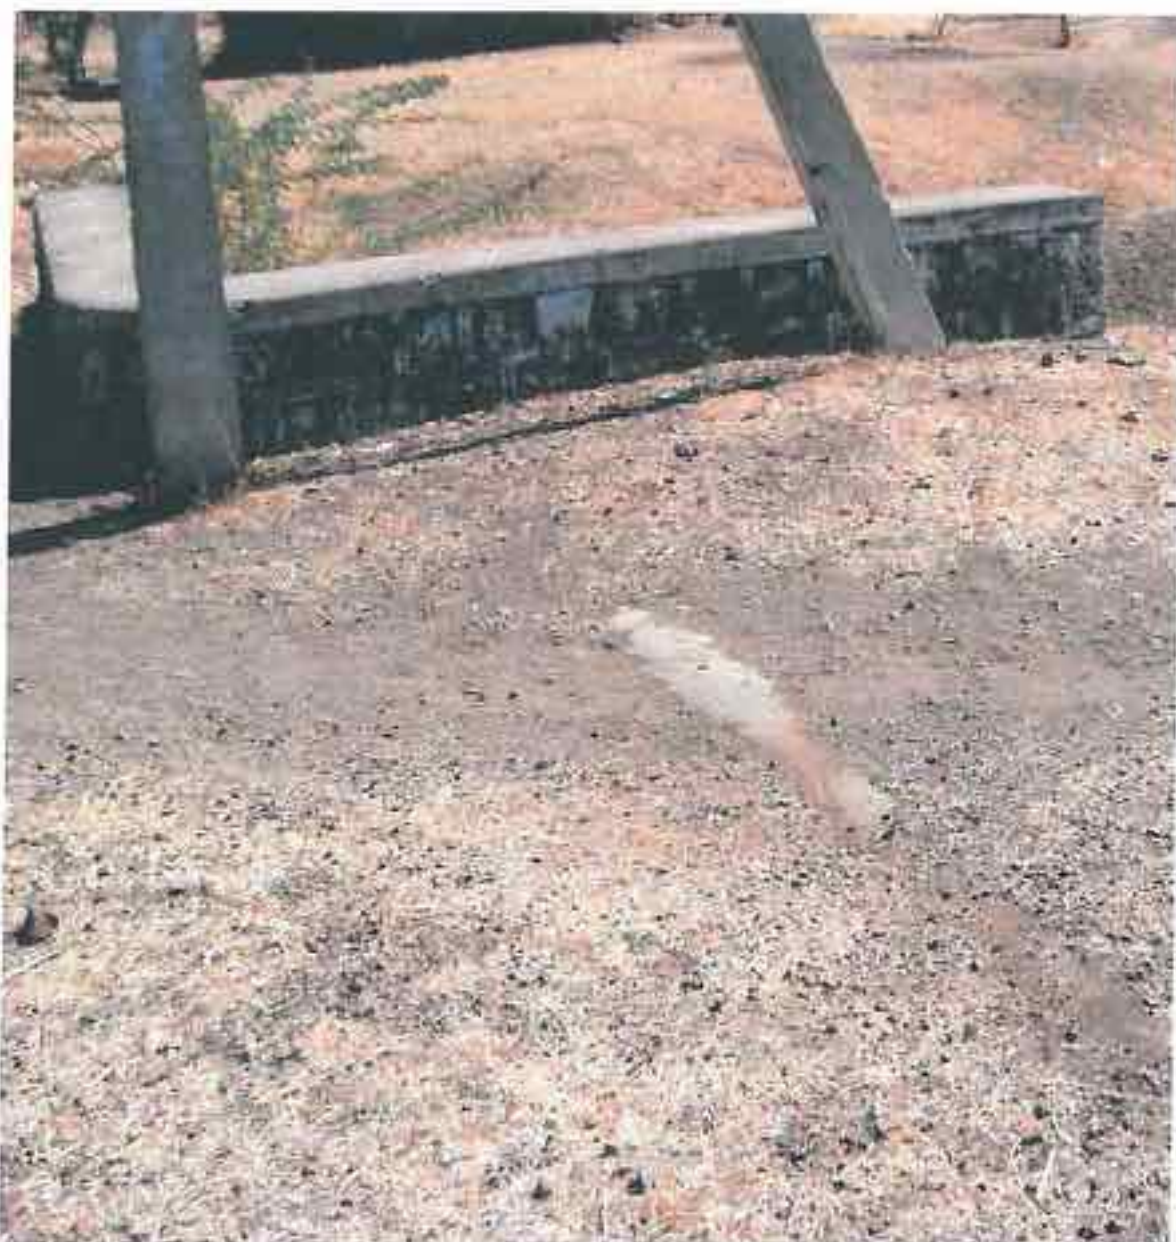
Borlai I

Plate 2.6.10. Typical Inadequate Cover/Cushion over the pipe, pipe visible on the road. Poor execution and supervision.

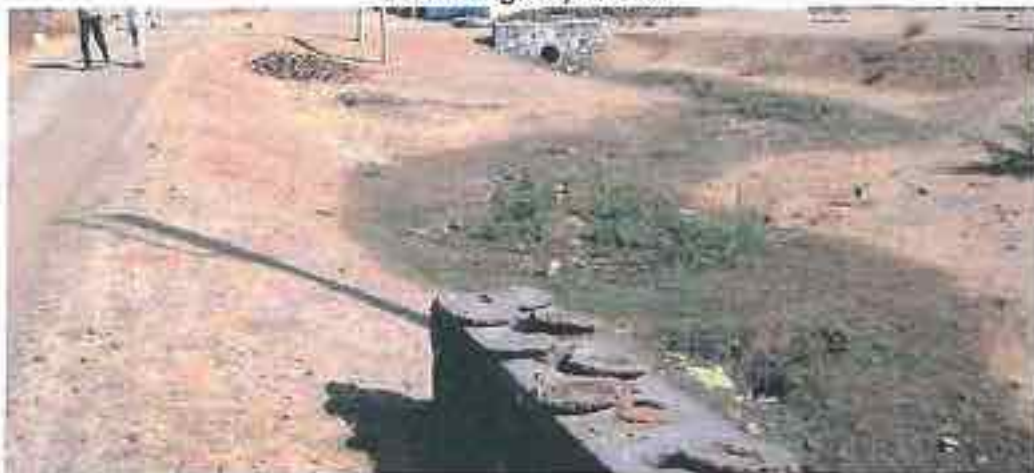
Borlai II water flows in zig zag pattern to find out the culvert made

Plate 2.6.11. Drainage Water from culvert left free to find its own course/another culvert in between the plots : No training of water-ways and terrain (Typical)

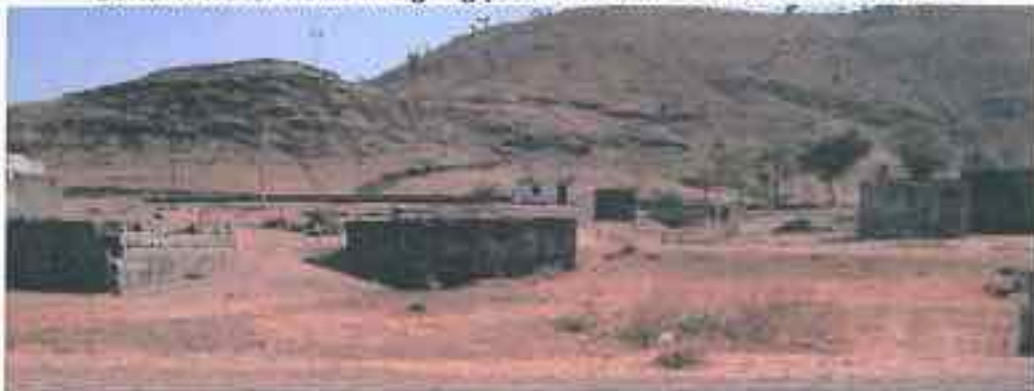
Borlai II: Another set of culverts-water from hills left free to zig-zag

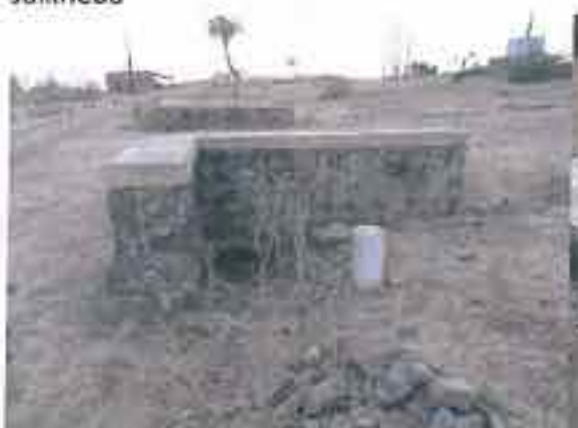
Lohara : plot no 103 in front of culvert mouth

Plate 2.6.12. Typical Plots in front of Culvert Pipes: Insensitive planning and execution.....cont..

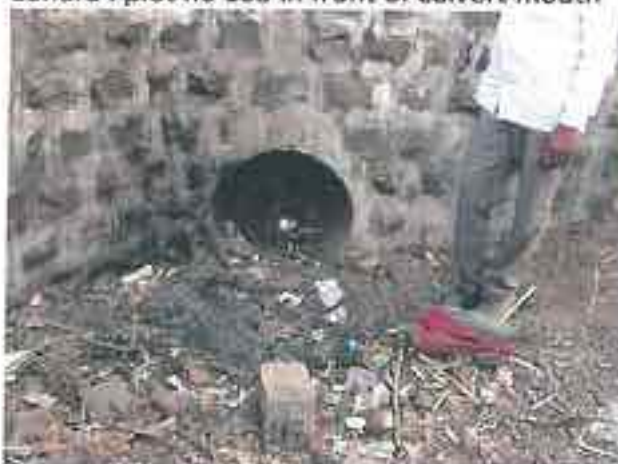
Takiapur: Plot 117 in front of culvert outlet, plot 119 in front of same culvert inlet

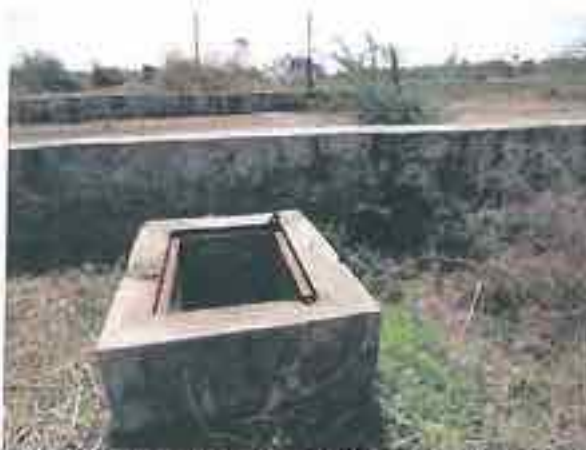
Ganpur (Narmada Nagar): Air valve Chamber, Cover also missing to facilitate immersion

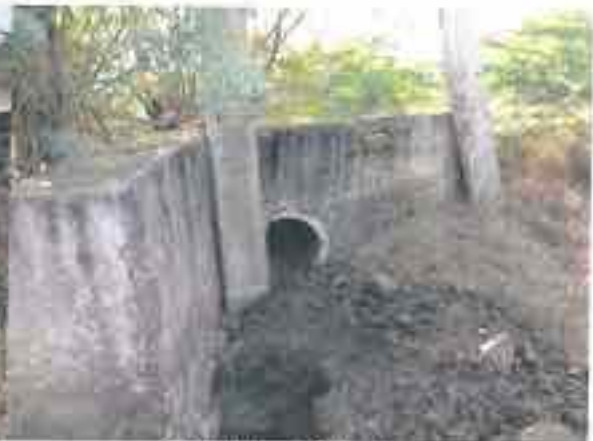
Chikalda: RCC Pole

Plate 2.6.13. Infrastructure too close to Culverts: Overall Poor planning and execution.....cont..

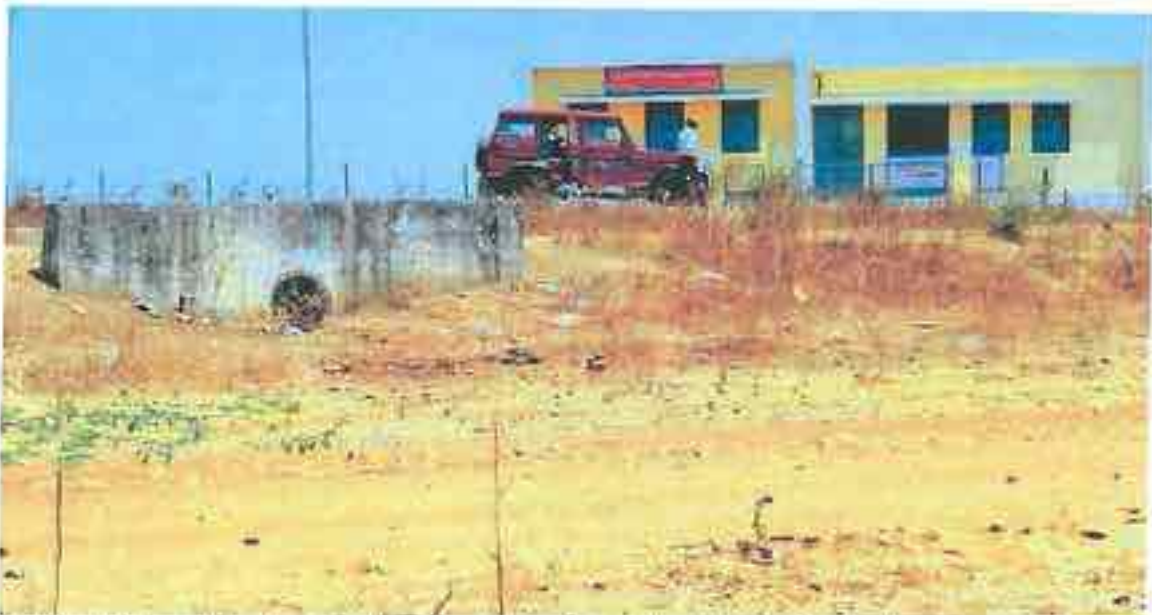
Gawla I: Culvert discharging directly on an oft used pathway: No drainage control

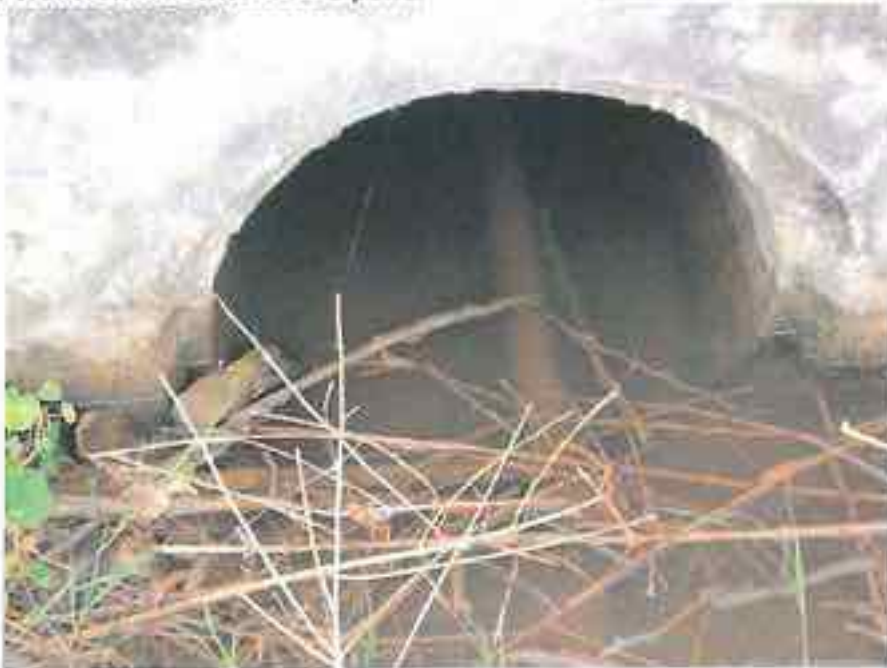
Ratwa: Water supply pipe submerged in flooded culvert dirty water

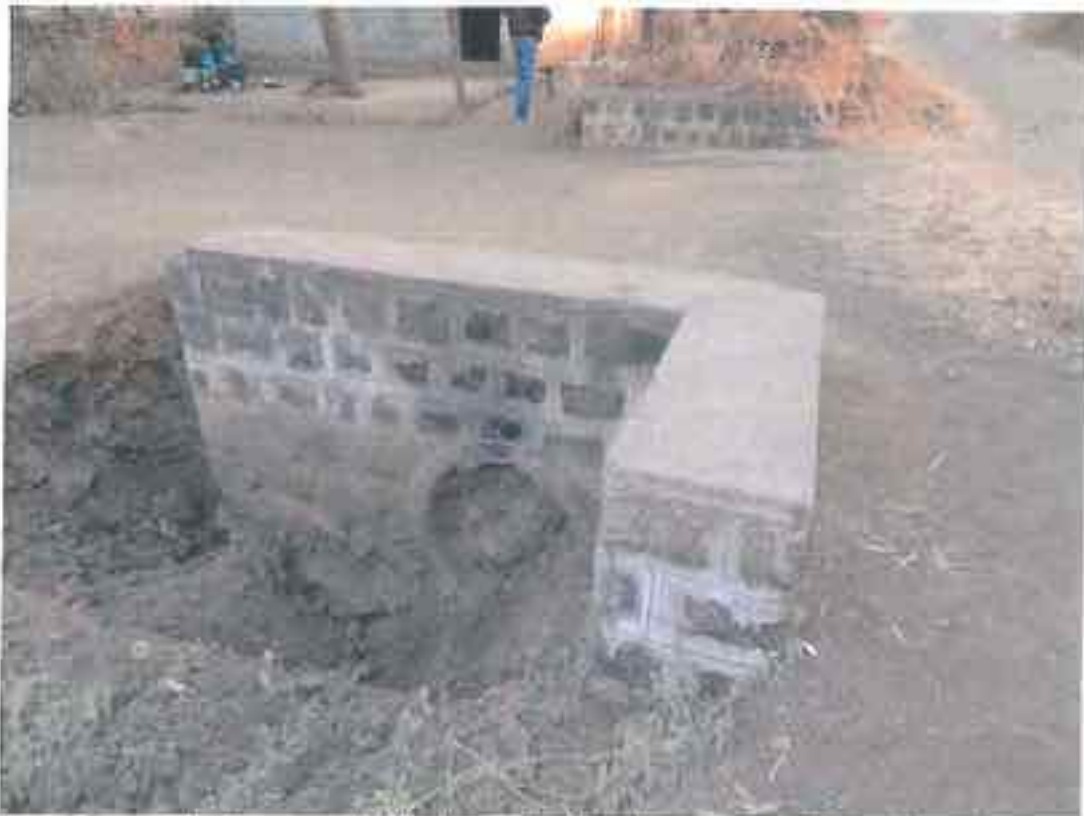
Eklera : Topography has completely changed after the construction work at the site. The culvert pipe had to be dug to be seen, as evident from the mud on the wall and inside the pipe.

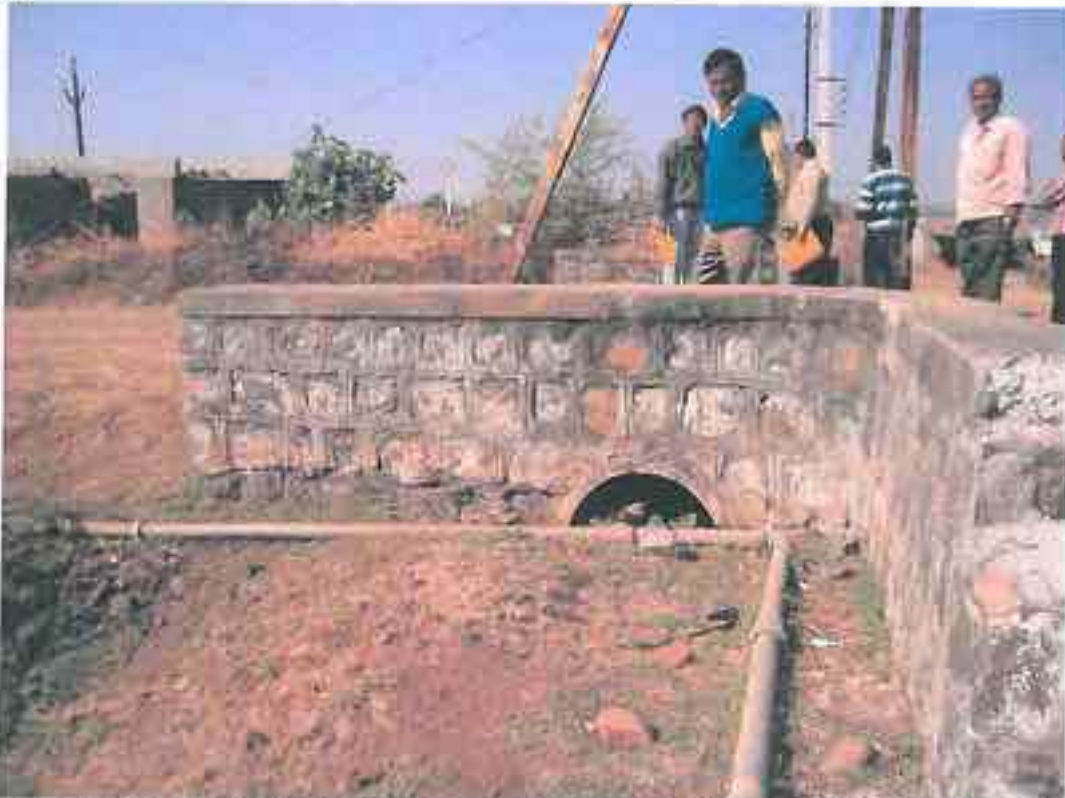
Borlai II: Topography has changed so much that the culvert mouth has almost been buried, and a water supply line has been carelessly laid on the eroded consolidated sediment brought to the culvert mouth by flowing water.
