Evaluation of the Quality of Civic Amenities at Rehabilitation Sites of the Sardar Sarovar Project

**Sardar Sarovar Project - Fake Sale Deeds and Rehabilitation Sites
Irregularities Inquiry Commission**

April, 2014

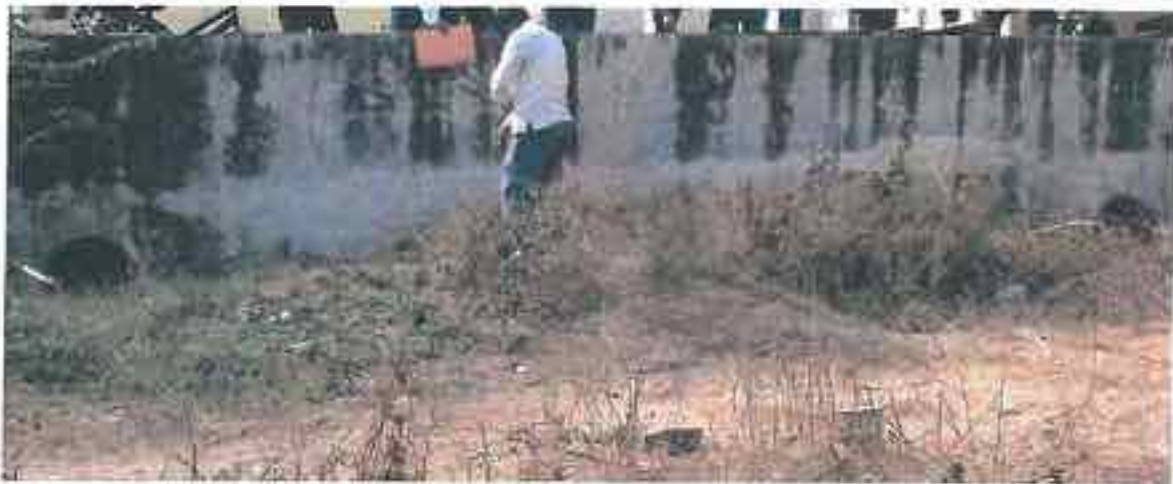
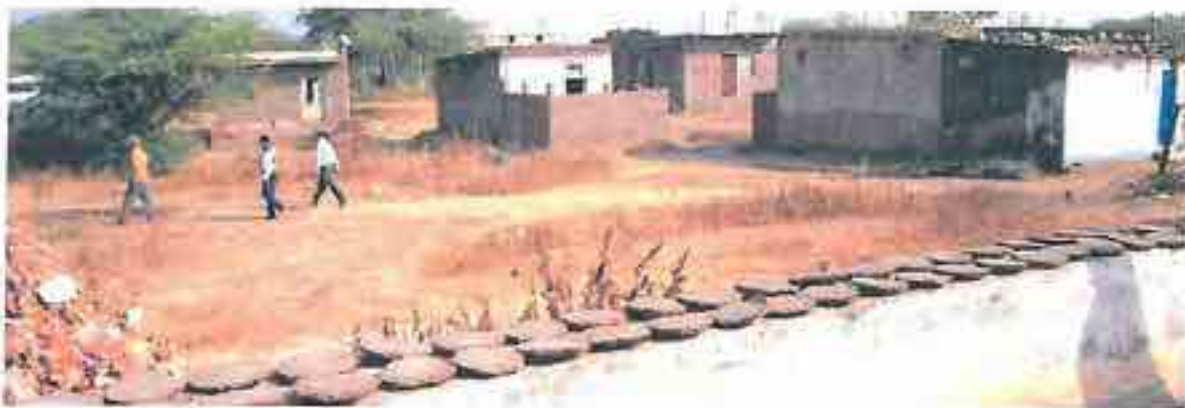
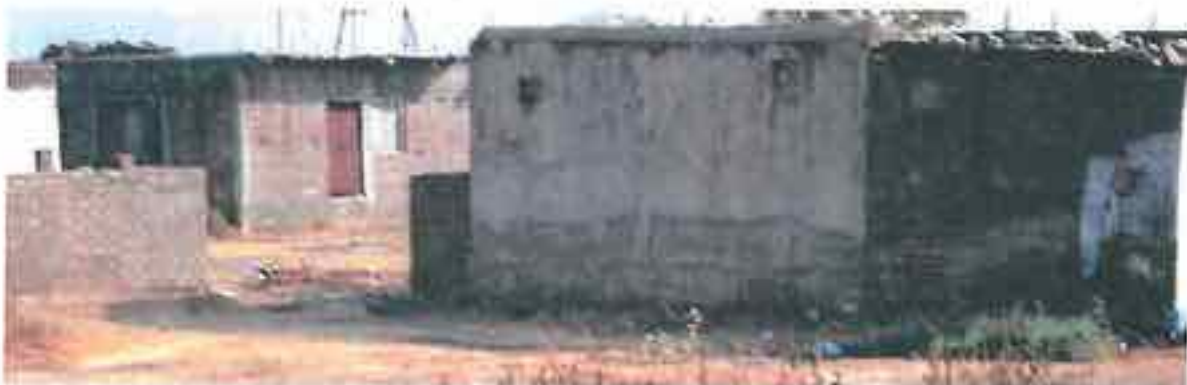
Kukra (Badwani): Culvert discharging into plots (plot 39-40) at the back of Primary Health Centre across the road (top). On the house in front (middle and bottom photographs) there are visible signs of dampness left by waterlogging in the last monsoon as the culvert discharge has no watercourse available and water logging is common.

Plate 2.6.16. Flooding due to Culvert Discharges (Typical)

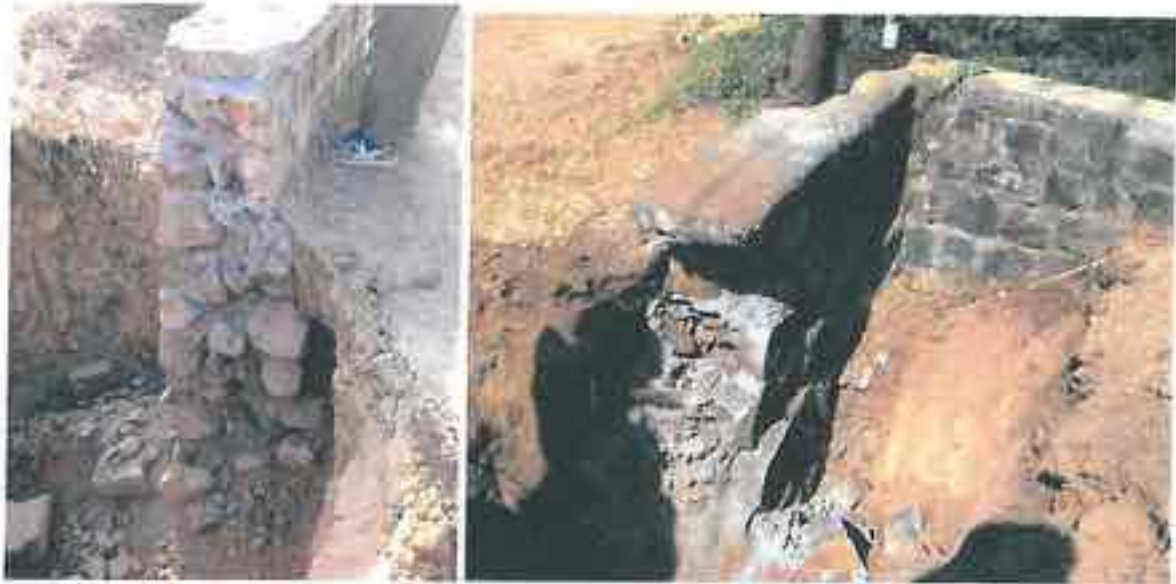
Amlali: RR Masonry Culvert. Poor workmanship and quality. Culvert pipe mouth seen blocked, and how water will pass through is beyond imagination. Upstream ground level is above road formation level, so water is overtopping road formation rather than pass through culvert pipe

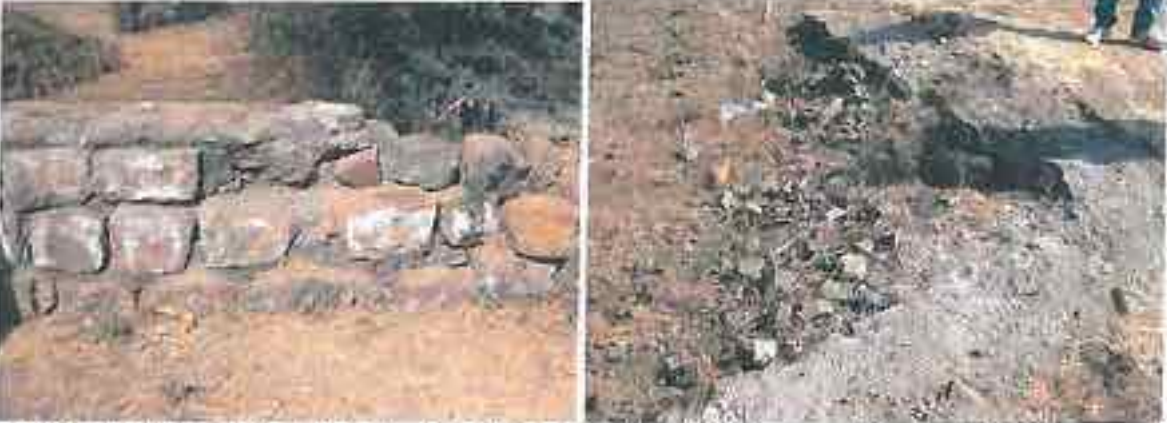
Jamda (left) & Borlai I (right): RR Masonry culvert with poor joints and inferior work quality

Plate 2.6.17. Poor construction of stone masonry culverts (Typical)--Poor masonry work, poor joints, inappropriate curing and poor foundations.....cont..

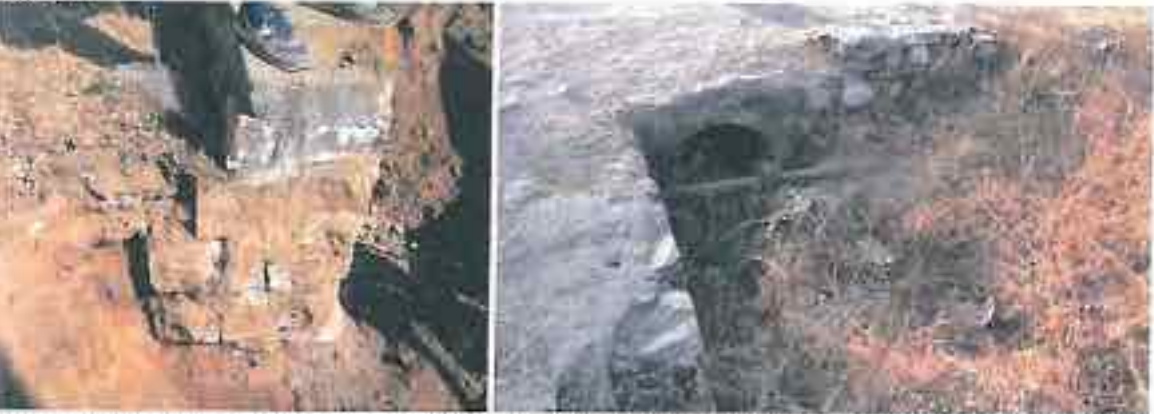
Poor quality of workmanship with poor masonry work at culvert foundation at Bhawti II (left) and head wall of RR Masonry culvert at Dharamrai (right)

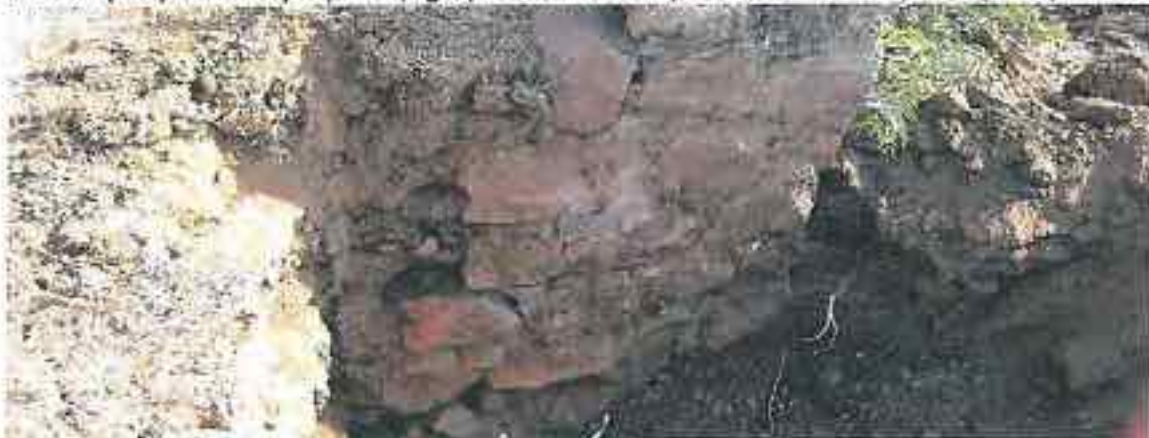
Bijasan: Foundation of RR Masonry culvert showing very poor joints

Plate 2.6.17. Poor construction of stone masonry culverts (Typical)--Poor masonry work, poor joints, inappropriate curing and poor foundations.

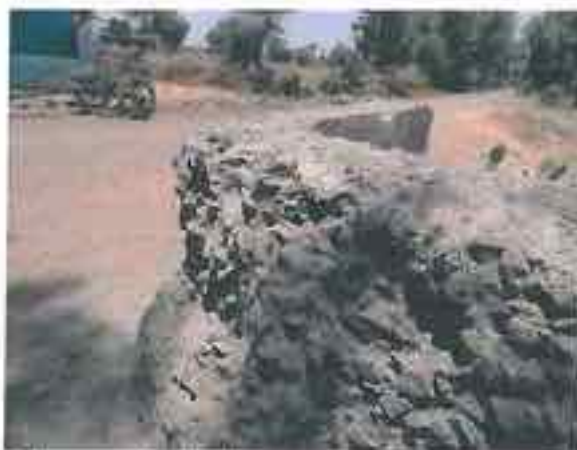
Vishwanath Kheda

Plate 2.6.18. Poor construction of cement concrete Culverts (Typical) -- Large flaky aggregates, Poor concreting, and lack of curing.....cont..

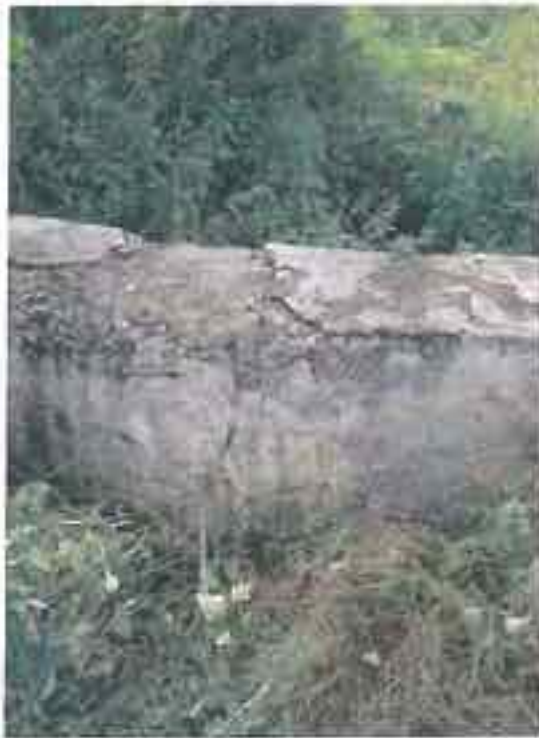
Nisarpur

Plate 2.6.18. Poor construction of cement concrete Culverts (Typical) -- Large flaky aggregates, Poor concreting, and lack of curing.

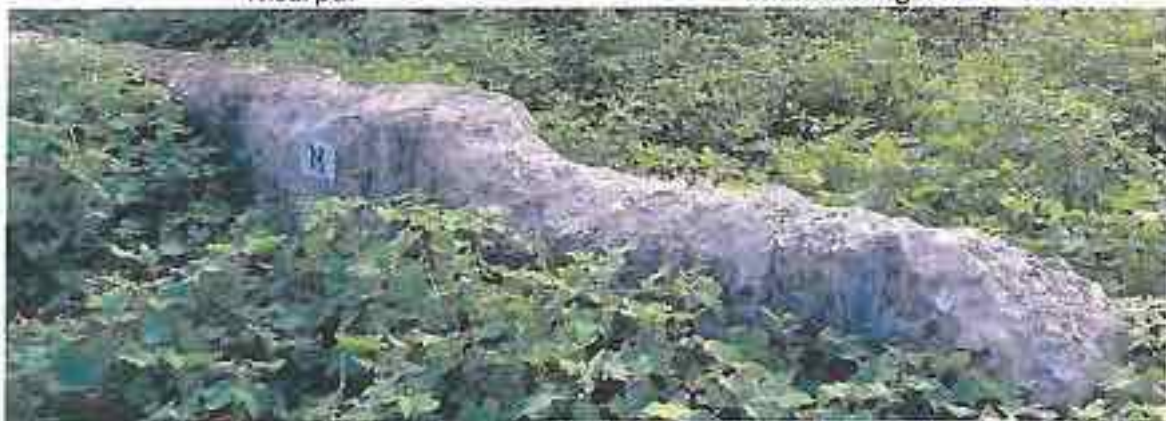
Umda: Poor concrete quality and construction

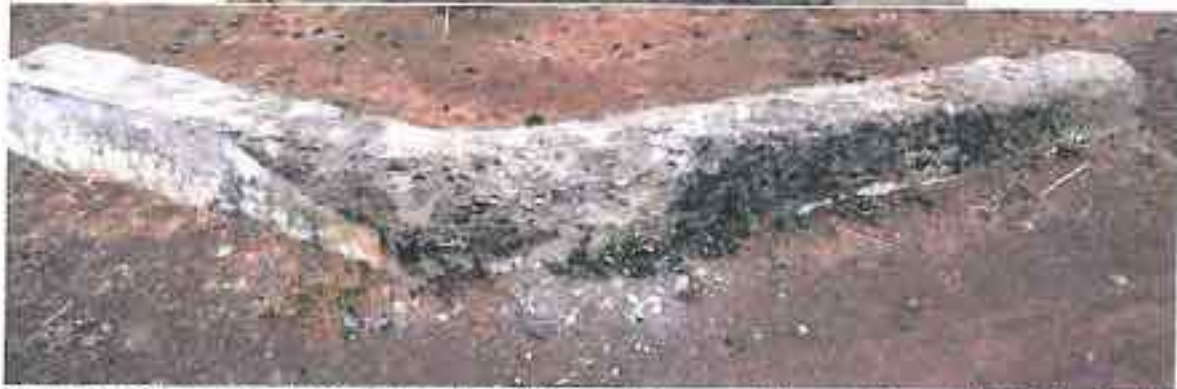
Beganda: Culvert No 1 (top two photos) had plaster over it nearly 1 cm thick. The inside material was extremely poor quality, and could be easily peeled by bare fingers. Even 8 cm long flacky aggregate material was found. There was hardly any binding seen. From the colour inside it appeared that curing was inadequate. Overall poor quality. It appears that plastering work has been a ploy to hide the quality of material inside. In some cases (example, bottom photo) even whitewashing was noticed (whitewashing on culvert structures has been carried out rarely, and was mostly not seen), and was obviously carried out to hide the poor quality. Similar issues were prevalent in other culverts, example, Culvert no 8.

Plate 2.6.19. Culverts with plastering work (Typical)

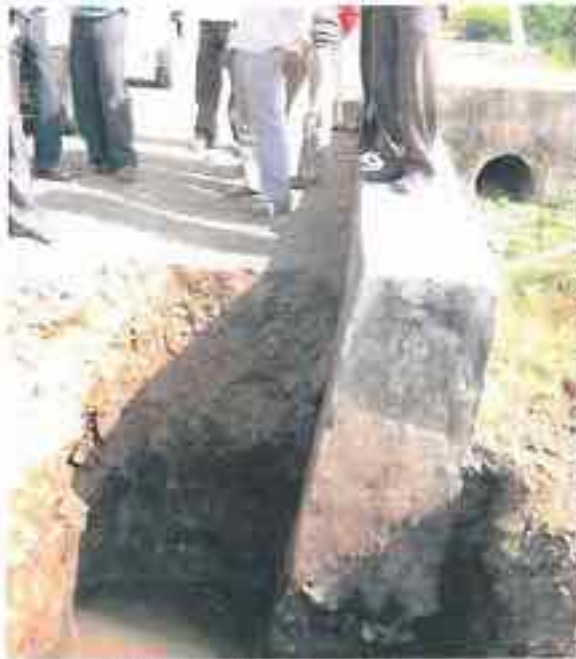
Typical poor concrete work. Plastering has been done over concrete, and culvert not seen in profile. Khalbujurg culvert headwall appeared declining outward and was not vertical.

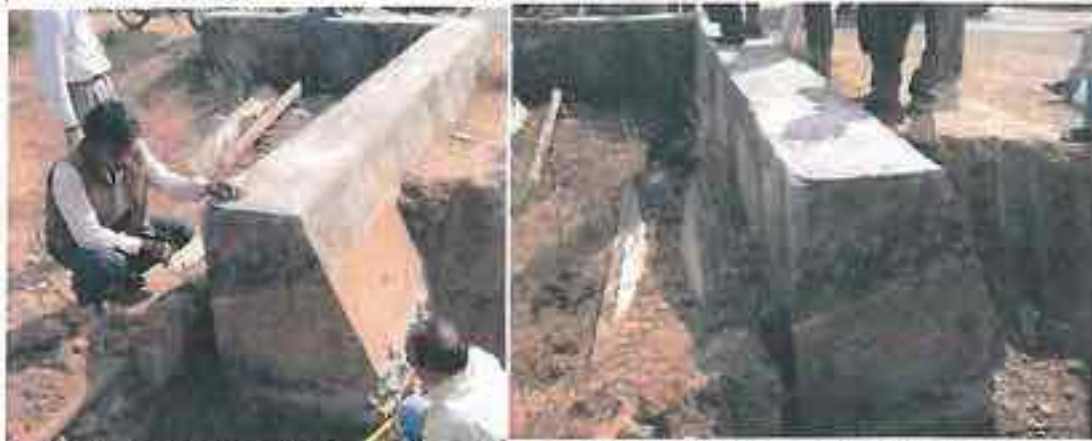
Balwada: Typical extra wide concrete section of culvert, and its poor connectivity with the drainage alignment (right)

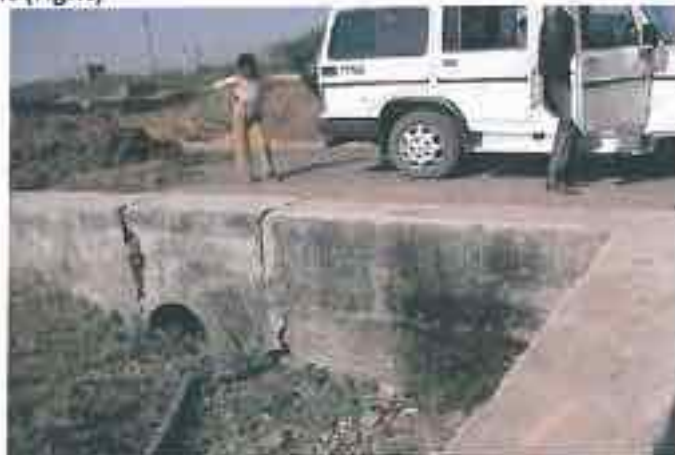
Khalbujurg: Headwall settlement of Cement Concrete culvert at Khalbujurg where BC soil strata exists. A result of inappropriate foundations resulting in differential settlements.

16. All foundations except pile foundations at Moreghadi and Khalbujurg laid have been laid without designs. In the absence of necessary geotechnical investigations, adhoc designs have been adopted by field in-charges who were actually not competent as per provisions of MPWD Manual-1983, to deal with complex design situations arising because of different/varying strata even where the super-structures were similar.

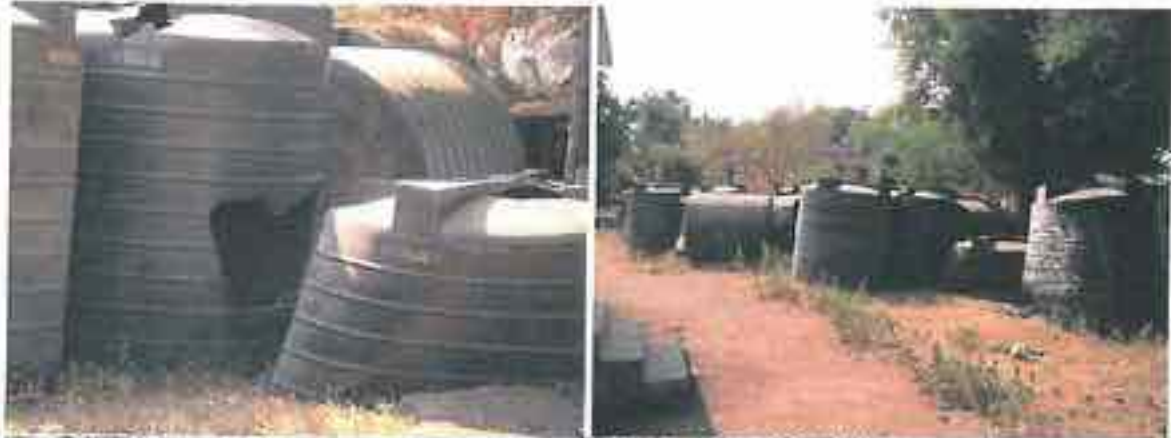
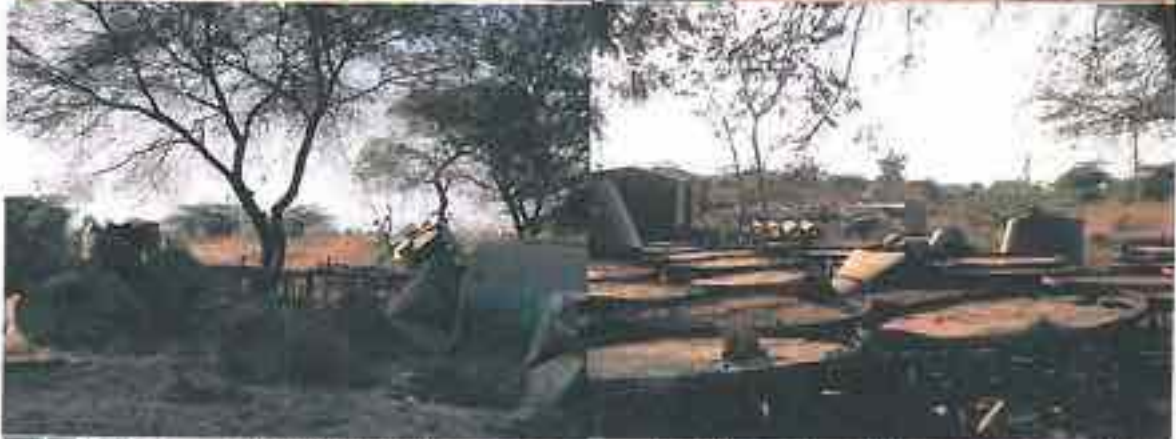
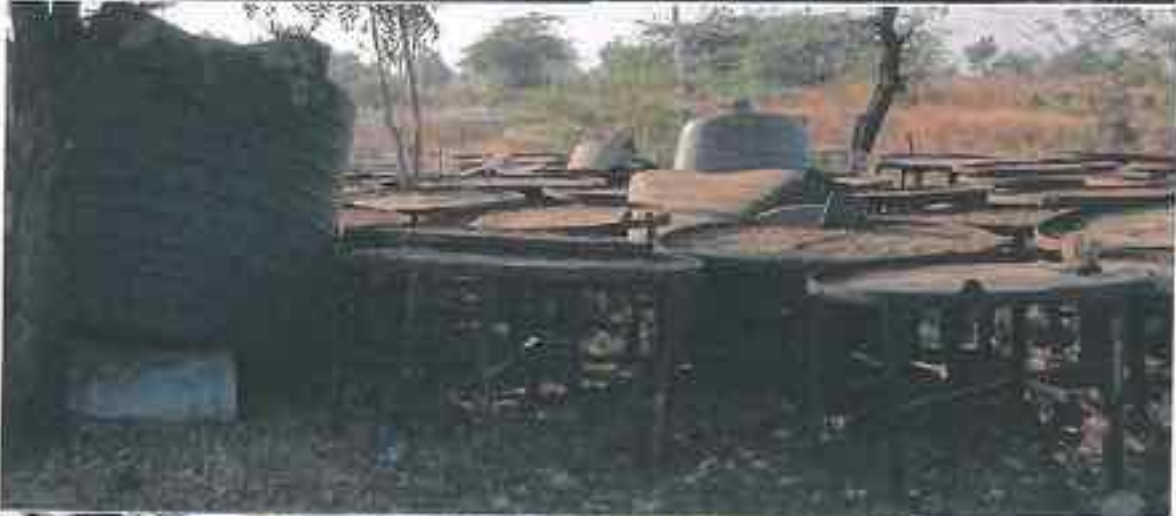
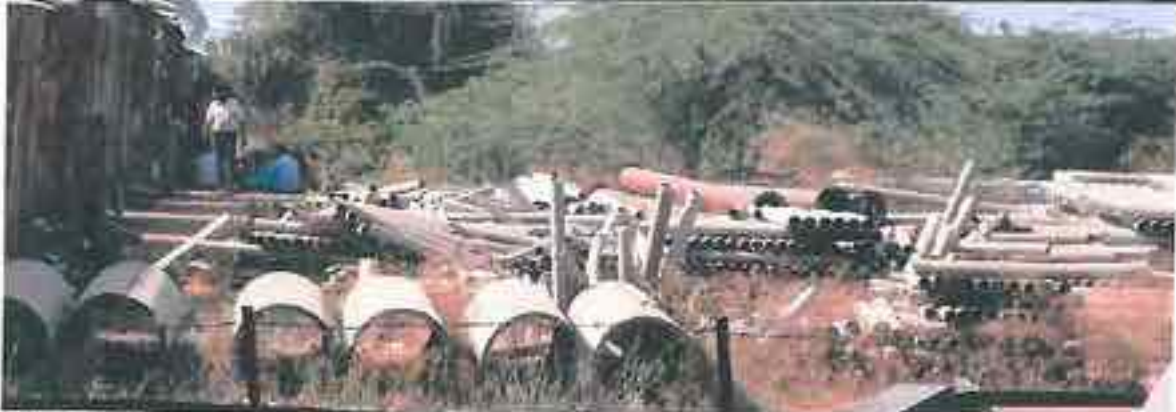
tanks and damaged and broken half-round and full pipes found lying in damaged condition at Bhilkheda site (Plate 2.7.1). Not just this, but large number of the half round pipes laid in surface drains were routinely found damaged at several R&R sites, and PVC Water tanks often found missing and damaged, even as no test results/certificates of half round pipes and PVC Cisterns are made available.

Plate 2.7.1. Huge numbers of pipes and PVC Cisterns stockpiled at Bhilkheda

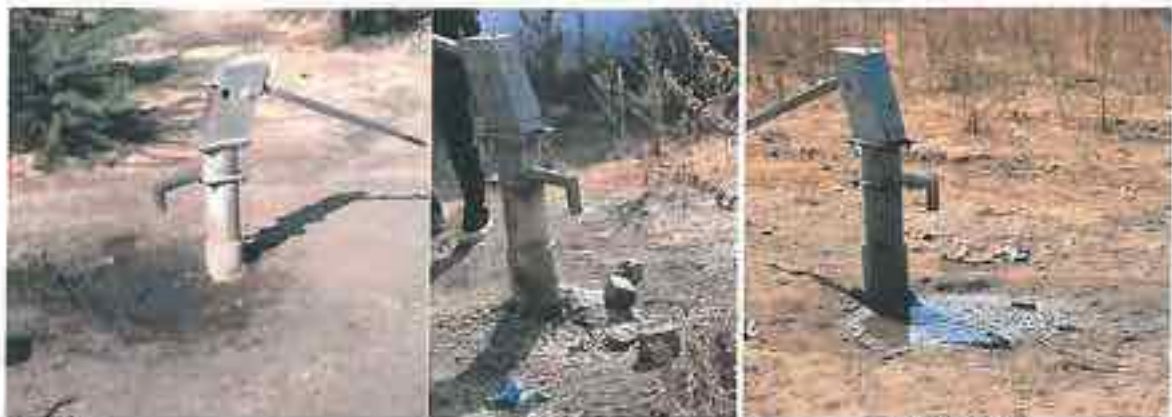
Plate 3.1.2. Handpumps without the mandatory Platforms (Typical)

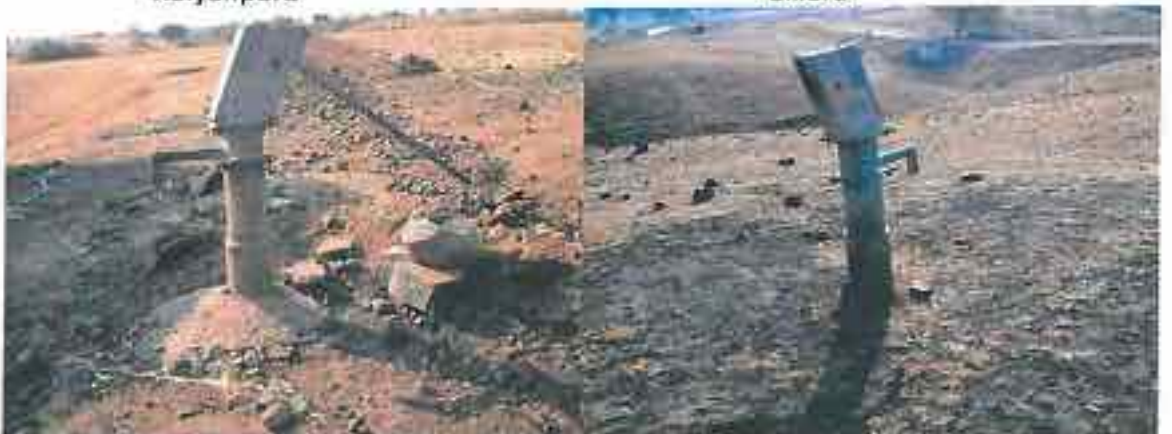
Dehar: Two different Handpumps

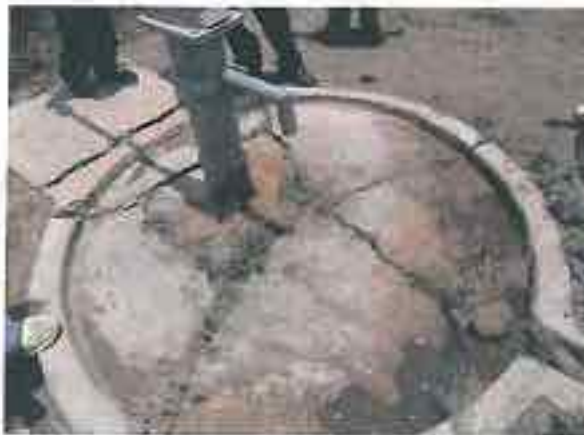
Kadmal

Plate 3.1.3. Typical Damaged Handpump Platforms: A running story across sites....cont.

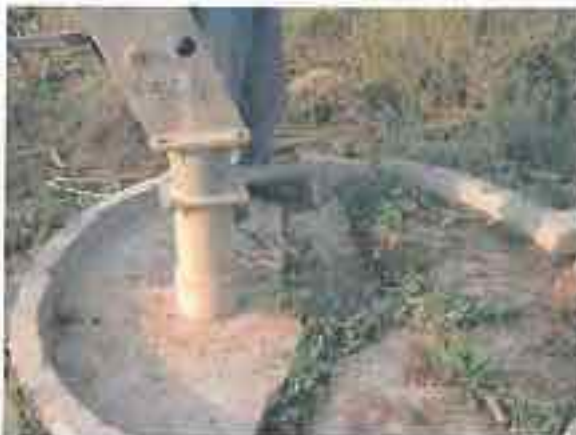
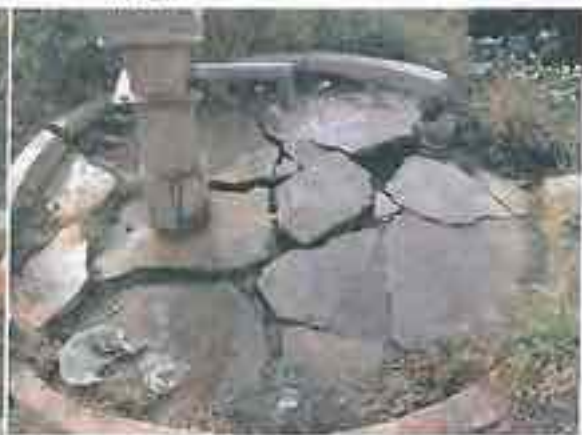
Kaisur: Two different Handpump Platforms

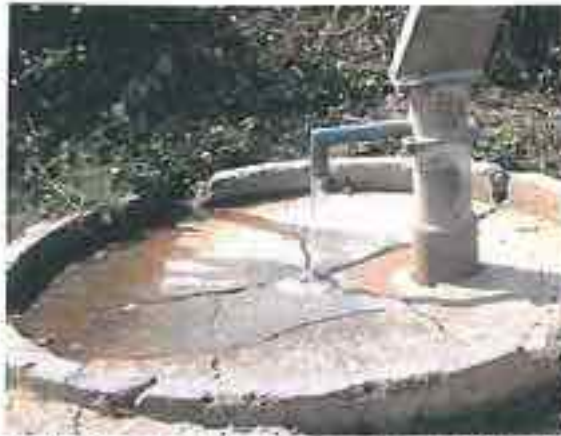
Khedi: Also the HP platform slope is defective

Plate 3.1.3. Typical Damaged Handpump Platforms: A running story across R&R sites

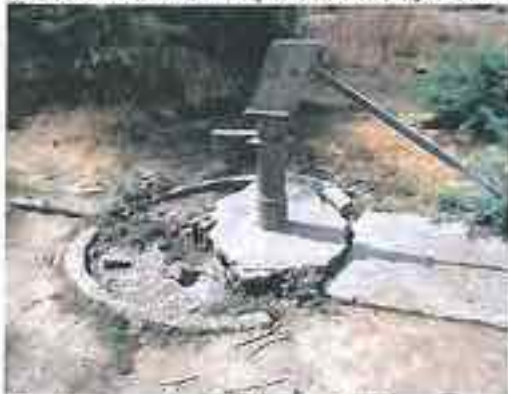
Khalbujurg: Case of Two Platforms

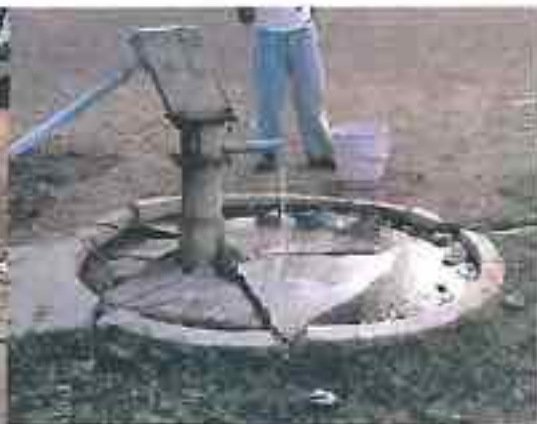
Khujawan

54. In large number of cases, the cracks were extensive leading to large damage of the platform (Plate 3.1.3). Such damaged platforms are of no use, and are essentially user inconvenient, besides being a source of insanitary conditions, as spilled water tends to flow at random. There were apparently no attempts made to maintain, make repairs or to recast such platforms, indicating poor maintenance also.

Plate 3.1.3. Typical Damaged Handpump Platforms: A running story across sites.....cont.

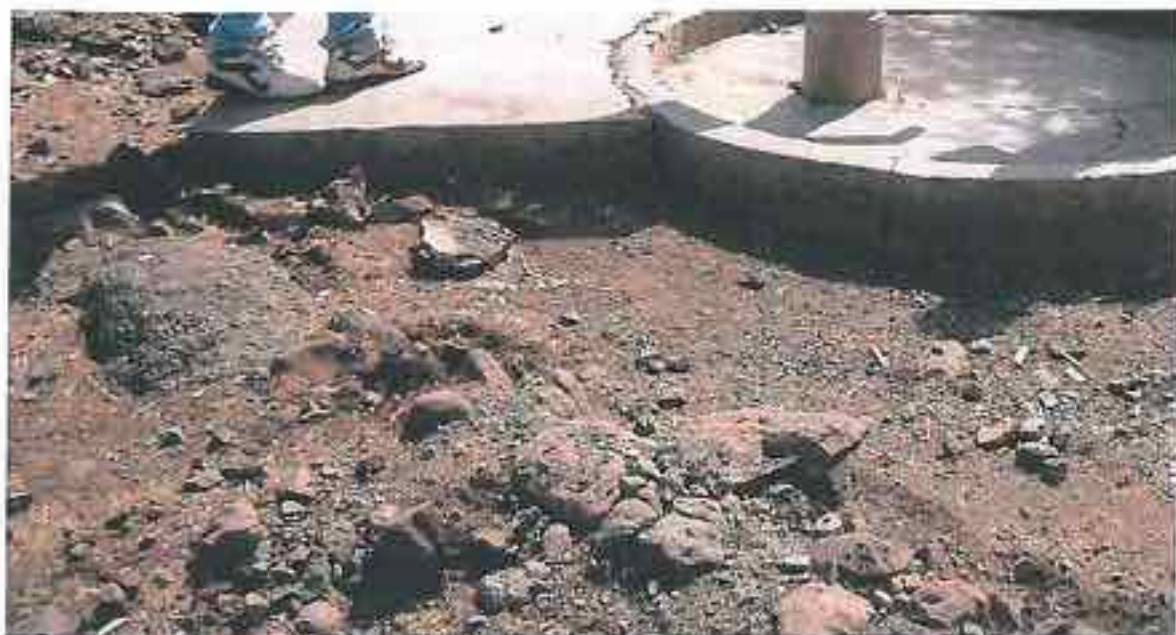
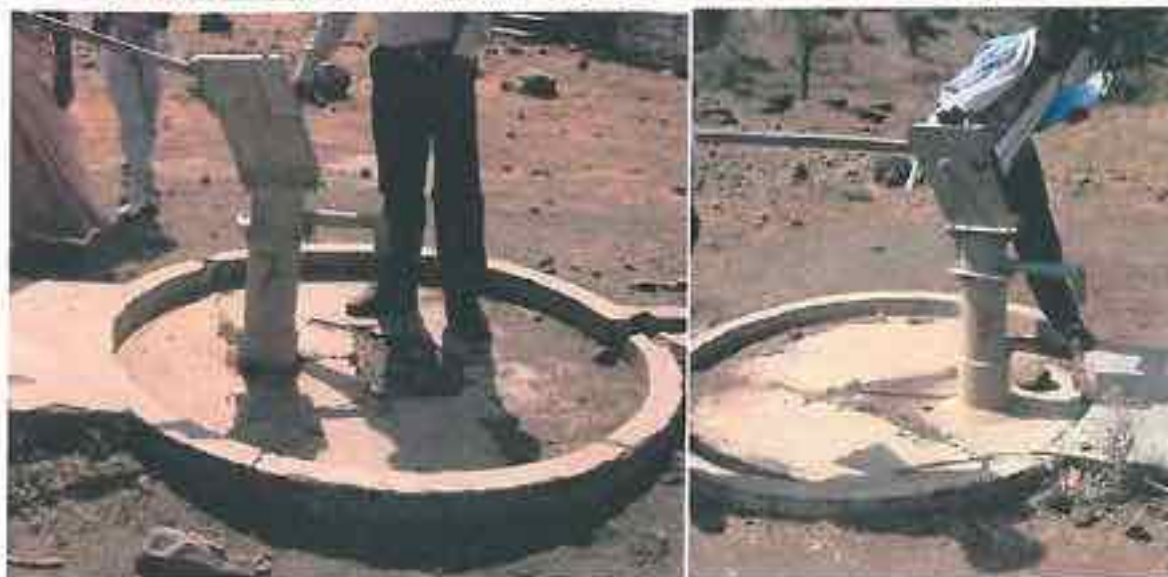
55. Such extensive Platform cracks/ damages were not limited to Black-Cotton soils and existed even when the strata was hard. For example, at Barahmangaon

(Theekri), Chichli (Kasravat) etc. where the strata are rocky/hard, a number of platforms were seen having cracks (Plate 3.1.4). This indicates poor execution, besides being reflective of the possibility of poor quality of construction material.

Brahmangaon: 3 different Handpump platforms

Plate 3.1.4. Typical Cracked HP platforms even in hard strata.

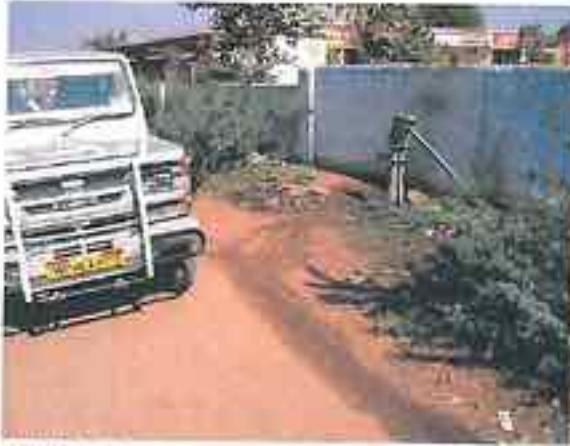
59. The HPs in most cases have inadequate drainage. The HPs discharge often to open grounds, compounding the problem of residents who already have a non-working surface drainage system. The stagnant pooled up drainage water (Typical Plate 3.1.5) would have had massive consequences for health of residents had these R&R sites fully developed, as such waters provide breeding grounds to mosquitos and insects, causing diseases like Malaria and Dengue and leading to insanitary conditions in general. The condition becomes more significant in the rural context as the Livestock is often attracted to such pools, and defecation therein further exaggerates the insanitary conditions.

60. The HP drainage has also not been planned and executed properly in the directional sense. The drainage was often seen randomly directed towards the roads, tree platforms, houses etc. (some photos in Plate 3.1.6) rather than be channelized towards drains or aligned with natural drainage. Insanitary conditions due to poor/ non-existent drainage were common.

Bhilkheda: Drainage spilling over Road

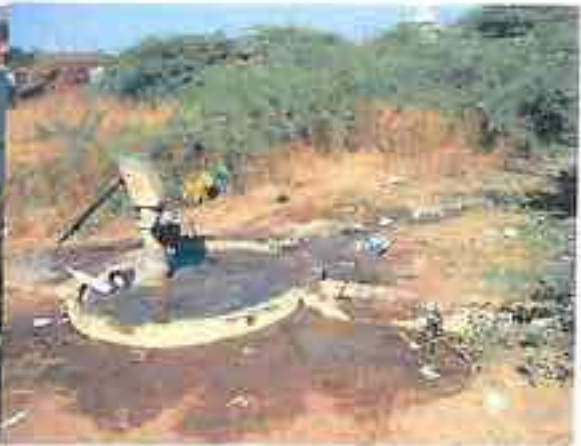
Bhilkheda: Another HP

Plate 3.1.5. Improper HP spill-over drainage and ponding at R&R Sites (Typical).....cont.

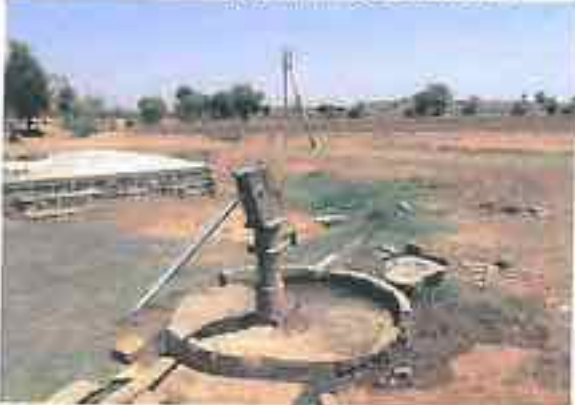
Mandwada: drainage towards road, HP Platform damaged

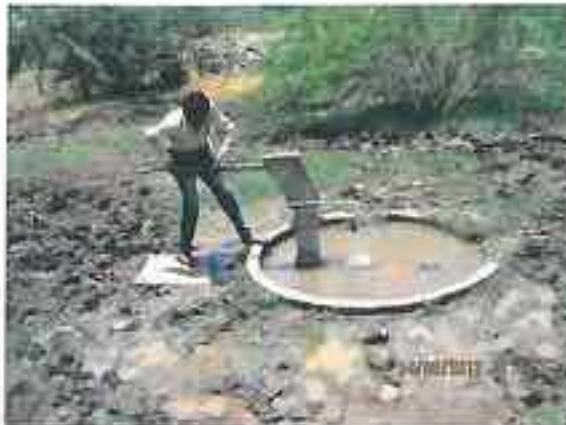
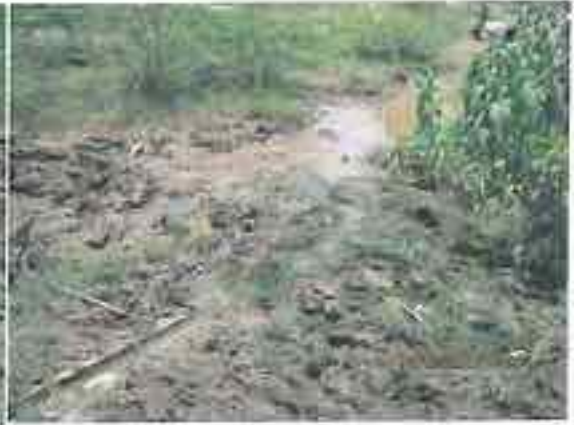
Perkhad: Two scenarios at the same handpump

Plate 3.1.5. Improper HP spill-over drainage and ponding at R&R Sites (Typical) (Note: All photographs taken in Dry Season).

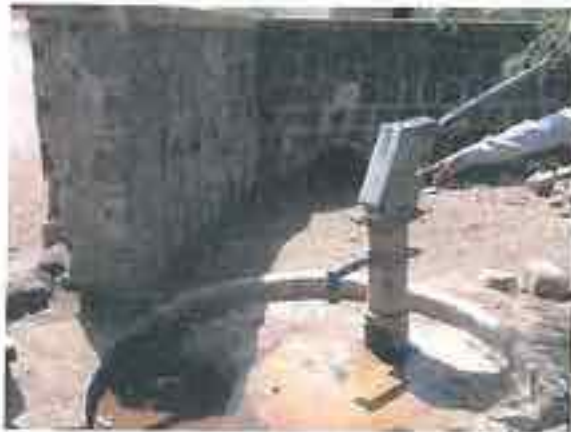
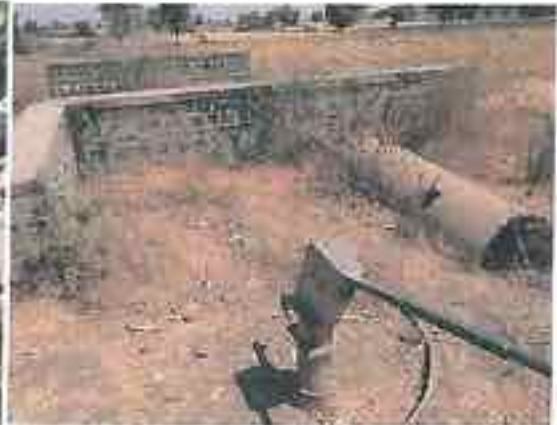
63. Planning/execution issues were also observed for Handpumps located right below the hilly topography leading to user inconvenience as the loaded water vessels would have to be carried up the hilly terrain day after day mostly by females and children. Similarly, locations on slope making HP Platforms susceptible to erosion from gushing surface water, poor approaches, faulty sloping of platform /drainage channels resulting in random spillage of drainage/spilled water (Plate 3.1.8) were some other relevant issues.

Kirmohi: Two different handpumps located in front of culverts.

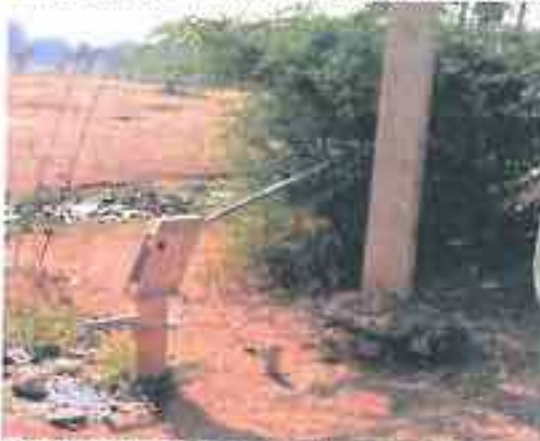
Kalyanpura: electrical pole prevents operation

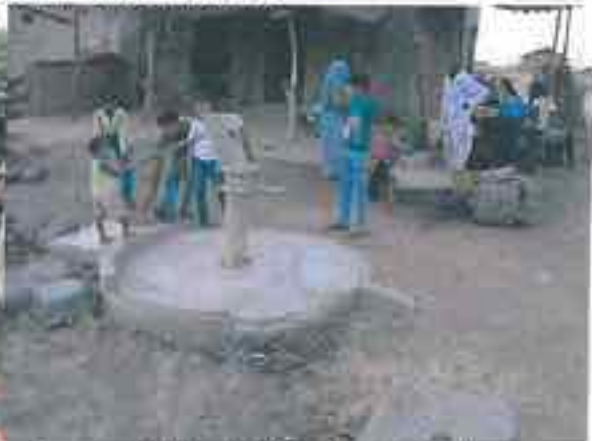
Balkhad: HP in front of a house.

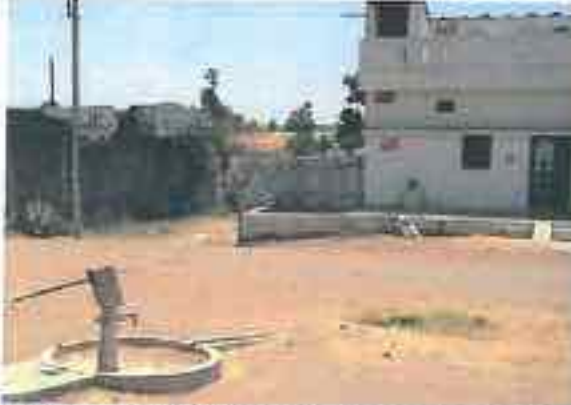
Vishwanath Kheda: Drainage on the road

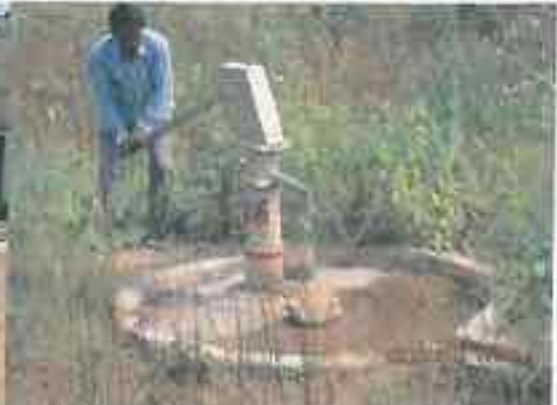
Nisarpur: No approach

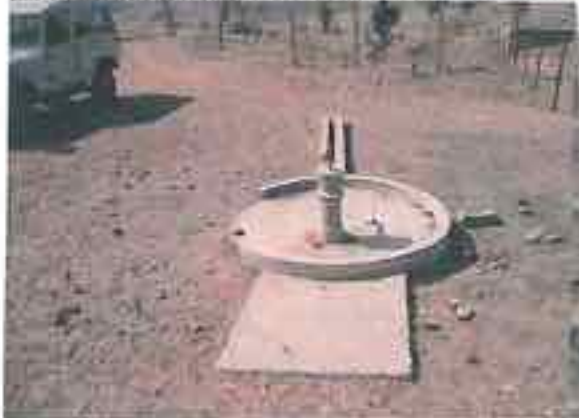
Kikarwas: Spillage on the road

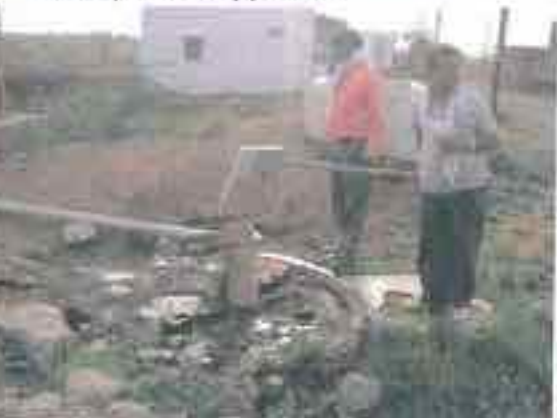
Chichli Kasrawat: Spillage has no place to go

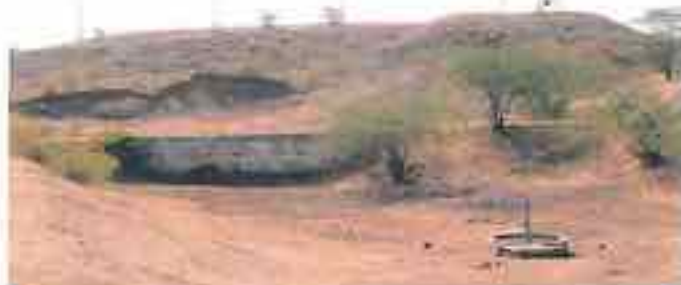
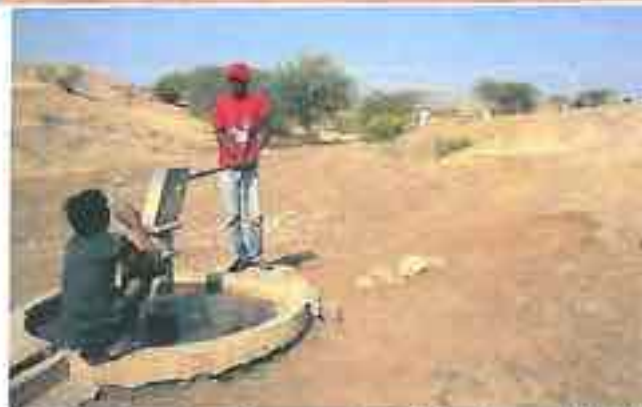
Kikarwas: Two views of the same Handpump. The HP is located in the Nallah trough. This implies likely erosion, flooding in rains, and an inability of people to take water from HP in rains. It also poses risk to life if flash floods occur in the Nallah during monsoons.

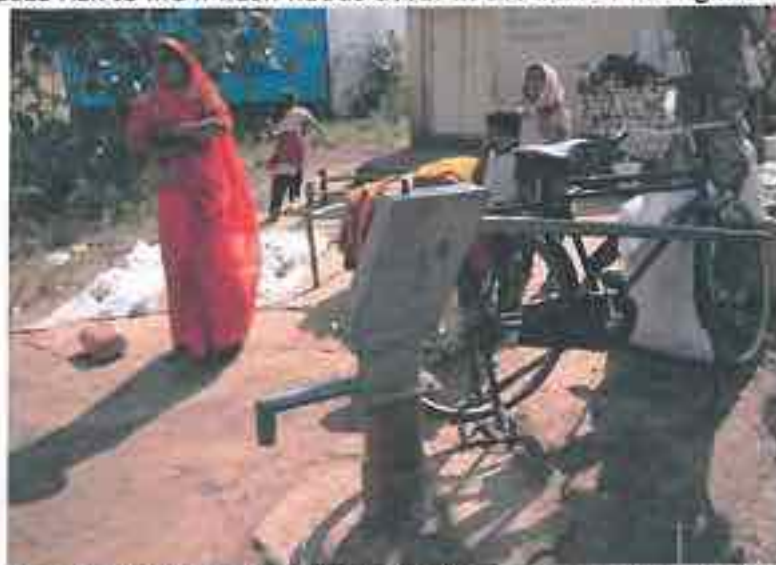
Borlai II: Objectionable HP Location—Right in front of a House. Problem for the Plot owner as public will visit the house at all times, and spills will create havoc and disputes.

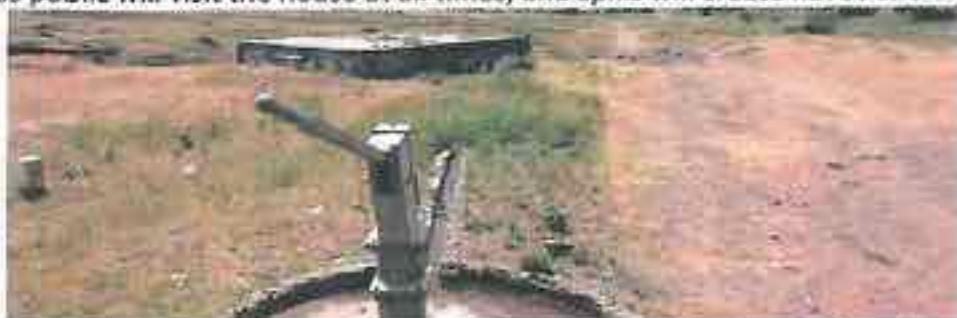
Musapura: HP located next to plot, and drainage directed to Platform/Road

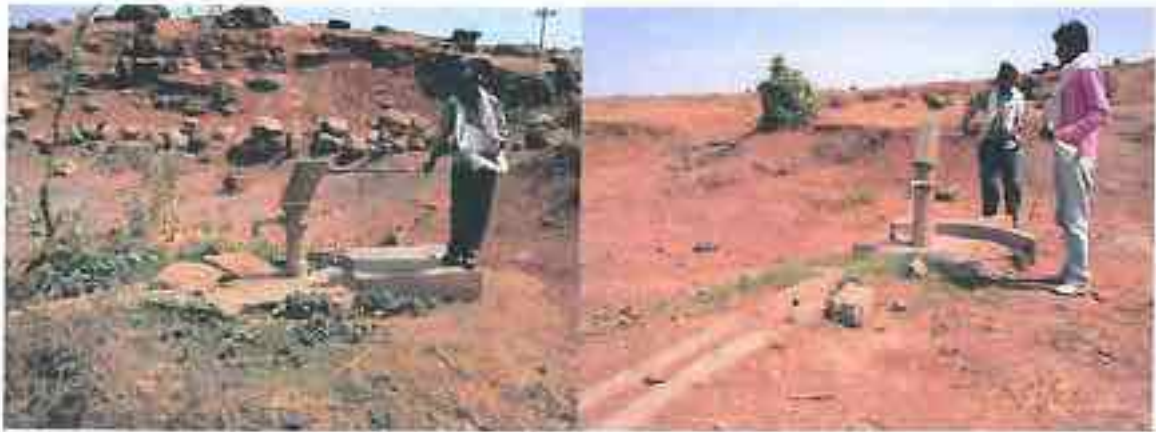
Brahmangaon: Two different Handpumps

Plate : 3.1.7. Eroded platforms/undercuts due to flash waters (Typical).

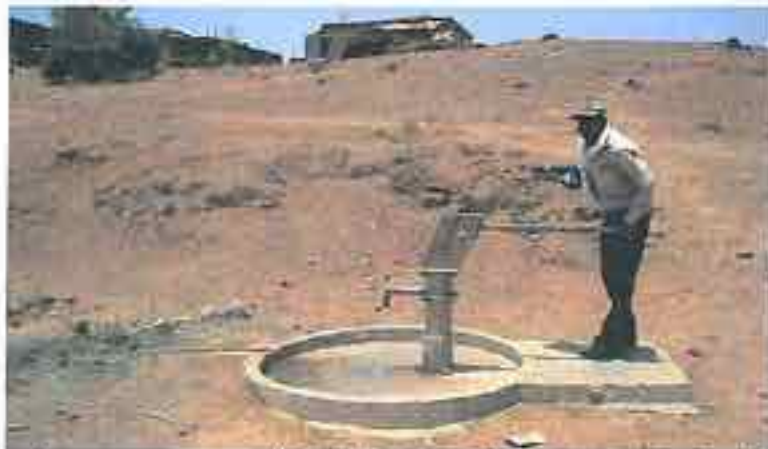
Chenpura: No drainage, no approach-Residents need to carry water load all the way up

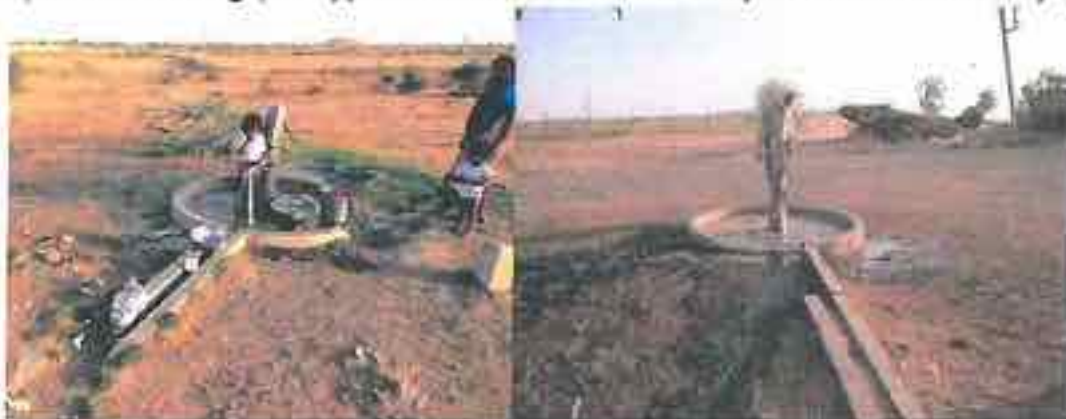
Balkhad: Two different HPs with drainage flow in all directions - the Slope of drainage channel is actually upwards, water finds its own path to drain towards opposite direction. Also, no engineered Approach to the HP seen.

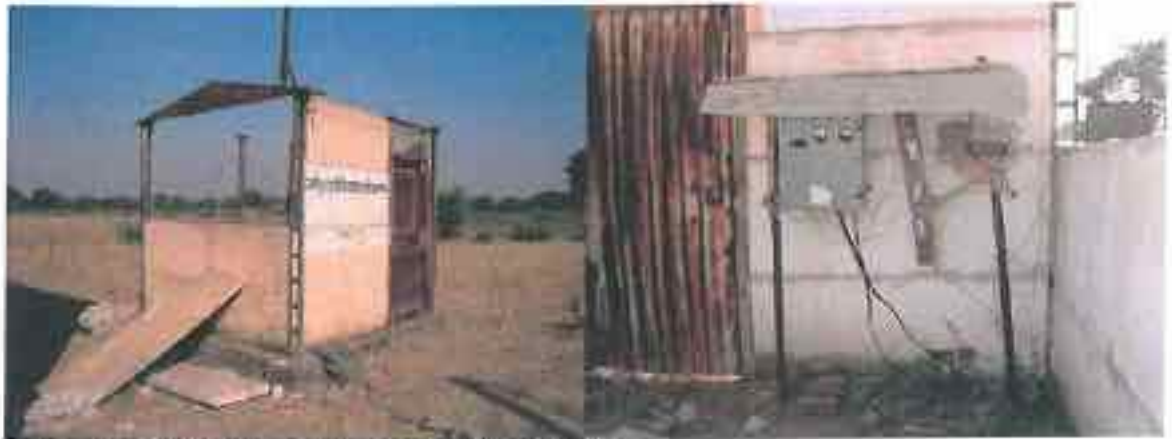
80. In large numbers of cases, the Pumphouses at the tubewells were constructed using pre-cast panels/slabs. However, these were of extremely poor quality, and have given way in a wide majority of cases with large damages being common. Large numbers of these pump-houses stand damaged: some have completely collapsed, while others need urgent repairs/replacement of pre-cast panels (Plate 3.1.11).

Kalyanpura: Outside and Inside the Pump House

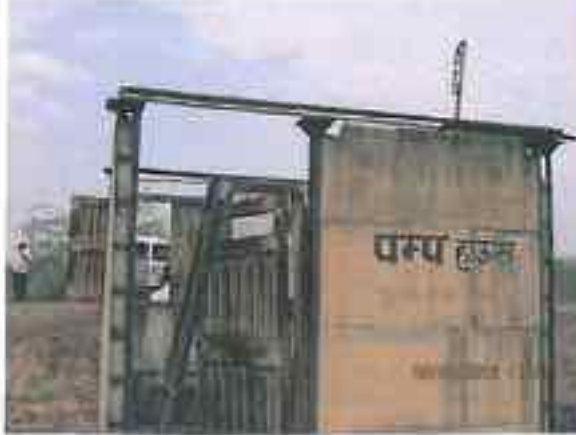
Dharampuri

79. In a few cases pumphouses were found abandoned. For example, at Dharampuri, Pumphouse No. 3 was found abandoned. It does not make sense as to why these structures were constructed, and if these were needed for installing pumps etc, why they were left abandoned, leading to unnecessary lock-up of capital.

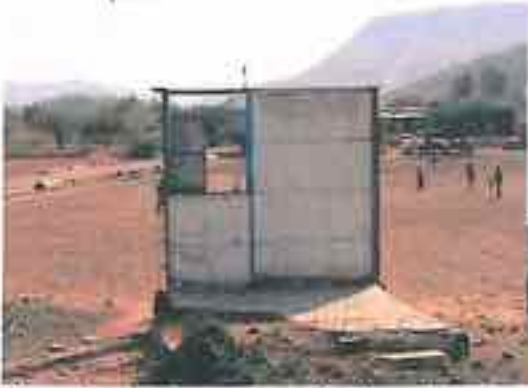
Bhavati - I: Remnants of a Pump House

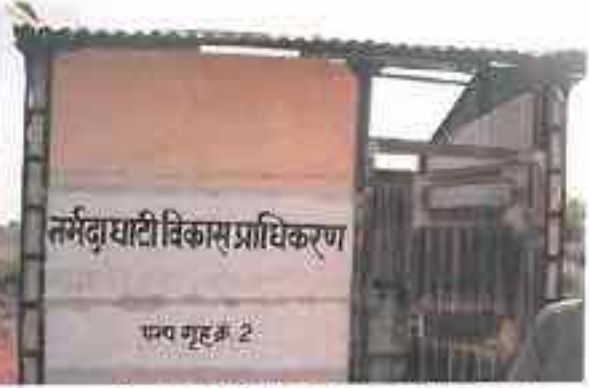
Borlai II: Part of the roof missing

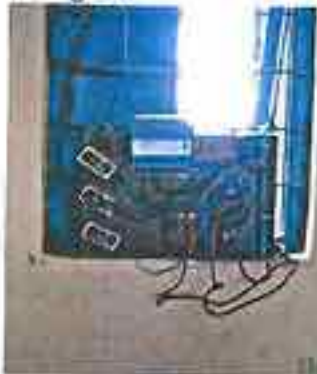
81. Inside these Pump-Houses, it was common to find poor connections in the electrical panels comprising the assembly of starters, fuses etc, or panels and electric meters lying randomly on ground or tucked to windows instead of being neatly and safely attached on to the wall on a board (Plate 3.1.12). It appears that proper arrangements have not been made to house the electrical panels and meters, and adhoc practice is in vogue, making the entire operation unsafe, more so as the pump-house outer structures have collapsed allowing unhindered access to passer-bys, children and even animals in large number of cases, even as electrical circuitry often lay on the ground.

Moregadhi: Panel Tied to window

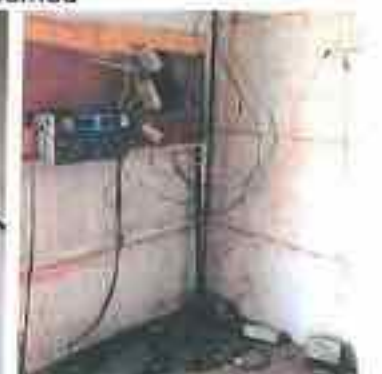
Ganpur Sirsi: Meter thrown on floor & direct connection made

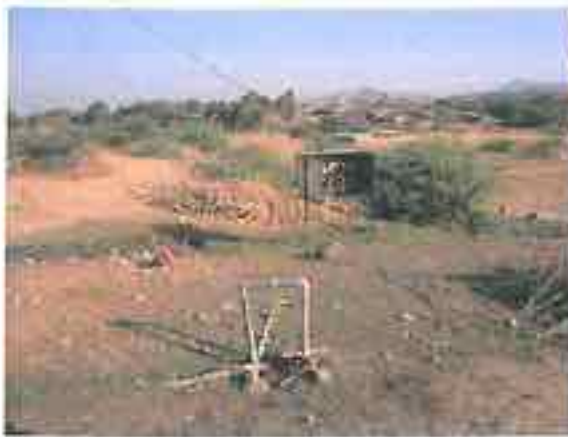
Bhawati-I

83. In several cases, one could see pump-house structure replaced by a small box in the open, thankfully, with a lock and key arrangement (Plate 3.1.13). However such metal boxes may not be entirely safe and may lead to current leakages and danger of electrocution to the operator or passer-bys especially during rains.
