Evaluation of the Quality of Civic Amenities at Rehabilitation Sites of the Sardar Sarovar Project

**Sardar Sarovar Project - Fake Sale Deeds and Rehabilitation Sites
Irregularities Inquiry Commission**

April, 2014

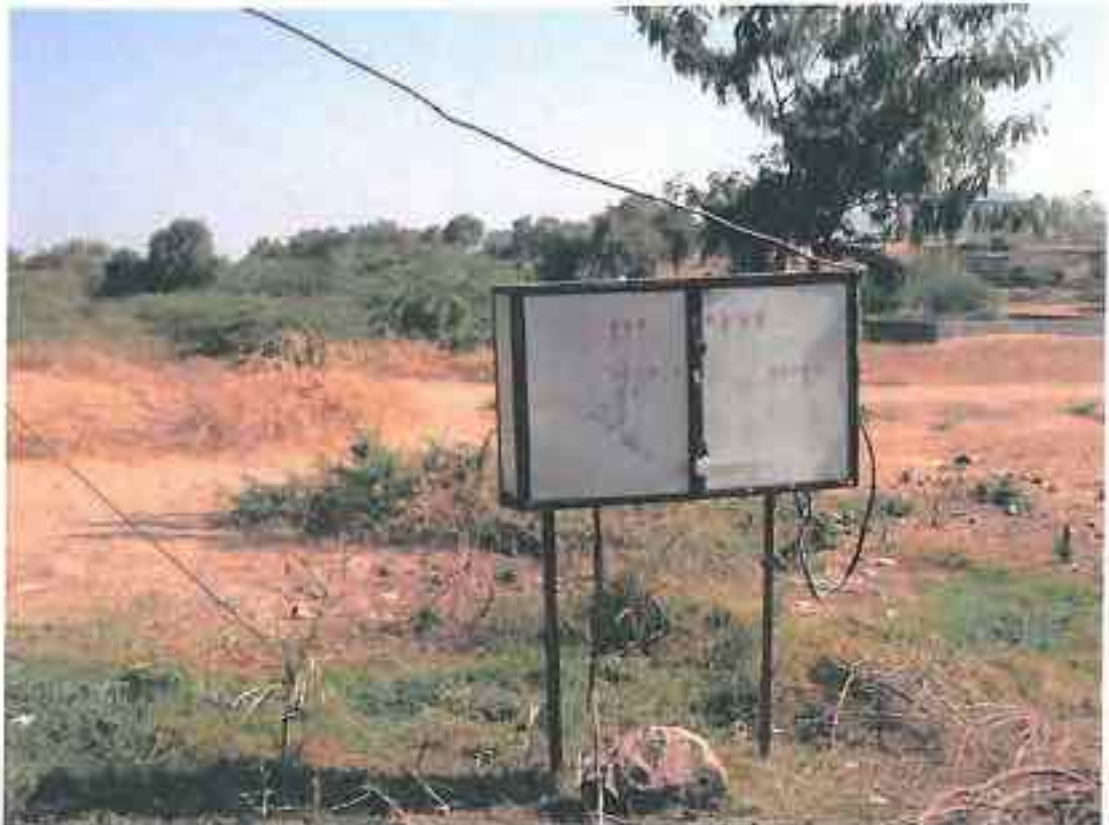
Bhavati I

83. In several cases, one could see pump-house structure replaced by a small box in the open, thankfully, with a lock and key arrangement (Plate 3.1.13). However such metal boxes may not be entirely safe and may lead to current leakages and danger of electrocution to the operator or passer-bys especially during rains.

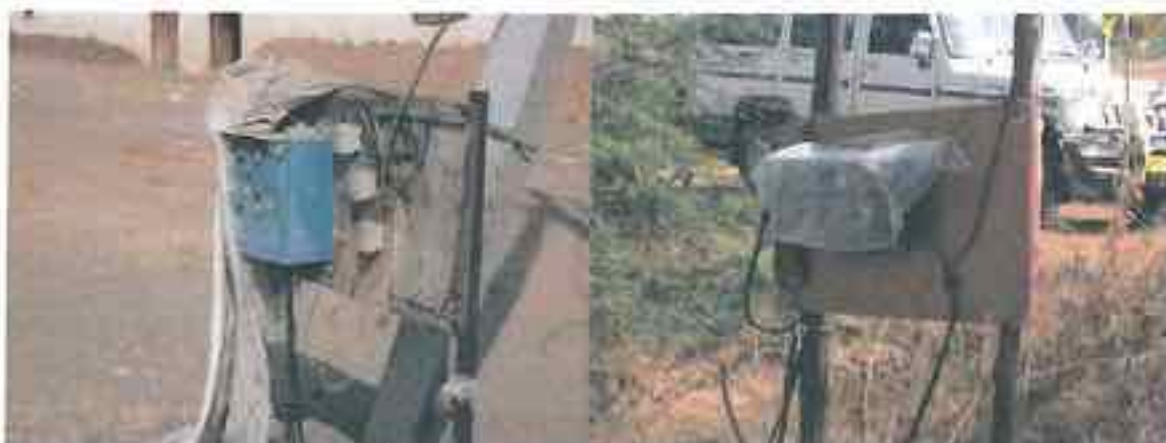
Khedi: View at Two different Pump Houses

82. Despite the fact that in most cases, water supplies are still being handled by NVDA, there have not been efforts to repair and maintain these pumphouses, and instead the electric panels have been often housed in open.

Plate 3.1.14. Electrical panels with Open Air Arrangements (Typical): Neglect of all Safety Norms

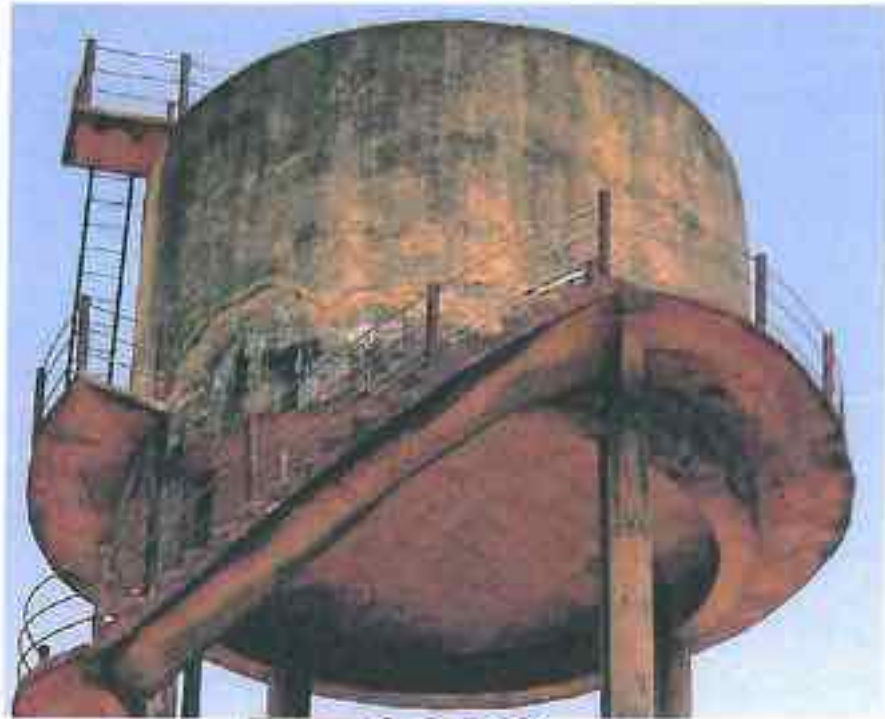
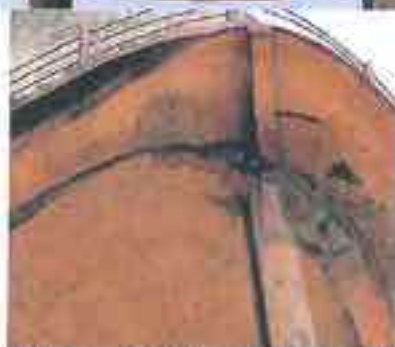
88. In some cases where the OHTs were evidently functional, there were signs of water leakage/seepage which were mostly plugged as per the standard practice. However, sometimes, as in Sala and Sirsani (Plate 3.1.15) this seepage, despite efforts to plug, was extensive and to an extent that the structure appeared rather endangered unless remedial steps are taken.

Sala: Signs of extensive leakage/seepage: Poor condition

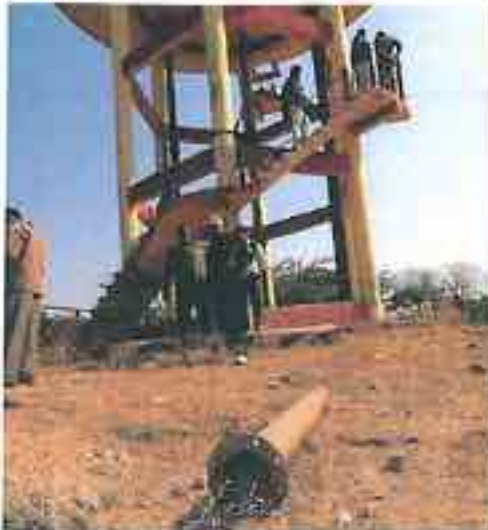
- At Chikalda, no pumphouse and no tubewell was seen. No rising main was seen that could bring water to fill the OHT. Connections to the laid piped distribution system were also not found present.

Chikaída: OHT Constructed, but not connected to Network.
An Investment for Future?

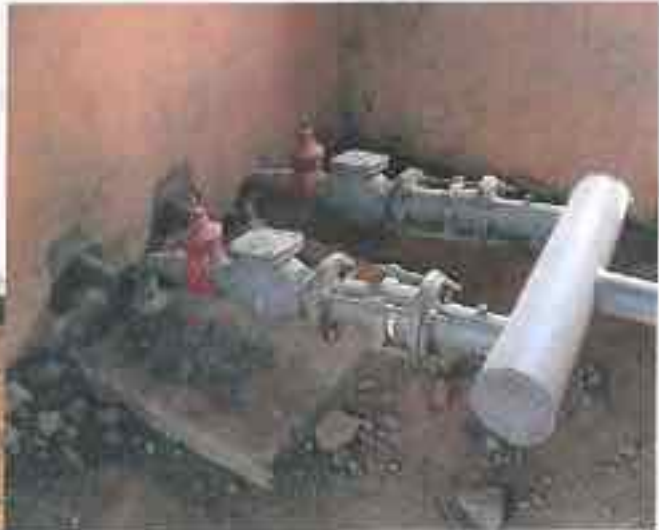
Awalda: Missing pumps imply OHT is defunct

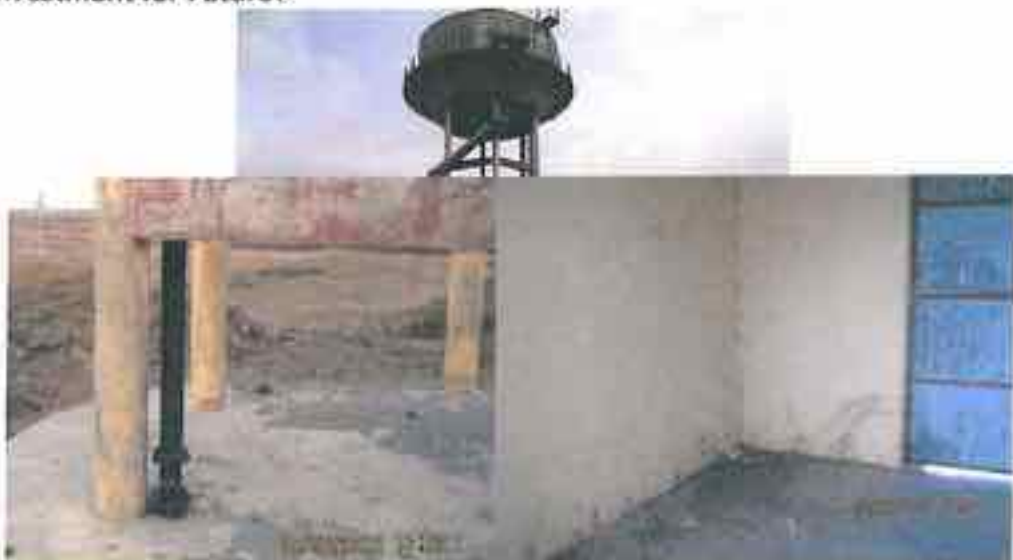
Khalkhurd Manavar: OHT built, but has missing Connections and Pumps

Plate 3.1.16. OHT Infrastructure rendered defunct and useless (Typical)

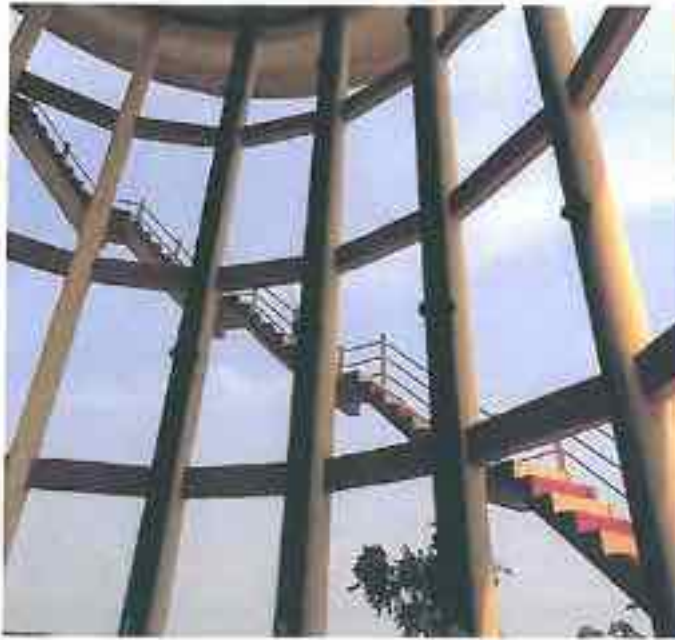
Nisarpur

Railings only provided on Outer-side

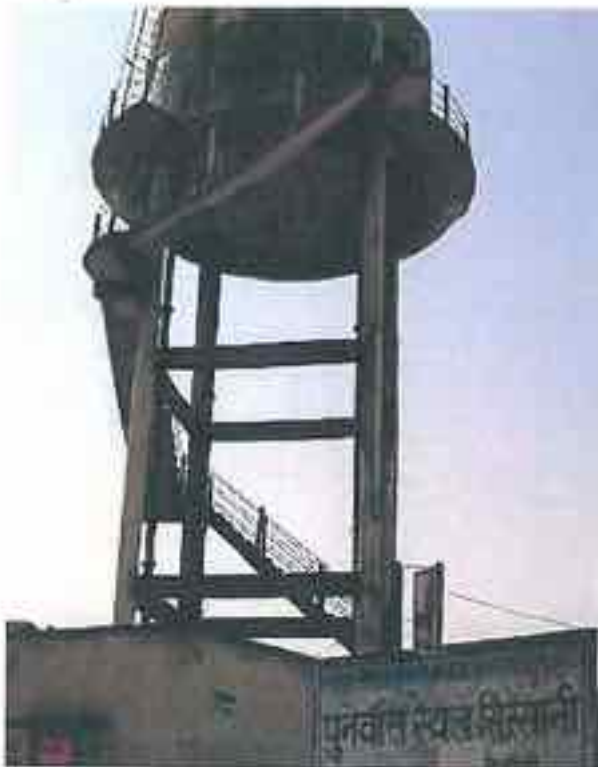
Sirsani

Railings on both sides

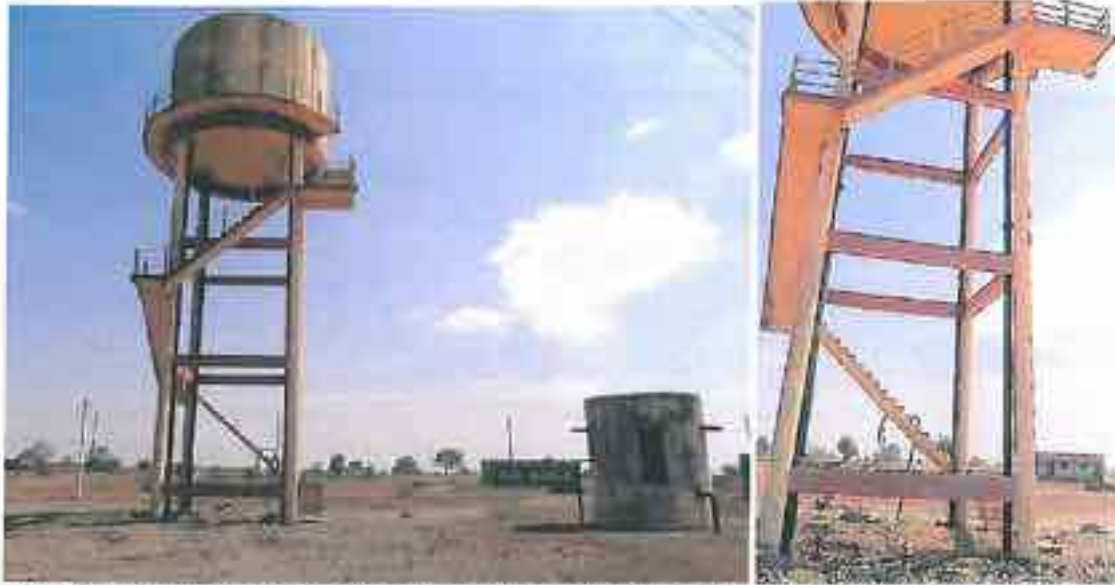
Ganpur (Manavar): No fencing and isolation of OHT Premises. OHT railing also partly damaged and missing in the lower steps: Poor maintenance

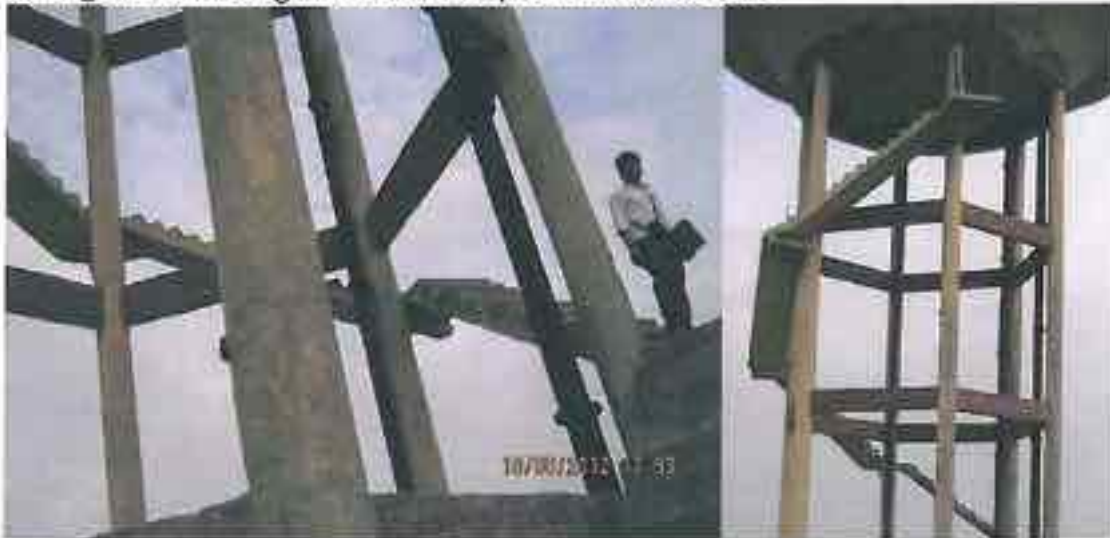
Khalkhurd (Manavar): Completely missing Railings, No gate: Easy access

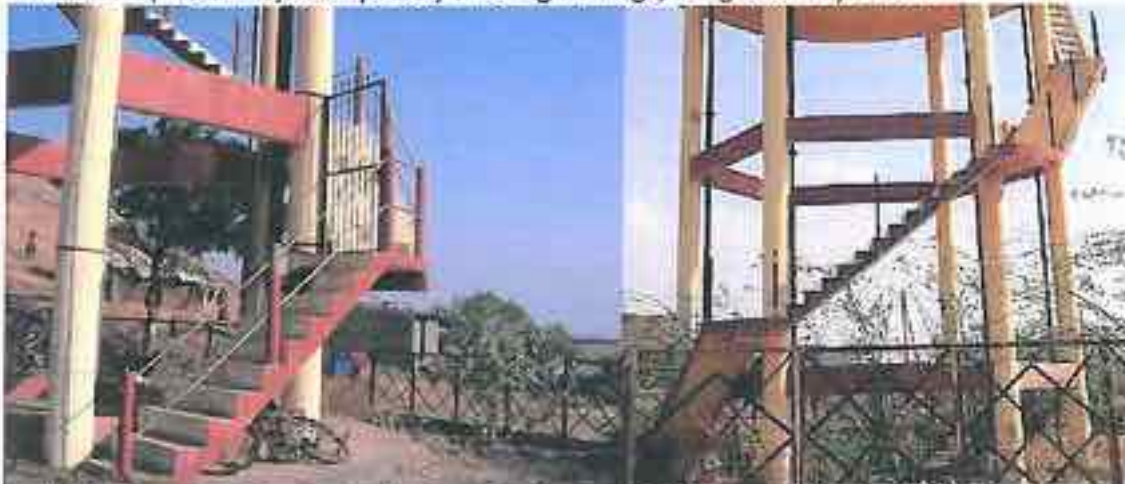
Borlai II: Premises fenced, and gate present on steps to prevent easy access to the top. And yet, the railing is only on one side of the steps.

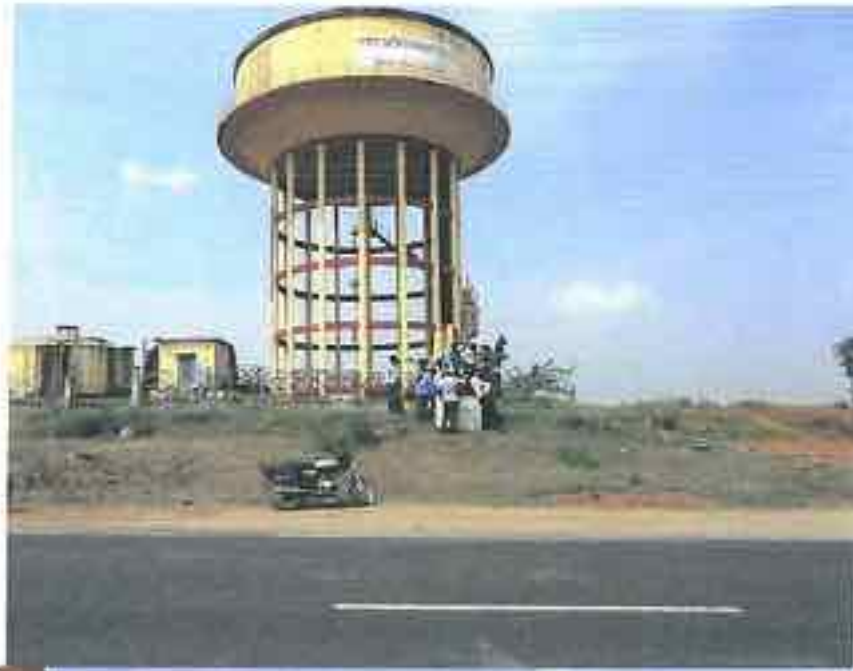
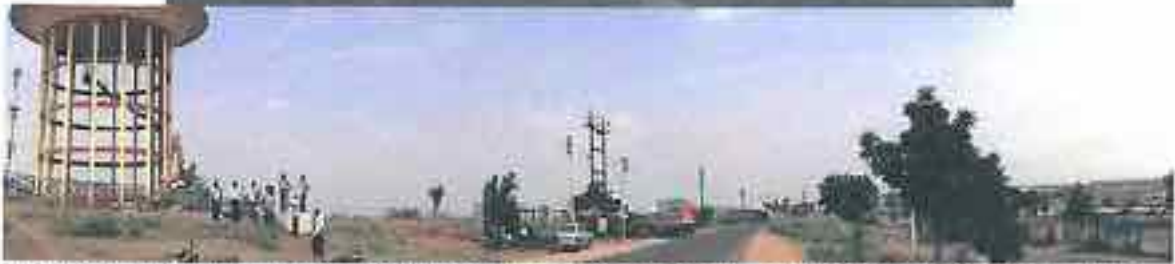
Nisarpur: scour/sluice valve discharges water to highway, crossing which it would enter hospital.

Plate 3.1.18: Lack of any Planning for Drain water from the OHTs (Typical)

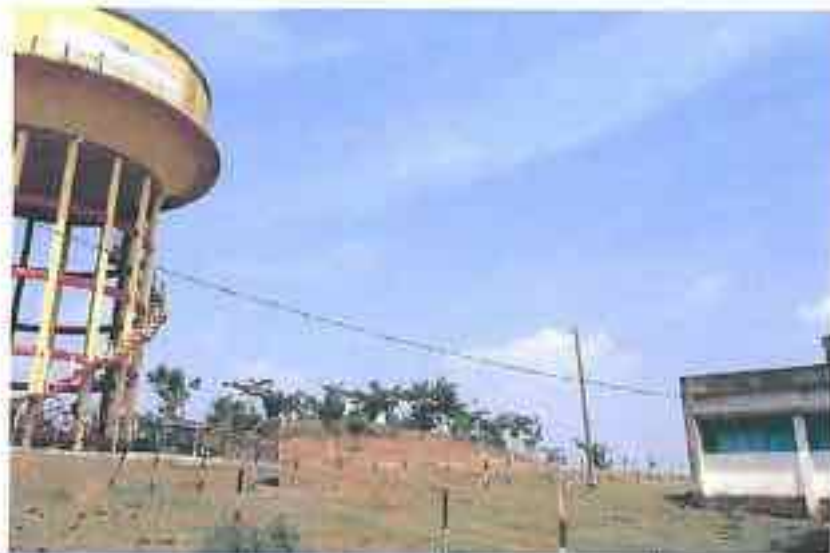
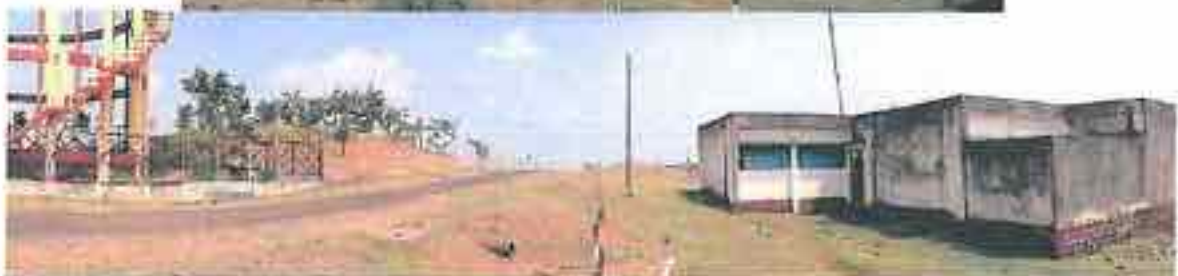
Nisarpur: For second OHT, discharge is directed into premises of Primary School (Pipe mouth seen in the photograph)

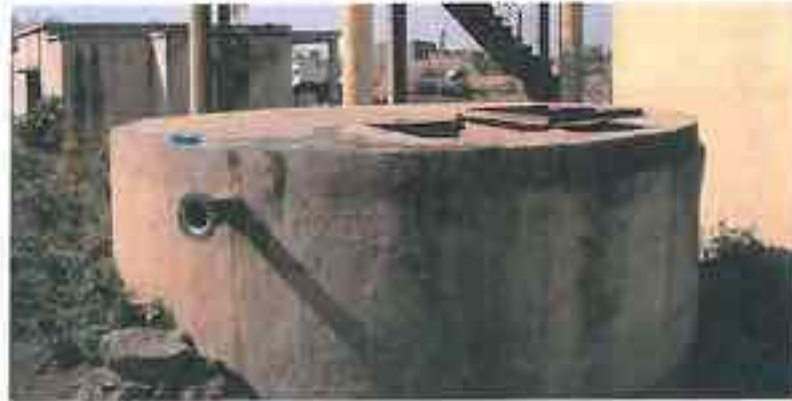
Sirsani: Adhoc Sumpwell Overflow provisioning

Plate 3.1.19: Typical overflows from Sump Wells: Lack of engineered drainage.

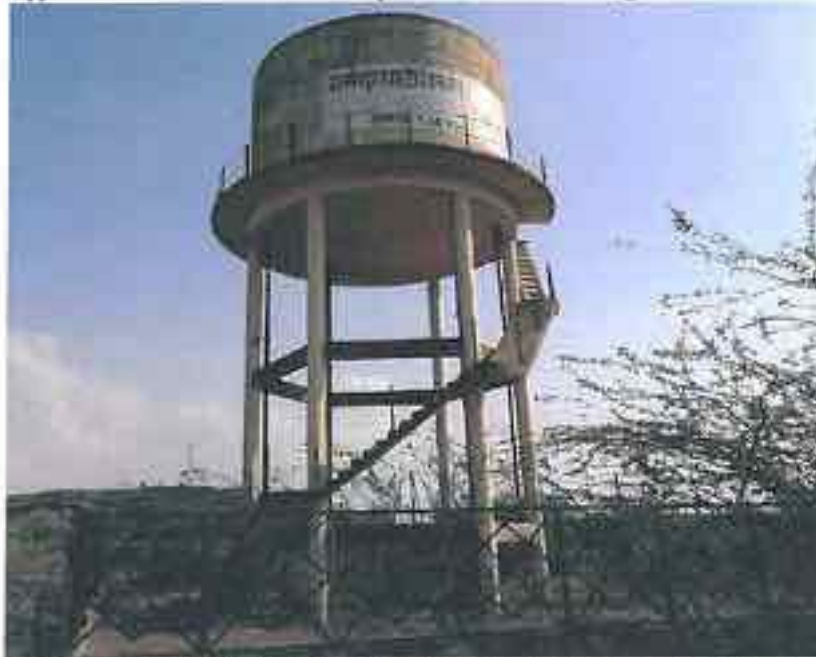
Gehalgaon : No provision of a sump for 150 KL OHT. Also note the missing railing.

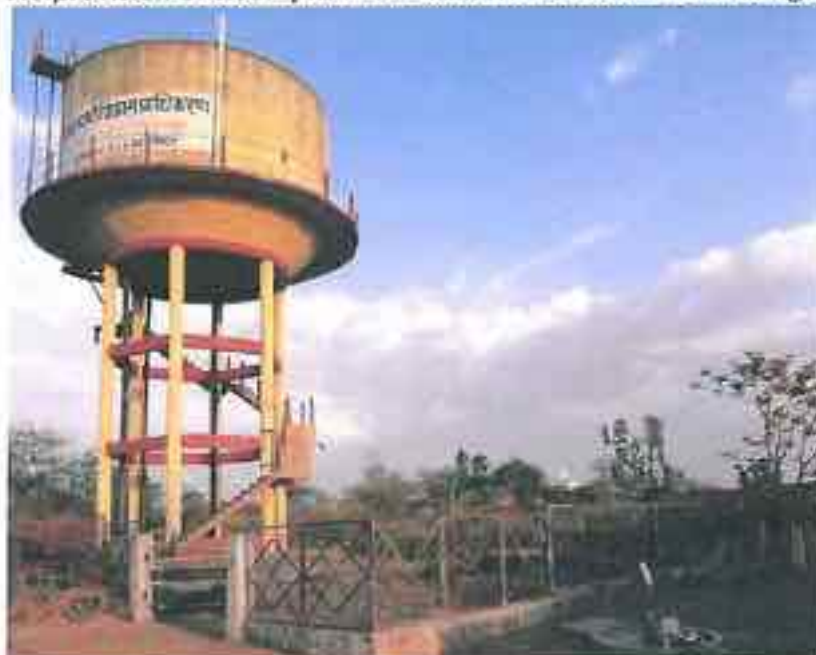
Chikalda: No provision of a Sump for 280 KL OHT. Also railing absent in part.

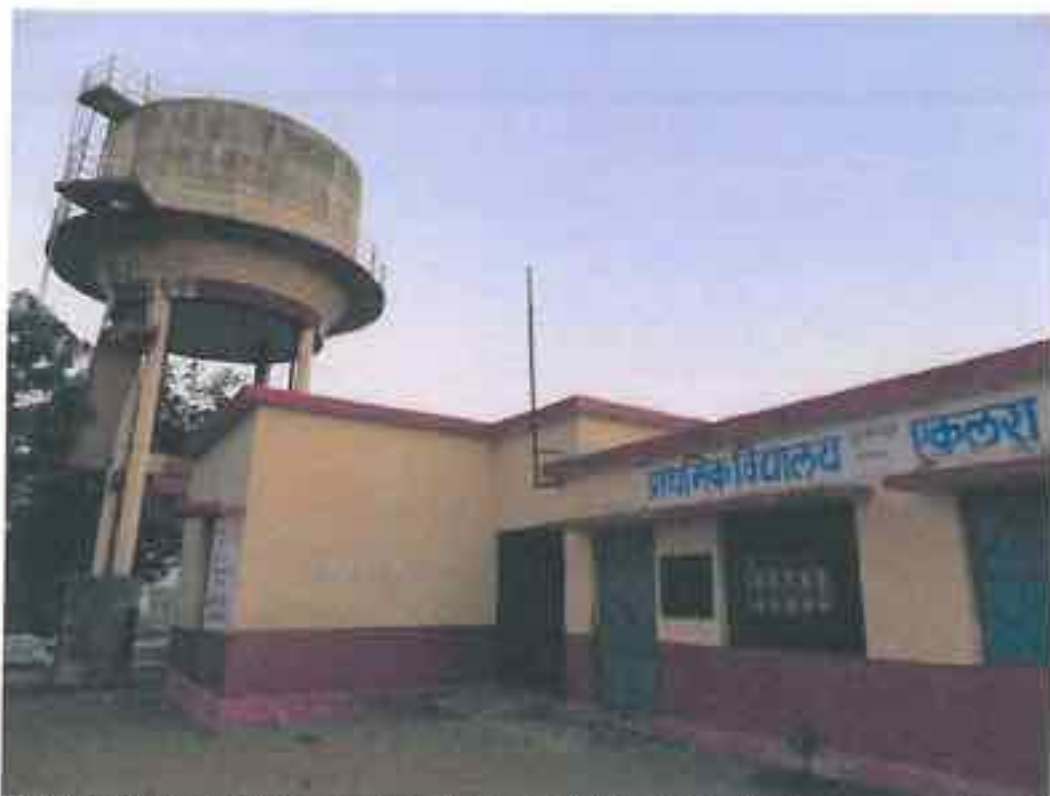
Eklera: OHT located in the premises of Primary School. No fencing present either for the school or the OHT, implying free access for the school children.

OHT premise not secluded. Gross callousness, negligence, poor planning and flouting of mandatory safety provisions.

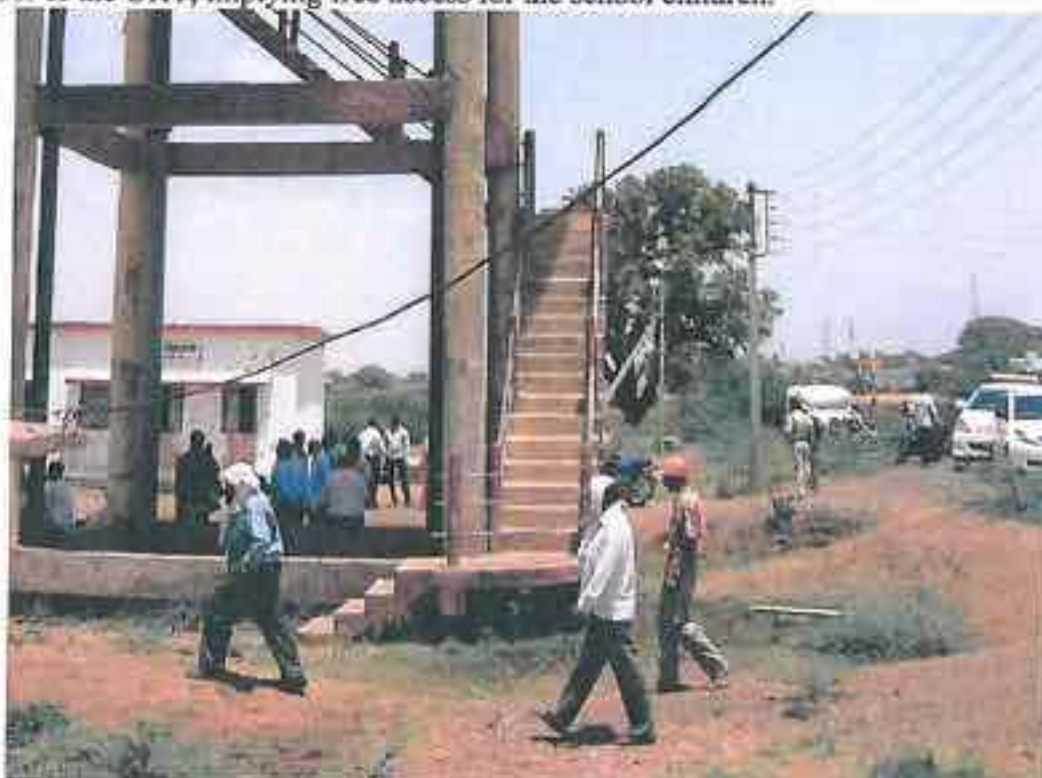
Sala: OHT in front of Primary School. No fencing in either the school, or in the OHT premises, and so school children/anti-social elements have free access to high rise OHT.

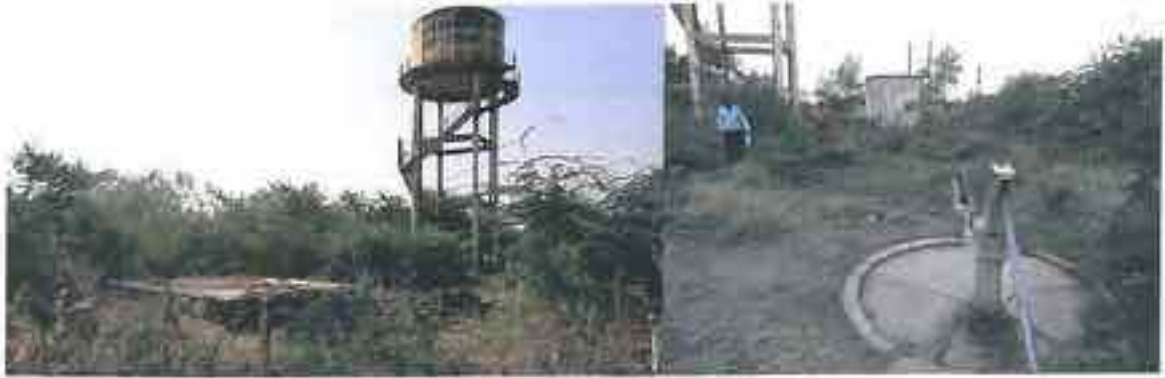
Moreghadi: A Tree Platform (Left) and a handpump (Right) inside the OHT premises, despite the fact that both amenities are of public use. Rather than seclude OHT premises, public intrusion is encouraged. Basics of Public Safety compromised due to poor Planning.

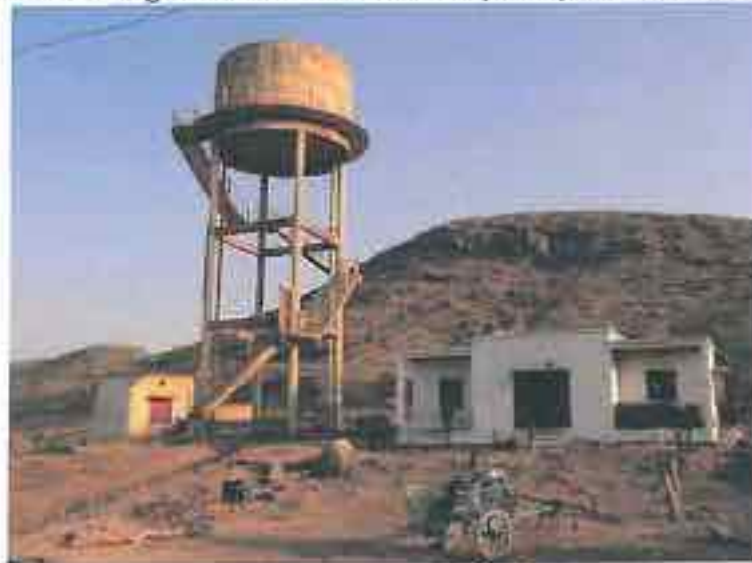
Sirsani: Missing fences, premises not marked and prohibited for public. Building lies too near. The OHT is located just below a hill where boulders lie loose, and may roll down damaging the OHT and risking the lives of people.

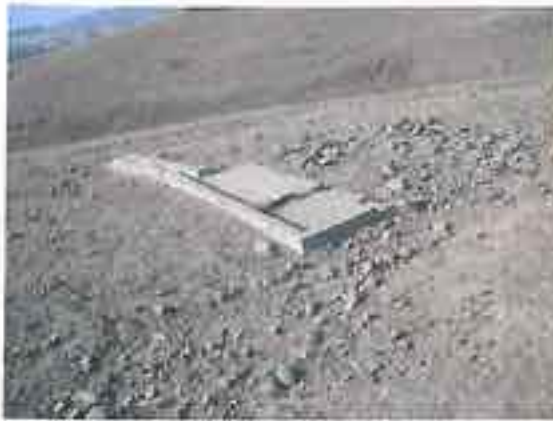
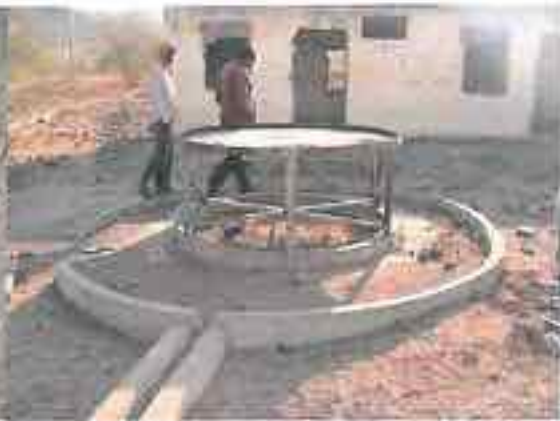
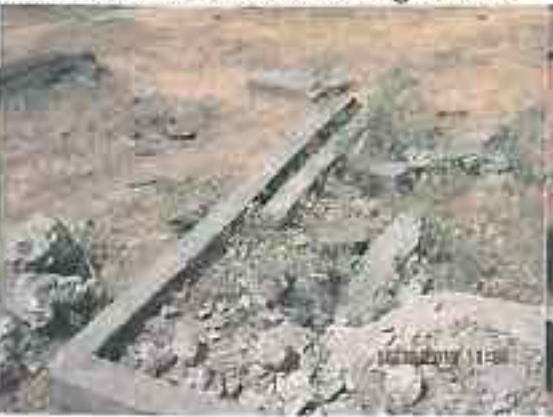
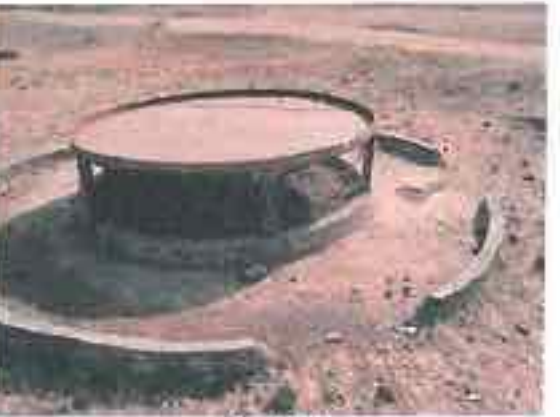
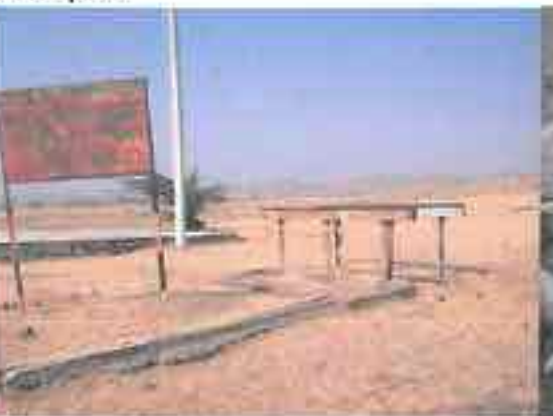
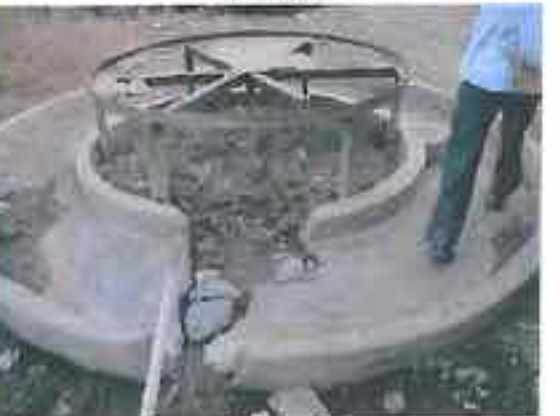
112. Large numbers of Cisterns were found Missing, throughout many of the R&R sites (Plate 3.1.23). This was rather peculiar as the water supply infrastructure has not yet been handed over at a wide majority of sites, implying that the maintenance is still with the execution agency (NVDA). Thus, any missing cisterns should have been replaced.

Plate 3.1.23. : Missing Cisterns at R&R sites (Typical)

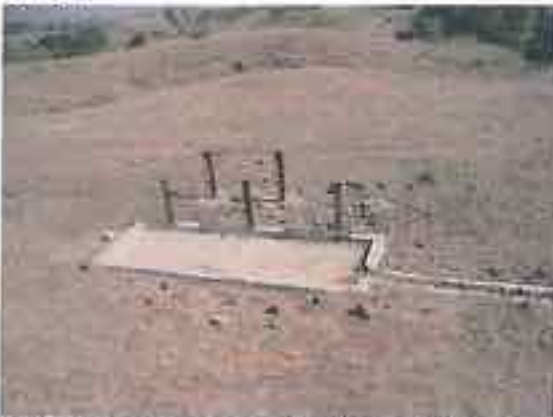
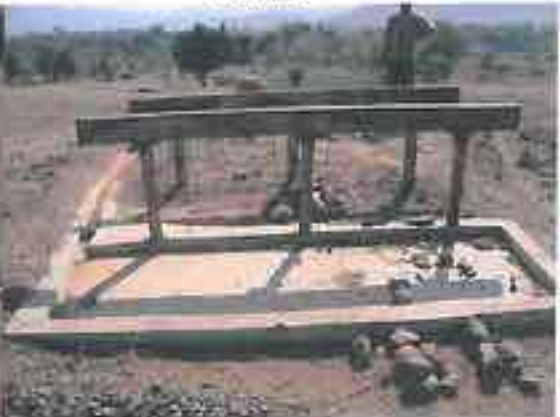
Kikarwas: Two cases of missing Cisterns

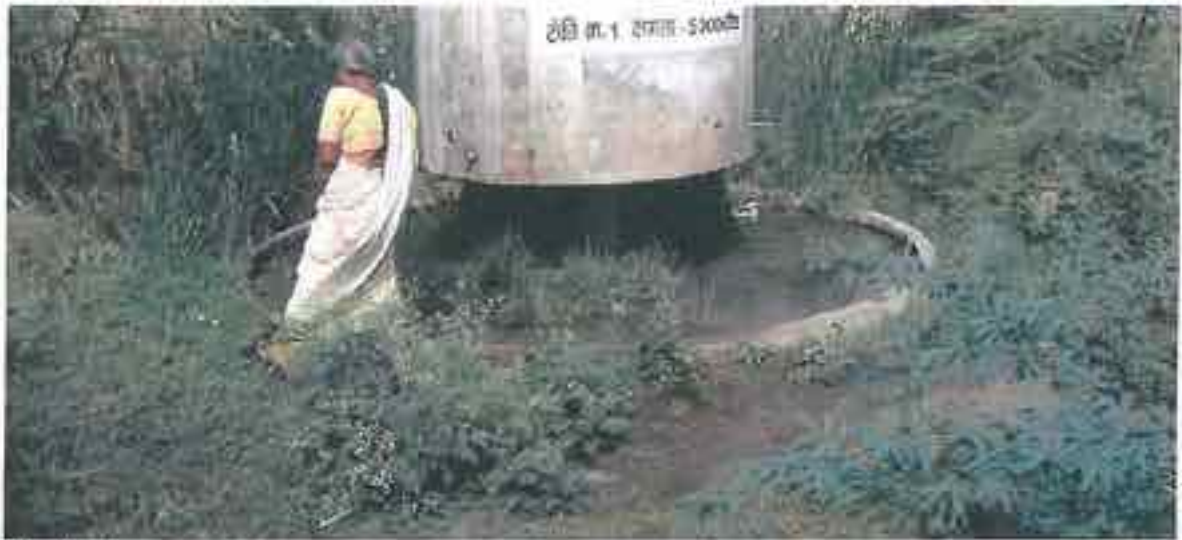
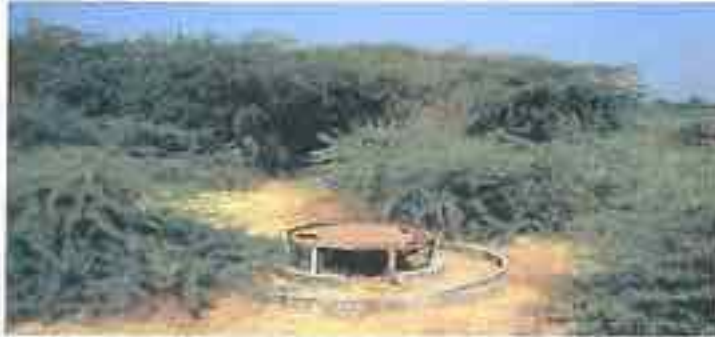
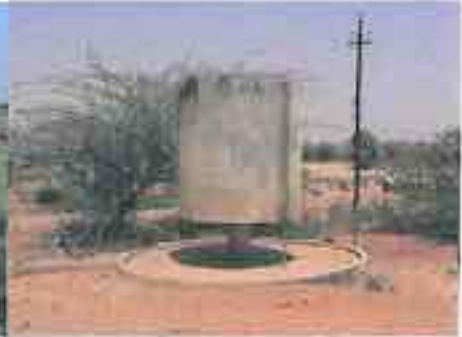
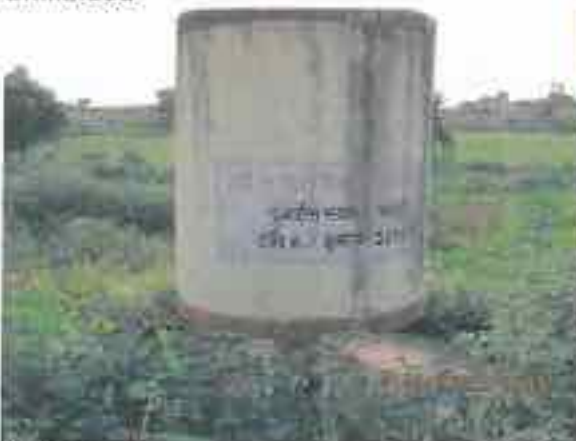
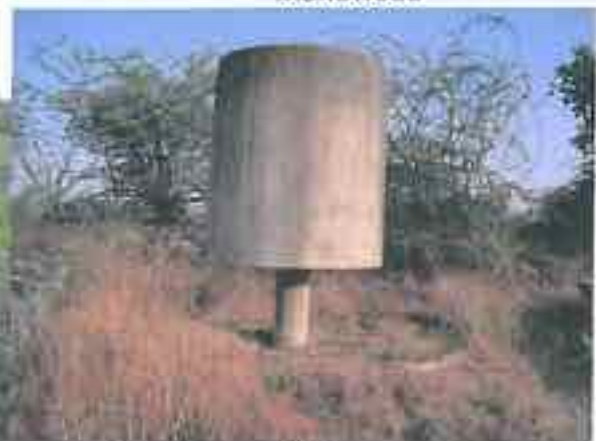
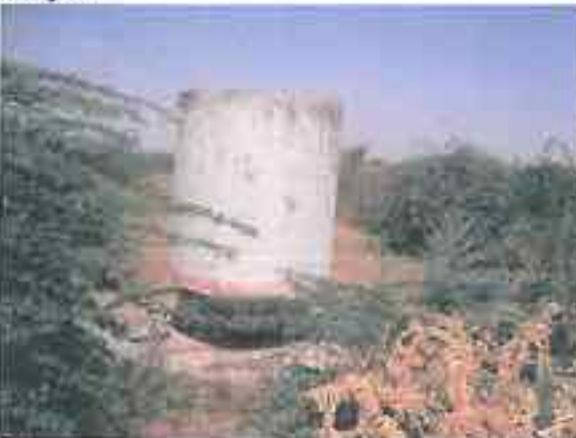
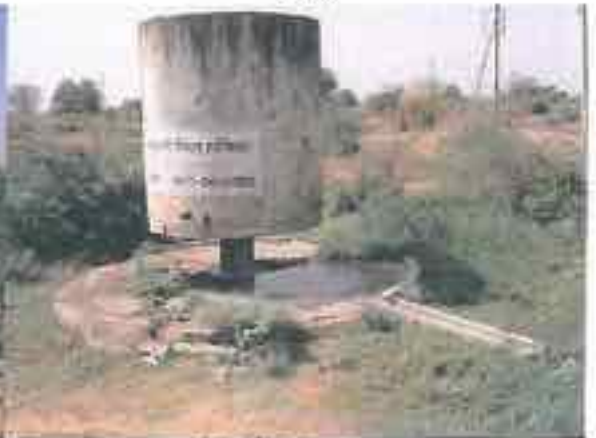
115. Besides the missing Cisterns, a large number of cisterns lay abandoned/out of use at several sites (Plate 3.1.24). Sometimes Cisterns were kept, but no connections were made, some of them had defunct inlet connections leaving them dry, others had no taps making the cisterns defunct, and some were not charged with water due to various reasons. Some cisterns were defunct due to damaged plumbing, while some others were even displaced from their platforms and lay randomly scattered. Such instances were aplenty with the result that cisterns were defunct in very large number of cases for some reason or the other.

Plate 3.1.24.: Typical Abandoned Cisterns at several Sites: Infrastructure wasted

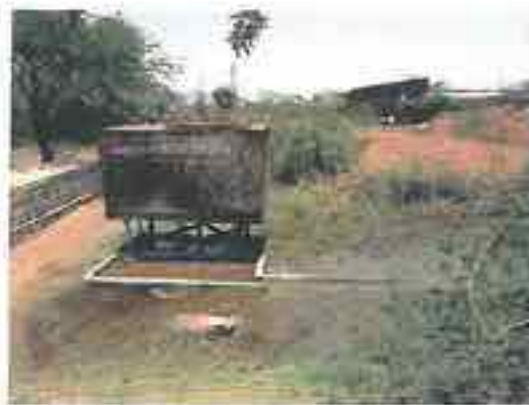
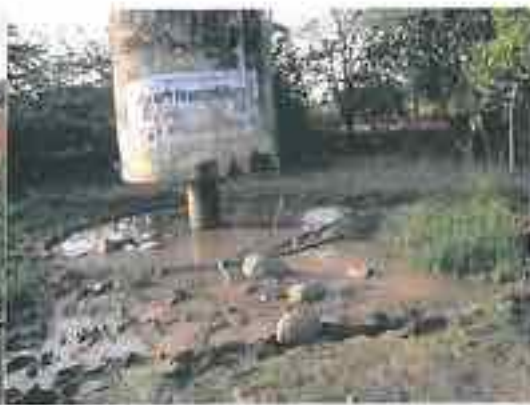
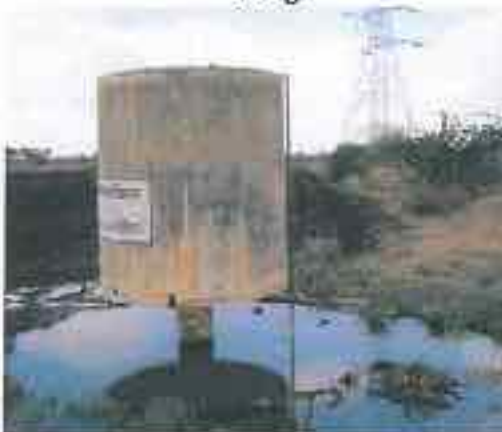
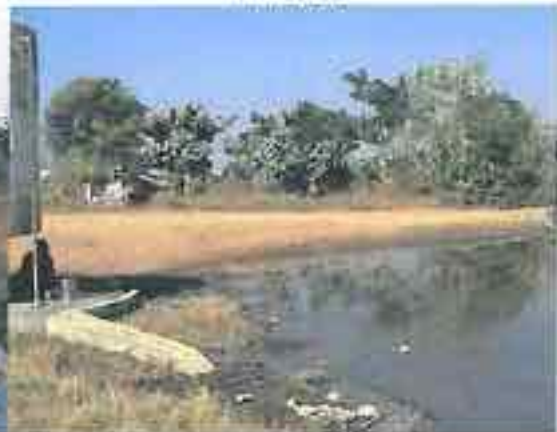
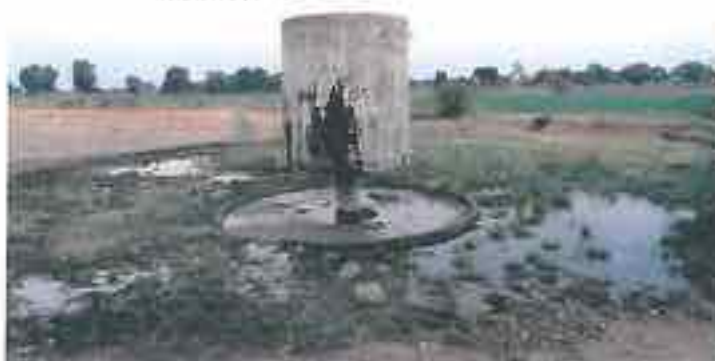
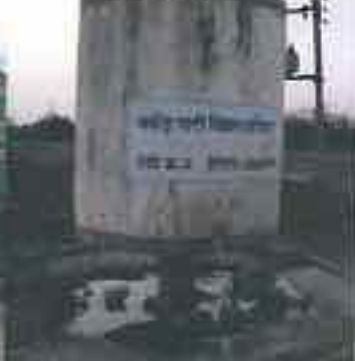
119. The drainage from the cisterns was similar to un-engineered drainage from handpumps. When both inlet and taps existed and were functional, and the cistern worked, many times there were no proper drainage arrangements in place leading to pooling of water and insanitary conditions (Plate 3.1.25). Drainage was often inappropriate, and was unplanned and adhoc, with water made to flow randomly or just pool up all around to stagnate and provide a breeding ground for mosquitos etc.

Plate 3.1.25: Typical water leakages and ponding at Cisterns (Note: All photographs taken in Dry Season)

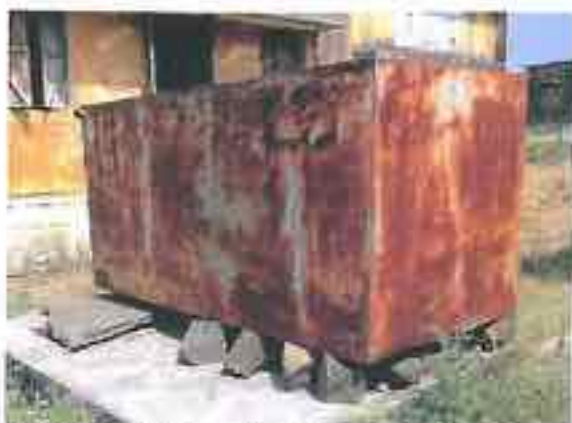
Musapura (Himmatgarh)

Nalvai: Two views of a cistern located in far flung area of hillock top. One can fathom how much line had to be laid, and how much electricity would be required for pumping water all the way. Heavier pumps would have to be used, and more maintenance would be needed. Inhabitants also need to carry the water load for large distances.

Plate 3.1.27. Inappropriate Cistern Siting (Typical)

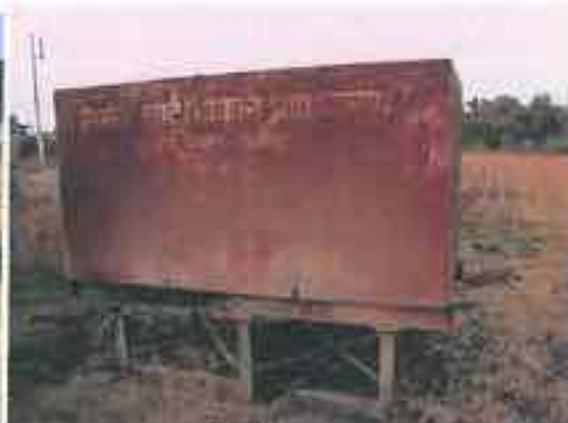
Jamda

Plate 3.1. 28. Highly Rusted Mild Steel/Pressed Steel Cisterns (Typical); Unfit to store drinking water - Lack of regular painting work and poor general maintenance

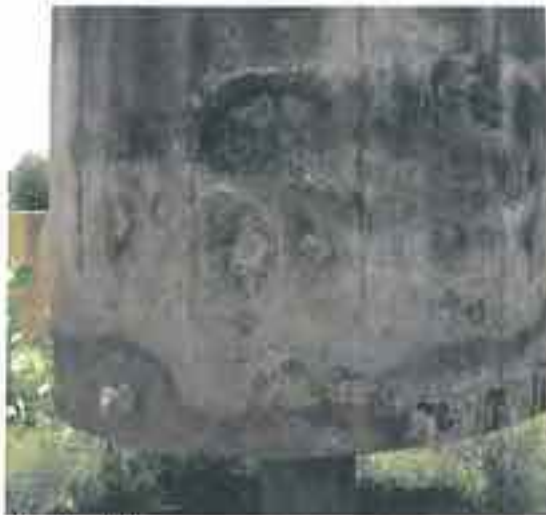
Raswa Deb

Plate 3.1.29. Typical damaged RCC Cisterns. Also noteworthy is the condition of the external paint work. Shoddy Maintenance.....cont.

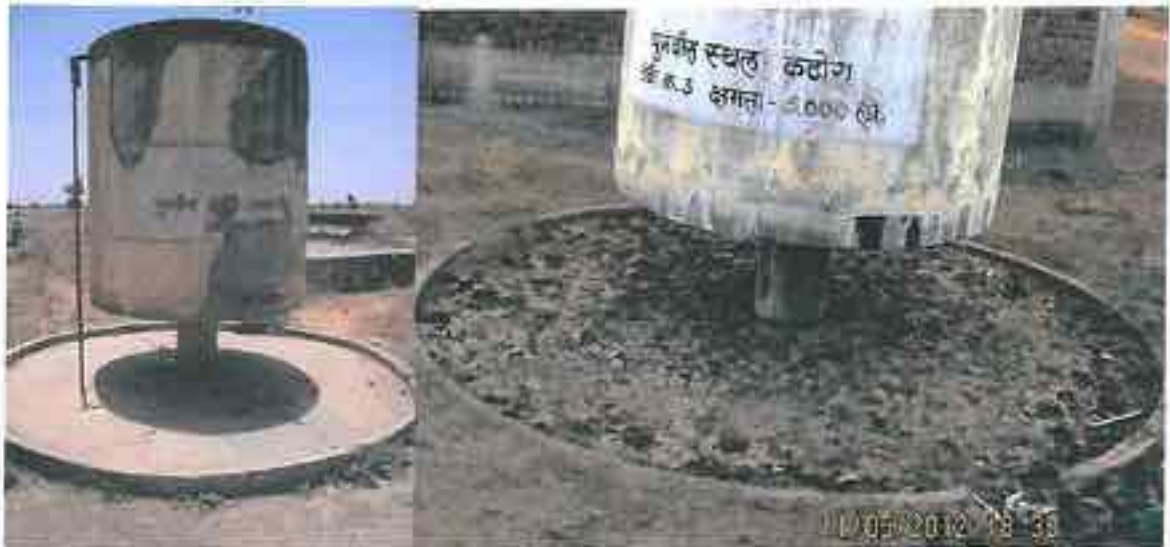
Lakhangaon

Plate 3.1.29. Typical damaged RCC Cisterns. Also noteworthy is the condition of the external paint work. Shoddy Maintenance.

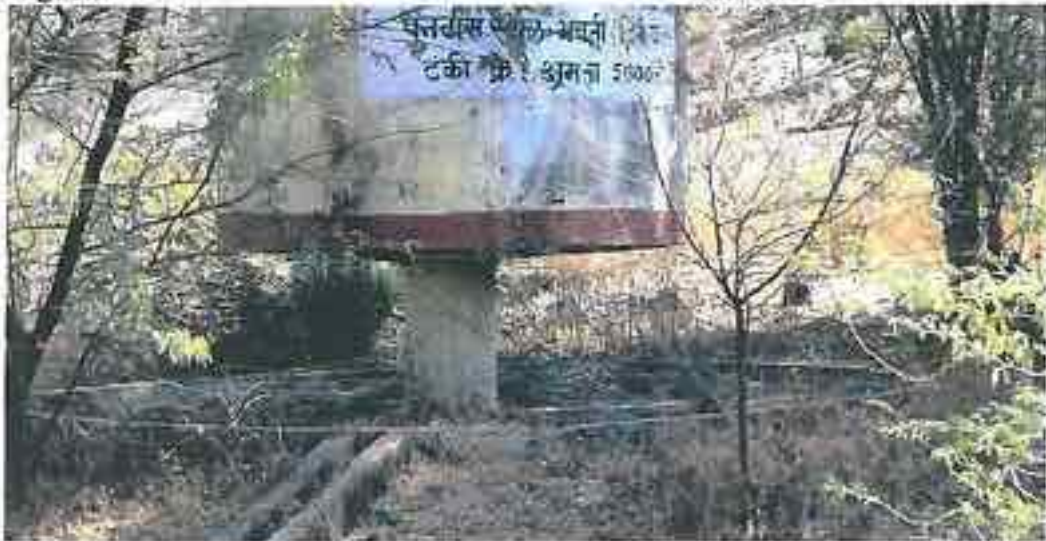
Bhawati-II: Mindless execution- the drain outlet channel lies at the base ring portion, while the opening of the ring portion does not drain into the drainage channel.

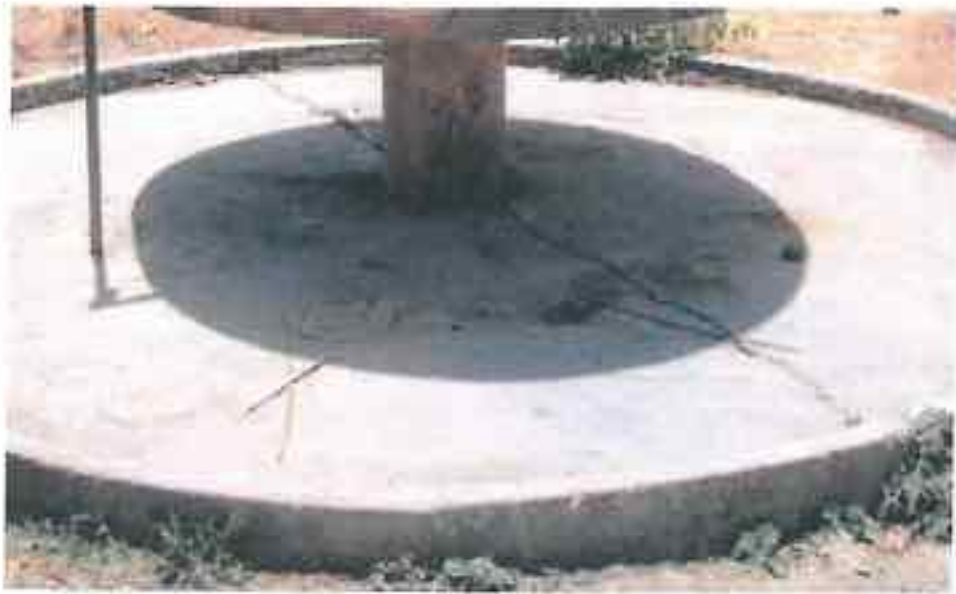
Lakhangaon

Plate 3.1.30. Typical Cracks/Damages in Cistern Platforms

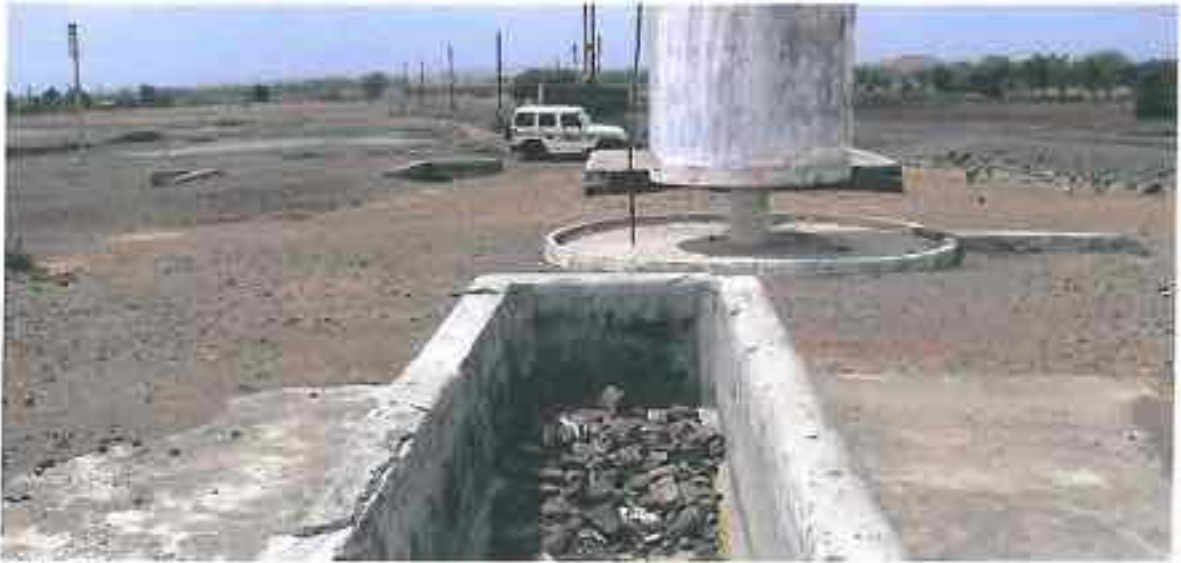
Barda Manavar

141. Where constructed, in large number of cases the halaos were found dry and defunct (Plate 3.1.31) because of the failure of the distribution system which also has incidentally led to the failure of cisterns often located near the halaos.

142. A wide majority of constructed halaos were also found bereft of any plumbing connections whatsoever, and were left dry throughout most of the 88 R&R sites (Plate 3.1.31). It was found that several times the halaos did not even have any inlet connection to fill them. As a result, a wide majority of constructed halaos were not functional at most R&R sites, impacting the availability of water for the livestock.

Plate 3.1.31. Defunct/Dry Halaos : A result of defunct cisterns, and missing inlet connections. Also missing are engineered drainage systems, and stop valves etc. to prevent overflows.

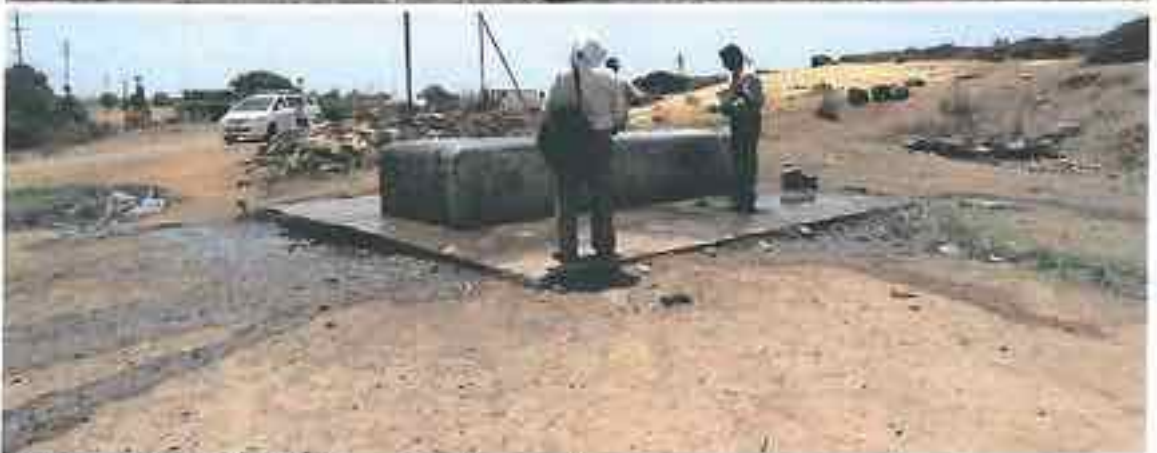
143. In fact, Halao inflow as well as outflow connections were both unsatisfactory (Plate 3.1.32). Halaos had no preventive mechanism against spills and overflows for saving precious water and to maintain sanitary conditions at the halao vicinity. A stop valve or a float ball or any other appropriate mechanism could have done the task.

Vishwanath Kheda: Wastage of precious water
No protection mechanism against overflows

Plate 3.1.32. Spills from the Halaos (Typical): An outcome of absence of a stop mechanism against overflows. Also note the poor drainage.
