Evaluation of the Quality of Civic Amenities at Rehabilitation Sites of the Sardar Sarovar Project

**Sardar Sarovar Project - Fake Sale Deeds and Rehabilitation Sites
Irregularities Inquiry Commission**

April, 2014

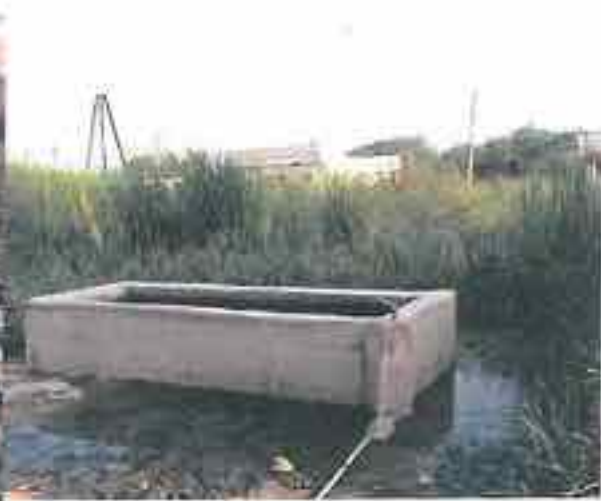
Datwada

143. In fact, Halao inflow as well as outflow connections were both unsatisfactory (Plate 3.1.32). Halaos had no preventive mechanism against spills and overflows for saving precious water and to maintain sanitary conditions at the halao vicinity. A stop valve or a float ball or any other appropriate mechanism could have done the task.

144. Similarly, the drainage from halaos was mostly not in place, and no provisions were made to drain the water to nearest drains in an engineered fashion, so that even if halaos are emptied for cleaning once in a while or their platforms cleaned and washed, water will pool up and create insanitary conditions all around. This then implies that once the R&R sites are fully operational, there would be large spills at virtually every halao, as is evident from few of the functional halaos having heavy waterlogging around them even currently.

Waterlogging all around: improper drainage: What would happen when animal faeces gets mixed up, and pollution spreads?

Plate 3.1.32. Spills from the Halaos (Typical): An outcome of absence of a stop mechanism against overflows. Also note the poor drainage.

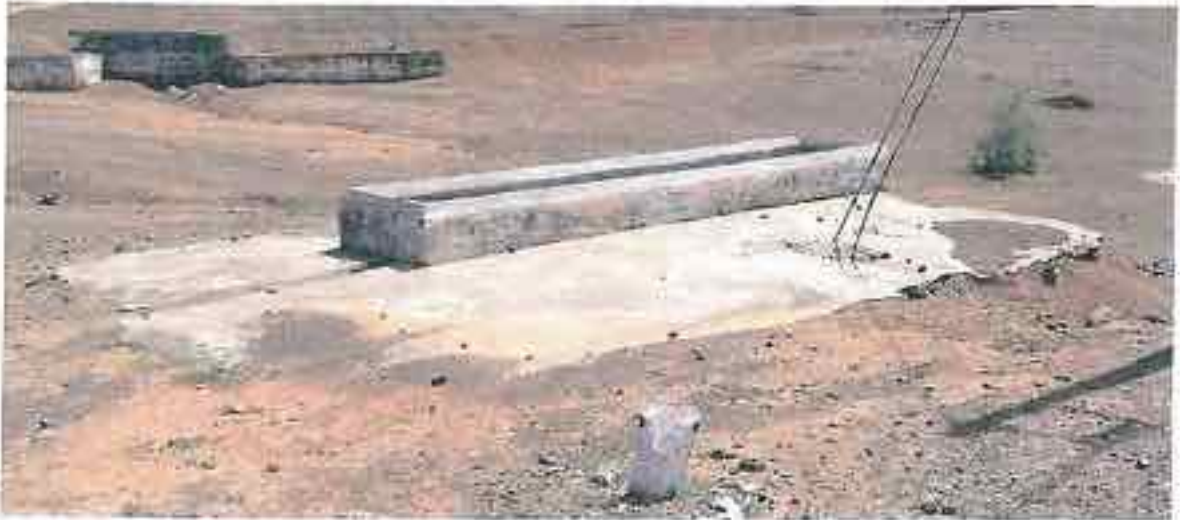
146. The halao locations were not appropriate due to other reasons at several sites (Plate 3.1.33). In some cases, the halaos were located too close to individual plots, implying that insanitary conditions would prevail and create nuisance for individual plot holders. Sometimes these were located too near or in front of culverts in low lying areas indicating the possibility that the drainage would carry the pollution (animal sewage). In some other cases, these were located too near to the main roads leading to adverse road safety and possibility of accidents due to frequent approach by livestock, as well as possibility of insanitary conditions such as the spillages mixed with animal sewage flowing on the road. Thus siting of halaos has not been appropriate in several cases.

Achoda: Typical Poor Location of a Halao: Right next to a Plot and not far away from a culvert having two drain pipes. The surface drainage water will get contaminated with animal faeces/urine in all likelihood.

Plate 3.1.33. Inappropriate Halao Siting (Typical)

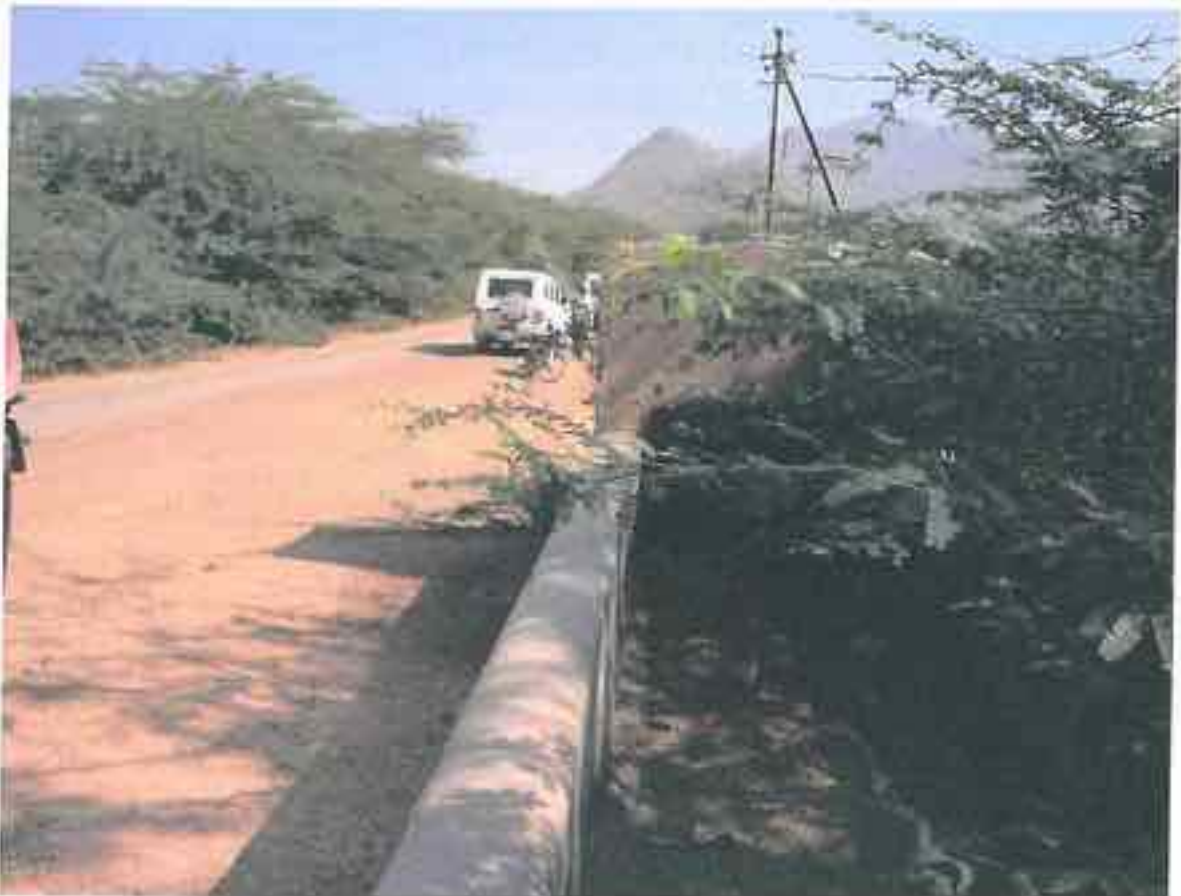
Bijasan: A Halao on the Main Approach Road. Detrimental to road safety in view of the likelihood of accidents on the main road as animals will often approach the road.

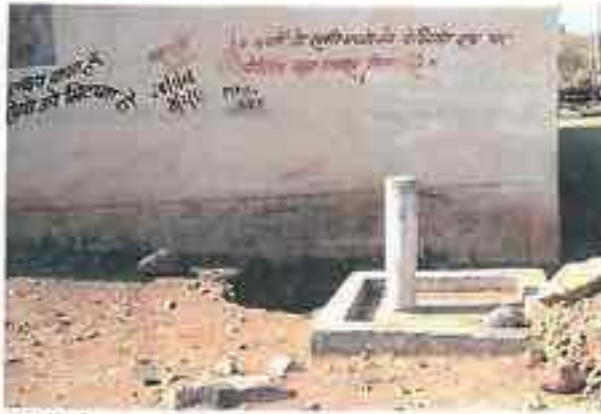
Amlali

153. The handposts where provided, were in a wide majority of the cases not working as water supply services themselves have failed at most R&R sites, and also because the taps and necessary connections to handposts were mostly found missing, and a very large number of these handposts were therefore dry and defunct (Plate 3.1.34).

Plate 3.1.34. Missing/Dysfunctional/Defunct/Dry Handposts (Typical).....cont..

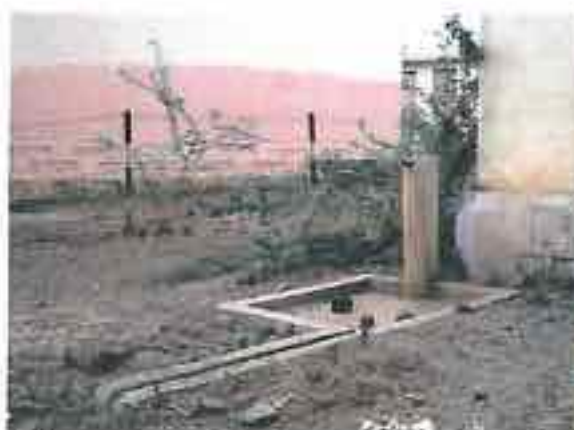
Urdana

Plate 3.1.34. Missing/Dysfunctional/Defunct/Dry Handposts (Typical)

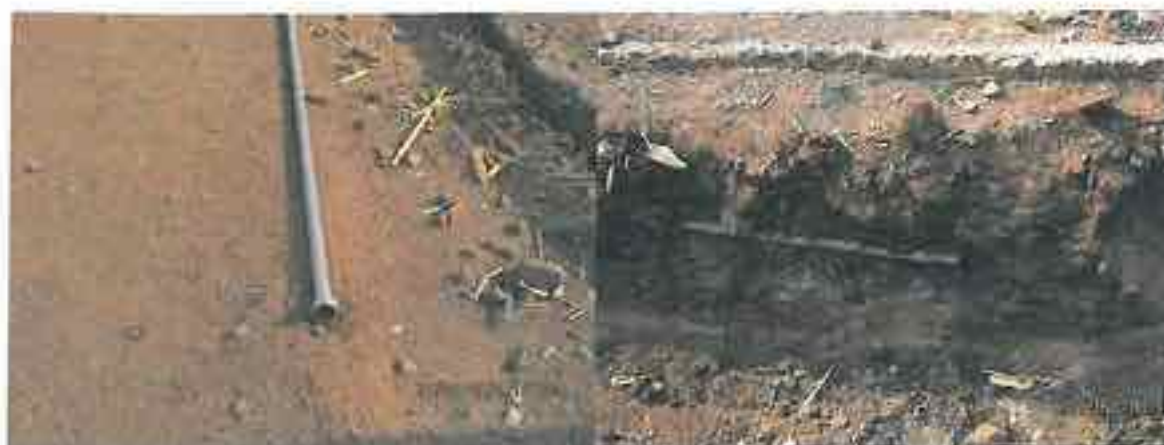
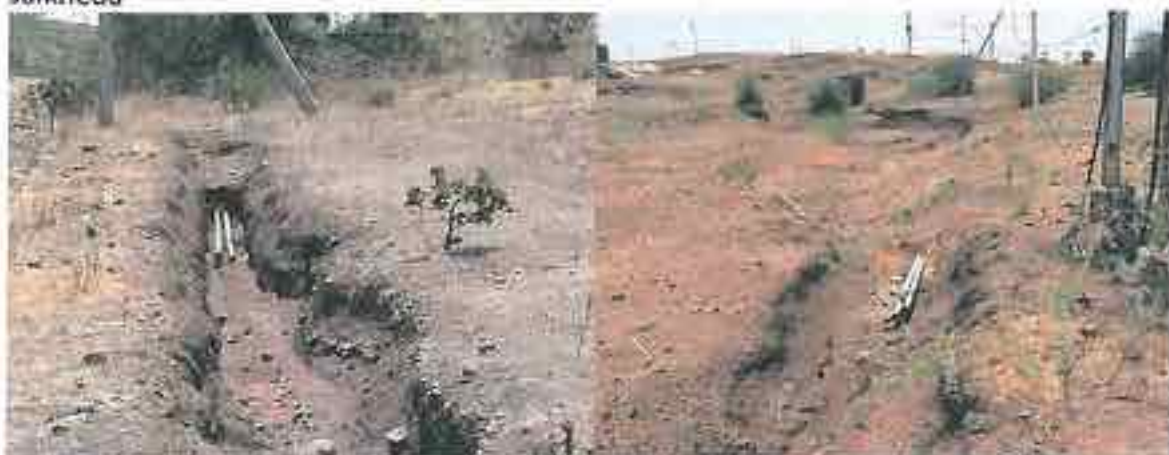
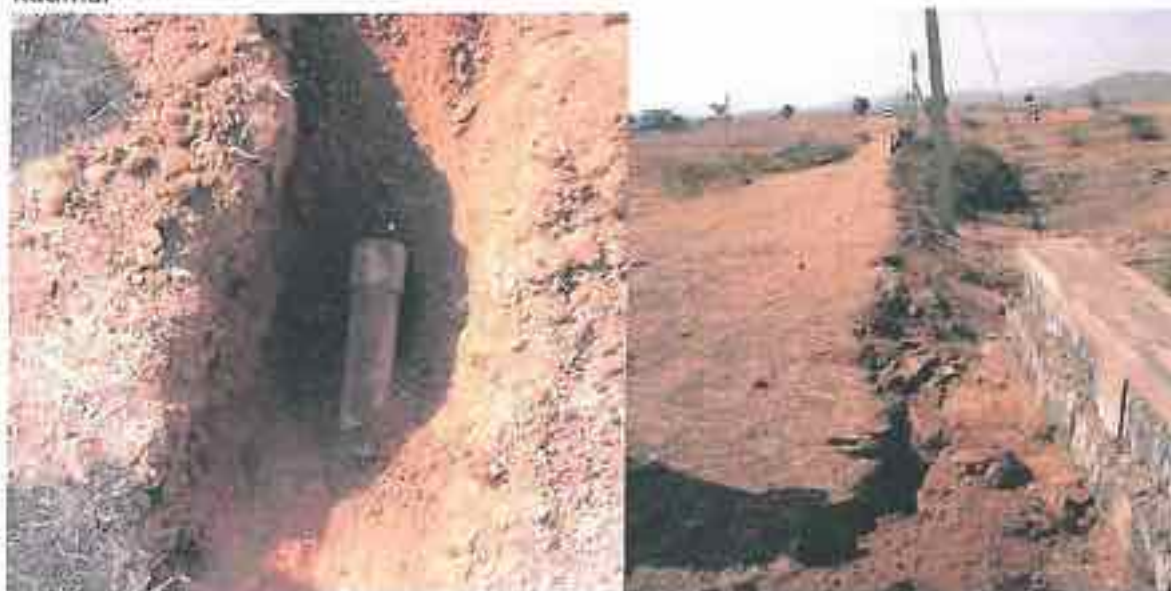
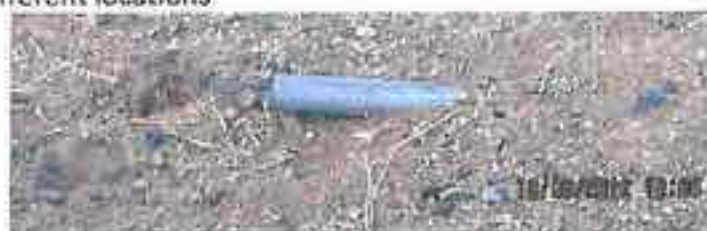
173. At a number of R&R sites like Awalda, Kadmal, Kikarwas, Nainpura Tarlai (Sondul), etc., the Pipelines were seen missing in certain patches (Plate 3.1.35). These lines appear to have been stolen, an outcome of the fact that most of such lines were not charged, and were not under use. Defunct / not-under-use pipelines are easy targets, more so because the pipelines have been laid out along the roads sometimes without even adequate cover, as it is easy to locate and take away the underground pipelines.

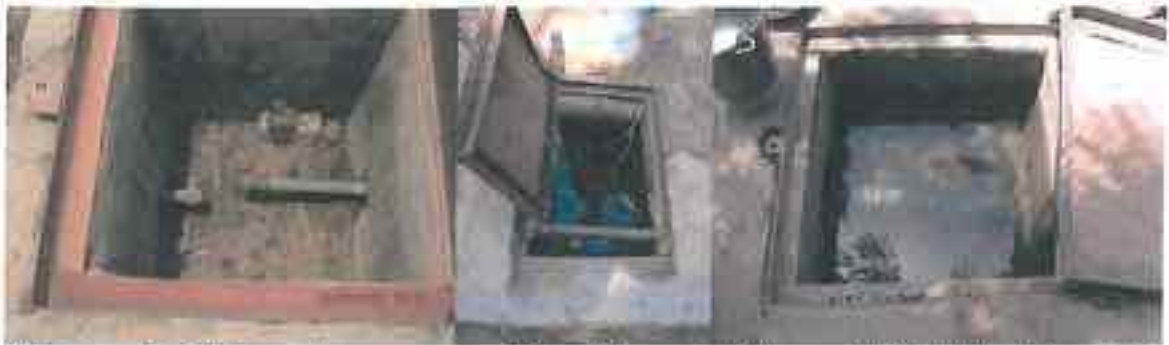
175. The valves of various types were often seen dysfunctional and lying defunct (Plate 3.1.36). The valve chambers were often seen chocked- indicating that regular servicing of the valves is not being carried out. In several cases, valves were missing, or were non-functional, chambers filled with debris indicating lack of periodic inspection, regular cleaning and maintenance as is mandatory. Apparently, little efforts have been made to keep the distribution system operational.

Dharampuri: Missing valve

Bhavati I and Vishwanath Kheda: Leaking valves

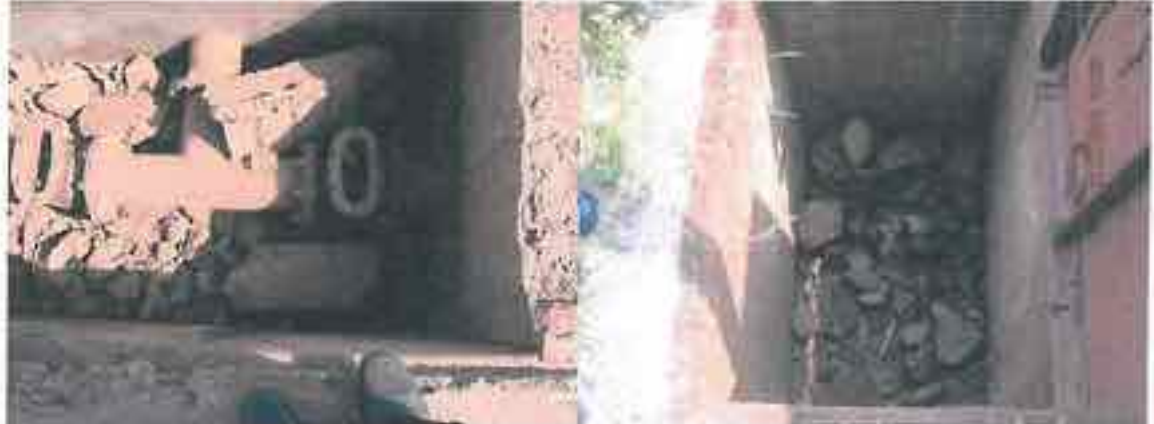
Brahmangaon Theekri (left) and Nisarpur(Right): Defunct, unmaintained, rubble inside

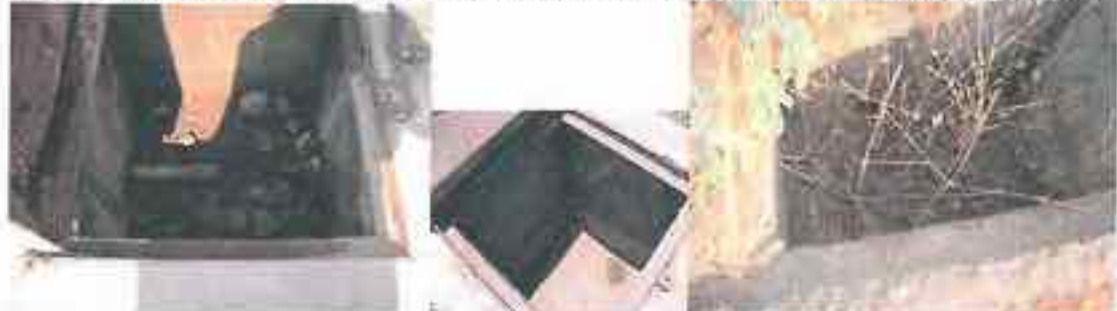
177. The Valve chamber covers were also sometimes found missing. In any case, the metallic Covers are likely to get stolen particularly when the R&R sites are not yet fully habitated. Stone slabs/Precast Cement-Concrete covers may have been more appropriate: equally effective, more economical, and less prone to thefts.

Amlali: Missing valves

Lakahangaon: Missing valves

Sondul: No cover, no valve

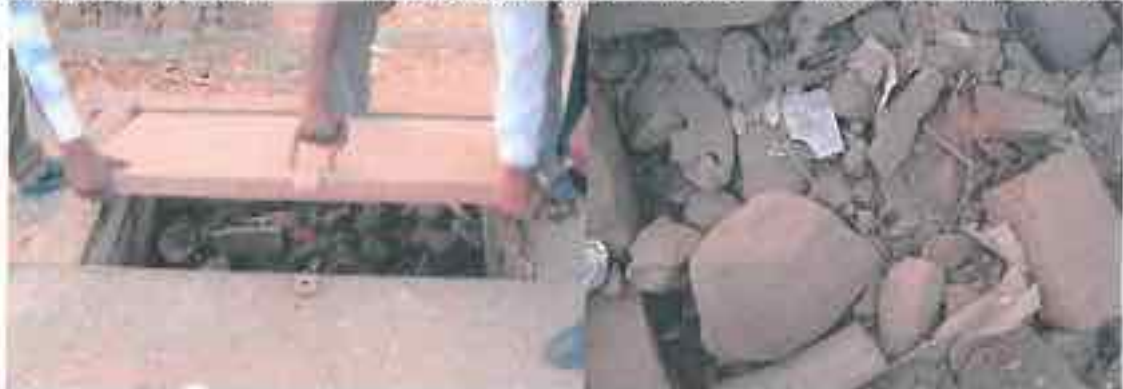
Bhilkheda: Inside of a Valve Chamber

Plate 3.1.36. Typical Status of Valve Chambers at R&R sites

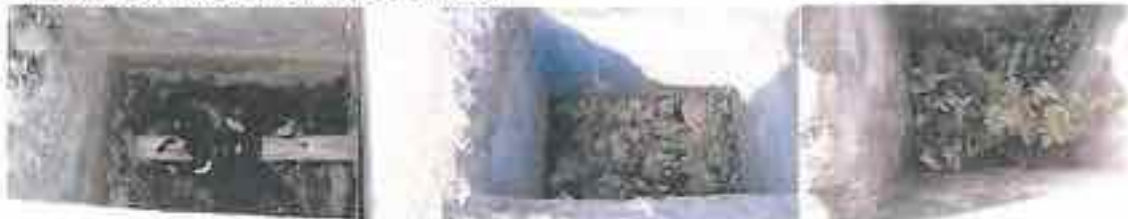
Awalda: Missing valves, broken connections, rubble inside Takiapur: Vegetation inside

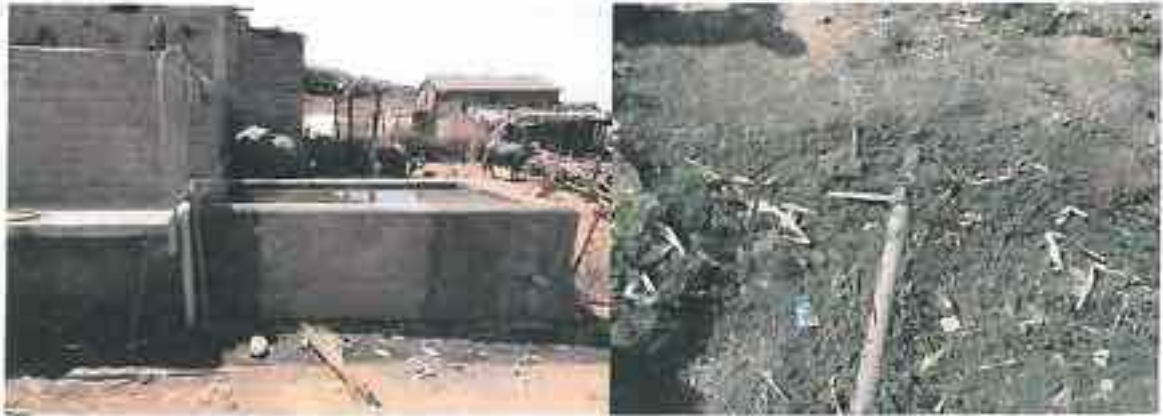
178. At some R&R sites illegal connections tapping into the distribution lines/rising mains, tube-wells, sumps, etc. (Plate 3.1.37) were commonplace. While, this highlights the water supply shortages outlining the need for assured water services to the consumers, failure to curb such consumer behaviour manifests into large leakages and losses, as well as drop in pressure head of the line resulting in failure to supply water to the consumers at the tail-end. Thus, few individuals illegally tapping into the line (obviously the more powerful and rich enough to afford pumps, risk illegal connections etc), often deprive large number of people of much needed water, as the water fails to fill up the public cisterns at the tail end, or to just reach the poor at the tail end.

Kirmohi : A private halao, fed by illegal connection from nearby 50 mm GI pipeline running from tubewell to cistern. Halao has no taps and stop valves, so water keeps overflowing and wasted. Such connections are routinely overlooked by authorities, and prevent majority of users from getting water at tail end and through cistern. Glaring lawlessness.

179. It is again the duty of the maintaining authority, NVDA in most cases, to rid the illegal connections, confiscate illegal pumps, lodge police complaints and taking legal action against those responsible for the pilferages. No such efforts seem to have been made at the sites, resulting in water crises at several places. Thus, the operating agency has failed to maintain the infrastructure against pilferages and thefts of water through illegal connections. Such inaction prevents equitable distribution of water and deprives a majority at the cost of few, creating artificial scarcity of water. Herein lies the role of both- the agencies responsible for water supplies in getting rid of illegal connections and taking action against erring consumers, and the NGOs in educating people to use the provided resources responsibly, equitably and wisely.

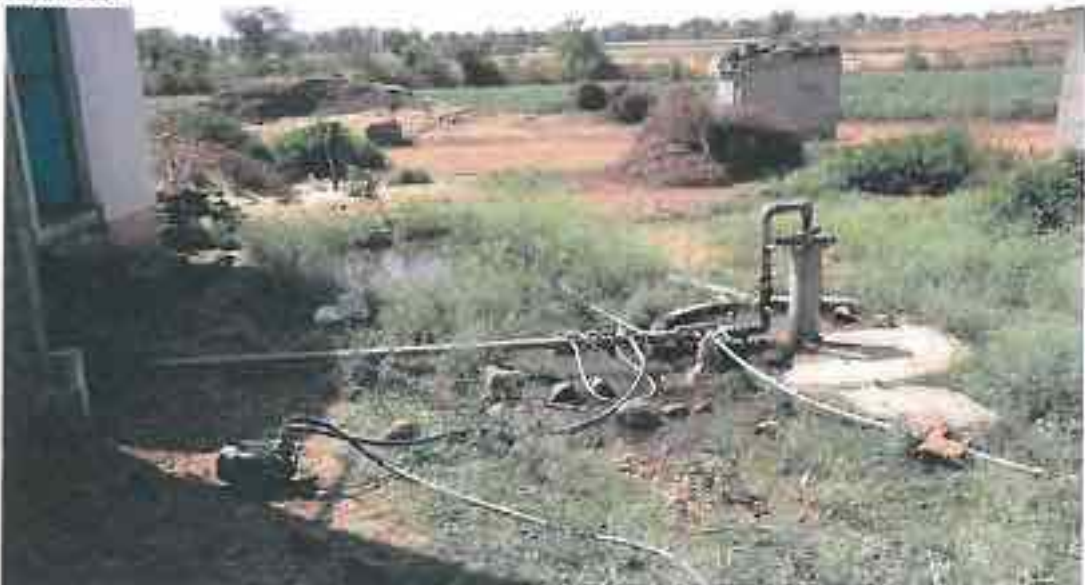
Nalvai: Extensive illegal connections from Tubewell outlet pipe taken by individuals. Even a private motor was found running on electricity drawn from the Pumphouse itself, so the cost of pumping goes into government account. Such illegal tapping would result in major loss of pressure and water leakages, making water unavailable at tail-end cisterns, and houses. Poor suffer as a result of deeds of few, even as authorities turn a blind eye.

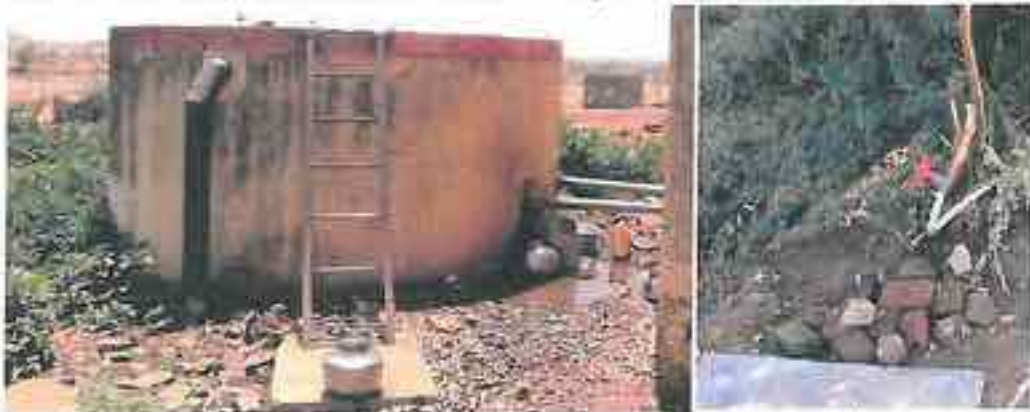
Mandwada: Sumpwell punctured to get water.

Plate 3.1.37. Illegal Connections: Inability of the maintaining authority to act even as people suffer at large.

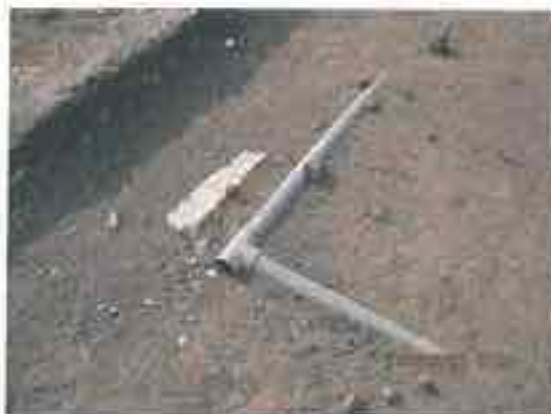
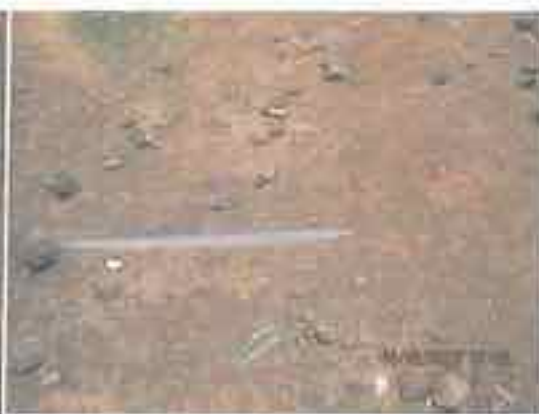
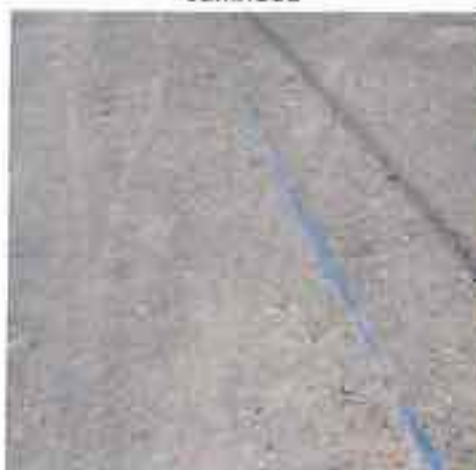
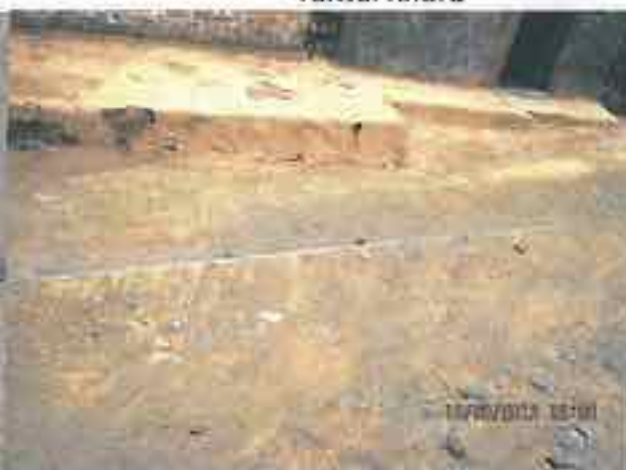
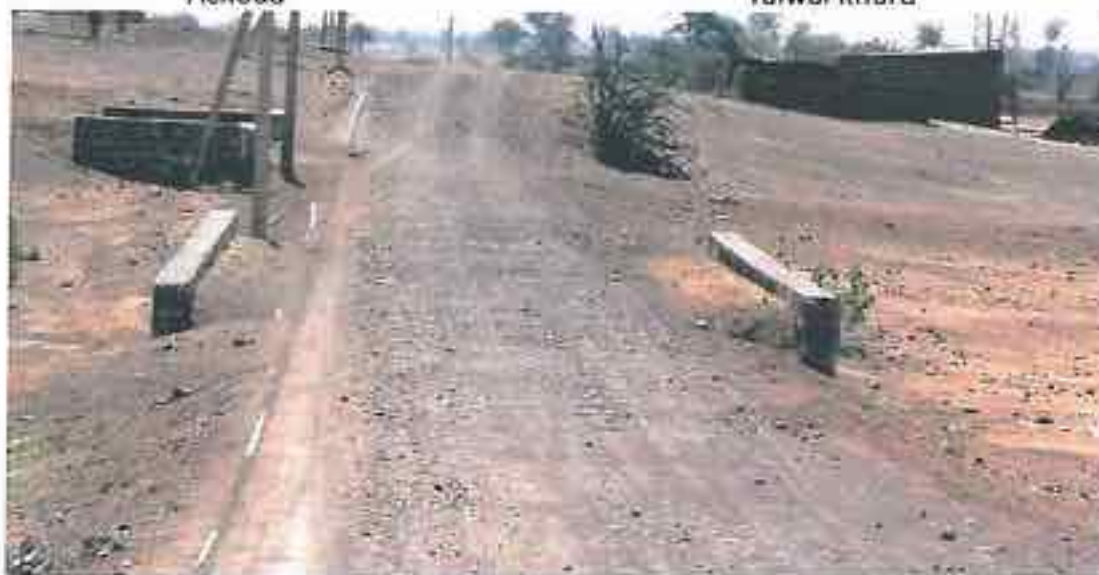
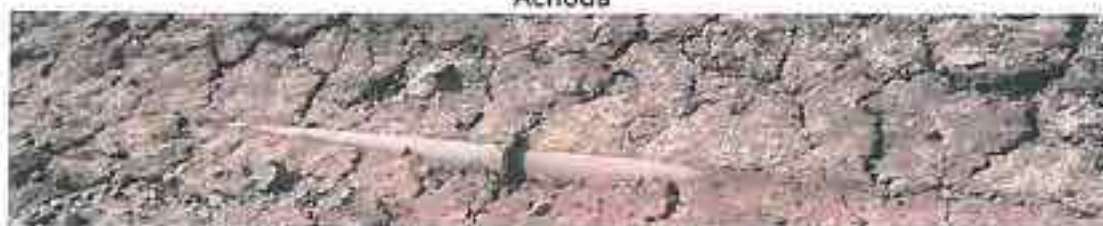
180. Then there were issues related to execution of work, which was often found lacking and was sometimes outrightly poor. In several cases (Plate 3.1.38) the pipeline did not even have adequate cover, and was visible in patches along the road. This enhances the chances of theft, and is rather an invitation to theft. Significantly, inadequate cover along the road side increases the risk of breakage of the laid out line due to passing vehicles on the road. It also greatly increases the chances of damage of the pipeline due to exposure to temperature changes, and to the vagaries of weather. Exposed pipelines indicate careless execution and poor supervision, as sufficient cover needs to be provided over the pipeline to prevent damages due to vehicular and other loads and due to vagaries of changing weather, including changes in temperatures and exposure to sunlight.

Visible Pipelines with Inadequate Covers make the pipeline vulnerable to theft and liable to damage due to passing vehicles, and because of Temperature changes.

Plate 3.1.38. Poorly laid Pipelines: Inadequate Covers along the road

182. The instances of grossly poor execution and supervision need to be reprimanded appropriately by the executing department.

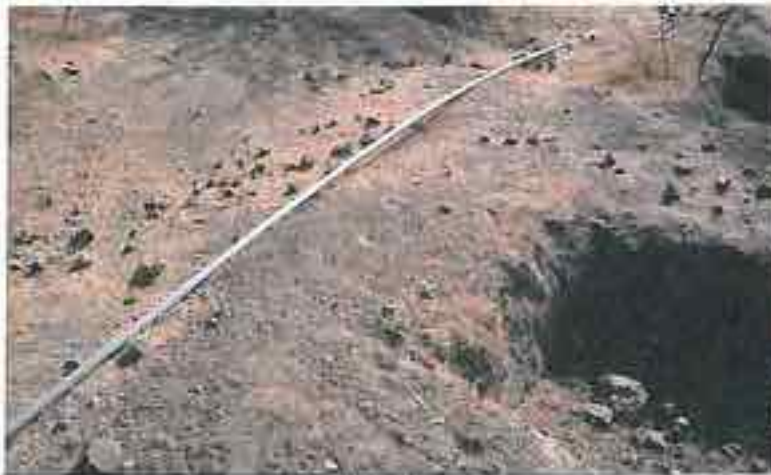
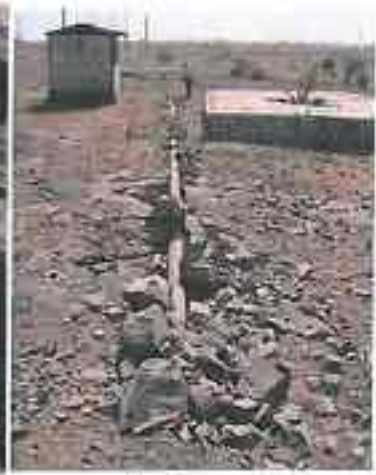
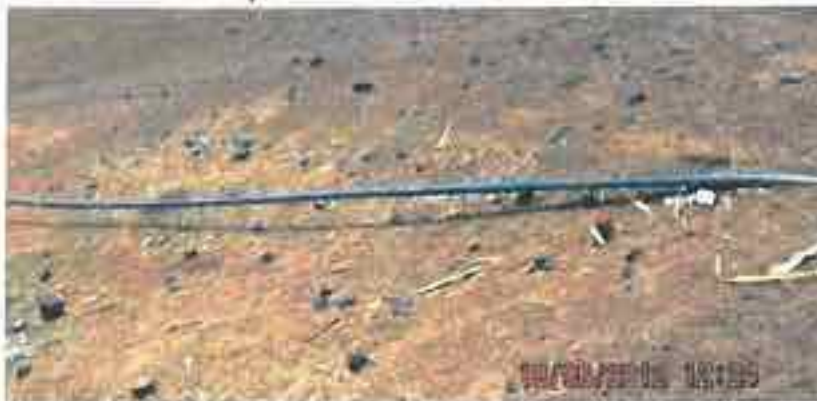
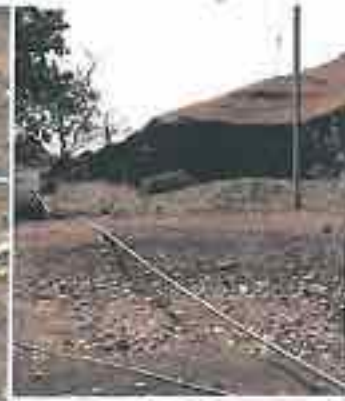
181. In some cases, not just the inadequate covers prevailed, but the execution was so poor that the bare pipelines actually could be seen thrown on the ground (and not laid over it) and overhanging in air in patches, and all this without any supports having been provided (Plate 3.1.39). At other times, the execution and supervision were sometimes so lax that pipelines were laid on the chocked culverts, over the deposited silt (Plate 3.1.39), without bothering to find the actual ground levels to lay the pipelines.

Pipelines overhanging in Air: Pipes vulnerable to theft and liable to damage

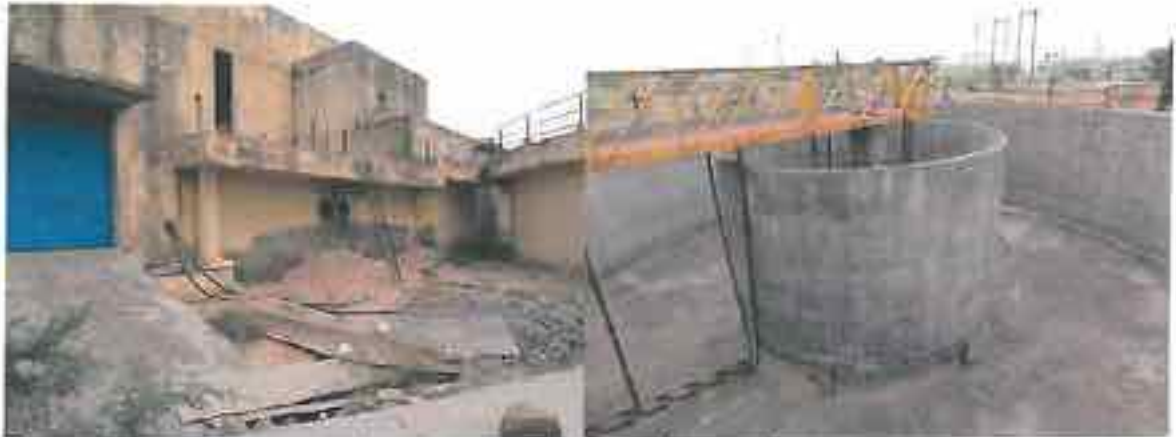
189. Site inspections revealed that currently even the two WTPs are not yet operational (Plate 3.1.40). One of the WTPs near Ganpur (Manavar) is still incomplete, while the other at Dharampuri was not found working during inspection, and has apparently never worked as the mandatory lab equipment that decides the dosages of chemicals to be added as per the incoming raw water quality at treatment plant (a mandatory feature for testing supplied and raw water qualities) were found non-existent.

191. The WTPs represent capital intensive infrastructure, and these have so far been wasted and lying defunct/incomplete/non-functional, unable to serve the inhabitants of the R&R sites, and resulting in locking of large capital without fulfilling the purpose for which these were constructed.

Ganpur (Manavar): Incomplete Water treatment plant works

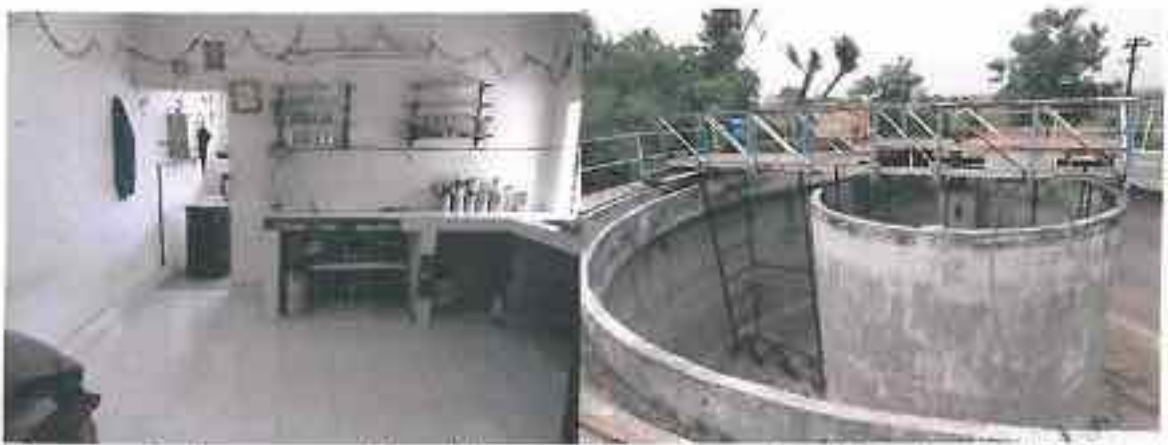
Dharampuri: Plant not working, lab was not found equipped, Treatment Units found empty and dry.

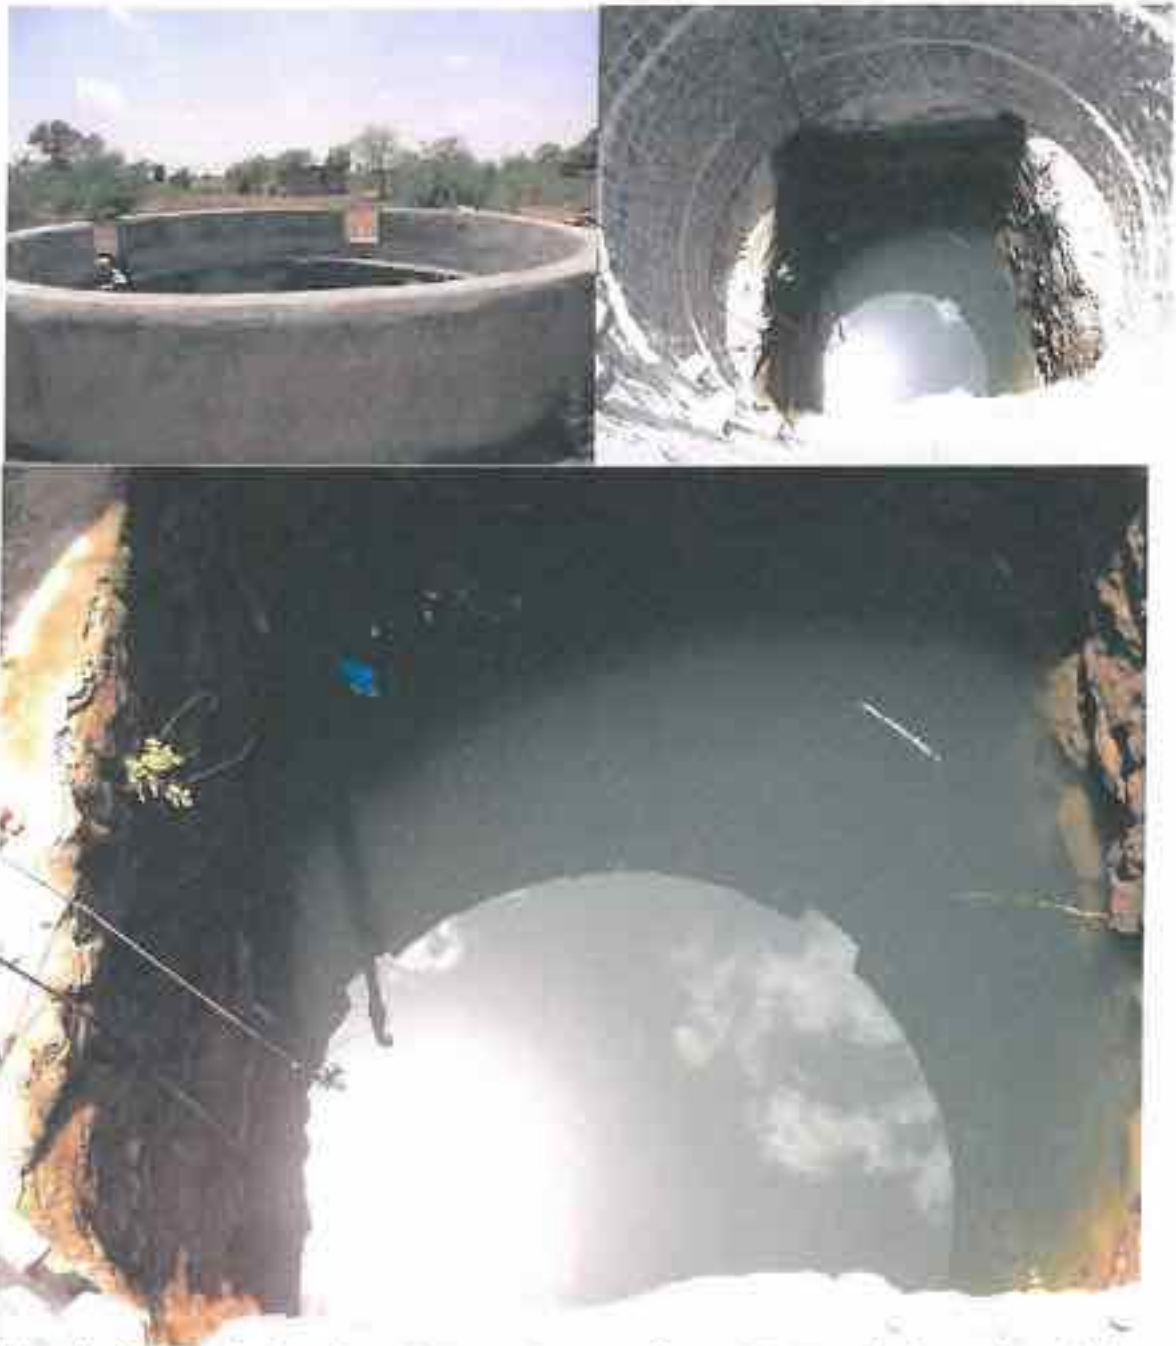
Plate 3.1.41. The case of Perkhad : Adhoc and Wasteful Water Supply Arrangements

After the failure of the tubewell, Narmada water from 4.55 Kms has been brought into the above open well. For Distribution, a new 110 mm PVC distribution network (700 m) for supply has been laid. Under an obviously unsustainable arrangement NVDA pays for the electricity bill of the pumping scheme while the distribution infrastructure has been handed over to the local body which collects tariffs for supply. Water quality remains untested, and the water put into the open well is supplied raw without any chlorination or any other treatment. Even visually, the raw water quality in the open well does not seem appropriate for drinking.

214. It is highly recommended that at all such sites sustainable sources of water supplies be developed with provision of adequate treatment as necessary, and only then the infrastructure be handed over. This is crucial as the Gram Panchayats may later on

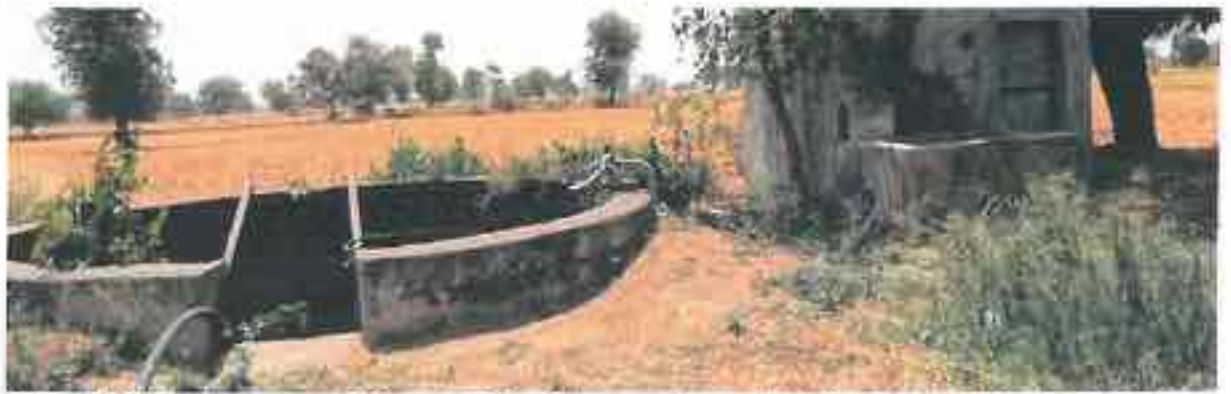
Plate 3.2.42. The case of Raswa Deb: Open well acquired for raw water supplies in summers.

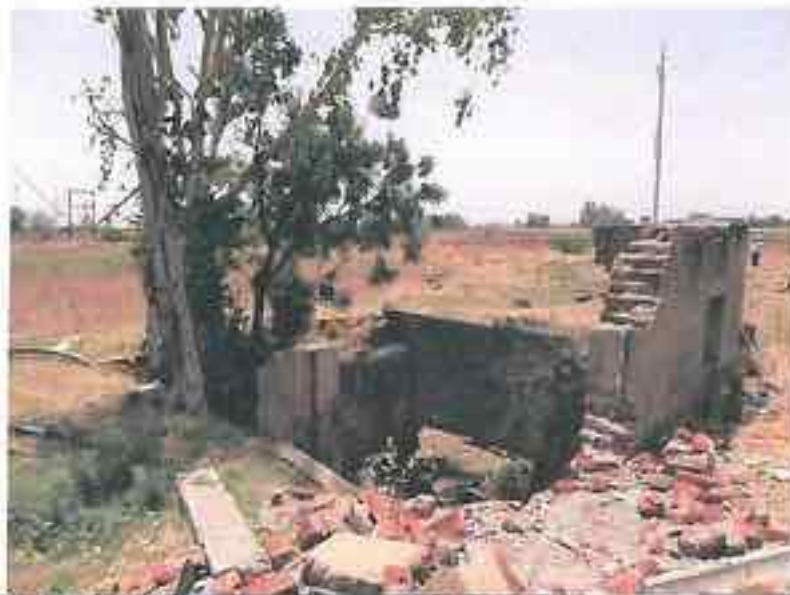
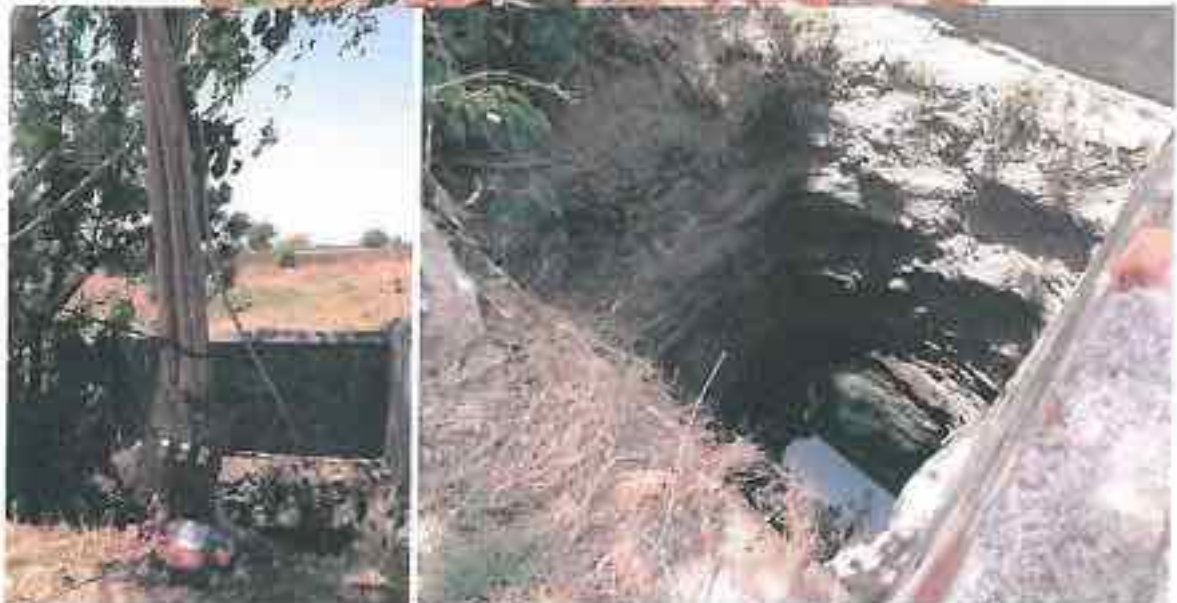
Semalda: Overhead Tank is mostly filled up by an Open Well acting as the raw water source, and having adhoc pumping arrangements. Note that the water quality is not tested, and no chlorination or any other treatment of the Open well water is undertaken. If the water supply is to ultimately depend on such sources, then the whole purpose of constructing massive infrastructure in the form of OHT, Tubewells, Rising Mains etc. goes waste, and the supply arrangements remain essentially adhoc, unplanned and unreliable.

Plate 3.1.43. Raw water supplies from Open wells: Adhoc Arrangements (Typical)

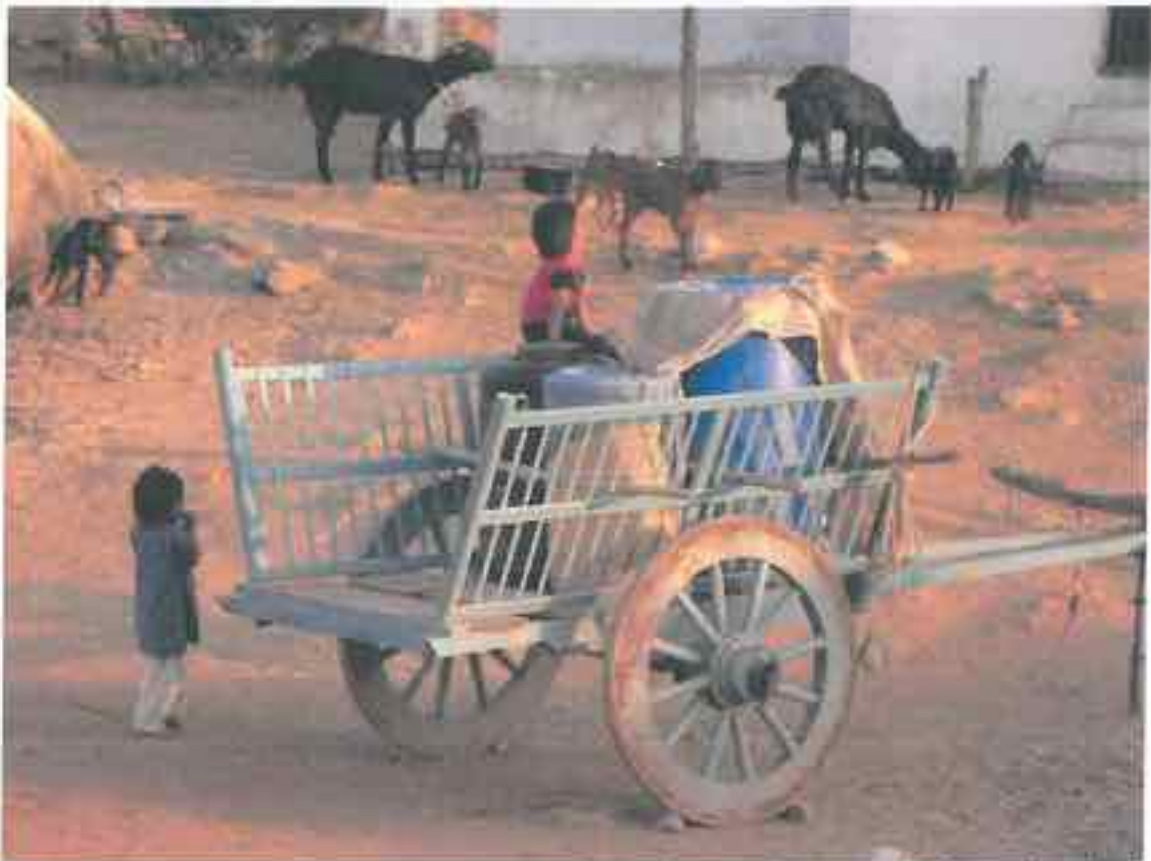
Sirsani: Water for human use transported on bullock Carts, but animals themselves have little facility

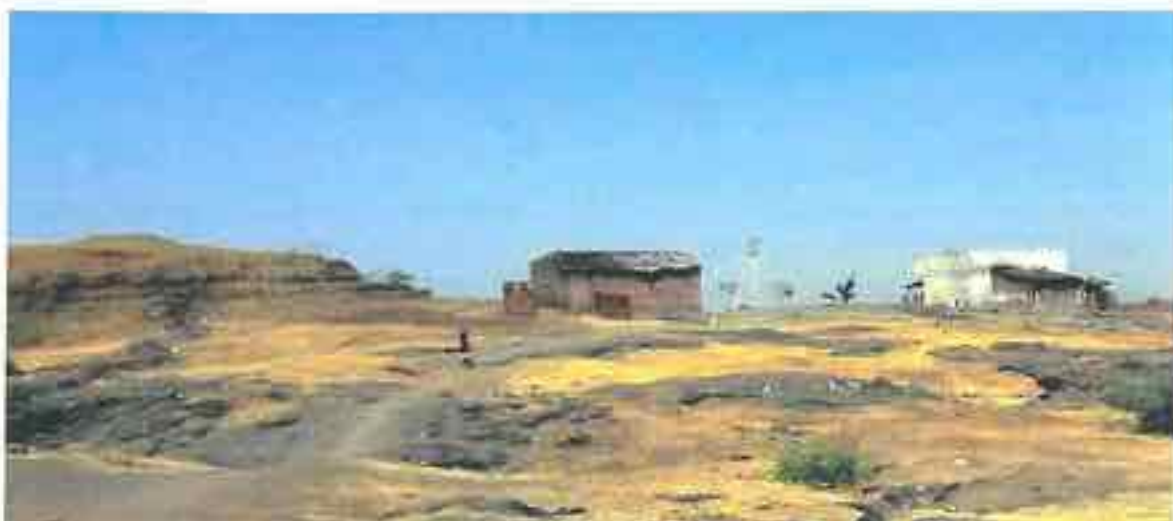
Chakeri: Reliance only on 2 working Handpumps in a hilly terrain which implies women have to carry water load on head for large distances (The tubewell and 2 cisterns lie defunct, a handpump also had no water)

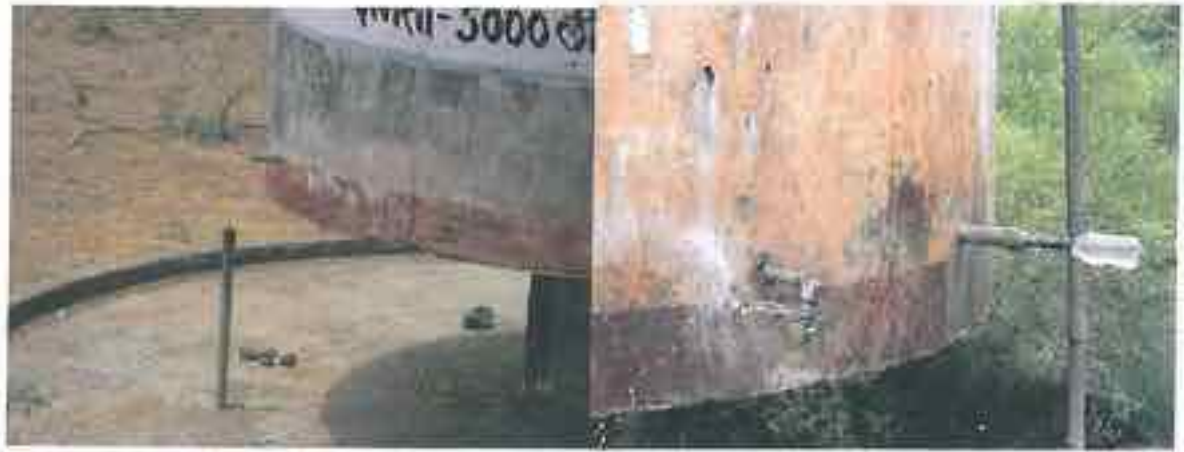
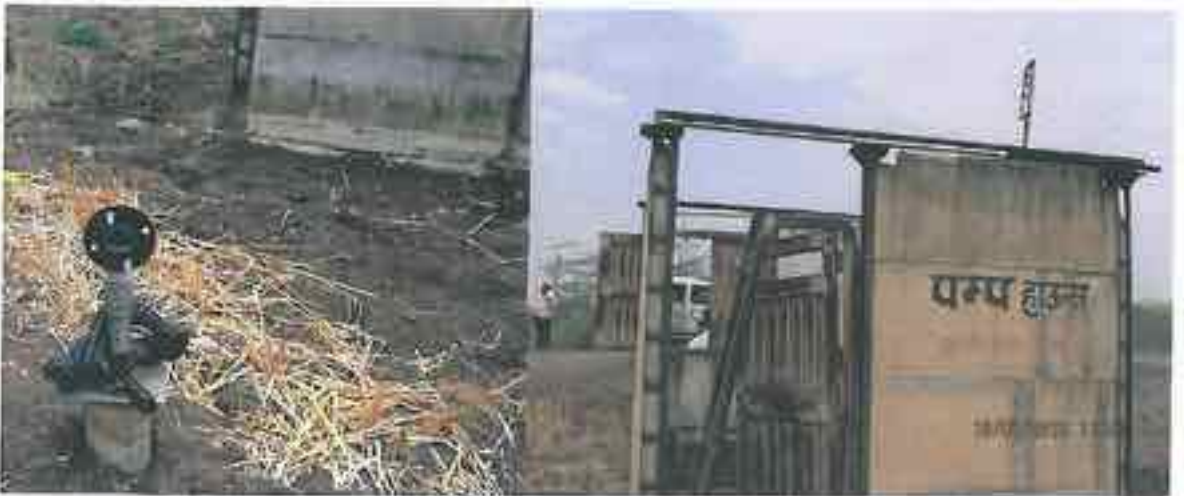
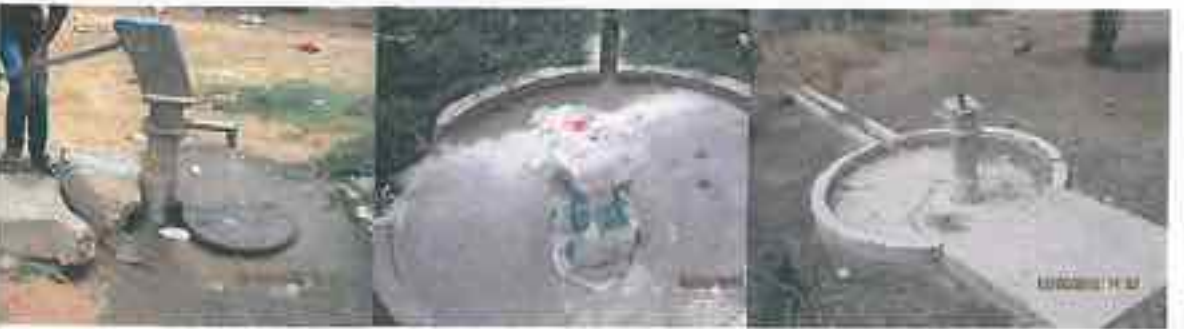
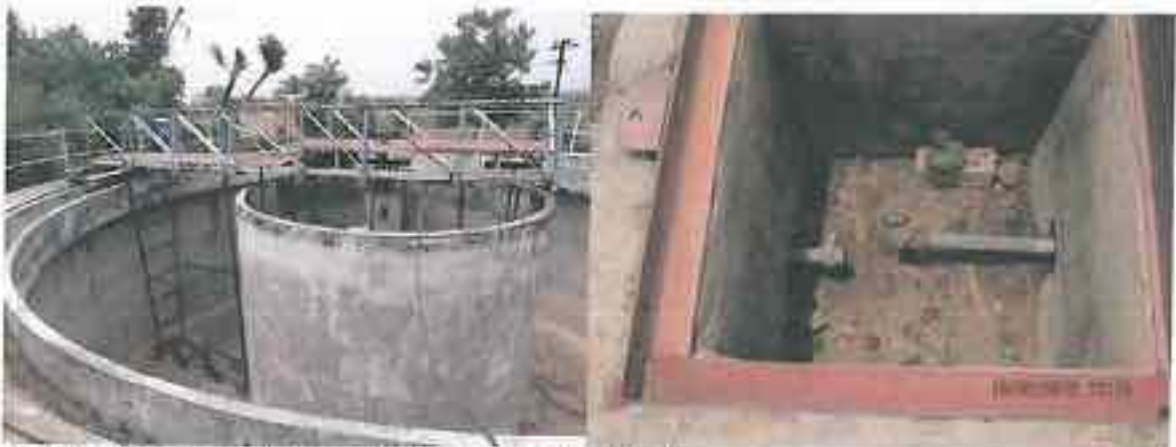
Deteriorating infrastructure, typical of most R&R sites.

Plate 3.1.45. Status of Water Supply infrastructure at Dharampuri (Typical)
