Evaluation of the Quality of Civic Amenities at Rehabilitation Sites of the Sardar Sarovar Project

**Sardar Sarovar Project - Fake Sale Deeds and Rehabilitation Sites
Irregularities Inquiry Commission**

April, 2014

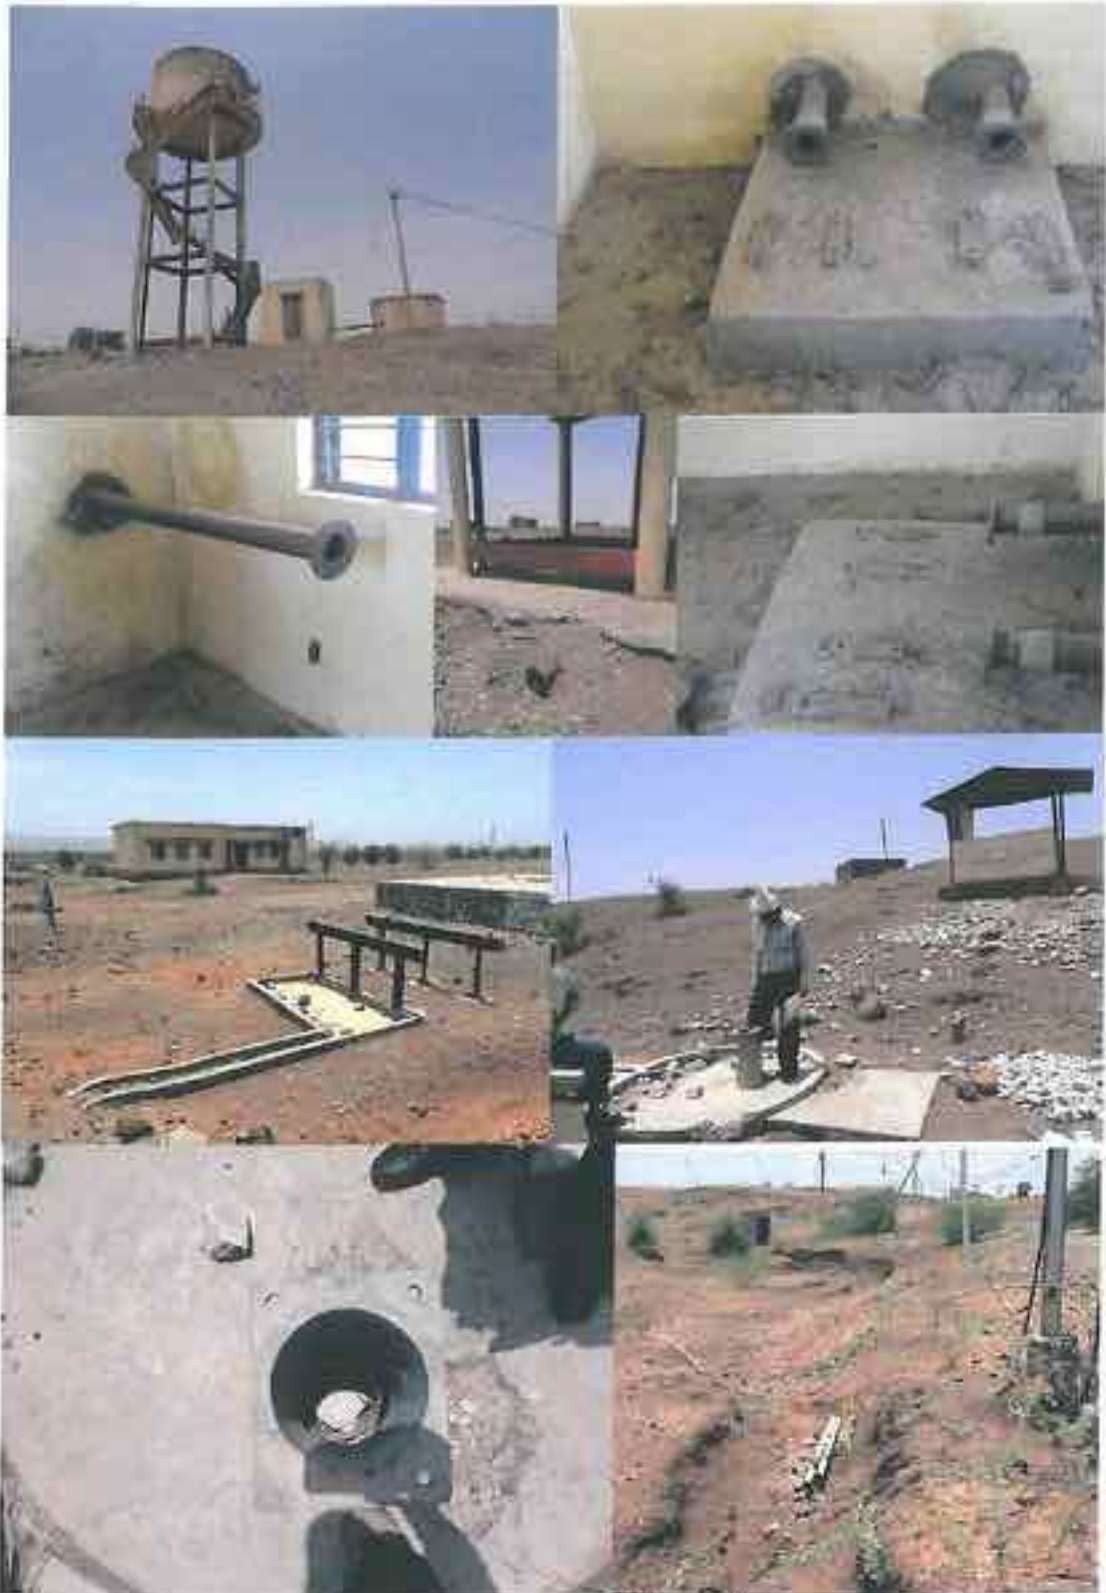
Plate 3.1.46. The State of Infrastructure at Kadmal (Typical)

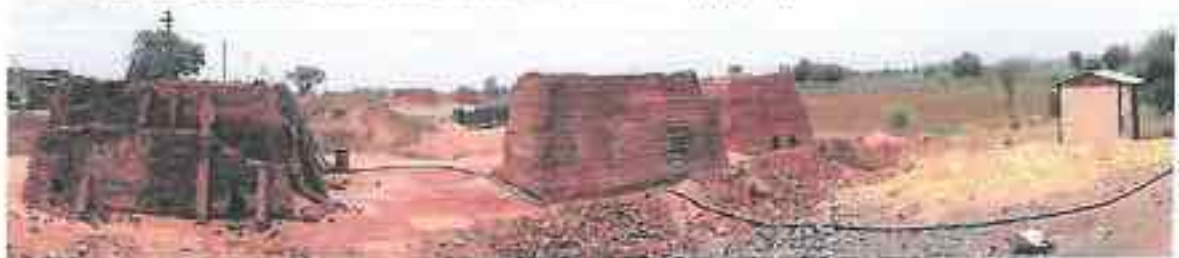
Plate 3.1.47. Tawlai Khurd: Brick making next to public TW, making it defunct (Typical)

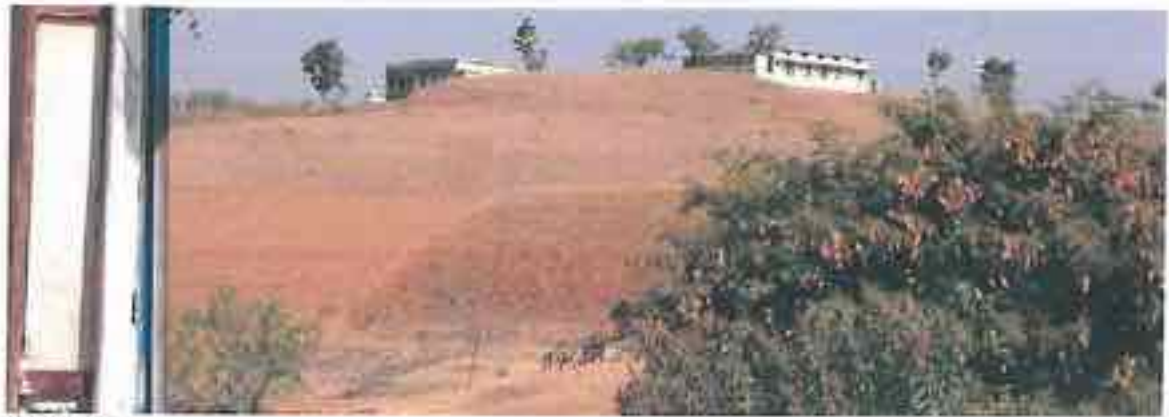
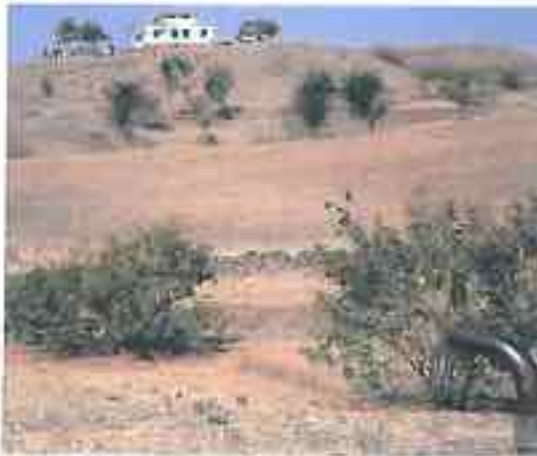
Kikarwas

The pipeline does not go directly up the slope over the hillock following a short path to save upon the pipe cost and the pumping cost (as losses are proportional to the pipe length), but the pipeline follows the path along the road, going around the hillock, following a gentle gradient needed for the vehicles to ply on road, but not required for the force-main pipeline.

Kikarwas: Pressure pipeline laid from tubewell (bottom Blue mark-at the bottom of hillock) to Cistern (Top Right Blue Mark- on Hillock top). The yellow pipeline as laid goes around the hillock, along the road to reach Cistern. The dashed (broken) yellow line from tubewell to Cistern over the hillock could have saved a lot of capital expenditure, and with curtailed length (no more than 60% of the presently laid line) could have resulted in lesser losses, lesser pumping costs, lesser electricity bills and lesser maintenance.

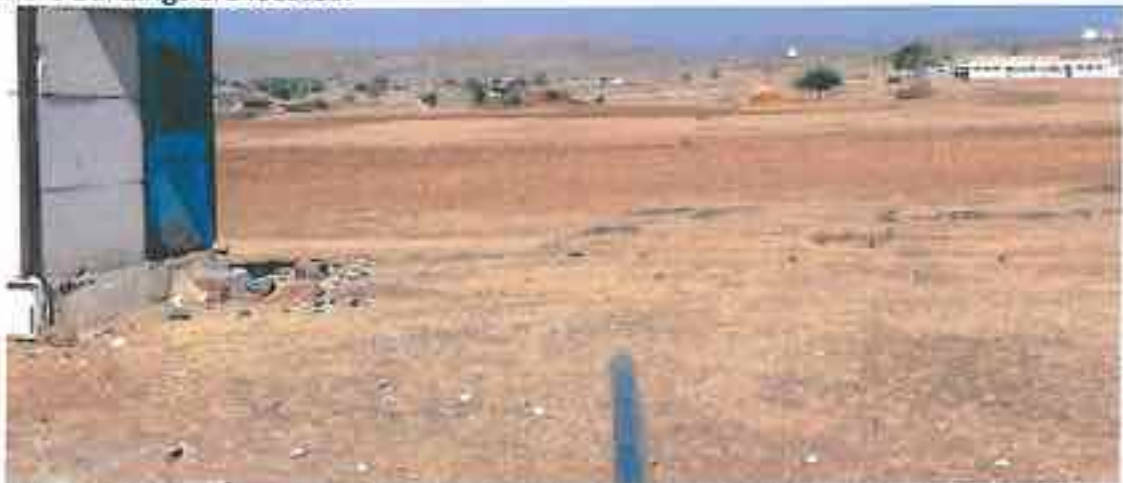
Dharamrai: Tubewell, pumphouse (bottom), the buildings (right top), and the far away two over-ground sumps (extreme right top dots). Huge distances for which water needs to be pumped, crossing entire site and even more as the tube-well lies in the crop fields outside the rehabilitation area.

Plate 3.1.49. The Case of Dharamrai: Disproportionate and Excessively costly scheme?

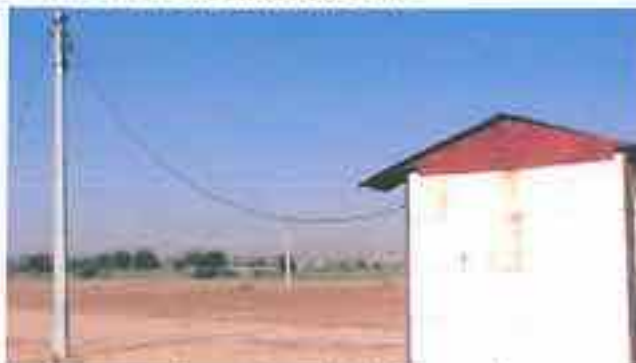
Separate electric line laid for pumphouse.

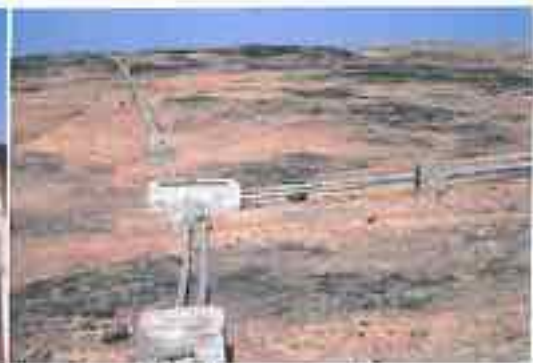
Huge Pipeline network for sumps

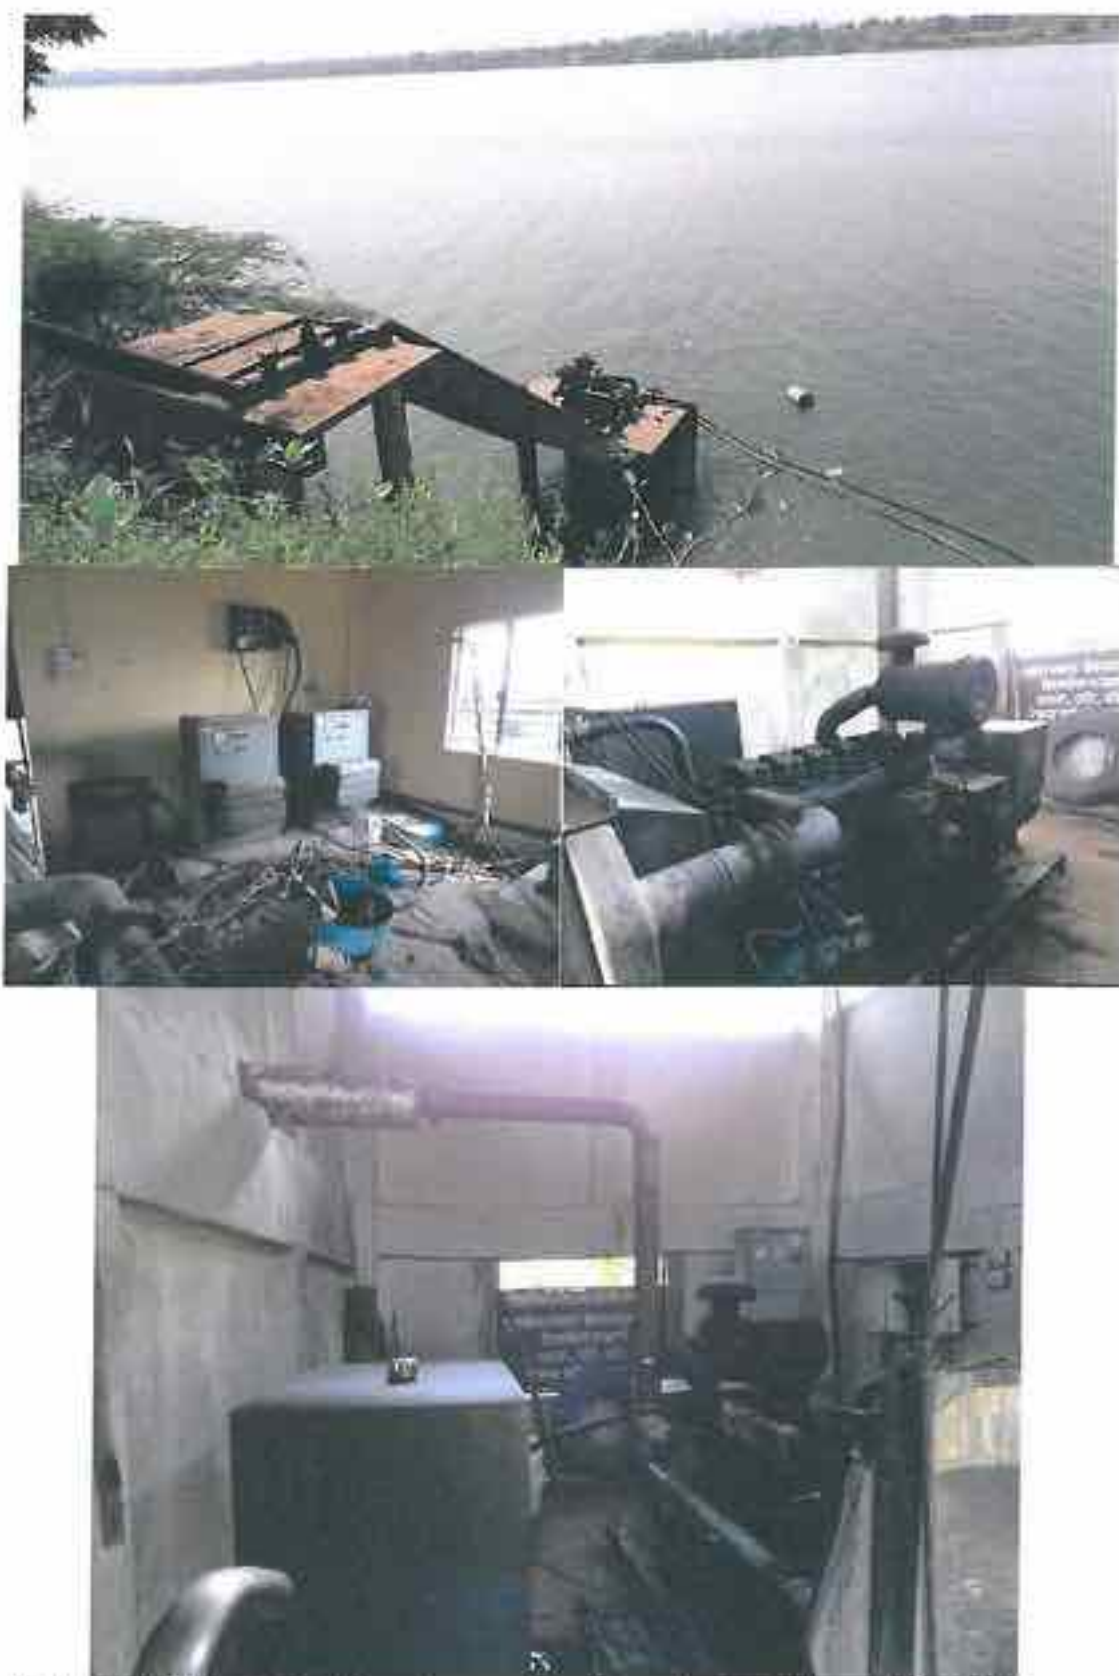
Plate 3.1.44. The Intake Structure and Equipment at Koteshwar Ghat, Nisarpur

405. Remarkably, January 2012 saw 2000 l consumed for a running of 65 hours (ie., 30.76923 l/hr for January), February shows 2400 l consumption for running of 78 hours (30.76923 l/hr for February), March shows 2800 l consumed for running 91 hours (30.76923 l/hr for March), April shows 2000 l consumed for a running of 65 hours (30.76923 l/hr for April), May shows 2600 litres of diesel for running 84.5 hours (30.76923 l/hr for May) etc.. Thus, the DG set needed 30.76923 litres/hr (more accurately, 30.769230769230769230769230769231 l/hr for every month) for running month by month in stretches spread over several months, with wide variation of ambient temperatures (ie, transition from winters to summers) and changes in water qualities (that change fluid properties) notwithstanding. Such precise averages do not exist in the real world, and it is hugely remarkable that the DG sets always consume same amount of diesel to 29 decimal places (shown rounded off month-wise). And such precision irrespective of the change in environmental temperatures from January to May when in summers every machine becomes less efficient due to high ambient temperatures. Such precisions in real world machines are never encountered and are most amazing, and it is only when records are prepared not at site but sitting in offices, that such precisions become real.

406. This team is not an expert in evaluating the genuineness of records. However the circumstantial evidence, including the fact that diesel consumption records were not being maintained at the Intake structure where the pumping is scheduled, and even the pumping logs were missing, leaves a lingering doubt over the authenticity of the Records being maintained. It is noteworthy that diesel consumption and running logs are maintained even for the government owned vehicles and are available in vehicles to be inspected at any time, and yet despite significant spendings on diesel records including the running logs were missing at the site in the present case. It is therefore recommended that this case of Intake at Koteshwar Ghat may be investigated by a specialized agency like CBI to verify the authenticity of the Records, as well as to verify if this structure represents assets built in submergence area. There are possibilities of large scale misappropriation of finances and swindling by way of diesel consumption shown in the records.

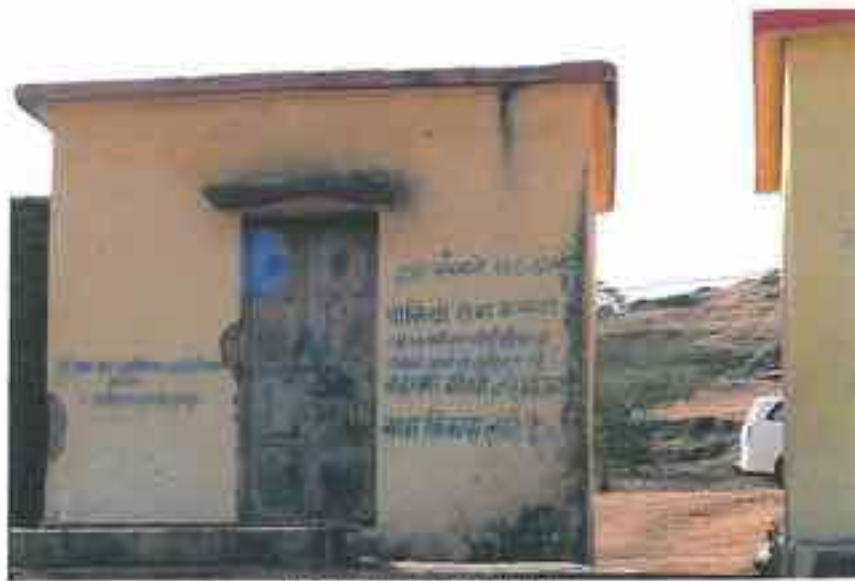
Borlai II: Locked Toilet

Plate 3.2.2. Toilets locked or put to alternative uses (Typical).

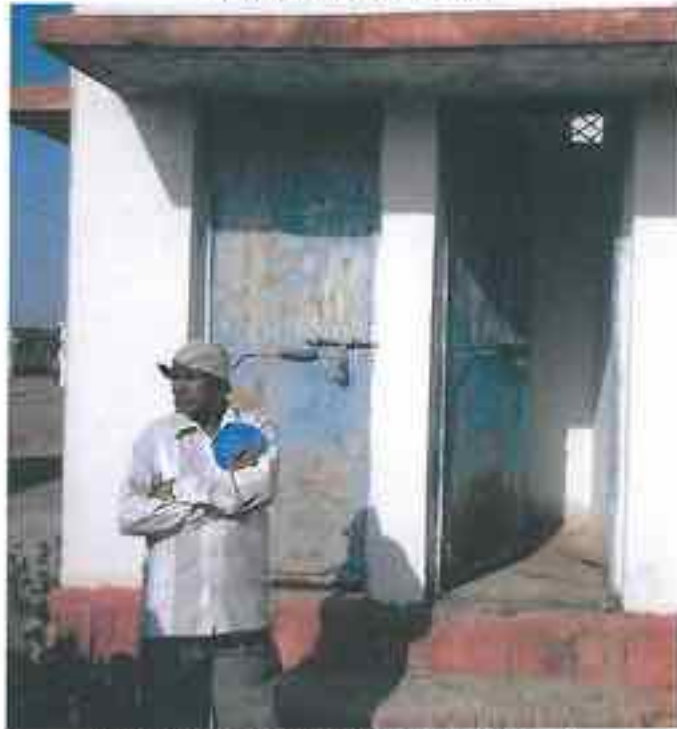
Kavanthi: One of the toilets is locked

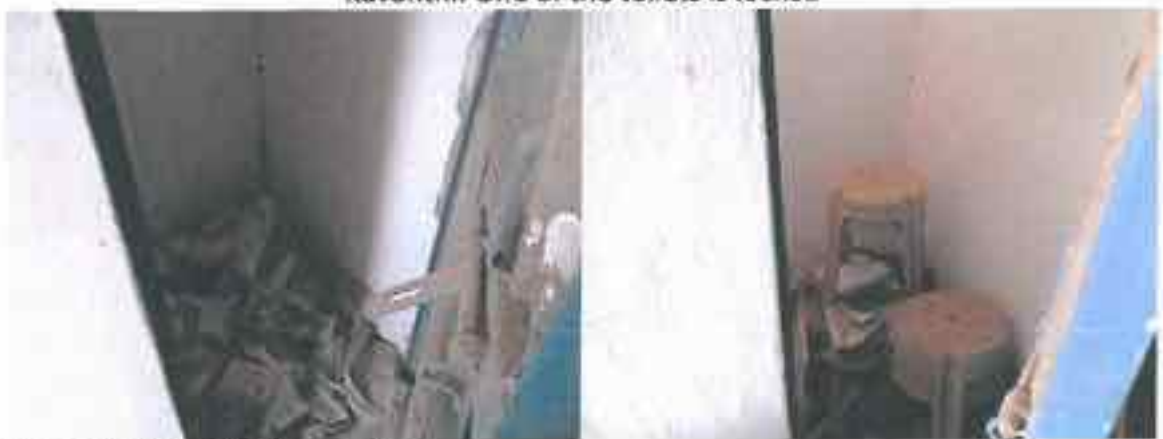
Dharamrai: Two different Toilets

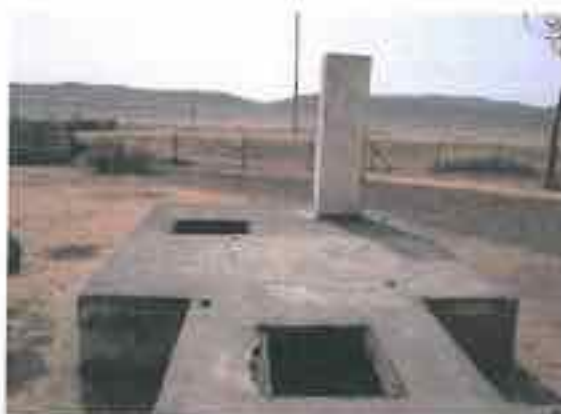
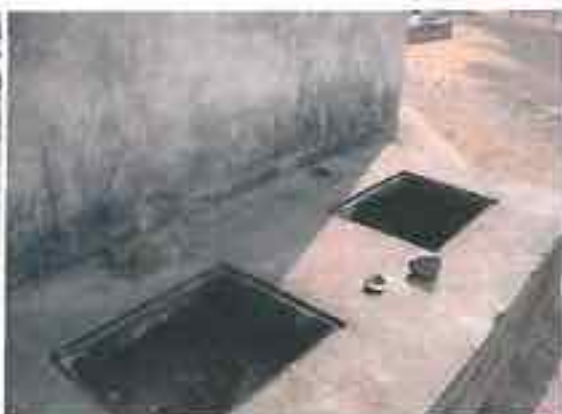
Dharamrai: Two different Open septic tanks

Plate 3.2.3. Typical Septic tanks. Mostly defunct with missing gas pipes & without access manhole covers--posing safety concerns.

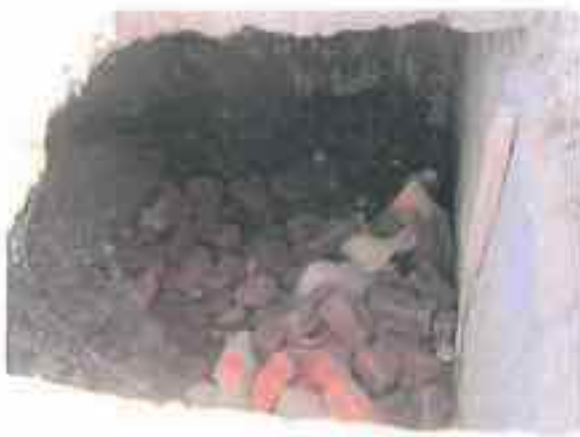
Morekatta

Plate 3.2.4. Inside of typical septic tanks: Poor construction qualities and rubble inside (Typical)

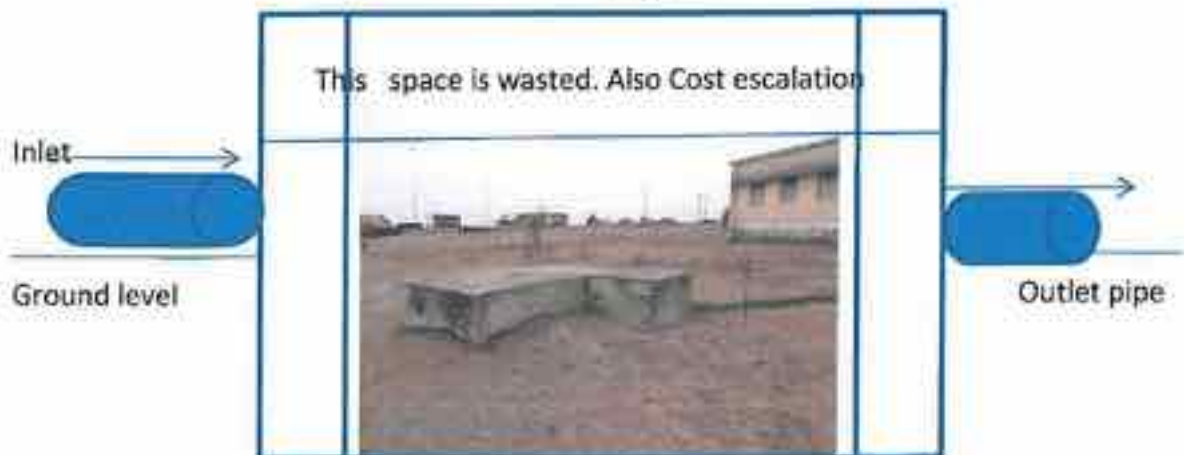
Typical Wastage (example, Beganda)

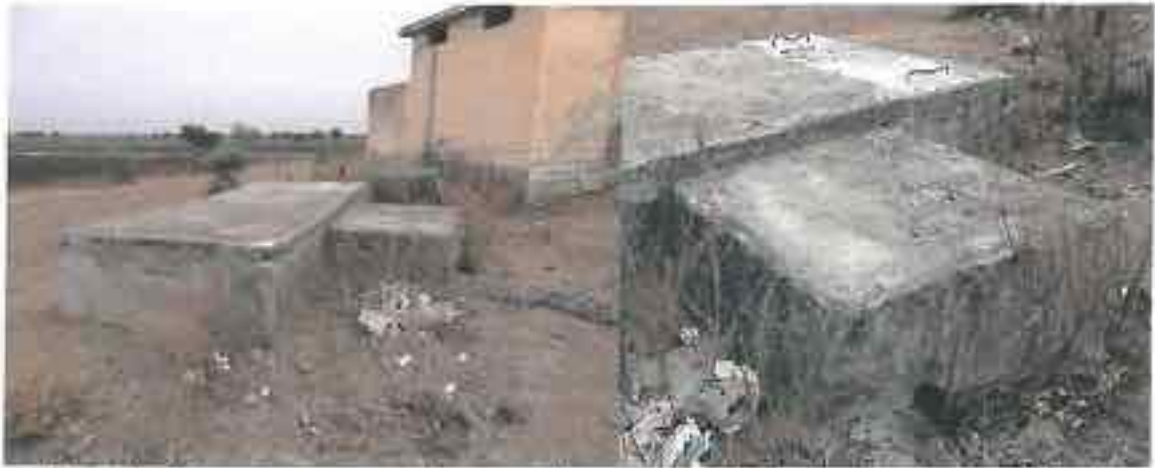
Beganda: No proper cover at the top—inspection and cleaning made very difficult

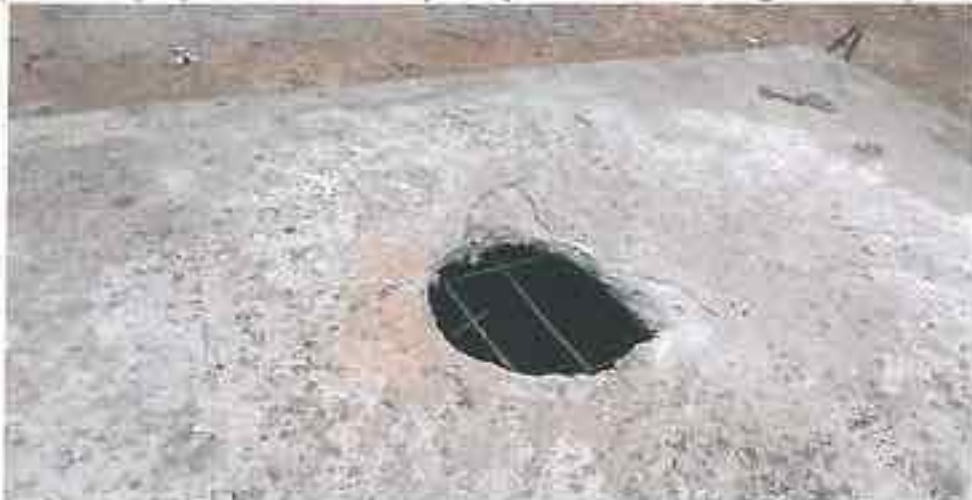
Beganda: Callousness in Construction: Septic tank Inspection/Entry chamber made as an afterthought after cutting the slab.

Plate 3.2.5. Opening on septic tank made later as an afterthought to enable septic tank inspection and cleaning. Poor execution and poor quality of concreting work.

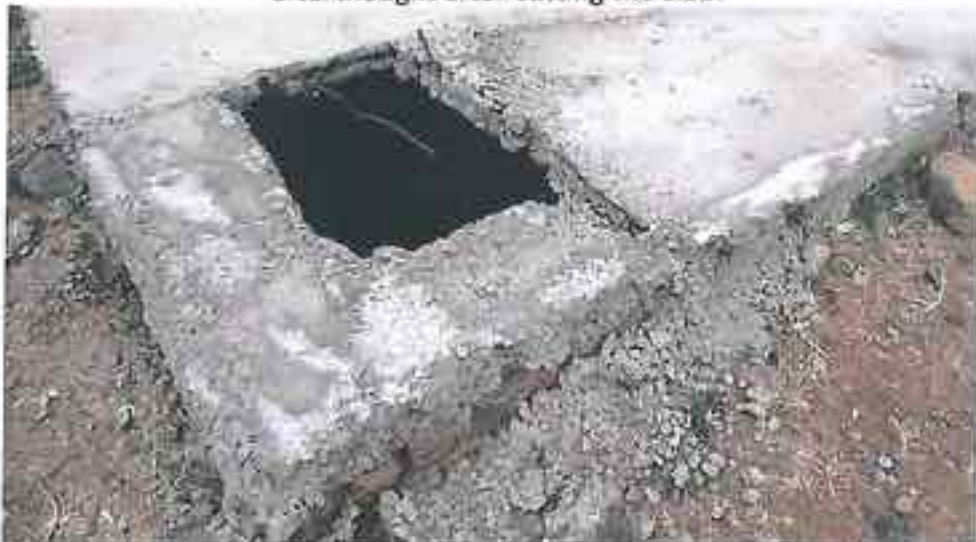
No base or access to central chamber

Barda Manavar: No outlet seen. Post-construction correction in the form of inspection/maintenance opening. The construction carried out later as a patchwork is itself is of very poor quality, not likely to last. Noticeably, Bricks are visible in the new part.

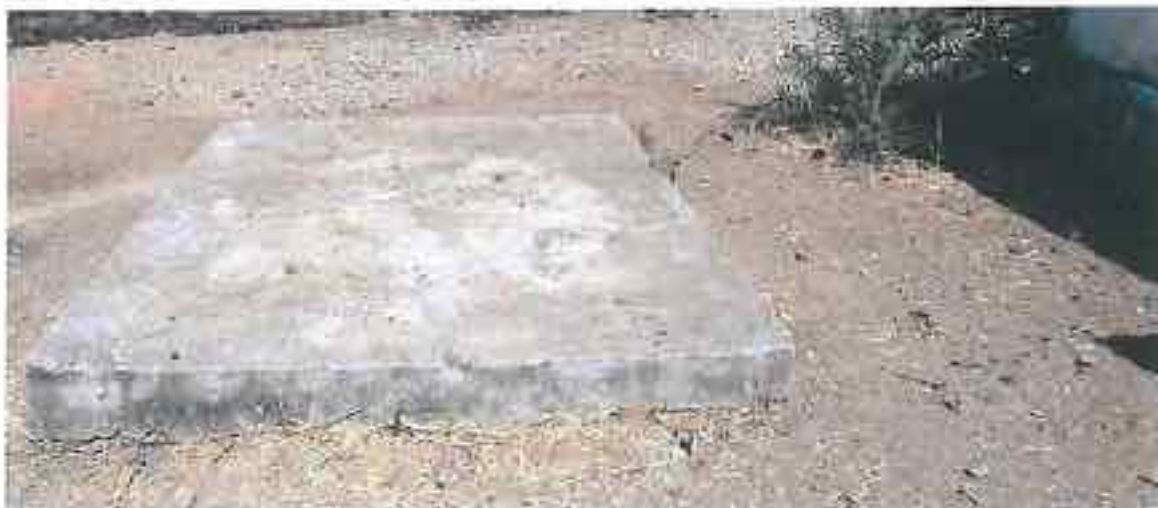
Chichli (Theekri) : Upper slab cast without any inspection opening. Inspection and Cleaning made impossible

Plate 3.2.6. Septic tank Upper slabs (Typical)

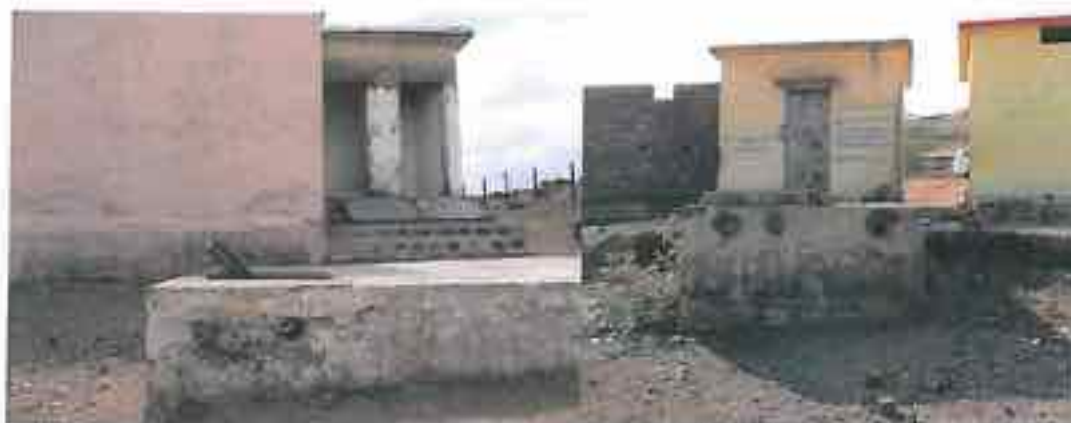
Plate 3.2.7. Septic tanks built to discharge directly on the ground surface in the building premises (Typical)

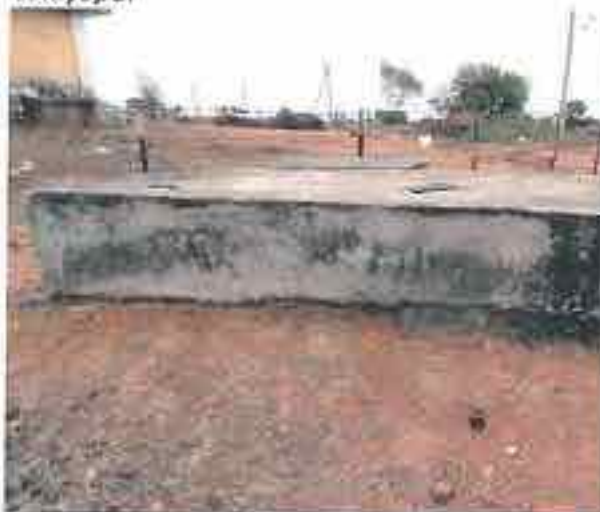
Beganda: Discharge on ground (right hand bottom corner)

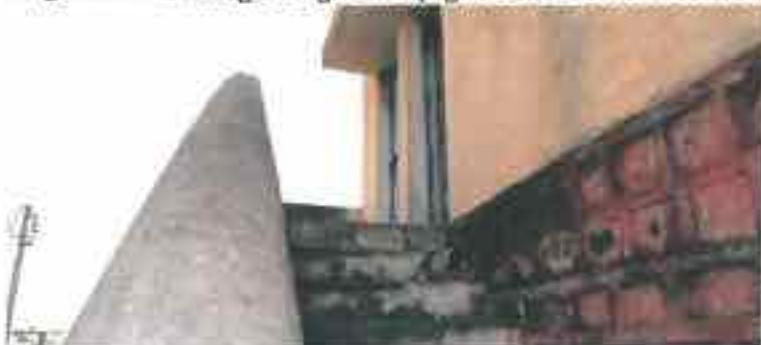
Nisarpur...The toilet pipe discharges to footsteps!!...

Thankfully, the toilets are defunct.

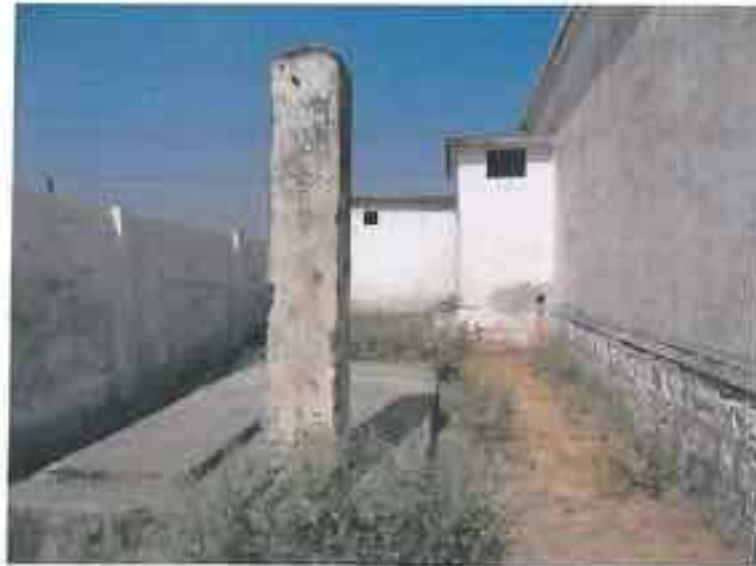
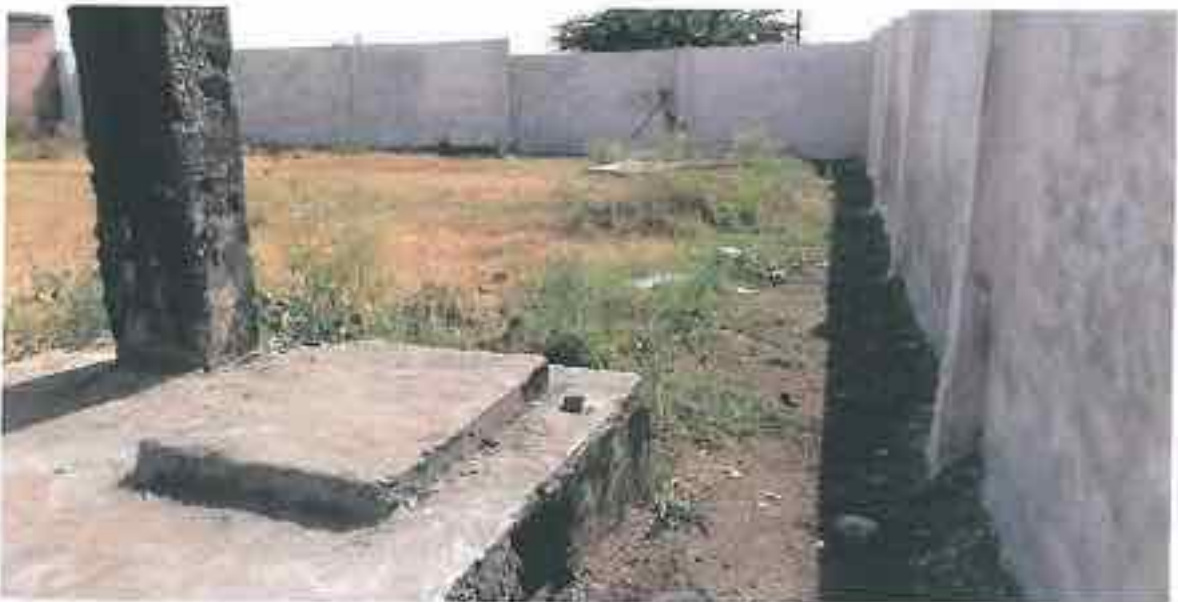
Jalkoti: A septic tank located 1-2 m from the building has non-existing pipe connection with toilet (Top). Effluent from septic tank is left to flow on ground in building premises, with a drinking water source, the handpump, only a few meters away (Bottom).

Plate 3.2.8. Poor locations of Septic tanks with respect to drinking water source

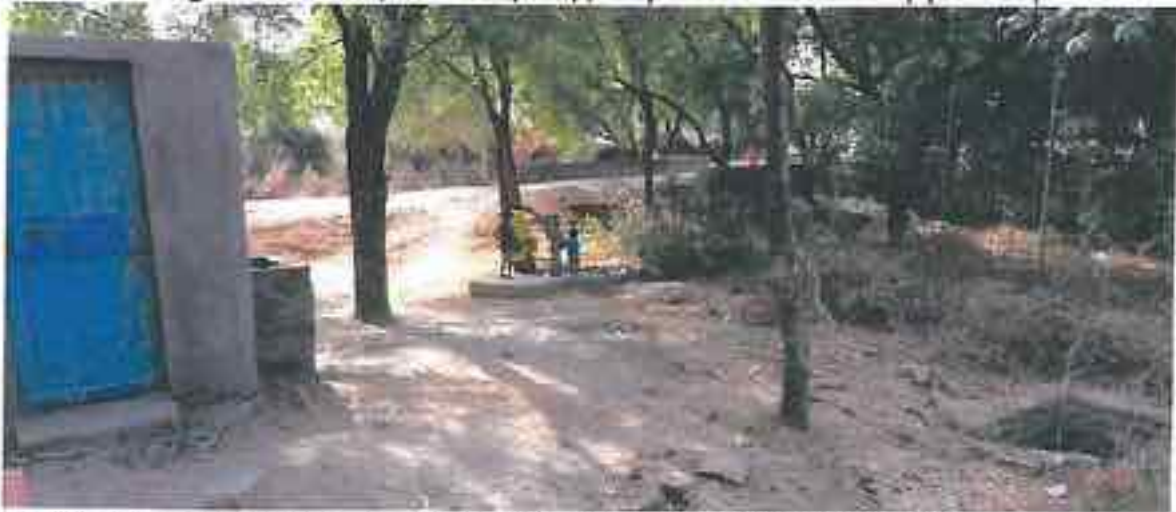
Golata: The toilet, septic tank, and Handpump lie only a few meters away.

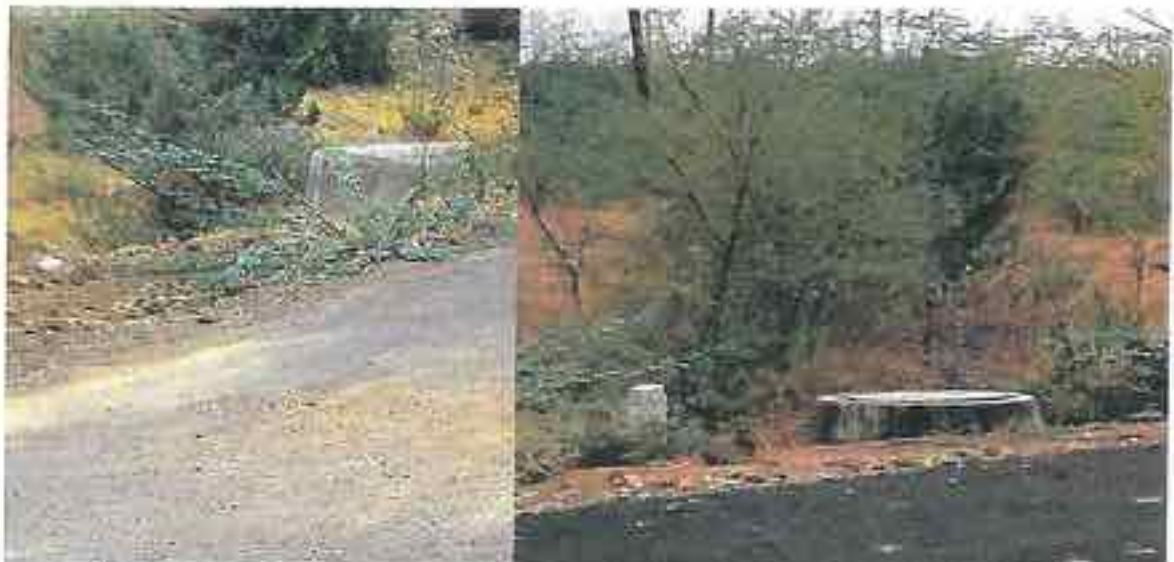
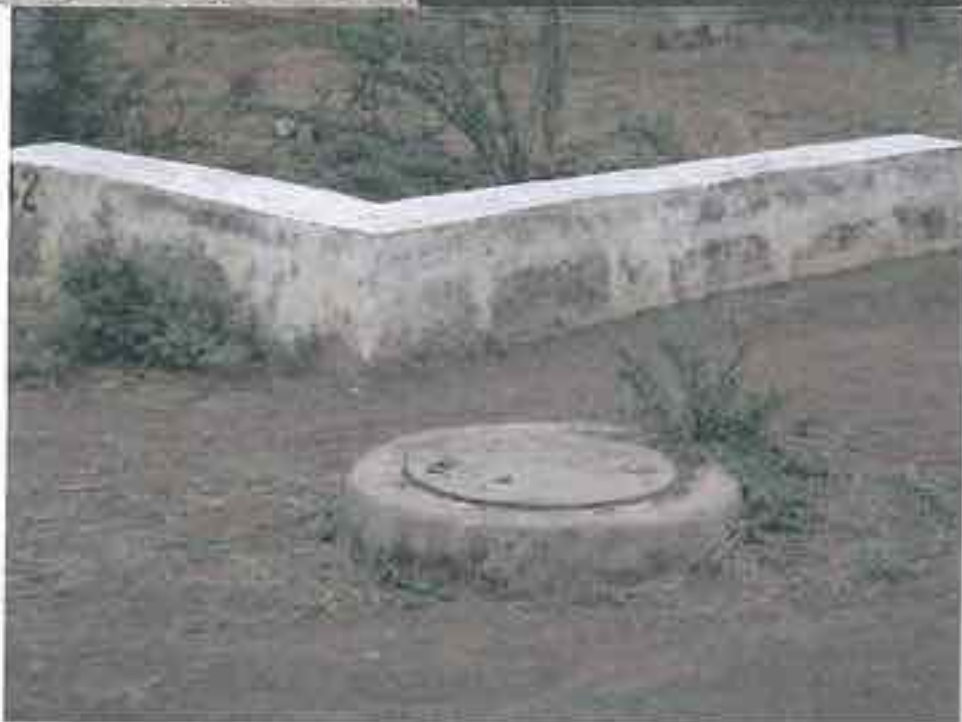
20. Some manholes were found above the nearby road level rather than flush with the roads (Plate 3.2.11), and this may lead to accidents once the vehicles start plying these roads. Even the persons walking on the road-side may sustain injuries, particularly because street lights have not been provided, and so road safety, especially during nights, stands compromised.

Plate 3.2.11. Dharampuri: Typical Manholes rising above road level. Safety jeopardised.

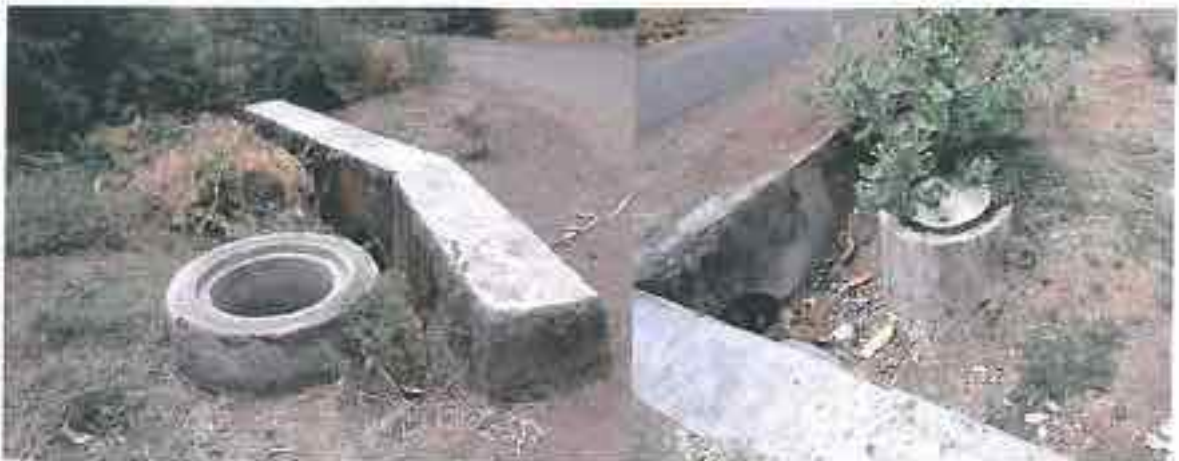
Equally seriously, there would also be possibility of sewage flowing in the open through the culvert drains if the sewer lines becomes clogged, chances of which are fair if a number of manholes remain without covers, as was the case at the site. Such flows leading to mixing of sewage with drainage water will invariably lead to insanitary conditions and would create significant public health nuisance.

24. Several sewer manholes were found without Covers, which may have been probably stolen, and have not been replaced by the maintaining agency. Coverless manholes not only facilitate mixing of drainage waters with sewage and vice versa, but significantly compromise upon safety of children and animals who are vulnerable to falling down, more so as some of the sewerages are deep enough to prove fatal.

Plate 3.2.12. Dharampuri: Typical Manhole Locations with respect to Culverts. Note also the missing cover in one case.

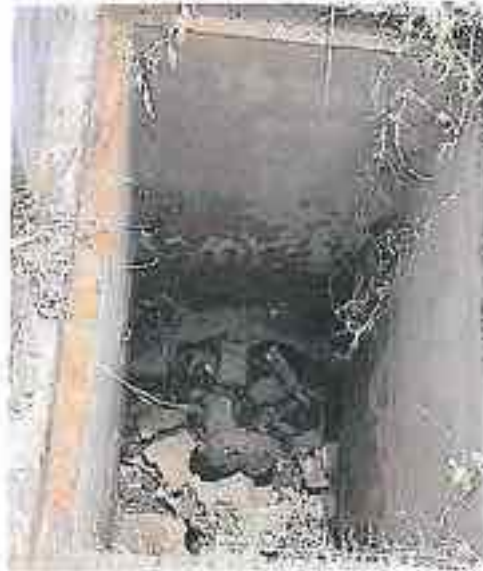
27. In another probable serious violation of standard engineering practices, it is likely that in some cases (Plate 3.2.13), for instance near Plot Number 1626, the water pipe line lies in very close proximity, and below the Sewer line manhole. This is a serious execution and supervision fault and is essentially a blunder and negligence as there exists public health risk of intrusion of sewage in water pipes which lie close nearby. The CPHEEO Manual, 1993 under section 3.5.3 clearly states that "Sewers as a rule are not located in proximity to water supplies", and this provision seems to have been violated.

Plate 3.2.13. Water supply line aligned with sewer line (Typical)

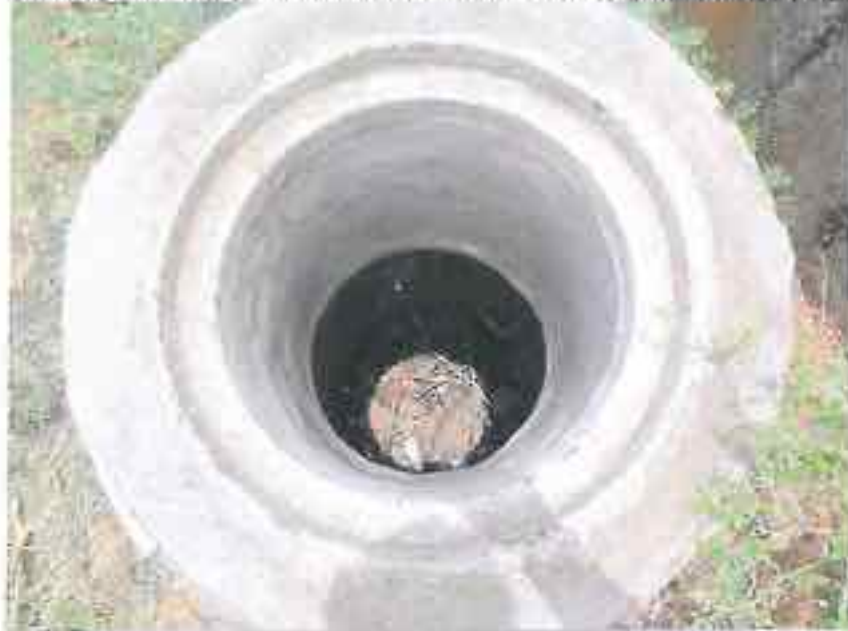
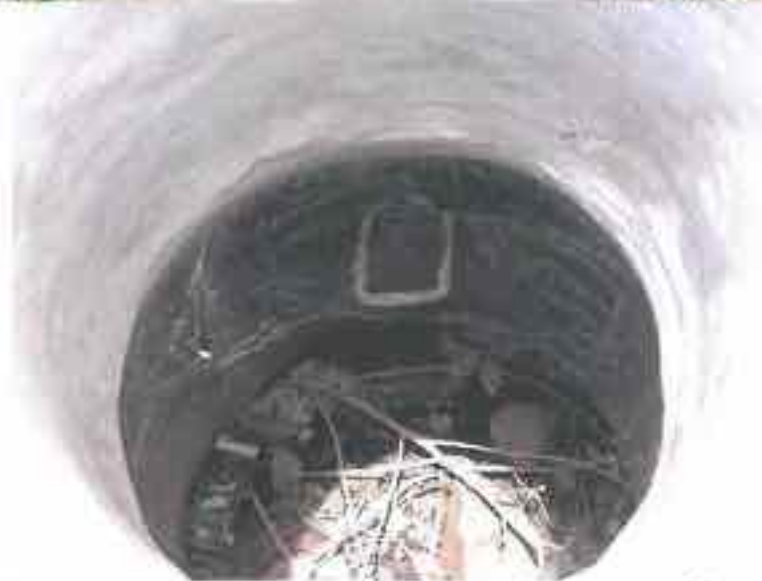
Plate 3.2.14. Dharampuri: Inside a Typical Deep Manhole – Sometimes just one or two footsteps provided even for deep manholes.

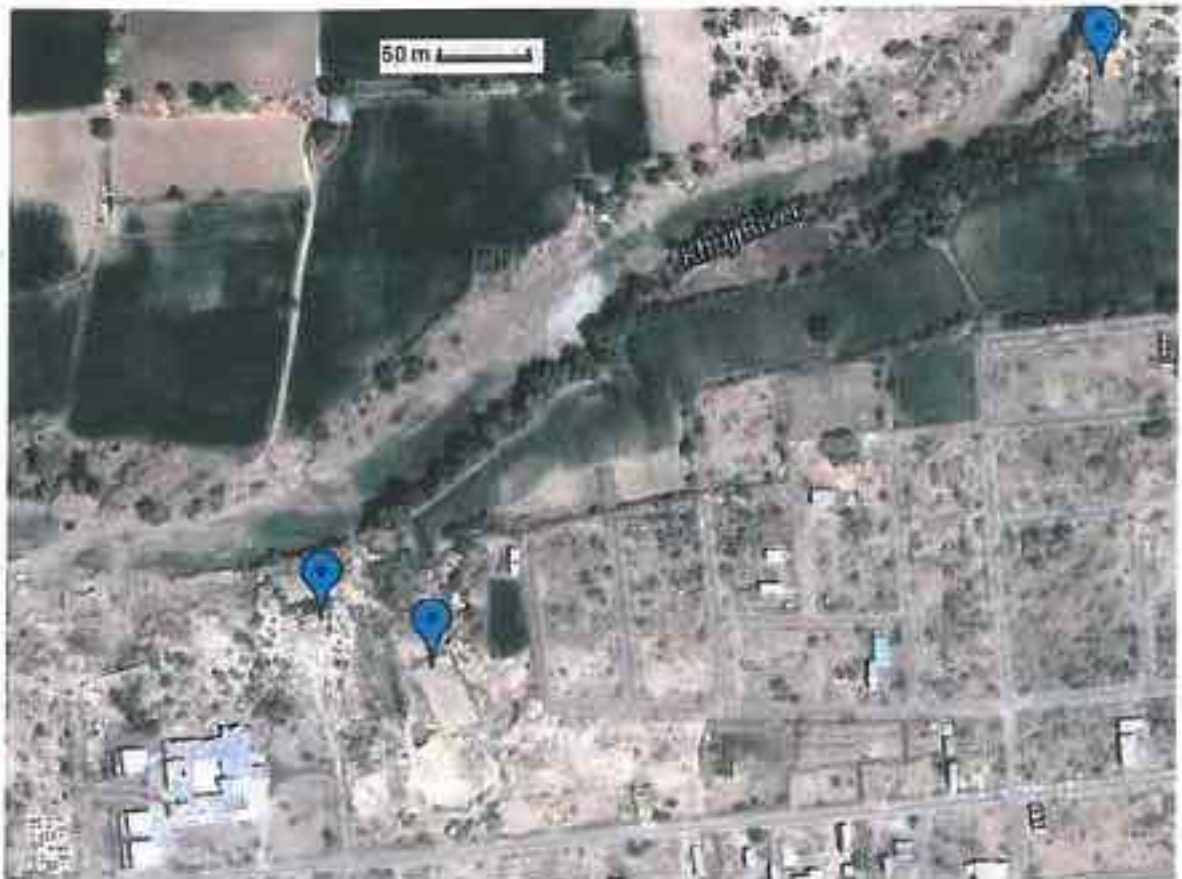
Plate 3.2.15. Satellite Imagery for Dharampuri R&R site

CPHEEO Manual on Sewerage & Sewage Treatment, Government of India Recommendation	Observation on Field at Dharampuri R&R Site
"Because of the unsatisfactory quality of the effluent and also the difficulty in providing a proper effluent disposal system, septic tanks are recommended only for individual homes and small communities whose contributory population does not exceed 300. For larger communities septic tanks may be adopted with appropriate effluent treatment and disposal facilities"	Septic tanks adopted for populations exceeding 5600, and even without any consideration of effluent treatment and disposal.
"In areas with porous soils this method gives satisfactory results.....should not be located in swampy areas or areas prone to flooding. In clayey, non-porous soils or where houses are closely spaced, suitably designed leaching pits may have to be used if septic tanks cannot be avoided"	At Dharampuri septic tanks were located in swampy areas prone to flooding in all likelihood

Location of 3 of the 5 septic tanks at Dharampuri shown in blue balloons. Note their proximity to the Khuj River. Two of the septic tanks are barely 25-30 m from the river while, one of the tank lies 60-75m away, discharging into the Nallah that drains into the River Khuj.

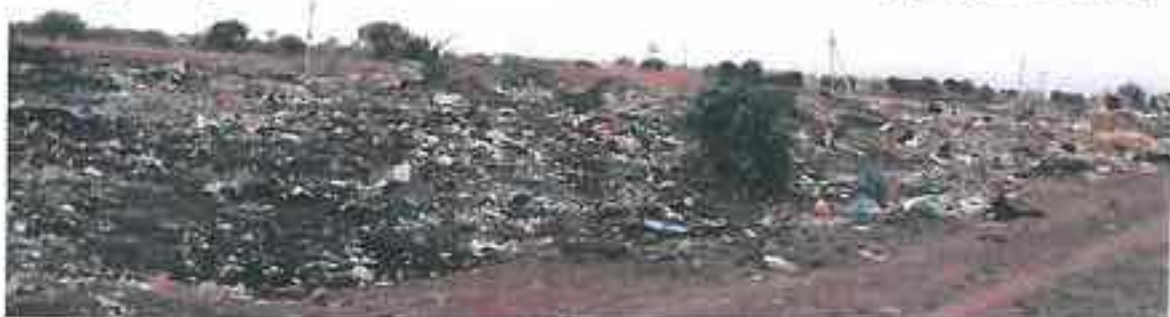
5. In fact, the problem of Solid Waste is intense in nearby urban centres and it was found that the solid waste from other places is being dumped at Khalkhurd (Manavar) (Plate 3.3.1), creating unhealthy environs. The R&R sites do not have any planned provision for solid waste dumping, and may either become dumping grounds for wastes from other habitations along with their own and will have insanitary conditions prevalent as in Khalkhurd, or will end up polluting other places by their solid waste. This issue therefore needs to be urgently taken care of.

Plate 3.3.1. Khalkhurd (Manavar): Dumping ground for Solid waste from outside

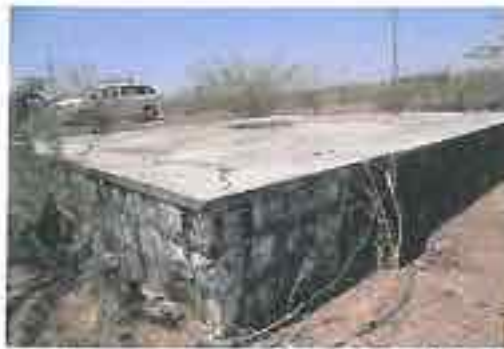
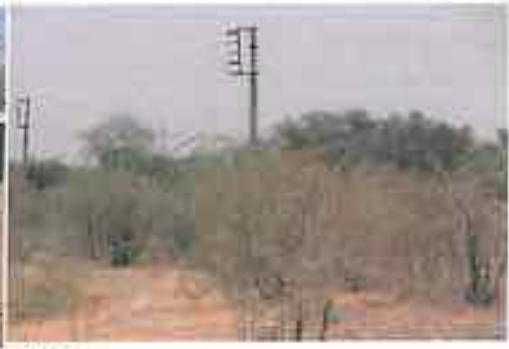
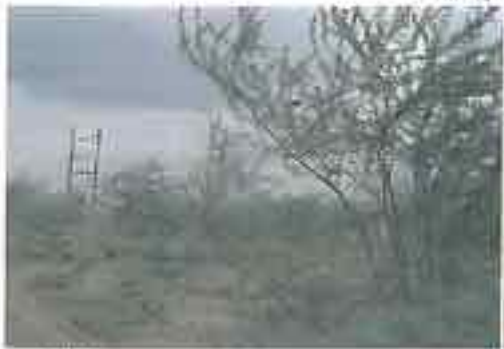
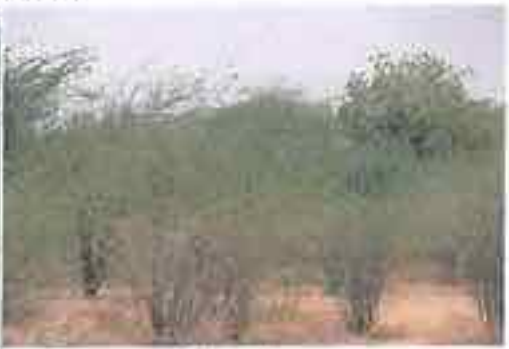
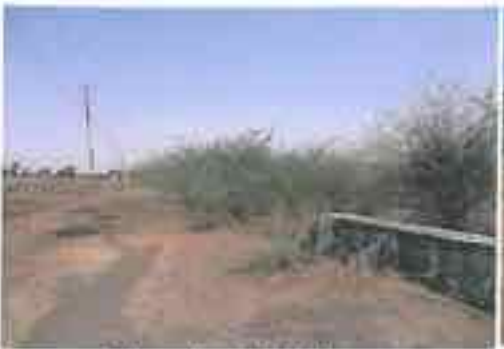
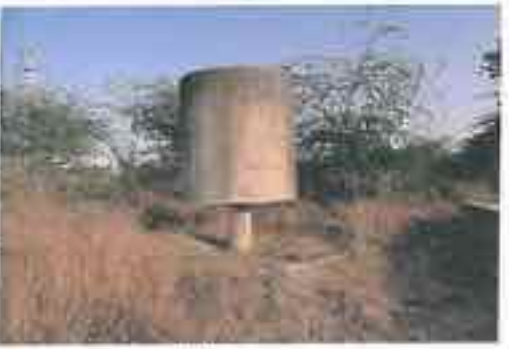
33. The state of Environmental ambience at several sites was extremely poor. At large number of R&R sites, whether inhabited or not, the Babool (American Babool) was found all-round. This is a highly thorny shrub with thick thorns, and has virtually no use. It has overgrown and has invaded the habitats at R&R sites (Plate 3.3.2) by way of material brought for the development works of these sites from outside. It has now spread over large areas, resulting in interference with free usage of the site including of the roads, tree platforms, halaos, handpumps, cisterns etc., loss of aesthetics, hindering the motion of vehicles on roads, and creating trouble for those walking due to hard long thorns. Immediate steps need to be taken to counter and limit this menace; else there are chances that the specie would spread all over the area, creating havoc at not just the R&R sites, but at other villages and possibly in the entire region.

Plate 3.3.2. Extensive American Babool: Endemic problem at most R&R Sites
