Evaluation of the Quality of Civic Amenities at Rehabilitation Sites of the Sardar Sarovar Project

**Sardar Sarovar Project - Fake Sale Deeds and Rehabilitation Sites
Irregularities Inquiry Commission**

April, 2014

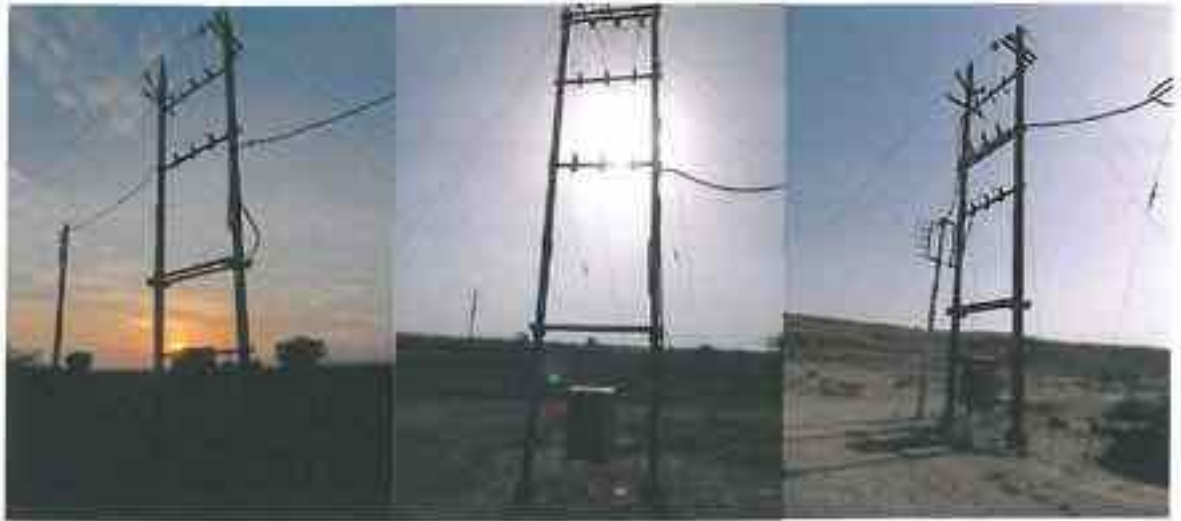
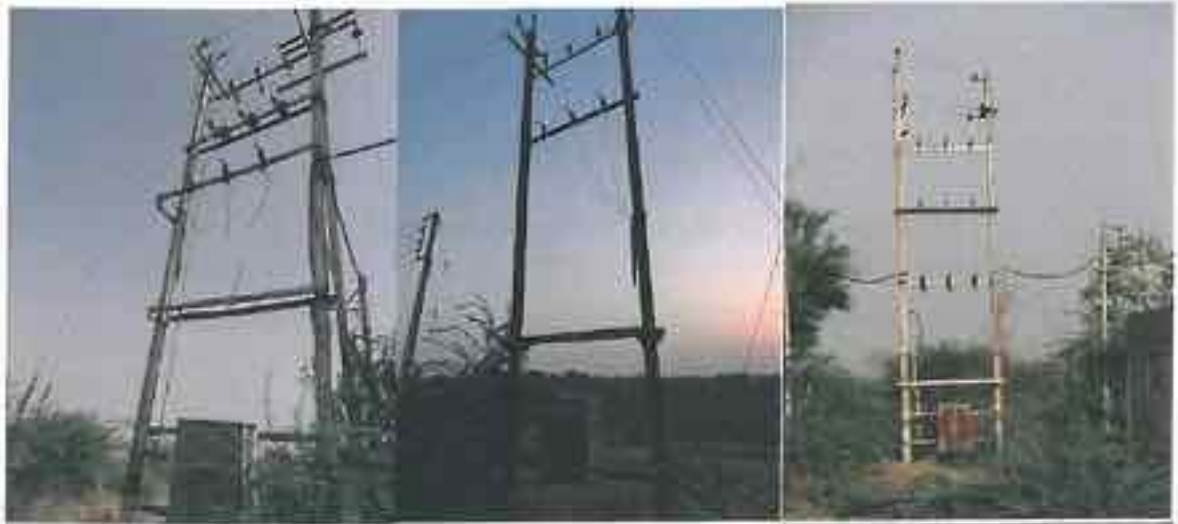
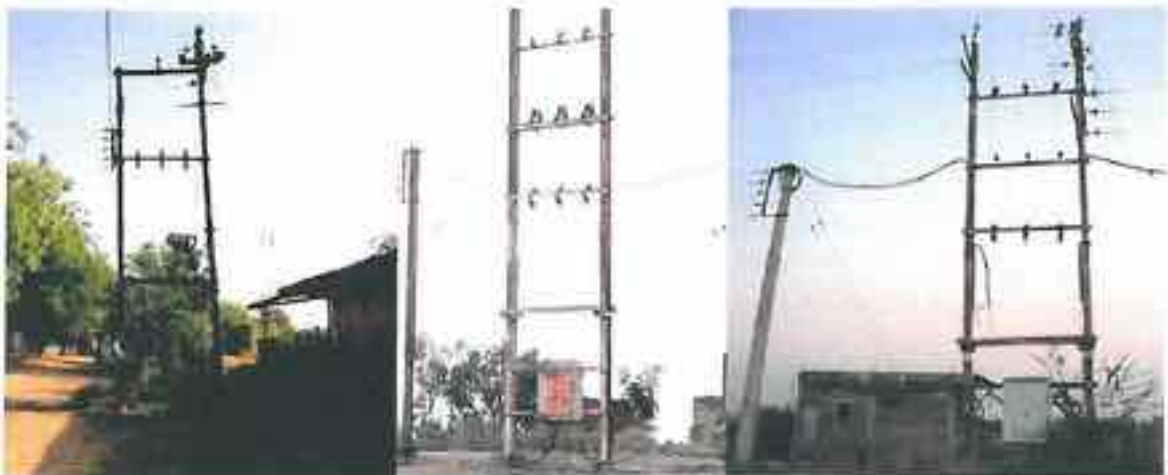
2. A total of 519 Transformers have been claimed as installed at the R&R sites. At almost every site, large numbers of transformers were found missing (Plate 4.1). Few of the missing transformers at some R&R sites (14 in Manavar Tehsil) have been taken off by the Electricity Company and kept in their "safe custody" for fear of being stolen, while some have actually been stolen (7 in Kukshi) as per the information provided by Madhya Pradesh Paschim Kshetra Vidut Vitran Co. Ltd, (MPPKVVCL) Dhar Circle (Annex 4-A). Despite the numbers in "safe custody", and the stolen transformers, the number of missing transformers remains very large.

Plate 4.1. Typical Missing Transformers.....cont.

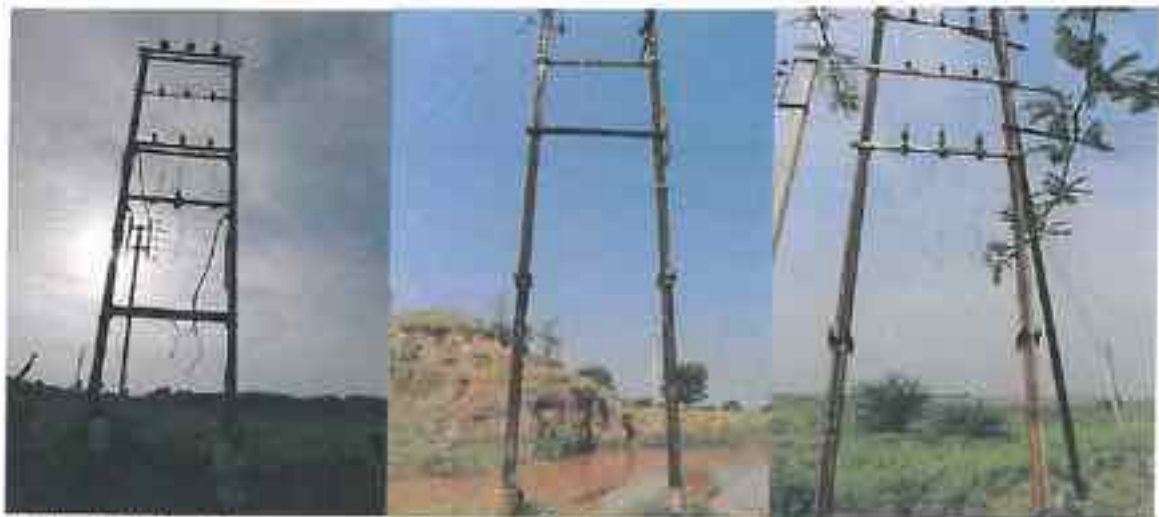
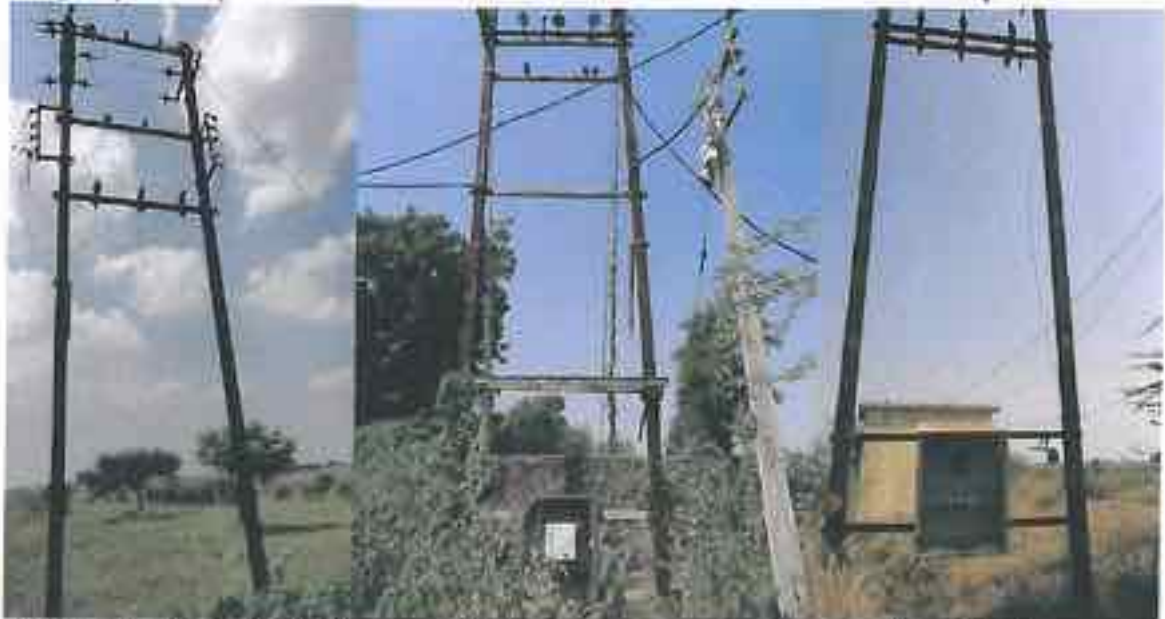
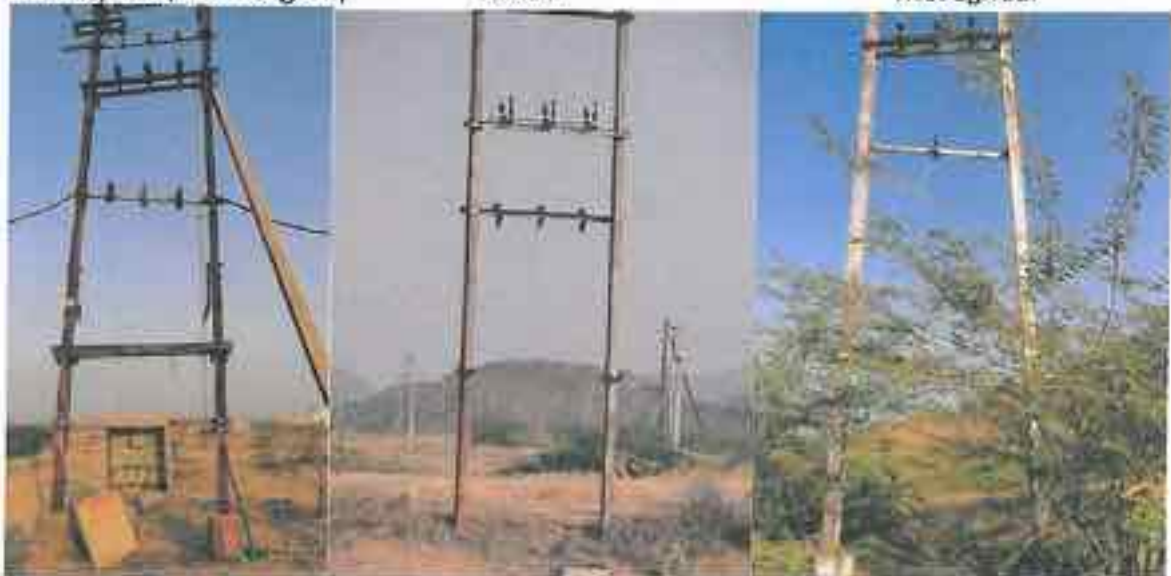
Plate 4.1. Typical Missing Transformers

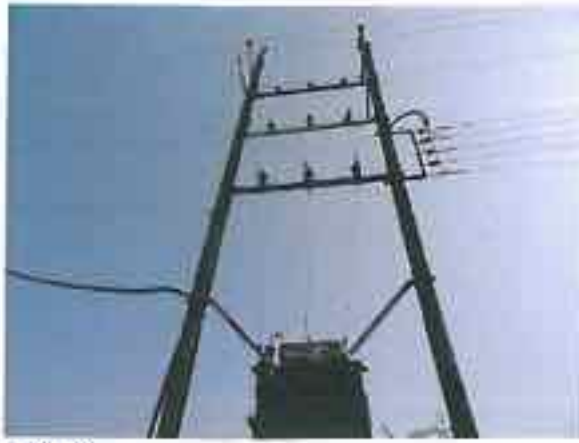
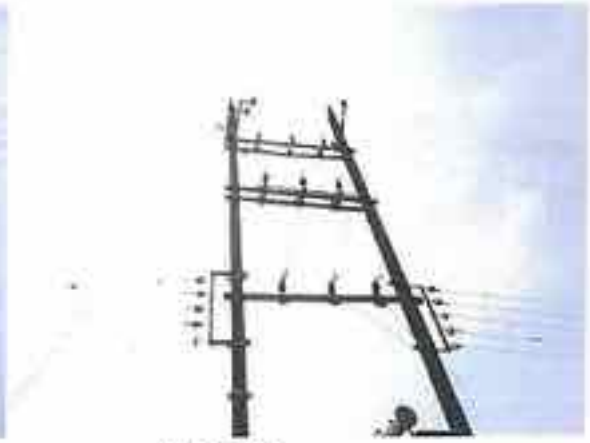
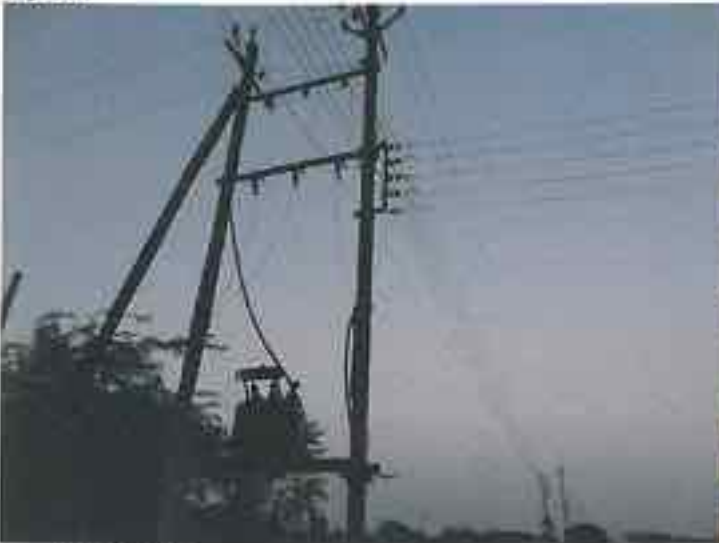
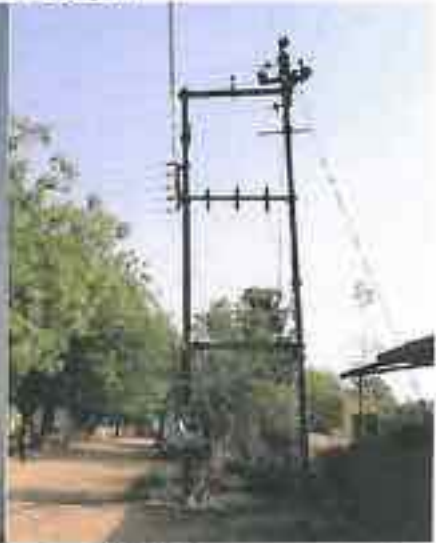
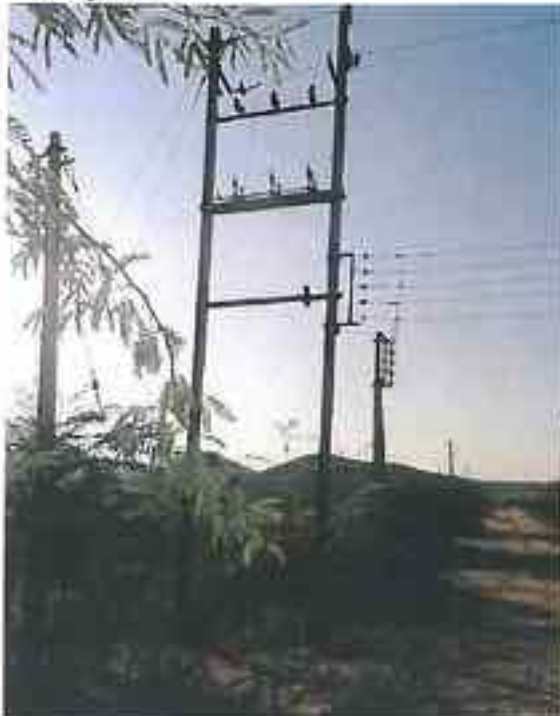
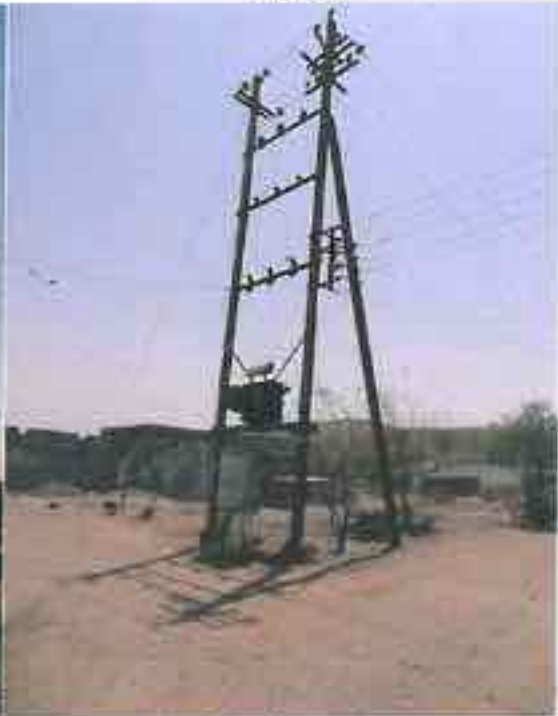
30. In a number of instances, arrangements were made to connect the lines directly to the poles hoisting the transformers in complete violation of approvals by the Chief Engineer (Electrical safety) and Chief Electrical Inspector (Plate 4.3). Thus, no separate pole was sometimes found to connect the LT lines, or if present, was rendered defunct, and the mandatory triple pole arrangement was done away with (Plate 4.4).

4.4: Transformers poles connected directly to the conductors. The Third pole is either defunct or does not exist (Typical). Blatant Violation of safety Standards.

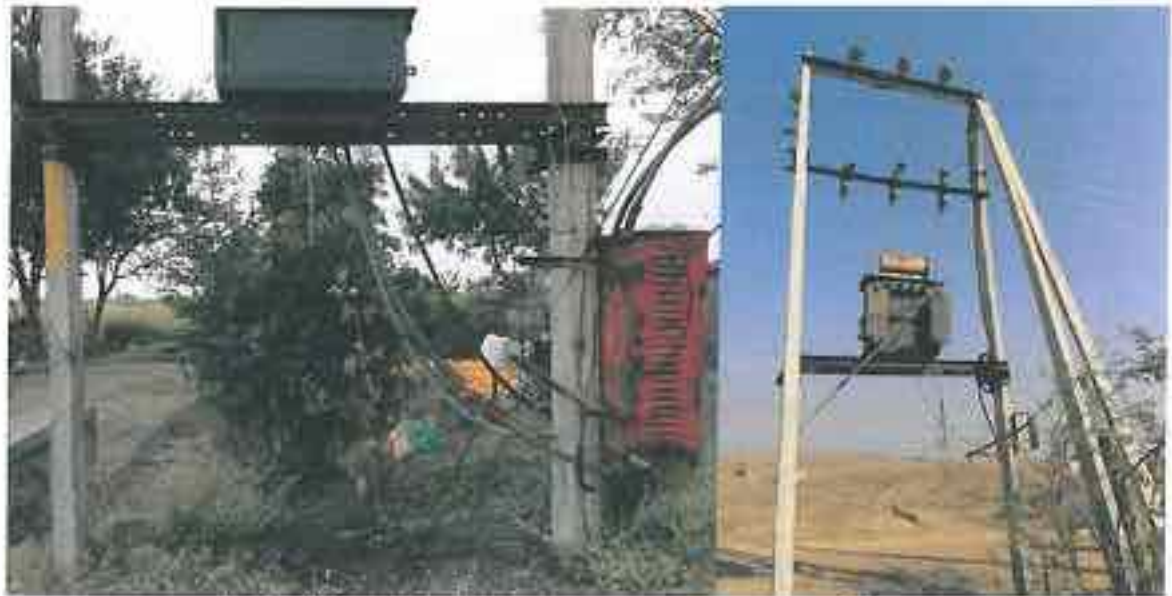
31. In certain cases, the Transformers were found hoisted on PCC pole supports (Plate 4.5), instead of the usual metal supports found almost throughout the R&R sites. While this may be permitted, in some cases this led to reduced height of conductors implying safety concerns when the third pole was not used, and connections were directly carried out from poles hoisting the transformers.

Plate 4.5. Transformers on PCC poles (Typical)

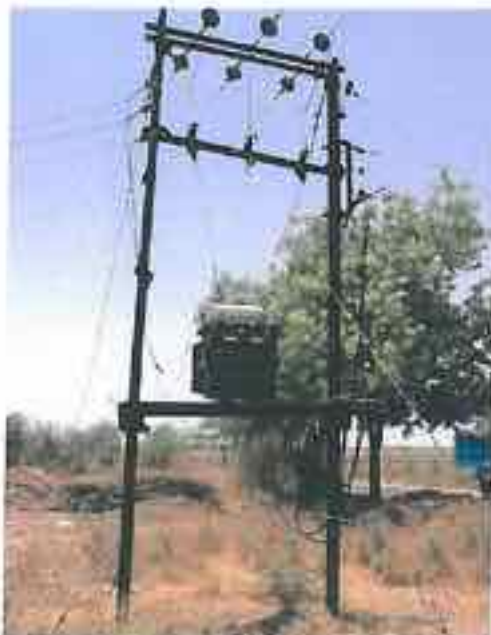
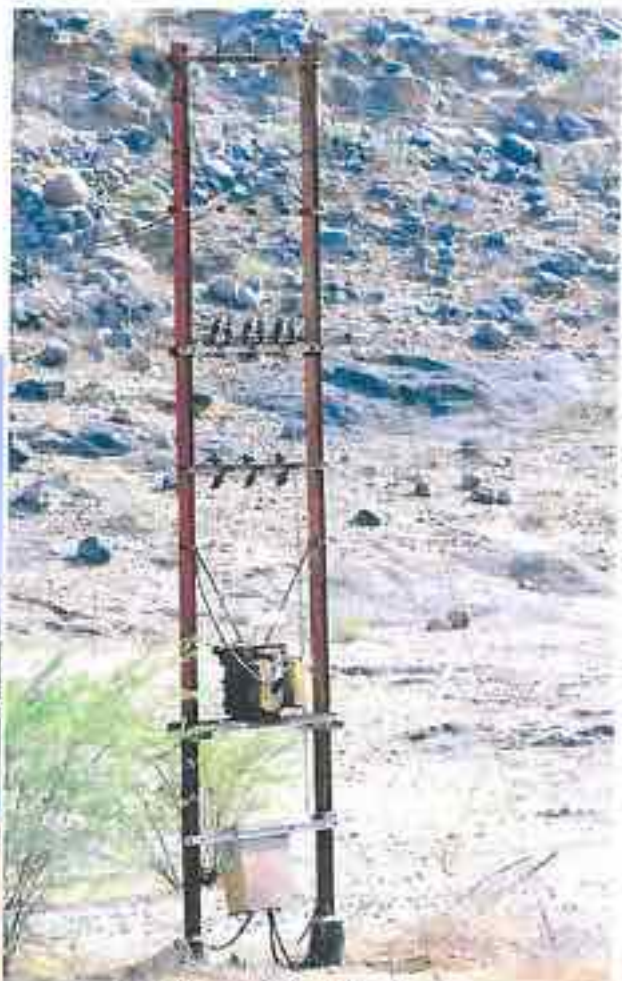
32. Significantly, deviations were noticeable in the form of reduced Pole widths/heights on which transformers were hoisted (Plate 4.6) at sites like Jalanpur Dhalkheda, in violation of widths as specified by the Chief Engineer (Electrical safety) and Chief Electrical Inspector (Plate 4.3). Narrow widths obviously constrict the arrangement of various accessories, bringing them nearer, which is detrimental to safety, thereby significantly increasing the risks.

Plate 4.6. Typical Noticeable Deviations in Heights and Widths.

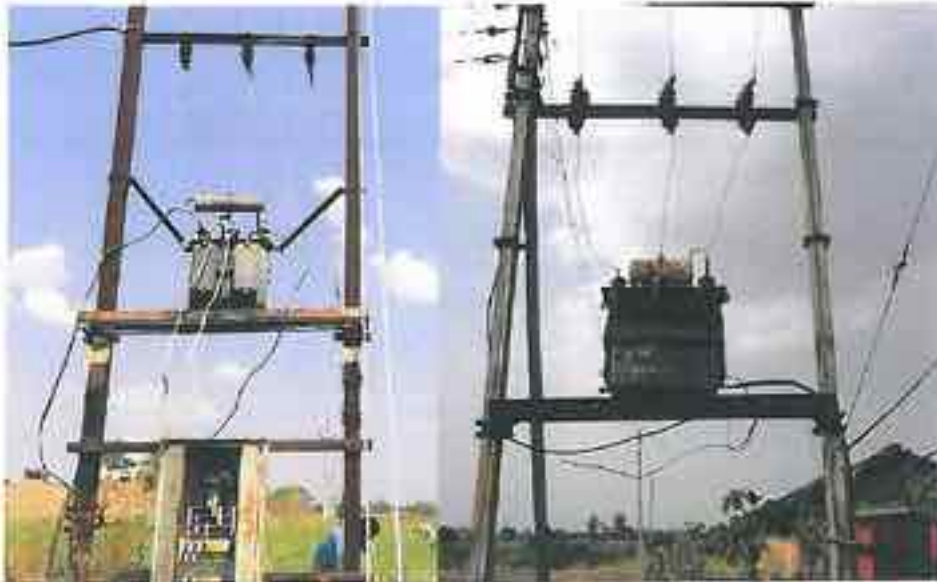
Typical Absence of AB Switches (Left-Moosapura(Dhar) and Right Kesur (Ramnagar))

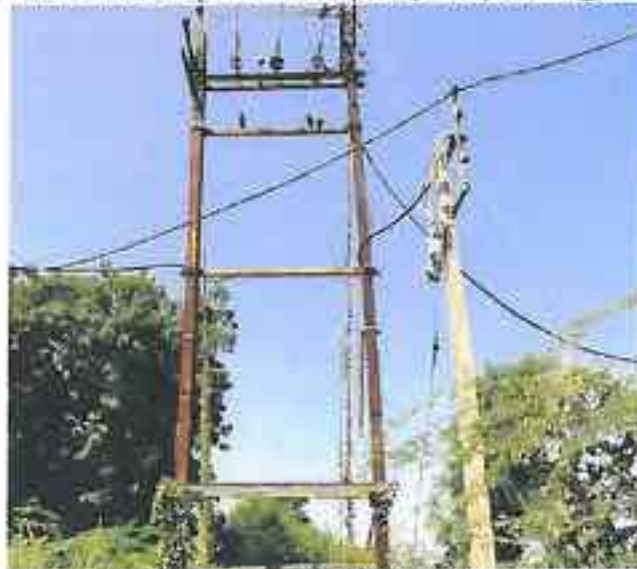
34. A major compromise with safety was missing/no provisioning of AB switches at very large number of R&R sites. The air break switches are gang operated devices to isolate the Transformer, Overhead lines, System or Cables from distribution network when necessity arises. At large number of R&R sites (nearly 65), AB Switches were not provided. At other sites, these were either completely missing, or were found without operating handles and so not likely to operate, or were simply found damaged with upper part placed on MS-channel. Finding appropriate AB switches was not a common occurrence, and constituted a major breach of safety requirements (Plate 4.7).

Jalkoti: Only the handle of AB Switch remains

Plate 4.7. AB Switches not seen at a large number of sites: Compromise with safety

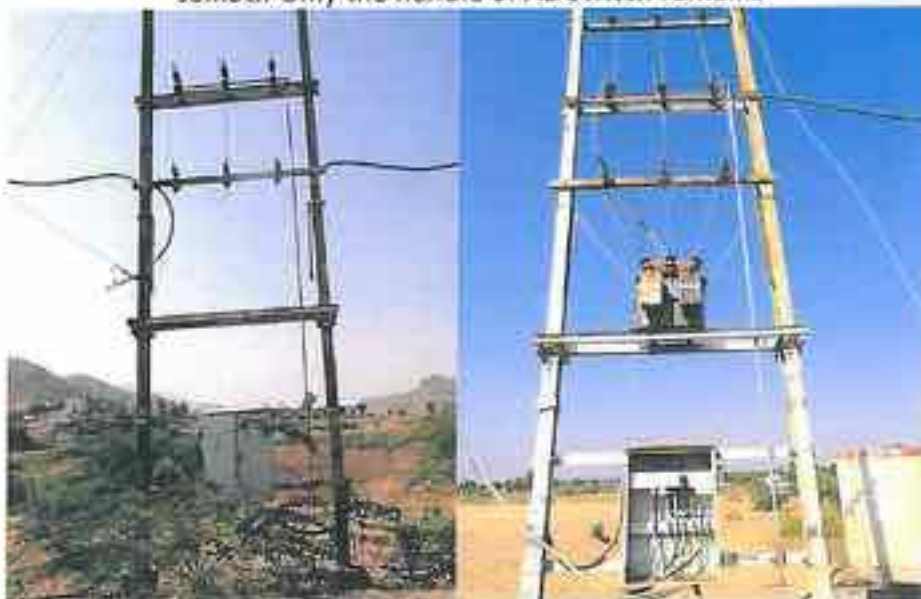
Awalda: AB switches present in two cases-Not a very common occurrence

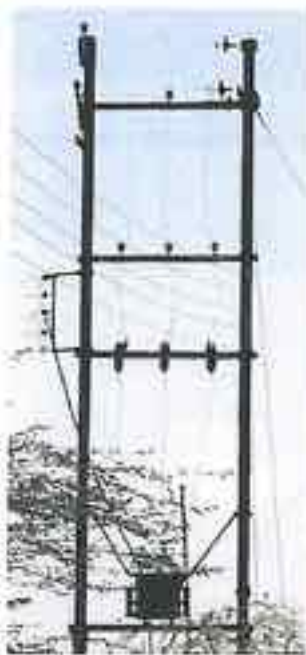
35. Another safety device, the Lighting Arrestors (LAs) were also sometimes found missing, or inappropriately placed (in contravention to drawing approved by Chief Engineer (Electrical safety) and Chief Electrical Inspector: Plate 4.3), or damaged and burst or bypassed (Plate 4.8). Arresting the natural Lightning is essential for the protection of electrical network, transformers and public utilities including appliances from the surge voltages that may happen during the cloud lightning. If the Lighting Arrestors are not working and available, electrical surge of excessively high amplitude would reach the network and may lead to widespread damage of electrical network and appliances at the consumer end. Not providing the Arrestors is a violation of rule 92 of the Indian Electricity rules, 1956 and also of the design approved by the Chief Engineer (Electrical safety) and Chief Electrical Inspector (Plate 4.3) and is an essential compromise with the safety of the designed network and safety at the consumer end.

Kadmal: Missing LA

Plate 4.8 . Missing/ Inappropriately placed Lightning Arrestors (Typical)

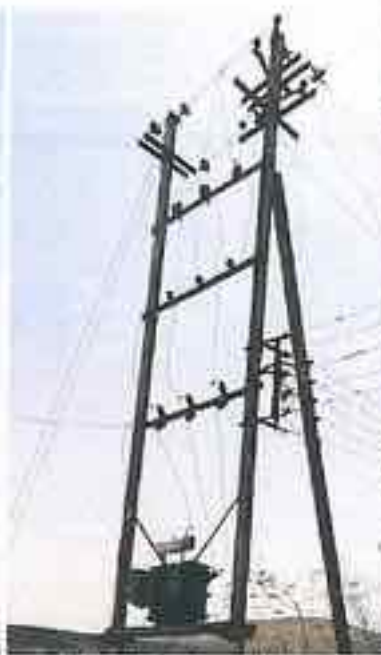
Anjad Barda: Missing LA

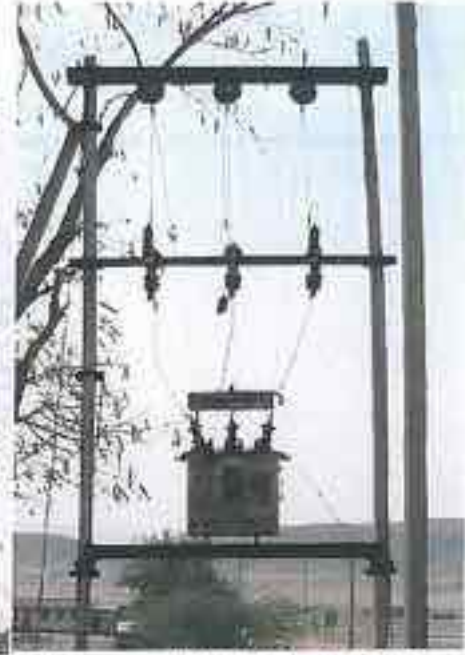
Dharamrai (Kukshi): only 2 LAs present, 1 seems burst, Also Placed Inappropriately

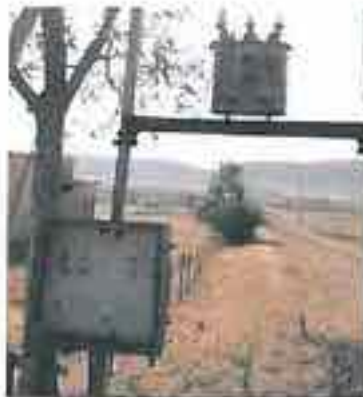
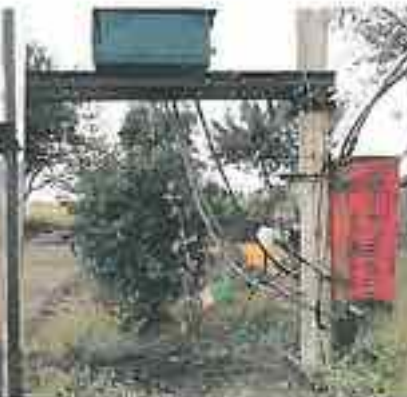
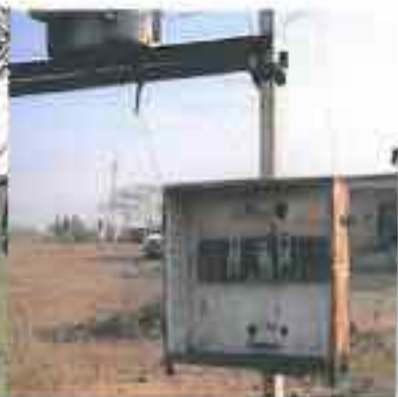
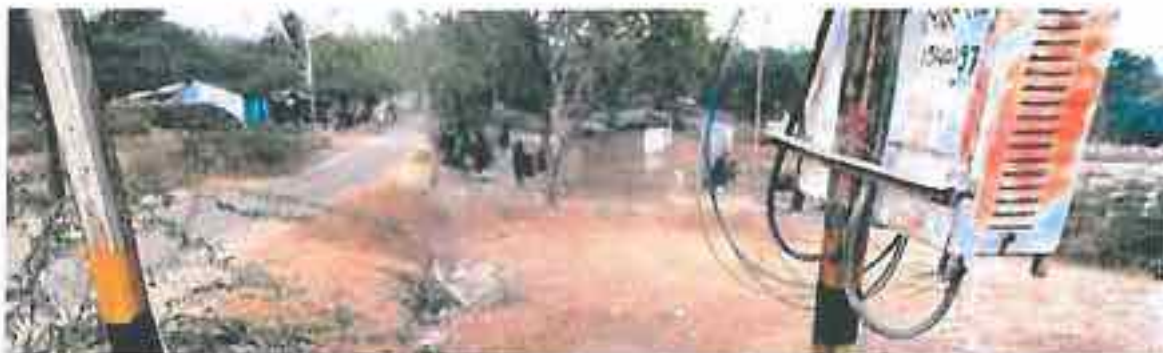
38. Another safety concern was inappropriate placement of the LT Distribution boxes. Several times these were not installed correctly, and rather than placing these in the centre of two poles on proper supports (angles/channels), supports were not seen provided, and box was mounted on a single pole itself (Plate 4.9). This compromised the safety, as such placements reduce the mechanical strength against lateral forces, and such placements are in violation of layout design approved by Chief Engineer (Electrical safety) and Chief Electrical Inspector (Plate 4.3)

Plate 4.9. Typical Inappropriate placement of Distribution Boxes on single poles. Compromise with Safety and Security.

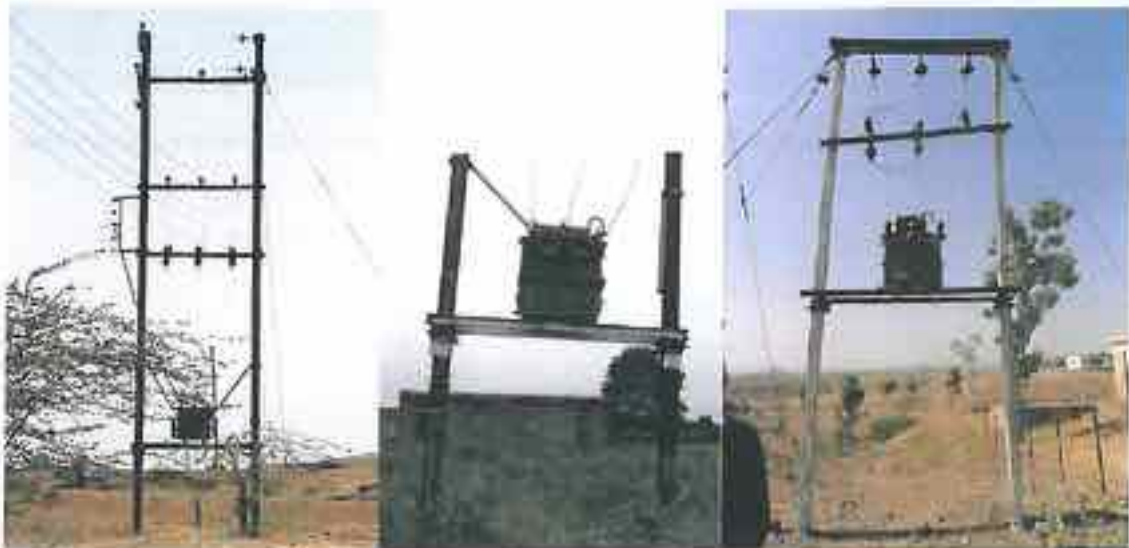
39. Similar to large number of missing transformers, the Switchboards and Switchgears were also missing frequently. The panel boxes were sometimes absent entirely (Plates 4.10), or were often merely present as empty boxes with missing Switchgears (Plate 4.11).

Plate 4.10. Missing Switchboards (Typical)

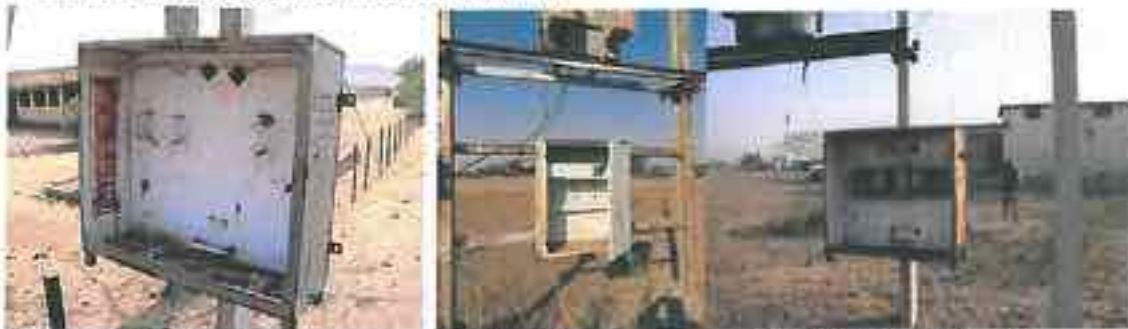
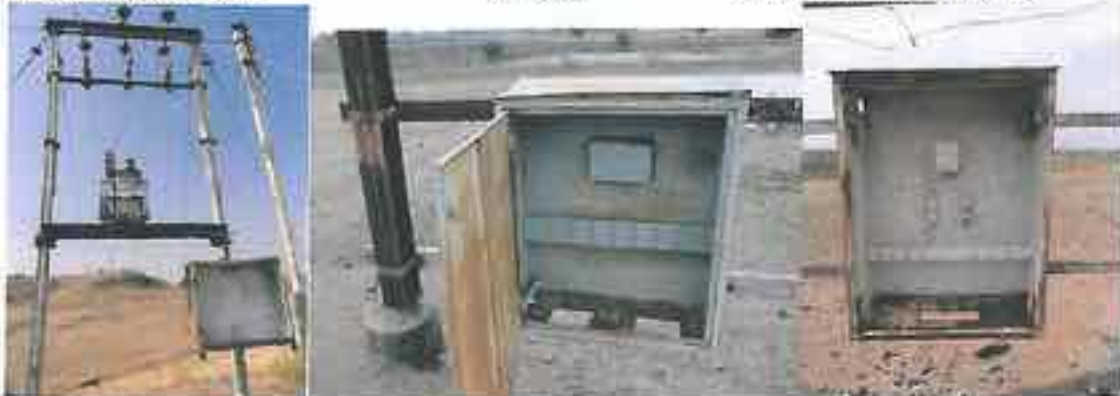
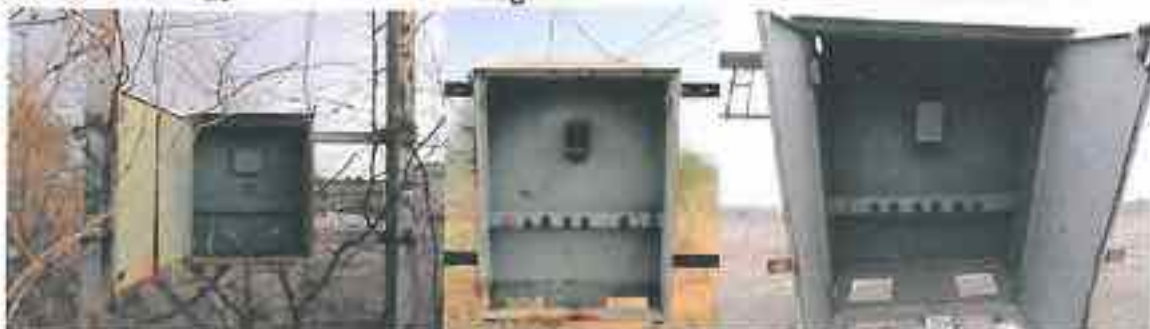
Plate 4.11. Missing Switchgears: Just the Boxes remain, mostly without even covers (Typical)

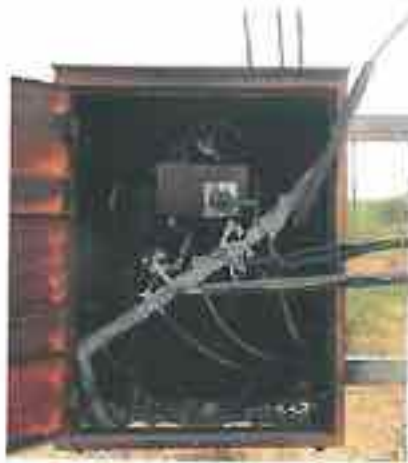
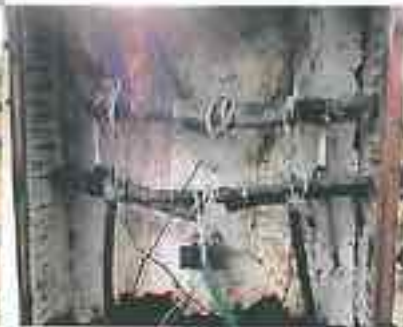
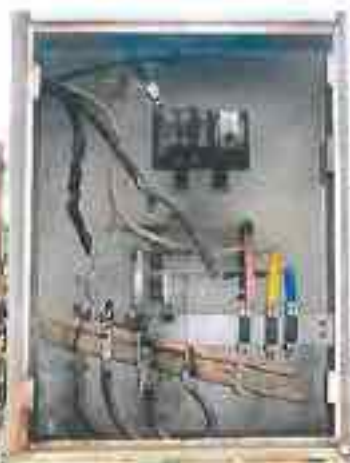
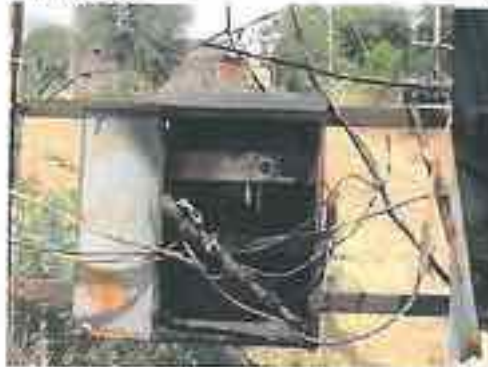
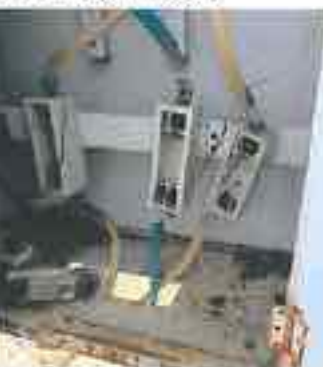
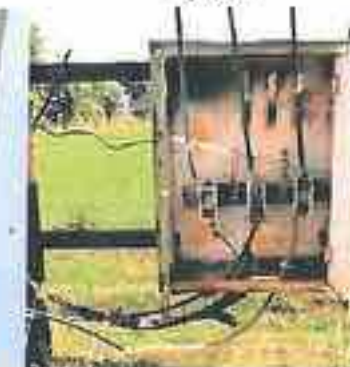
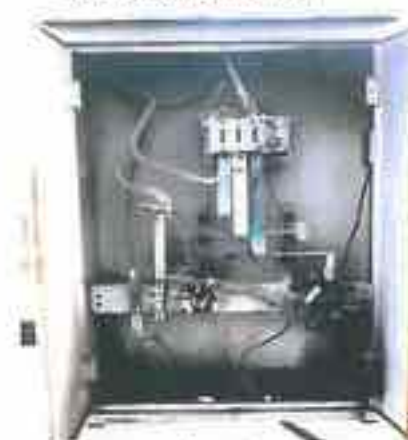
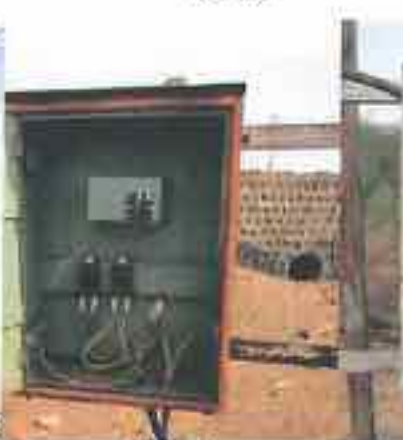
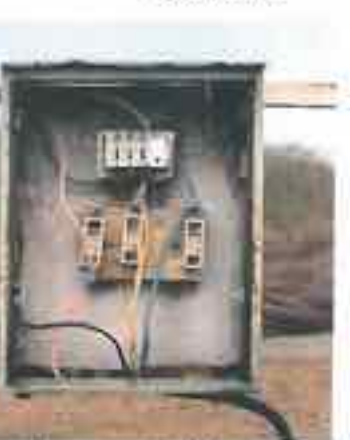
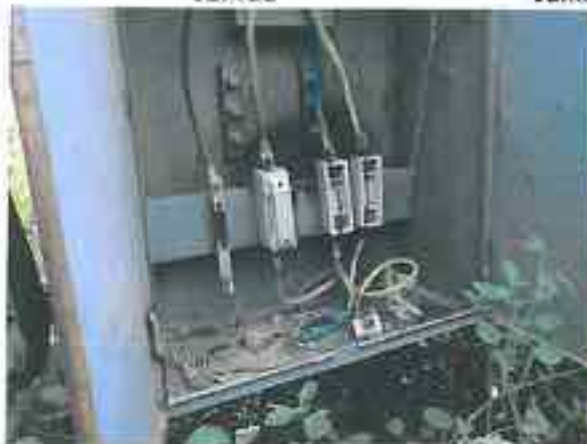
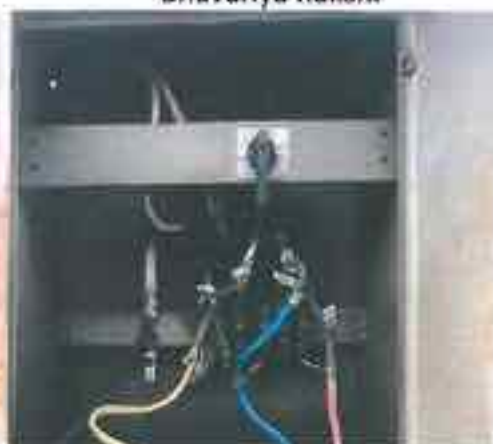
41. The LT boxes and the Switchgears, when present, often had poor quality which in itself was a cause of concern at several sites, with adhoc connections visible at large (Plates 4.12).

Plate 4.12. Adhoc & Poor LT-Box Arrangements and Connections: Safety Compromised

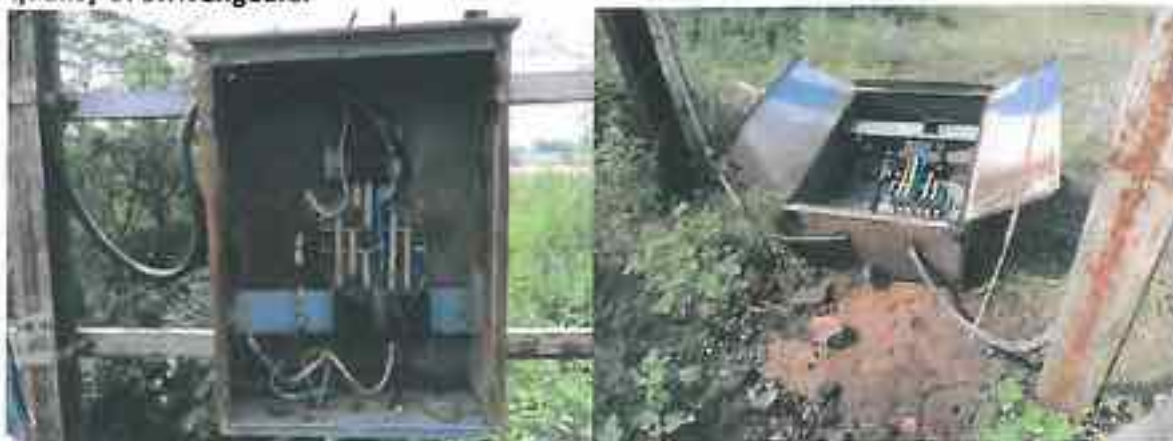
45. There were instances where at the same site, the panels had MCCB and Switches, while some others had no such safety provision. Plate 4.14 indicates one such instance at Nisarapur. Thus, there did not exist a universal template across the R&R sites, and even amongst the same site, indicating adhoc planning and execution.

Plate 4.14. Two Panel boxes at the same site: Nisarpur, One without covers and Switch, and the other with covers, but lying on the ground, open, but with Switch. Thus differences in Panel quality were observed even at the same site.

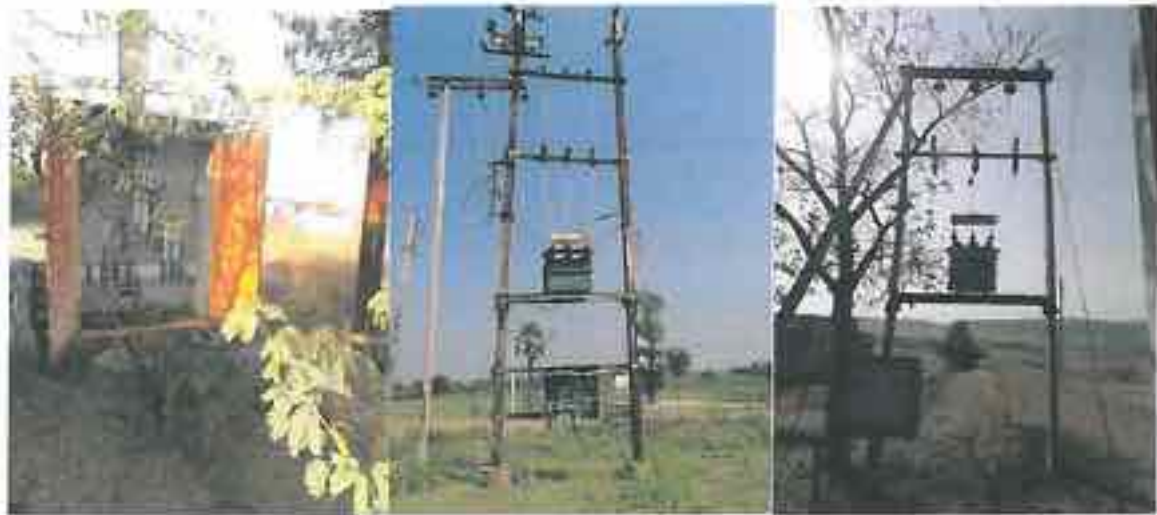
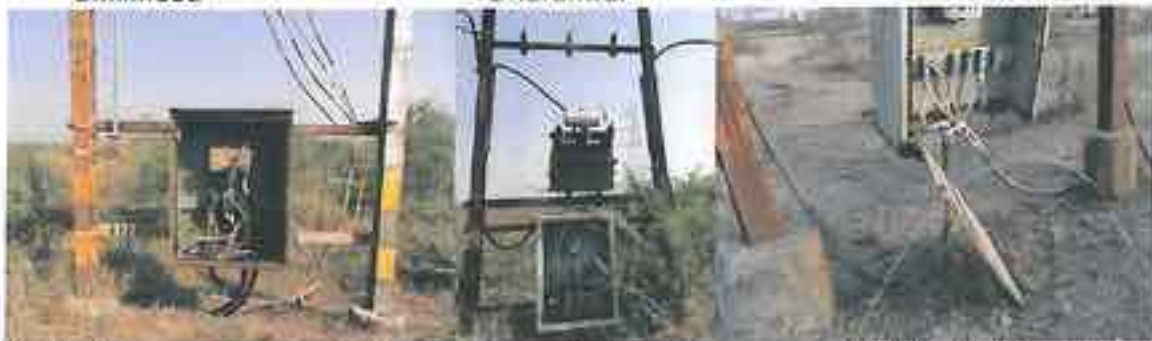
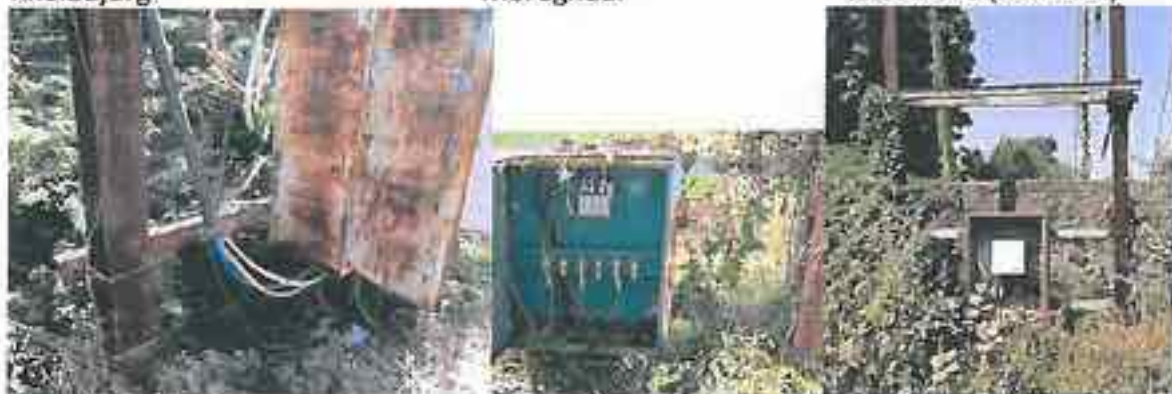
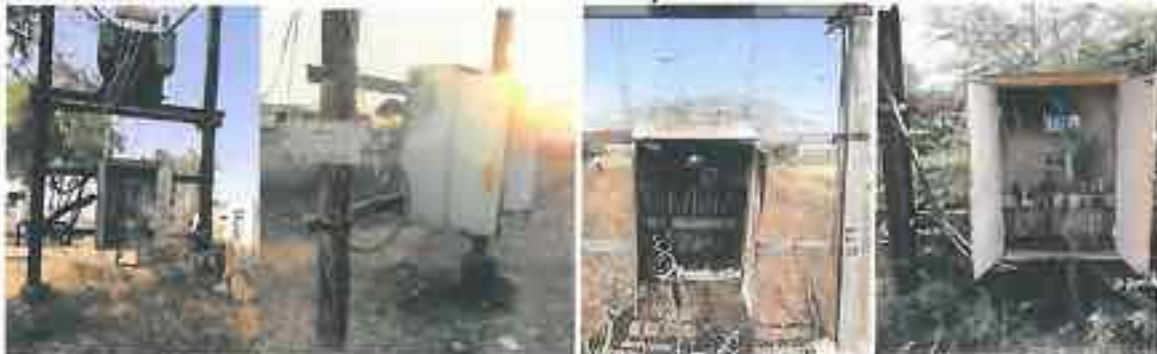
47. Besides the above lapses with regard to safety, one more widespread and significant security lapse has been the height of the LT box above the ground. This has been a matter of negligence at large number of sites, where significant number of panels were almost at the ground level, just 25 - 40 cm above (Plates 4.15), allowing the children and animals unrestricted access, more so when the switchboard cover boxes were found missing as has often been the case, and even

Plate 4.15. Safety Hazard: Inappropriate ground clearances for panel boxes. Additionally, the Switchboards often have missing/open covers without locking arrangement whatsoever, and hence are easily accessible (Typical). Also poor qualities.

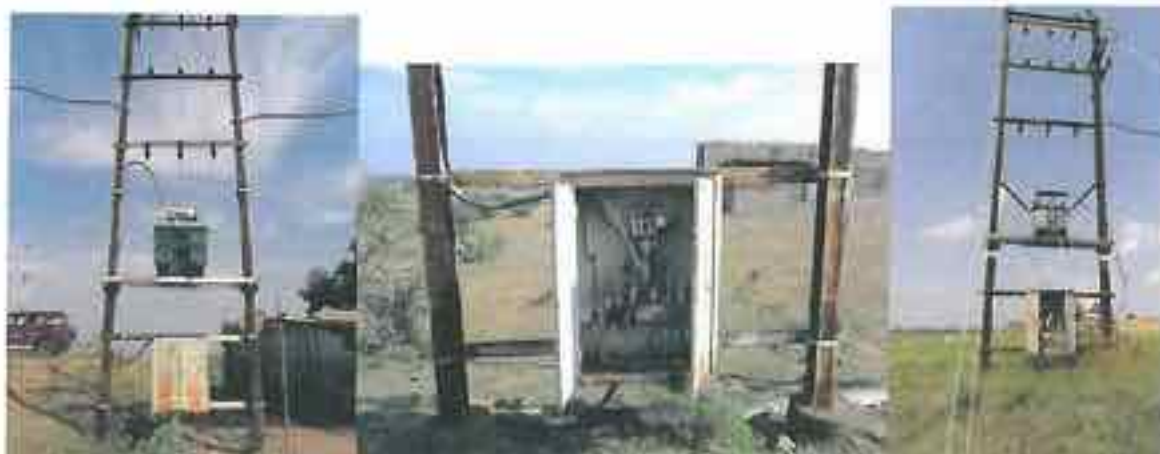
48. Such lapses were not limited to remote and smaller sites. Large R&R sites and even the recently installed infrastructure had similar quality concerns. Niasarpur is a typical case (Plate 4.16) where sometimes even the transformers are accessible to passer-bys (Plate 4.17). Similarly, at Borlai II, under phase II where the work has been carried out in 2009 (Plate 4.18) the quality remained what it has been throughout for a majority of the sites. The repeated mistakes indicate callousness in planning, design and execution by the concerned agencies, and an inability to learn and improvise upon itself with passing time and experience.

Plate 4.16. Three cases at Nisarpur : No lock and key arrangement, and No fencing around. Note the height of panel boxes in each case. Children would be tempted to open the boxes, and animals can be intrusive. Poor planning, execution, and workmanship.

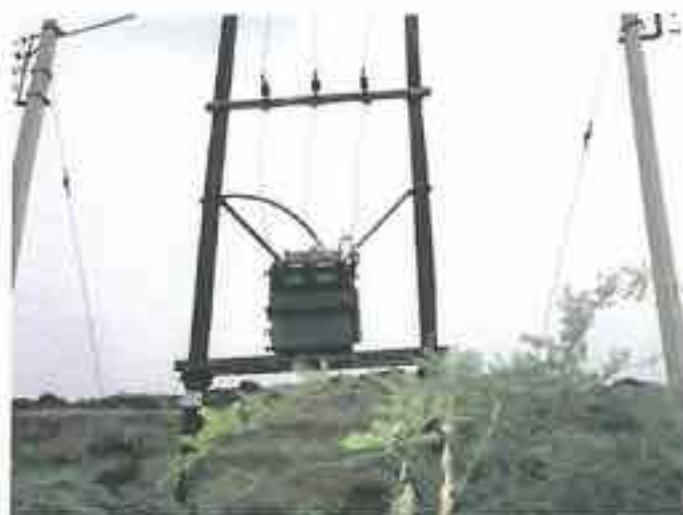
Plate 4.17. Nisarpur: Here even the transformer can be touched, little space left for installing a panel

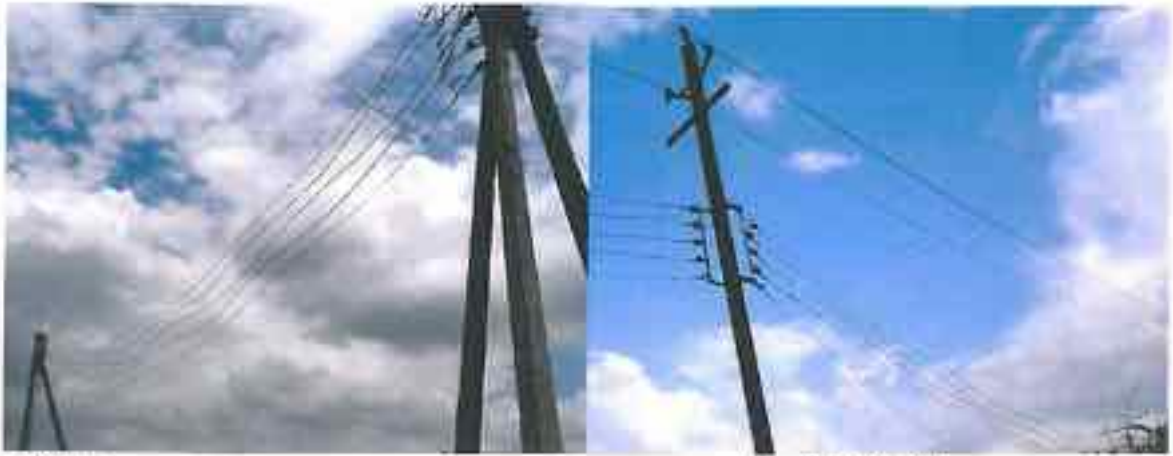
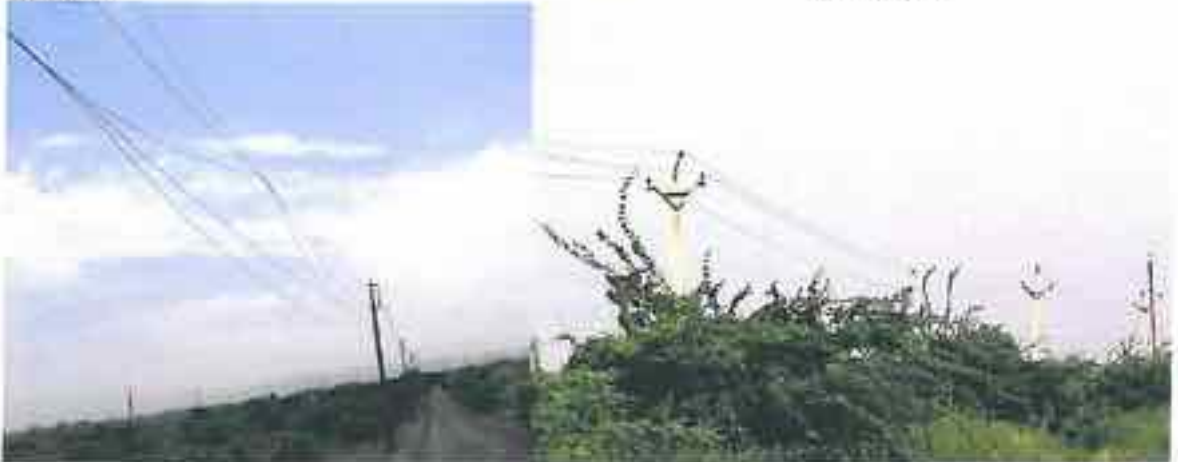
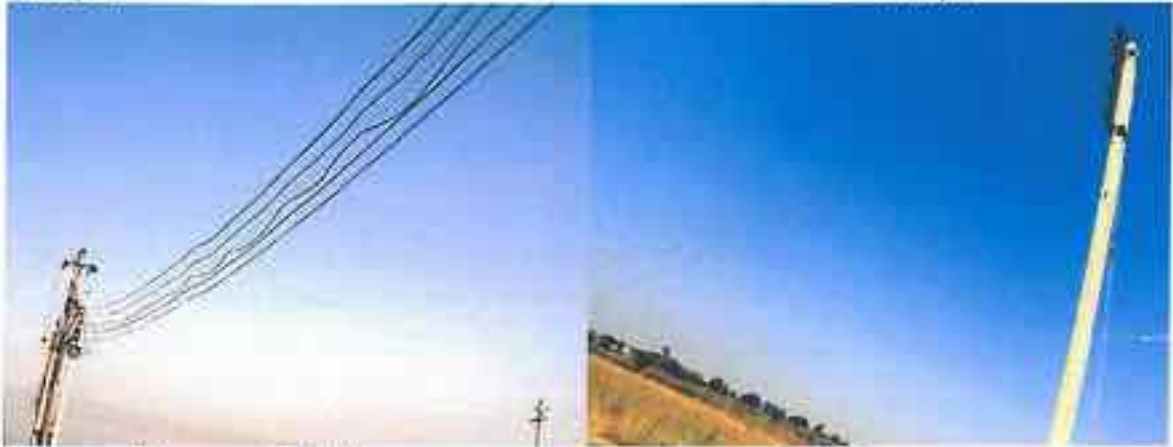
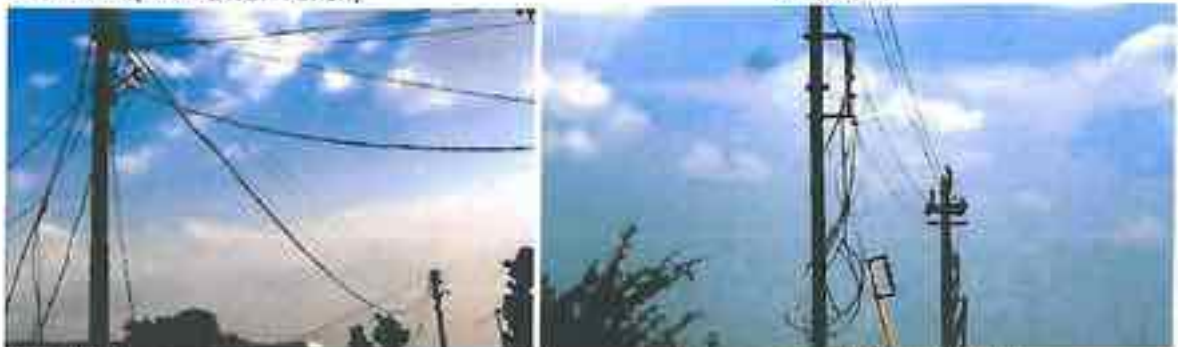
52. Conductor wires were very often seen loose and sagging at several sites (Typical Pictures: Plate 4.19).
53. Related safety concerns are mostly left unaddressed, as clashing of loose conductors cannot be ruled out resulting in interruptions of supply to consumers, increased maintenance problems, and reduction in the useful life of electrical infrastructure including distribution transformers.

Plate 4.19. Loose Hanging Wires (Typical)

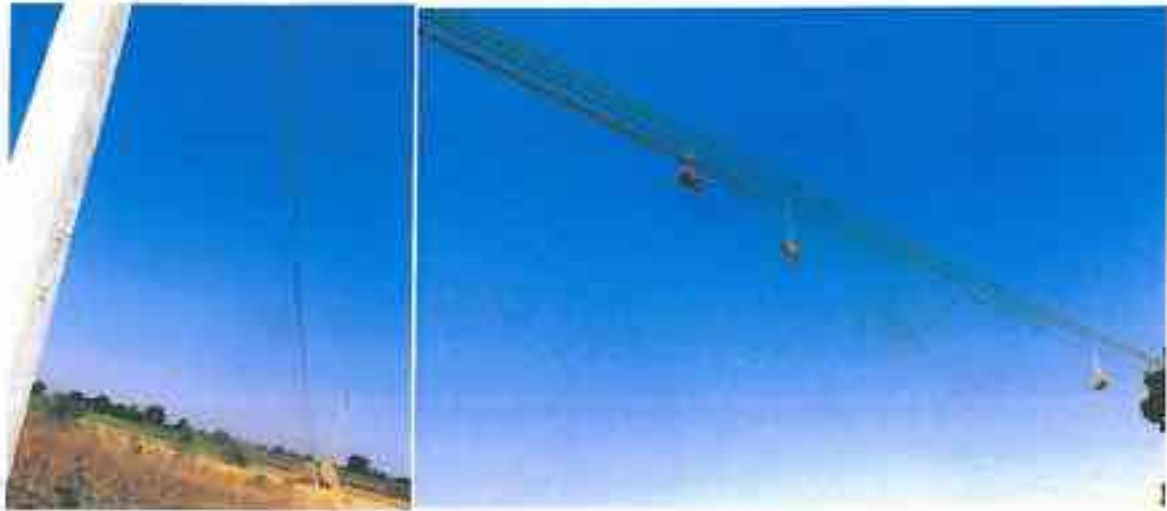
56. Despite loose and sagging conductors, the Spacers were not seen at sites. Sometimes, like at Chikalda for instance, the requisite gaps between loose conductors were sought to be compensated by hanging weights in the form of bricks (Plate 4.20). While, it is evident that the bricks could not be hung on charged lines by general public, it speaks volumes of the state of maintenance by the Supplier and maintenance authority at R&R Sites.
57. The likely reasons for loose conductors could be surmised as:
- Inappropriate work execution
 - Inappropriate quality of Conductors
 - Inclined poles at several places

Plate 4.20. Chikalda: Loose Hanging Wires, absence of necessary gaps amongst the conductors compensated by hanging Bricks.
