Evaluation of the Quality of Civic Amenities at Rehabilitation Sites of the Sardar Sarovar Project

**Sardar Sarovar Project - Fake Sale Deeds and Rehabilitation Sites
Irregularities Inquiry Commission**

April, 2014

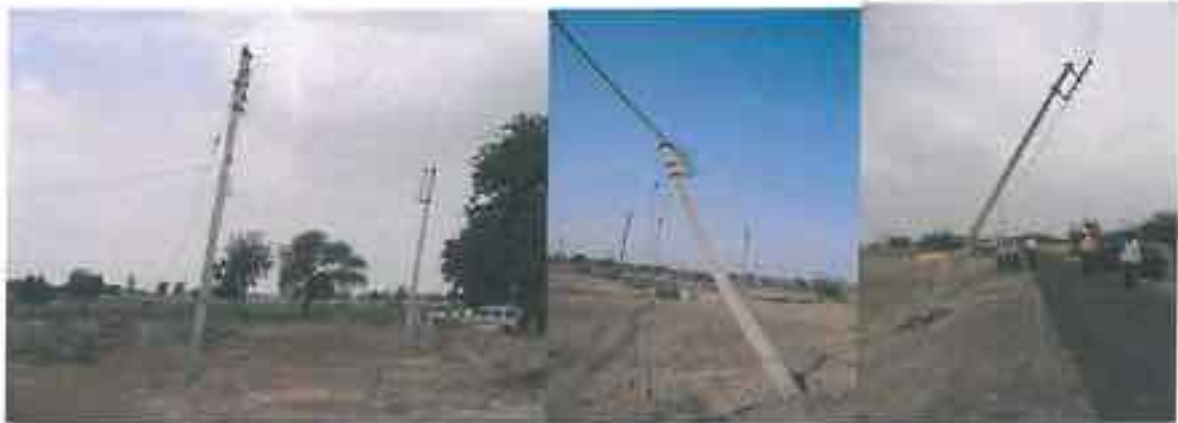
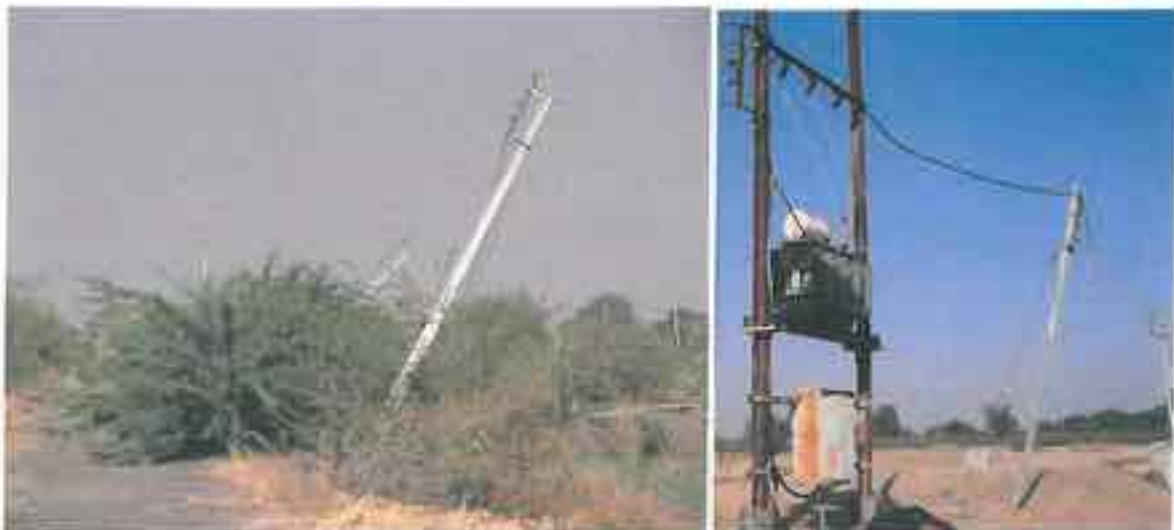
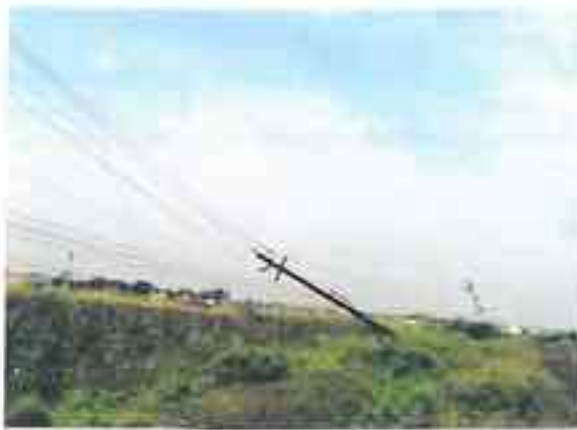
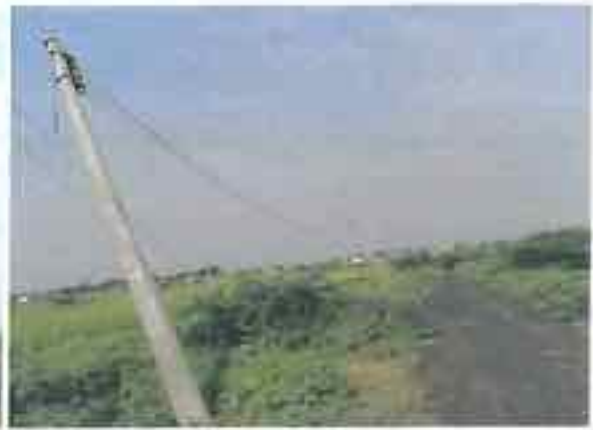
58. At certain sites, the loose hanging/sagging wires could also be a result of Inclined poles (Plates 4.21). This problem of inclined poles was endemic at several sites.

Plate 4.21. Inclined poles: A generic problem at several sites.....cont

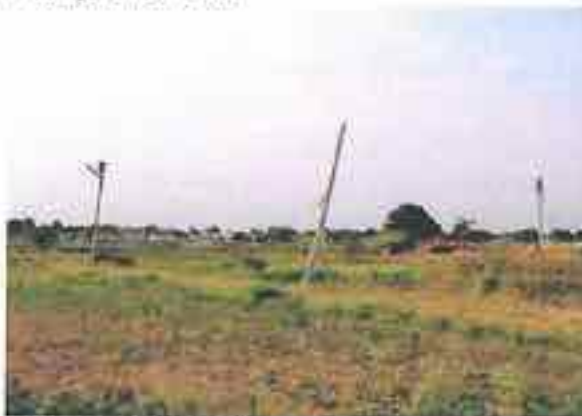
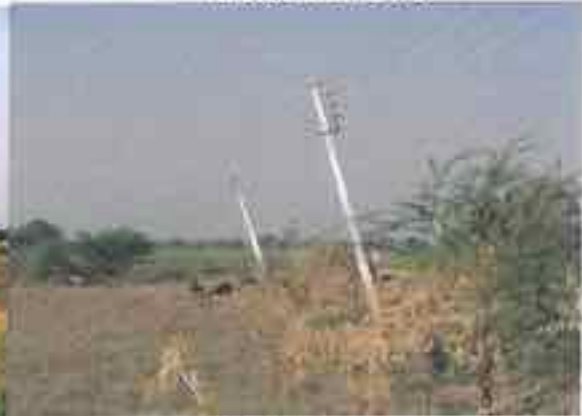
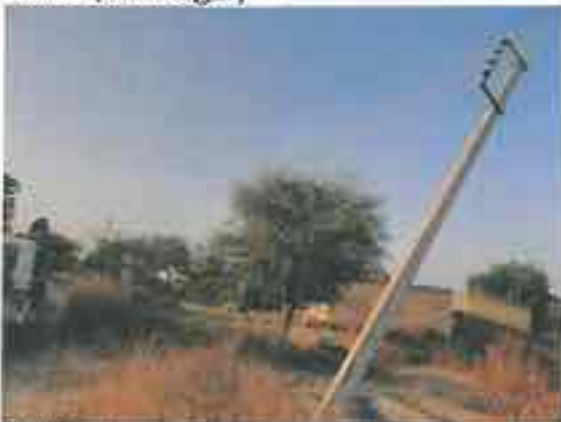
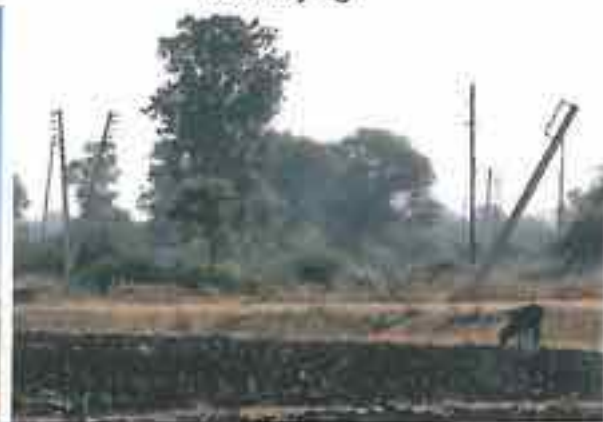
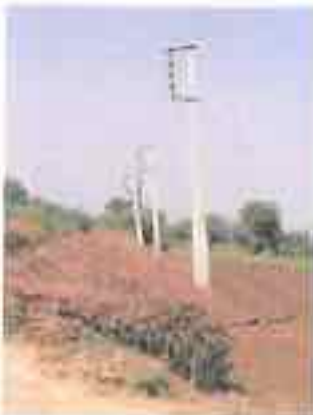
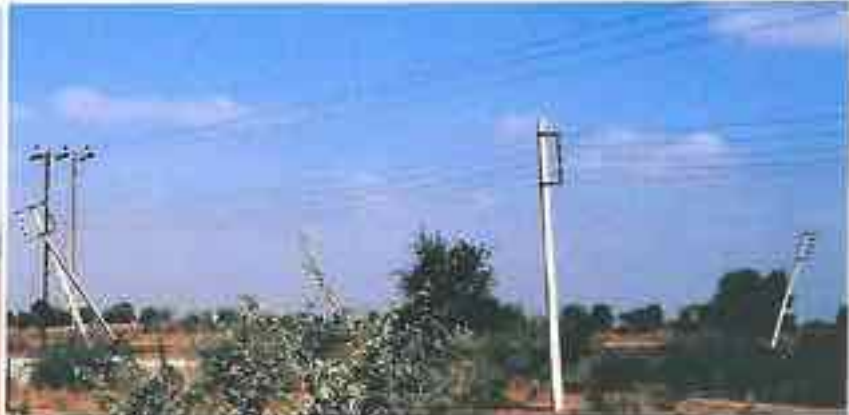
Plate 4.21. Inclined poles: A generic problem at several sites

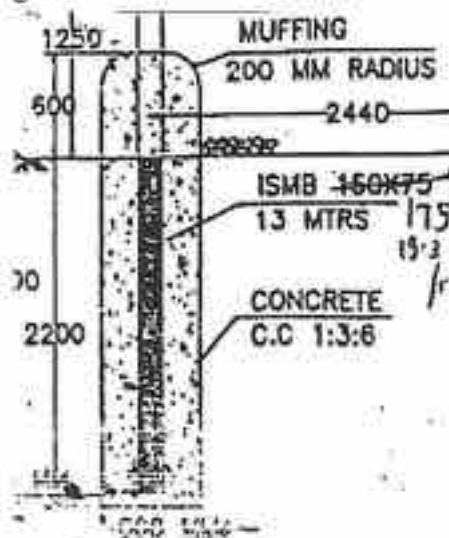
Plate 4.22. Muffings and Typical Concrete foundations as they should be (Source: Chief Engineer (Electrical Safety) and Chief Electrical Inspector, MP)

62. While Muffings need to be compulsorily provided as per the Chief Engineer (Electrical Safety) and Chief Electrical Inspector (Plate 4.3, cropped as Plate 4.22 below) for poles hoisting transformers, these were found missing in large number of cases (Plate 4.23). The necessary provision of concrete 1:3:6 put up 600 mm above ground, and much more below the ground level so that it is well entrenched into the ground as in Plate 4.22, and a radius of 200 mm was flouted at large. Similarly, the Muffings were also found missing for a large number of HB poles carrying High Voltages.

64. Also, while Muffings are intended to be entrenched deep into the earth (Plate 4.22), it was seen that they were largely present cosmetically over the earth (in case they existed at all), with little or no protrusions below ground level, defeating the very purpose of putting them on field for providing strength against disruptive forces. It appears that even where muffings were put up, it was more for providing a cosmetic assurance, rather than for purpose of being a necessary functional element providing support.

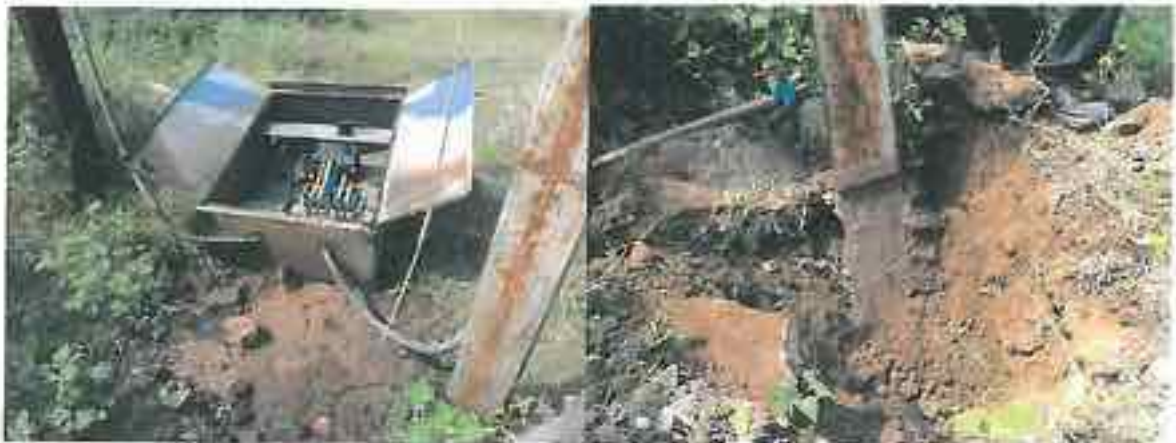
Nisarpur: Missing Muffings for two different poles

Plate 4.23. Missing /Barely Visible and Substandard Muffings

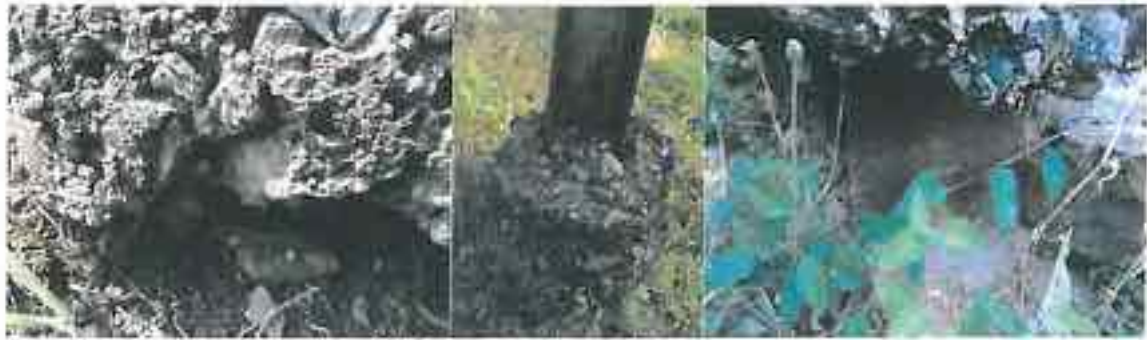
63. In several cases, where some kind of Muffings were found, quality of concreting left much to be desired (Plate 4.24). While, the quality of cement and concrete should have been regularly tested, no reports related to quality tests for cement, concrete etc. employed for construction of muffings at any R&R site were found in the records. Evidently, the quality of concrete was never determined.

Very Poor concrete quality: 3 different poles at Nisarpur

Plate 4.24. Muffings: Sub-Standard, Not-Upto Specification Work, Often Cosmetic, Very Poor quality of Concrete

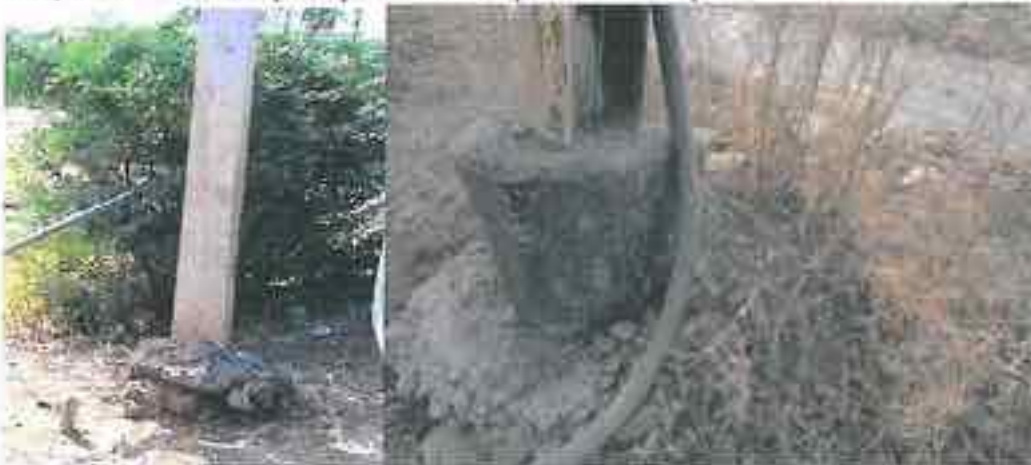
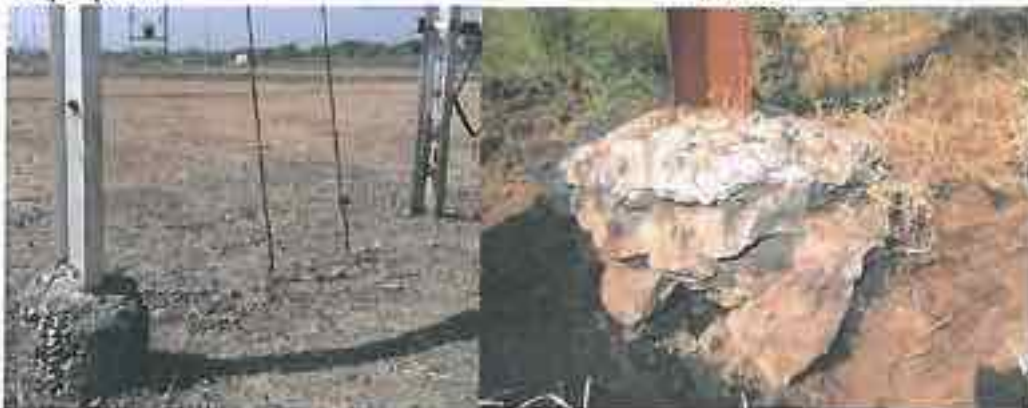
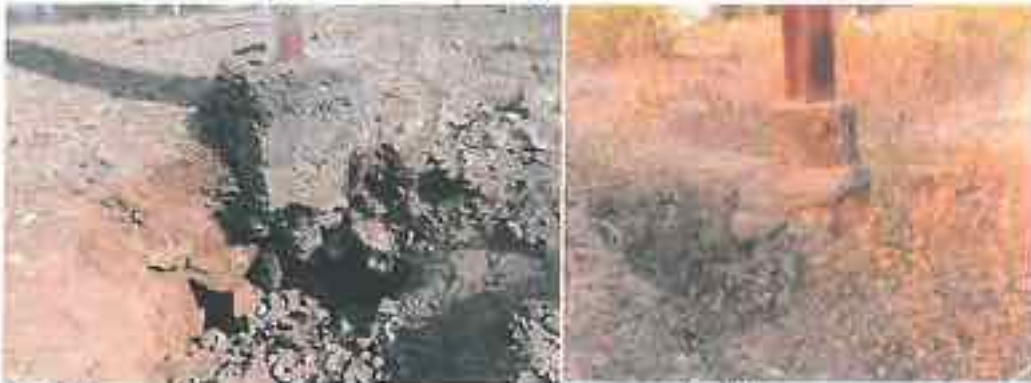
Borlai II (Phase II) : A recent 2009 Construction
Note that the nearby pole has no muffing at all.

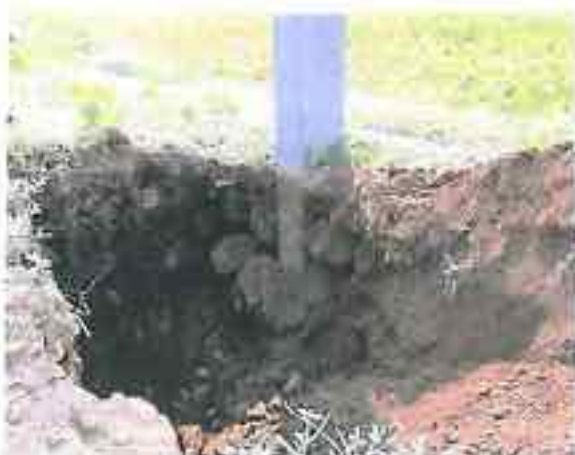
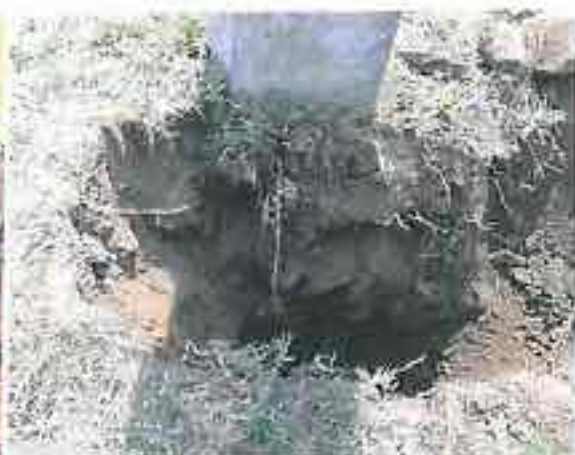
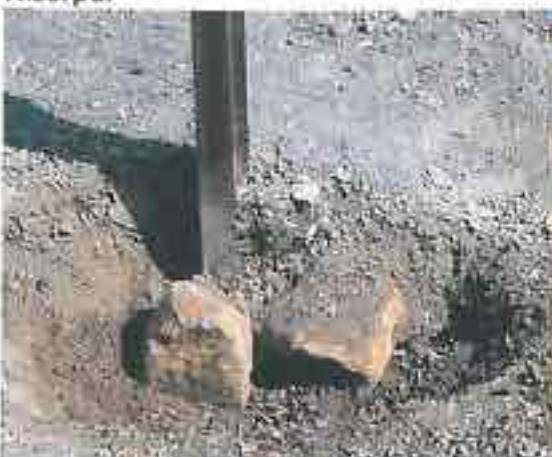
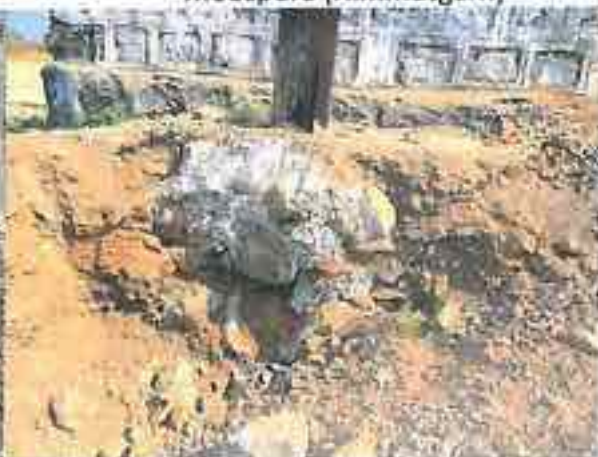
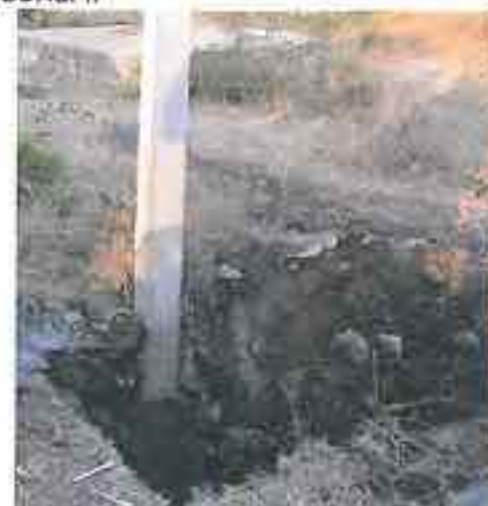
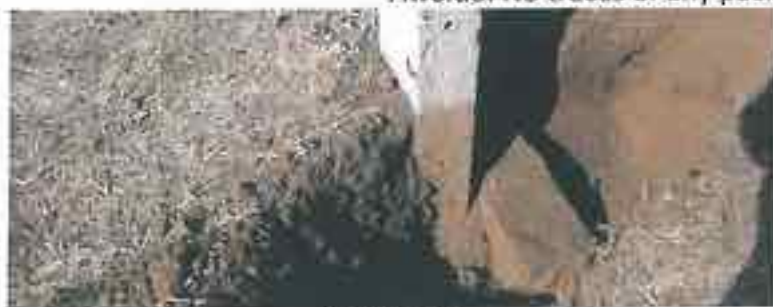
65. When foundations of Poles were investigated, the single largest cause responsible for wide inclinations of poles emerged. It was absolutely revealing and shocking that poles could be laid with such gross carelessness and shoddy work, and such shoddy work can be accepted, approved and made payments for. Some of the typical pole foundations as seen on the field are exhibited in Plate 4.25.

68. In the field it was found out that the Packings were invariably and consistently not upto specification.
69. In several instances, Packing/concrete was not present at all.

Plate 4.25. Typical Foundation Packings at some R&R Sites.....cont..

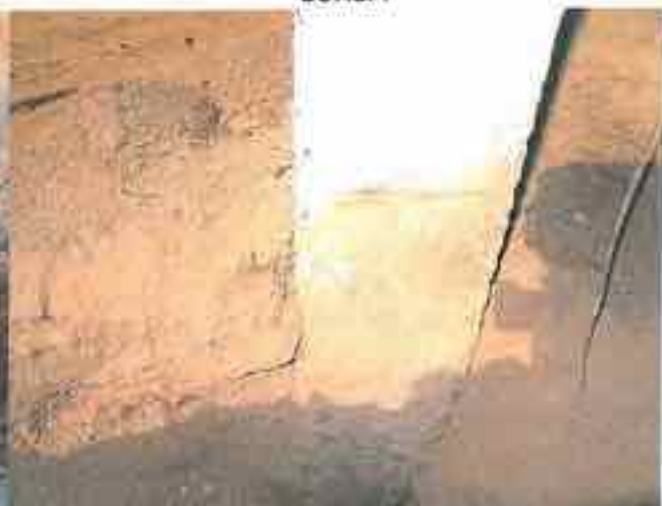
Awalda: No traces of any packing whatsoever

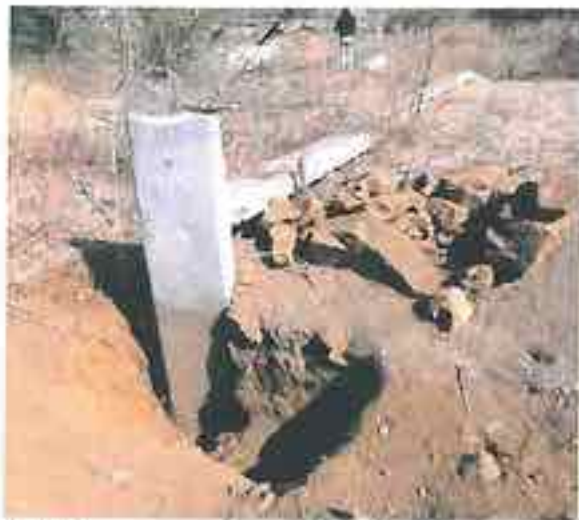
Bijasan

Packing unearthed: Meagre quantity of stones of arbitrary sizes picked up at random to complete formality of packing. Complete absence of packing boulders.

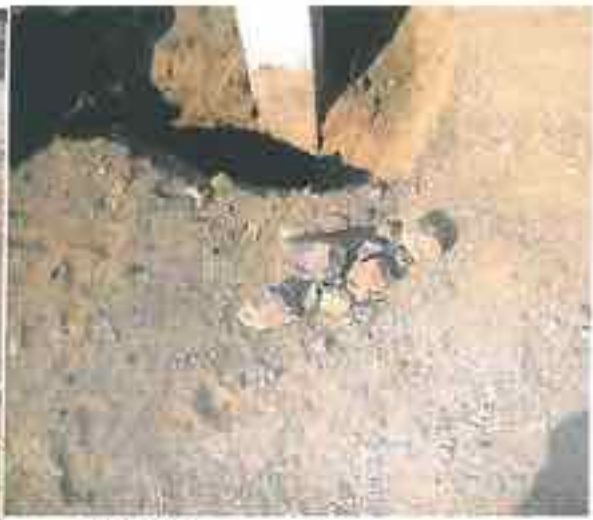
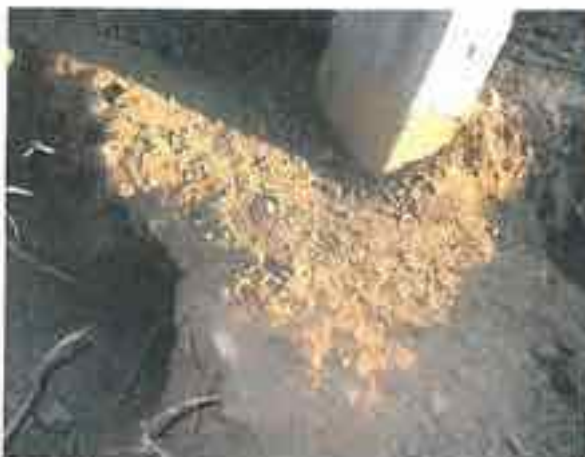
Plate 4.25. Typical Foundation Packings at some R&R Sites.....cont.

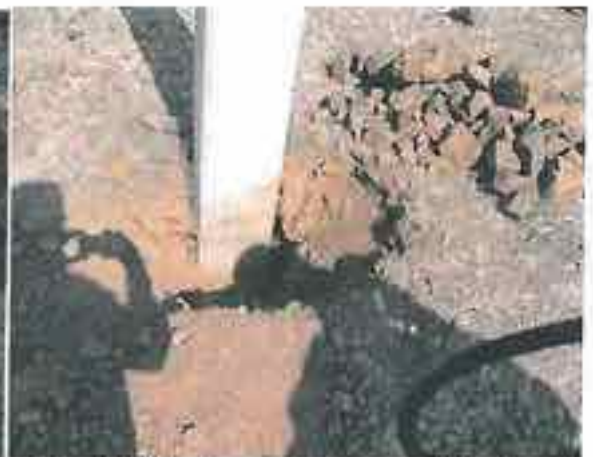
Dehar: Pebbles/aggregate as packing stones

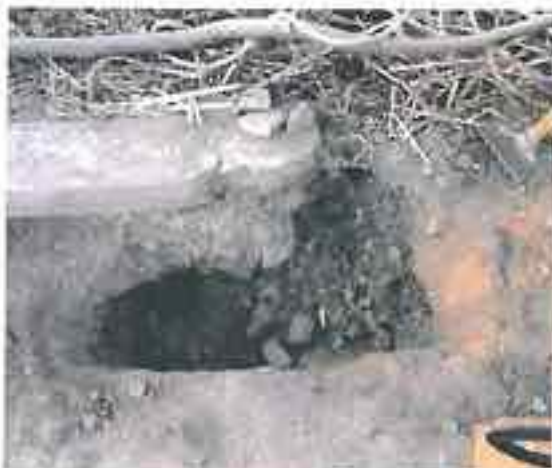
76. When foundations are poor, the poles will invariably incline, causing hazards to residents and their domesticated / other animals. In a number of cases, the poles would even swing because of the wind pressure (Table 4.4). For the same reason, a number of fallen poles were also seen at several sites.

Sirsani: No trace of pack around a fallen pole

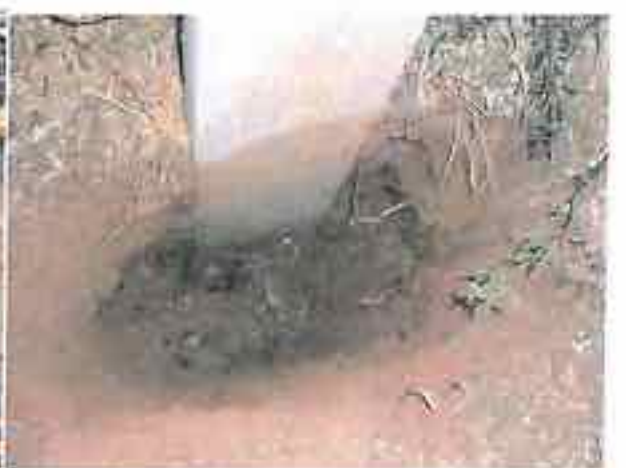
Jamda: Absence of any packing

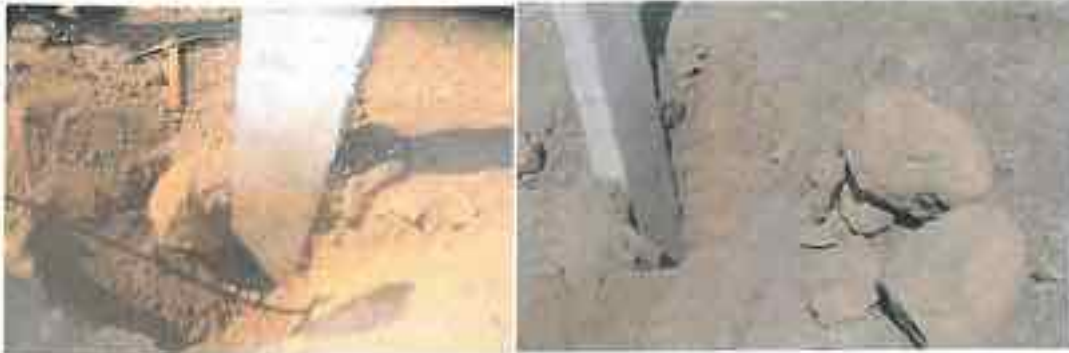
Dharamrai: Inappropriate poor Packing

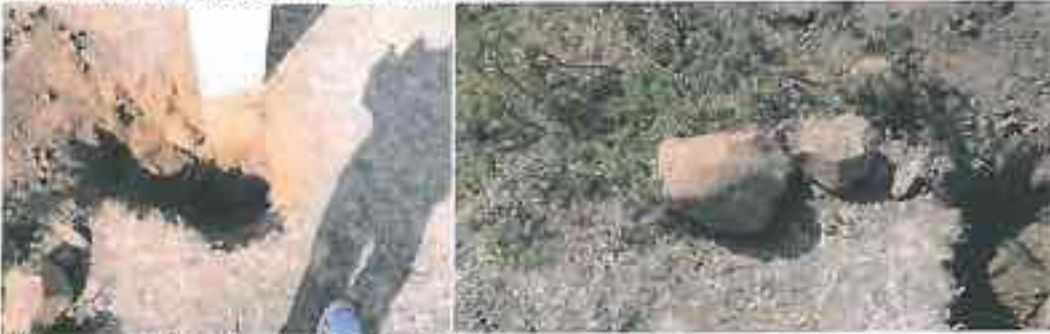
Kikarwas : The Pole And the pack

Plate 4.25 . Typical Foundation Packings at some R&R Sites.

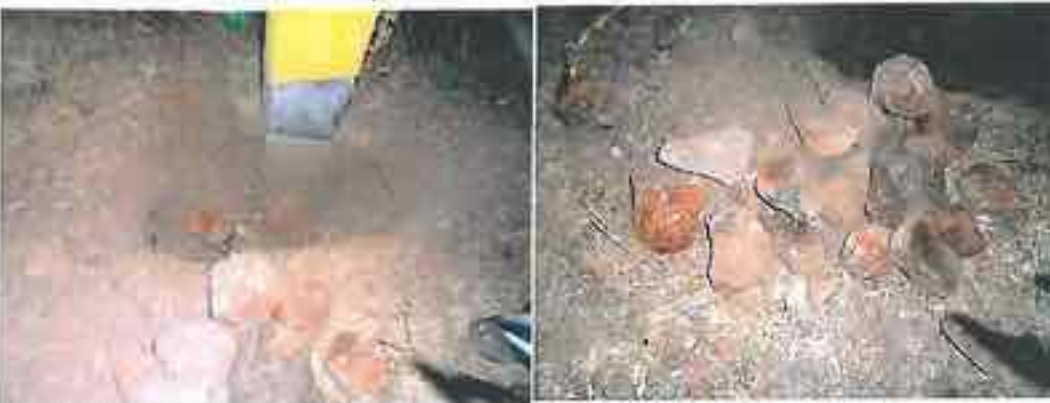
Eklera: Packing size and depth.

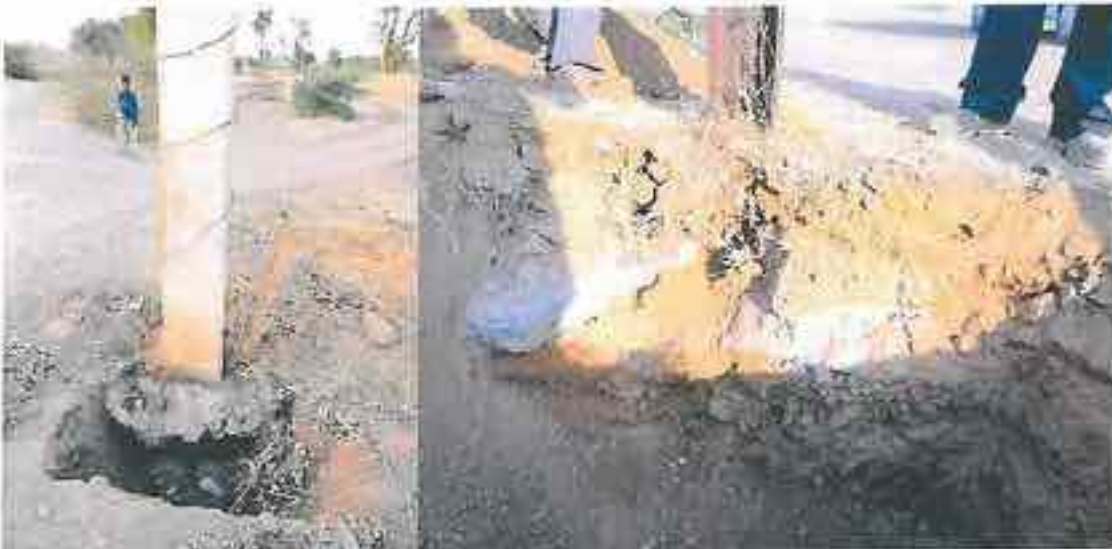
72. In certain instances, it was observed that some small quantity of concrete was poured around to provide a semblance of resistance against inclination (Plate 4.26). However, quite obviously this was shoddy work, and in no way could compensate for lack of proper packing/concreting of appropriate depth.

Plate 4.26. Cosmetic Concreting: No effort to ensure strength against pole inclination

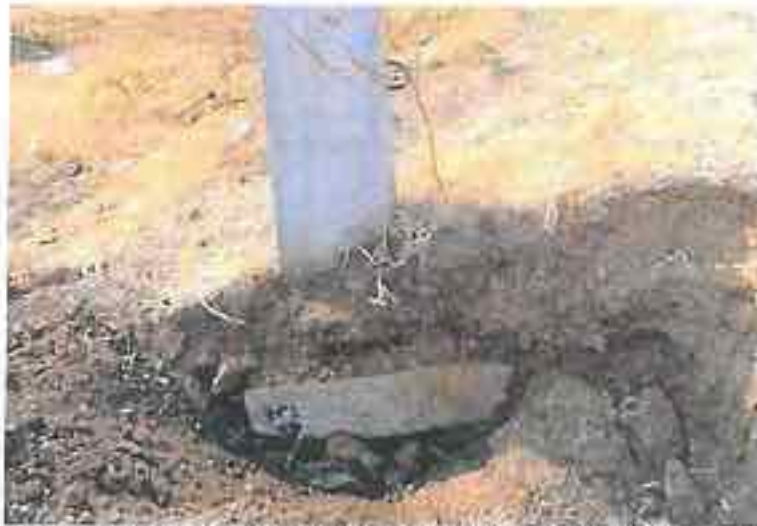
75. There were, in fact, instances where even the marking stones showing the plot numbers were found stacked randomly (Plate 4.27 and Plate 4.28), indicating that stones were picked up at the nearest convenient point, and then just thrown in without forming a pack. In one instance (Morekatta R&R site) a plot marking stone was the only piece of stone found as packing!

Plate 4.27. Borlaj I: Improper random packing, even readily available marking stones for plots (here plot no. 43 as evident) used as pole base packing

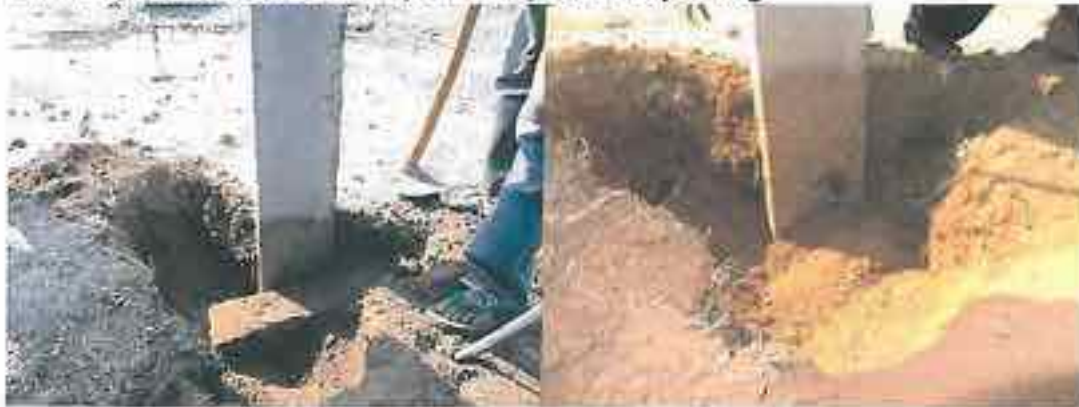
Plate 4.28. Morekatta: (Left) Readily available Plot marking stone stacked in pole base, (Right same pole after removal of this marking stone – No semblance of packing below

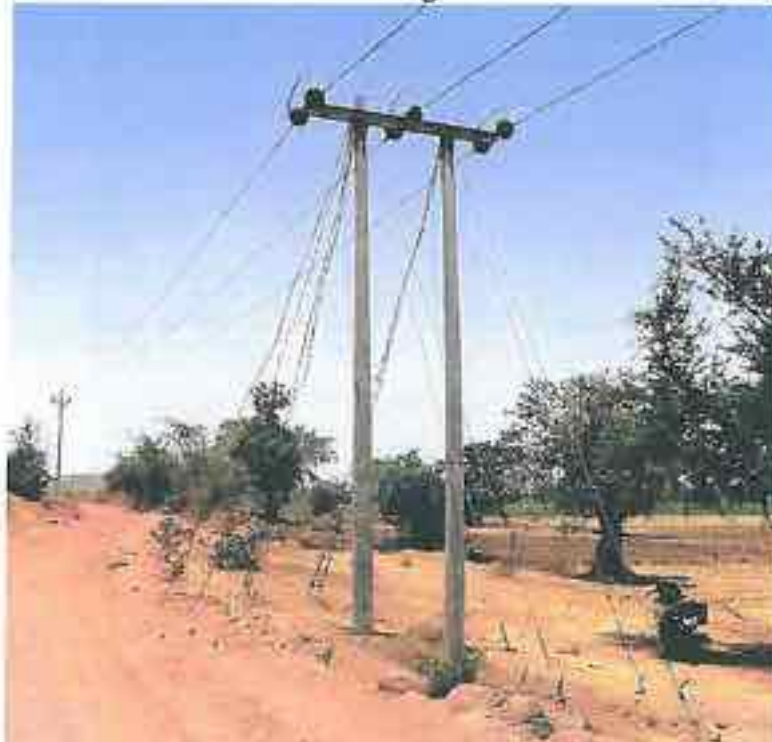
Plate 4.29. Vishwanath Kheda: When foundations are poor this is what may happen: As many as 10 guy wires seen supporting poles above which hardly has any load attached.

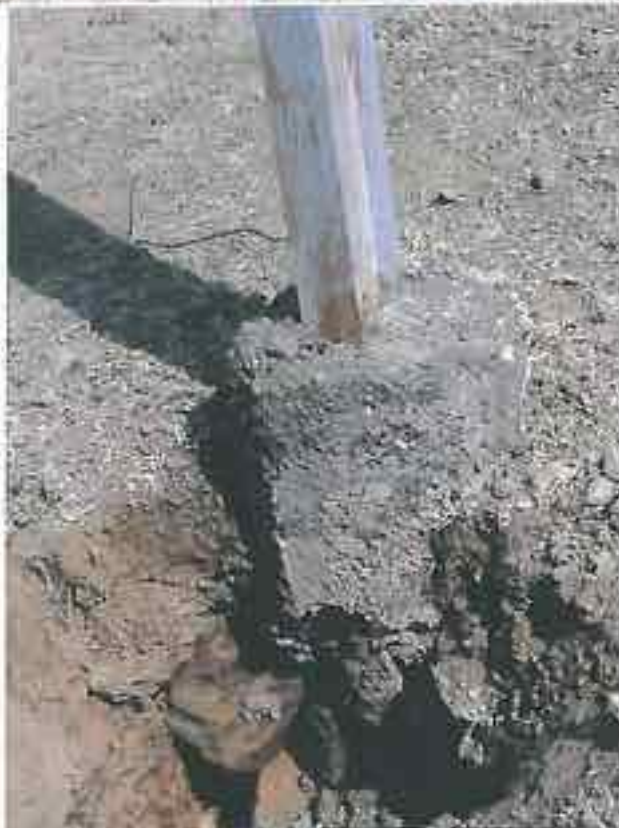
Plate 4.30. Borlai II Phase II - Metallic poles with recorded Concrete Foundations in MBs actually do not have even proper boulder foundations: Typical rampant malpractices – In some cases, muffings have been done away with (top photograph), while Cosmetic muffings provided in other cases to give an impression that concrete foundations lie underneath.

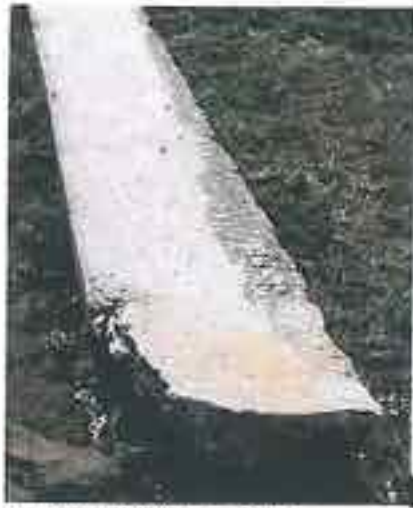
Nisarapur (A fallen Pole)

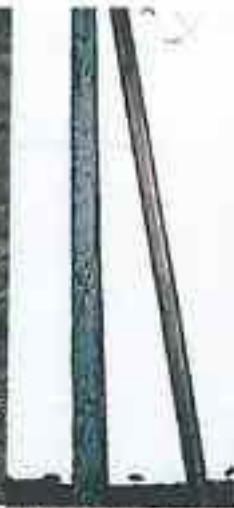
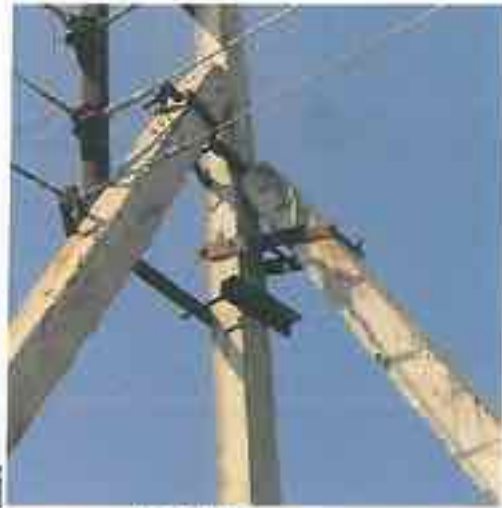
82. As many as 12620 numbers of PCC/RCC poles and another 5190 Metallic Poles (HB and RS Joists) have been deployed at various R&R sites.
83. At a number of R&R sites, the quality of PCC poles was not upto mark. The PCC was not laid smooth, honeycombing was visible, edges were blunt in patches, and damaged, aggregate visible, and sometimes the poles did not have a straight profile and were bent (Plate 4.31).

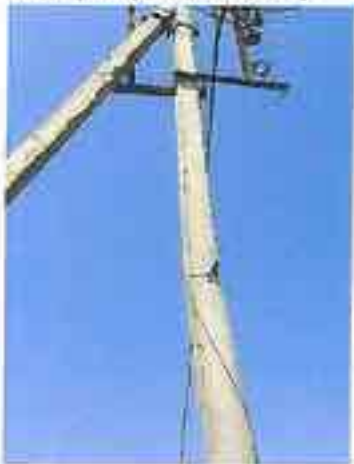
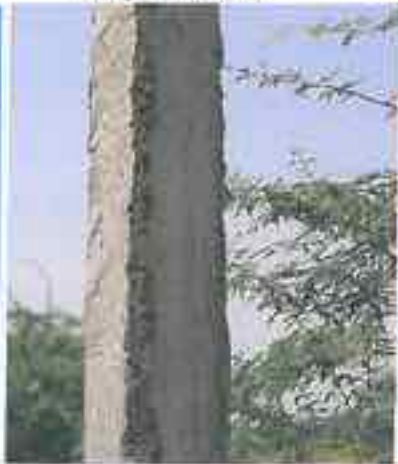
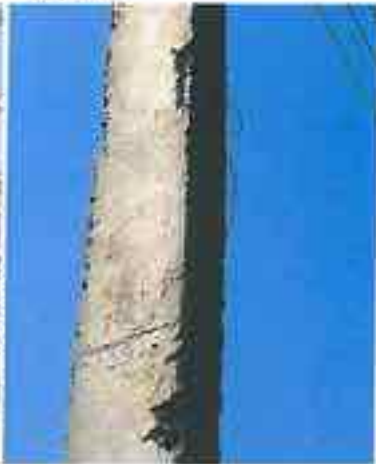
84. It was often observed that the earthing wires were mostly not cast inside the PCC poles, rather they were mostly seen loosely wrapped around the poles (typically some poles in Plate 4.31). This constitutes a flaw in the pole design ("Earthing shall be provided by having a length of 8 SWG GI wire embedded in Concrete during manufacturing..."; REC Specifications and Construction Standards,15/1979-7.9) and substantiates the assertion of poor pole qualities. In any case, the un-insulated external earth wires pose a risk to passerbys, especially the children and animals, and the danger of electrocution remains during faults, implying a compromise with safety.

Jalkoti: 3 Poles – poor qualities, missing Paint & external earthing wires wrapped around

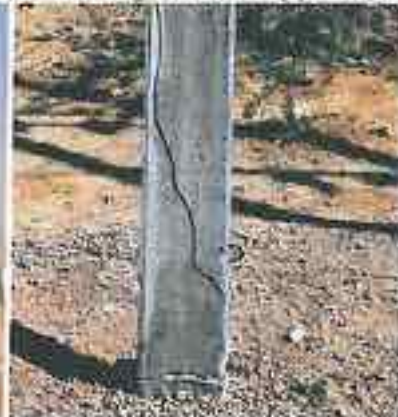
Borlai I: base crack & external earthing

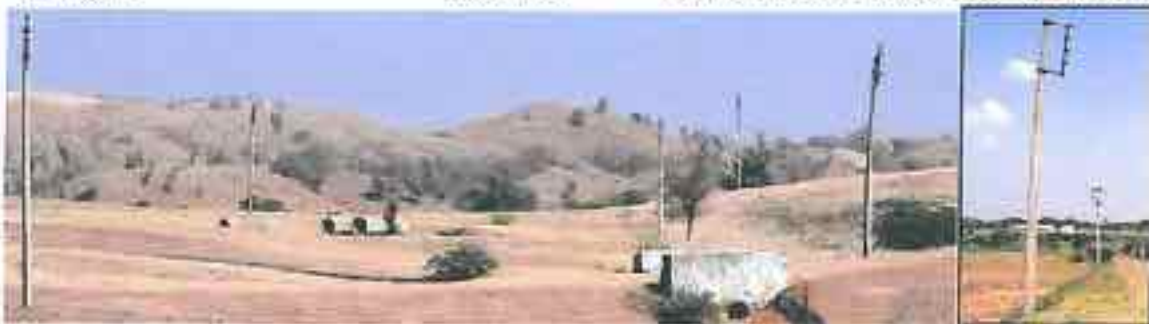
Poles not having straight profile: bent visible Kikarwas (Left) and Moosapura (Right)
Plate 4.31. Poor PCC Pole qualities

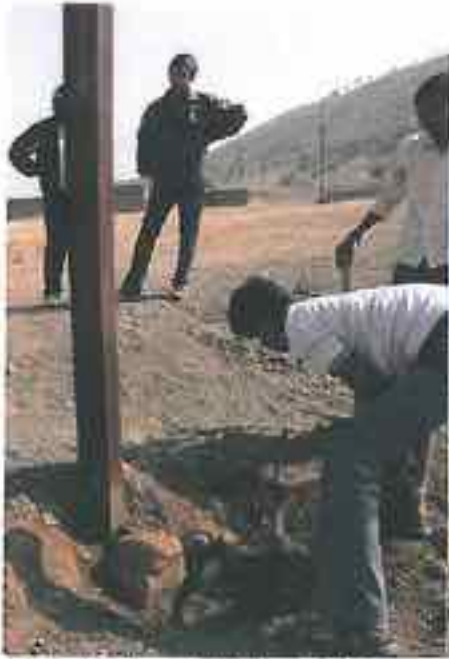
89. Most Metallic Poles were seen un-painted (Plate 4.32). The metallic poles were often seen even rusted indicating poor maintenance. It is possible that when the infrastructure was first commissioned, the poles may have been painted. However, even at recently commissioned sites such as Borlai II (Phase II), where pole erections have taken place in 2009, the HB poles were found un-painted, indicating that even the initial paint work may not have been carried out at some places. At some sites, though, it was possible to see traces of original paint still remaining.

Borlai II(Phase II): Year 2011
construction, and yet the paint is missing

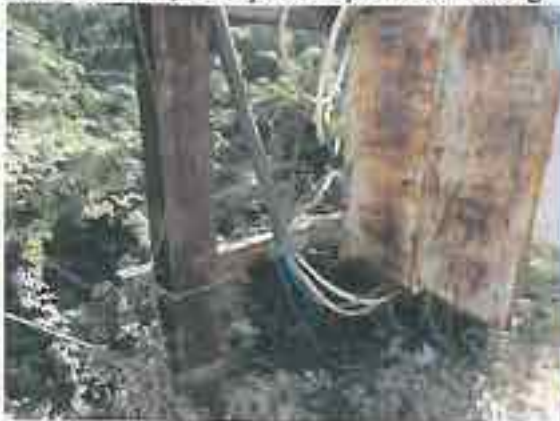
Bijasan: Two Rusted pole, one had remnants of paint work

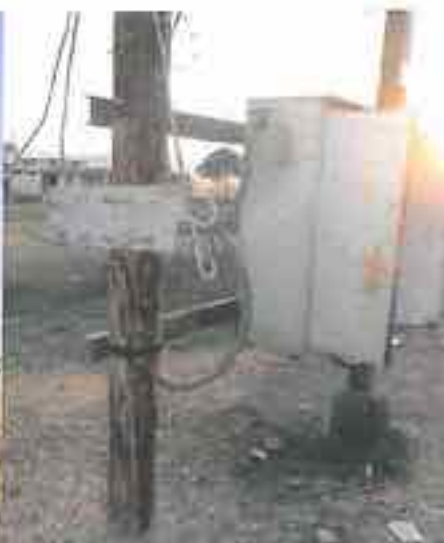
Amalali: some signs of earlier
paint remain along with rust

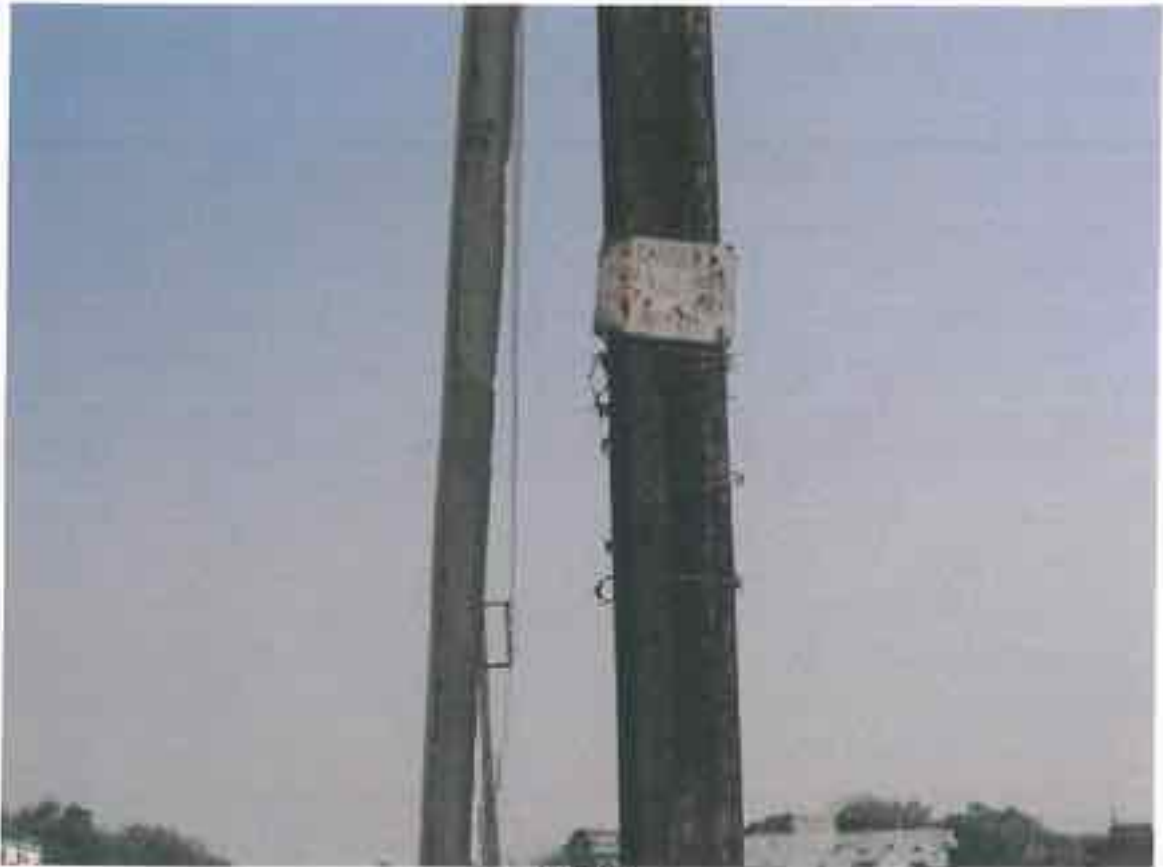
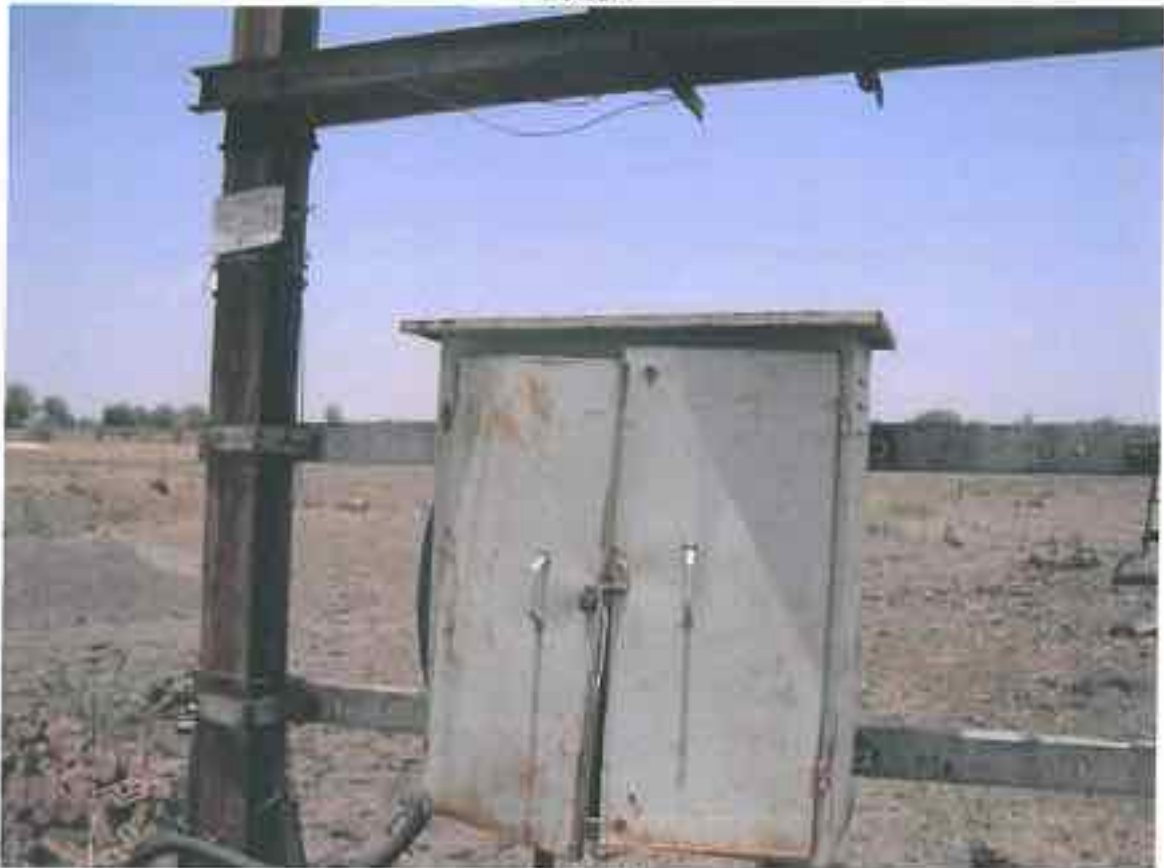
91. Barring some exceptions, one would not find the mandatory provision for Danger Notices confirming to IS:2551-1963 (Plates 4.1,4.2,4.33) on High voltage / transformer carrying poles at several sites, indicating a lack of concern to the necessary safety stipulations as per rule 35 of the Indian Electricity Rules 1956.

92. It was not always that anti-climbing barbed wires were found present on Poles carrying High Voltage lines or at all transformers (Plates 4.1, 4.2, 4.33). A provision of this, though, existed in MBs, and it is possible that either these were not installed since beginning, or some of these may have been lost with passage of time. It may be noted that the ends of the barbed wire are normally secured to poles by means of suitable iron clamps, and even these were seen missing most of the times. In any case, the anticlimbing devices should have been replaced and replenished by the maintaining authority. This is therefore also reflective of poor maintenance/lack of safety concerns by the supplying/maintaining authority at R&R sites, and is a breach of Rule 91(ii) of the Indian Electricity Rules, 1956 which pointedly asks for "Whether anticlimbing devices have been provided for each of the high voltage and extra high voltage supports?---Form III, Inspection Report under Rule 46".

Plate 4.33: It was not always that such danger signs were found, as well as anticlimbing barbed wire wrapped around: No paint still though, and signs of rusting.

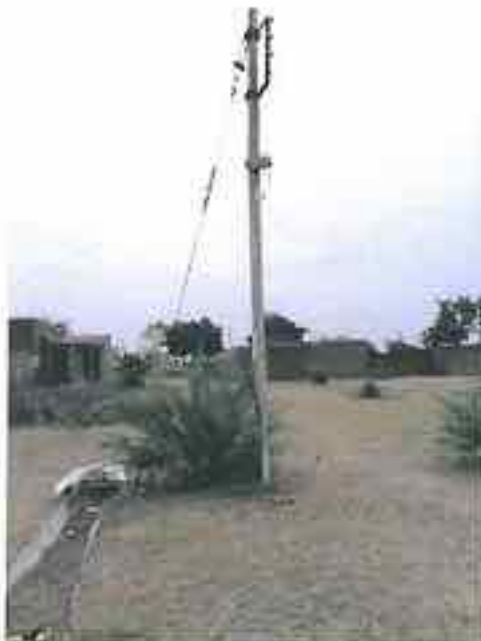
94. There were instances at several R&R sites (Plate 4.34) where poles were located on road shoulders posing safety hazard to passerbys, and to vehicles, including tractors and Bullock Carts. This becomes more serious when one considers other factors such as the R&R sites having no provision of street lighting for easy travel in nights, poles having inadequate foundations and therefore likely to incline on the road, and lines have insufficient brackets etc. and likely to sag on road crossings. Such electric lines need to be relocated proactively.

Sirsi Ganpur: Pole on road between road-side drain and road

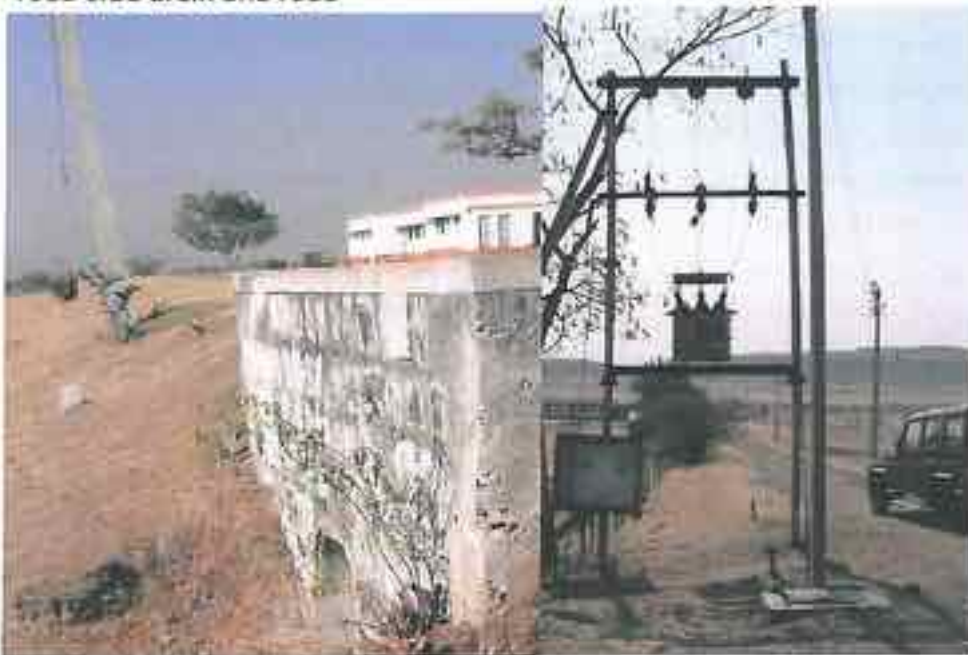
Dharamrai (Kukshi) Two different Poles encroaching upon Road shoulder/Road

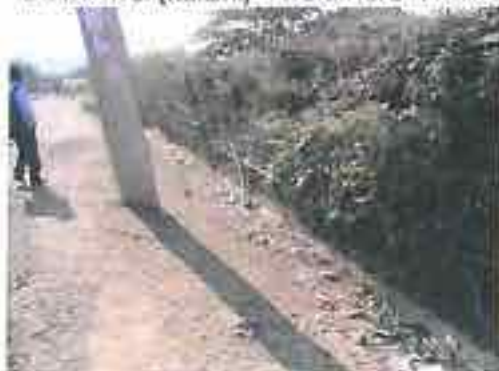
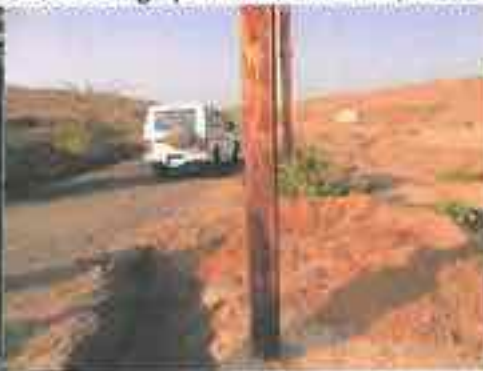
Plate 4.34. Electric poles on road shoulders: Safety concerns for drivers and for road travellers –Poor Planning (Typical)

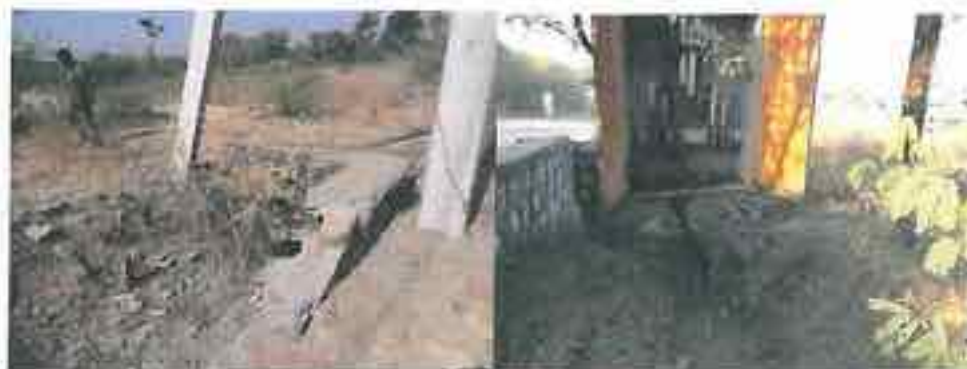
95. Another set of faulty pole locations was observed where the poles/transformers were located on culvert, or too close to culvert mouths (Plate 4.35) implying compromise on safety, increased danger of electrocution (more so in view of poor earthlings), likely pole instabilities as erosion of soil takes place due to gushing waters in rains. The low heights of transformer LT-boxes, further accentuate the associated risks. Besides, the poles may act as impediments to the free flow of water through the culverts, and the flowing water may erode the meagre pole foundations provided. In all such cases, and there were plenty of them, the Electric poles/transformers need to be relocated.

Amalali: Part on road, another part
In front of culvert mouth

Bhilkheda: Distribution box in front.
What if culvert gets chocked?

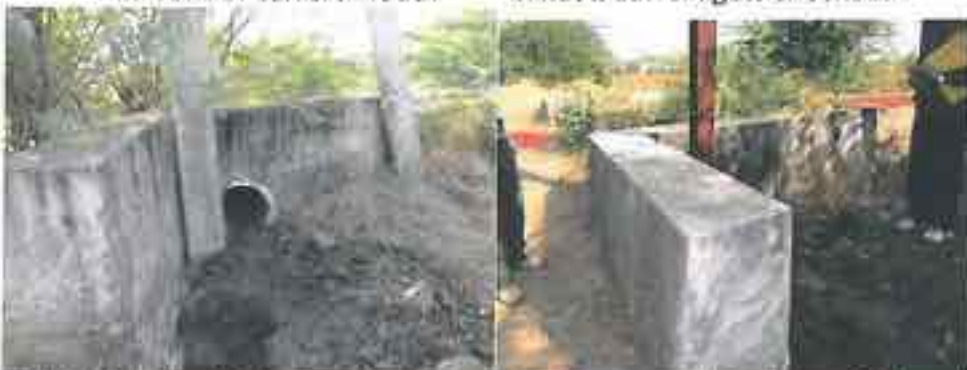
Chikalda: Two different poles PCC and HB constructed in front of Culvert

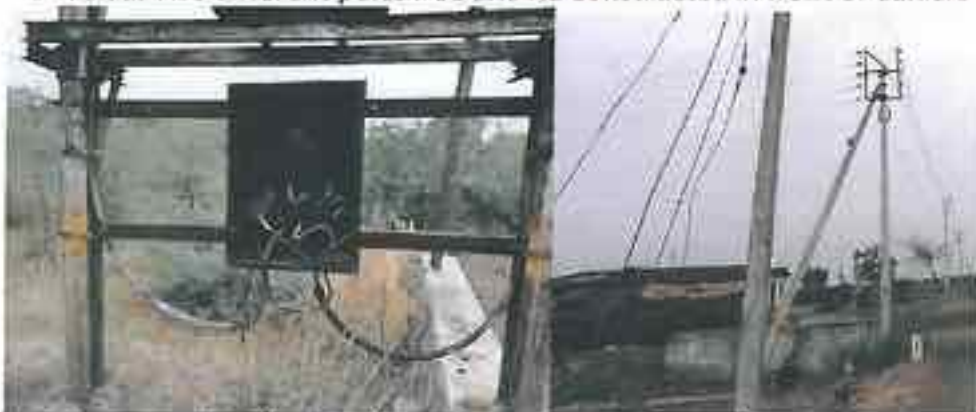
Dharampuri: Pole placed on Culvert

Plate 4.35. Typical Pole locations in close proximity to Culverts: Safety Compromised
