Evaluation of the Quality of Civic Amenities at Rehabilitation Sites of the Sardar Sarovar Project

**Sardar Sarovar Project - Fake Sale Deeds and Rehabilitation Sites
Irregularities Inquiry Commission**

April, 2014

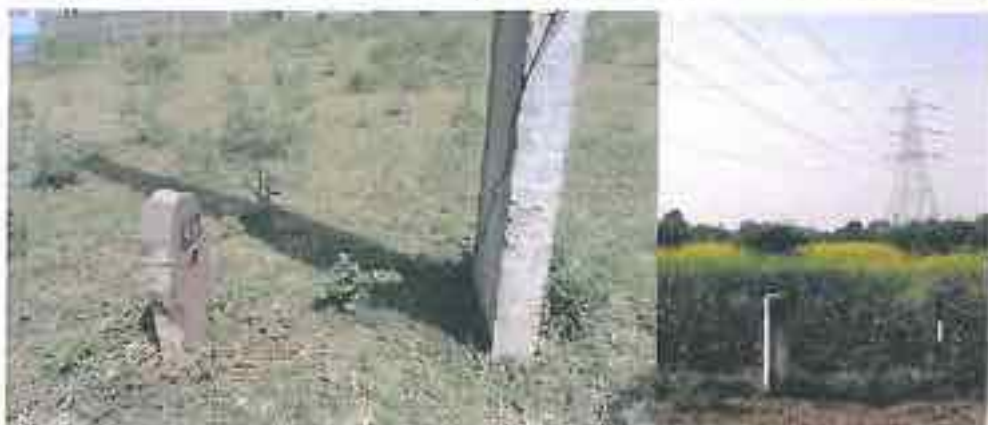
98. Such problems/disputes with regard to electric lines posing risks are likely to intensify as more and more people would get relocated into the R&R sites, and would start finding out that some line or the other passes in close proximity (Plate 4.36). It is therefore necessary to take proactive action in this regard and take steps officially to relocate the lines as per the provisions for ensuring safety

Plate 4.36. Safety issues will intensify in future as people realize risks after the construction starts on their plots.

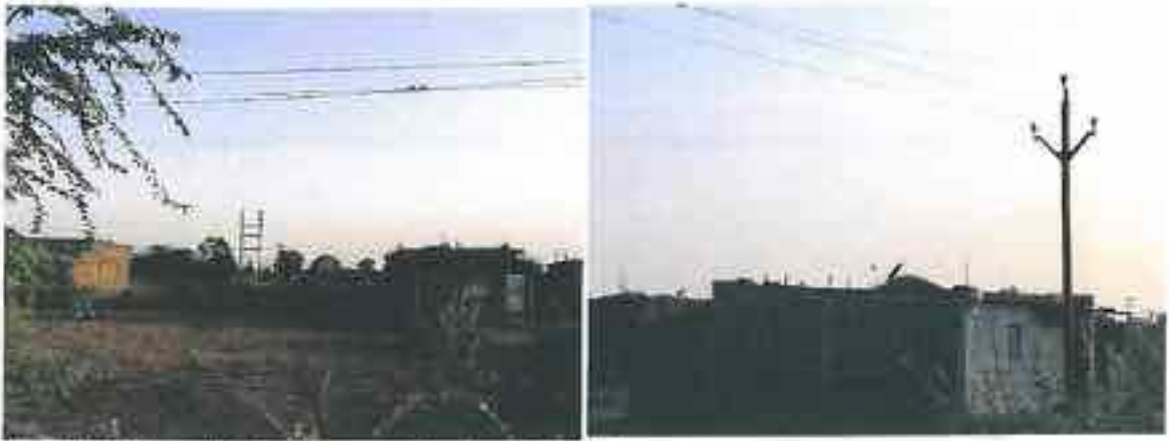
99. At a number of sites such as Nisarpur, Kukra, Khedi etc., it was seen that the electric lines, sometimes even the high voltage ones, were too close to the houses already constructed (Plate 4.37) or to the plots, violating rules 79 and 80 of the Indian Electricity Rules, 1956 which specify the minimum clearances to be maintained for various types of lines, thus compromising the safety of occupants of buildings.

Nimbola: The electric lines need to be relocated.

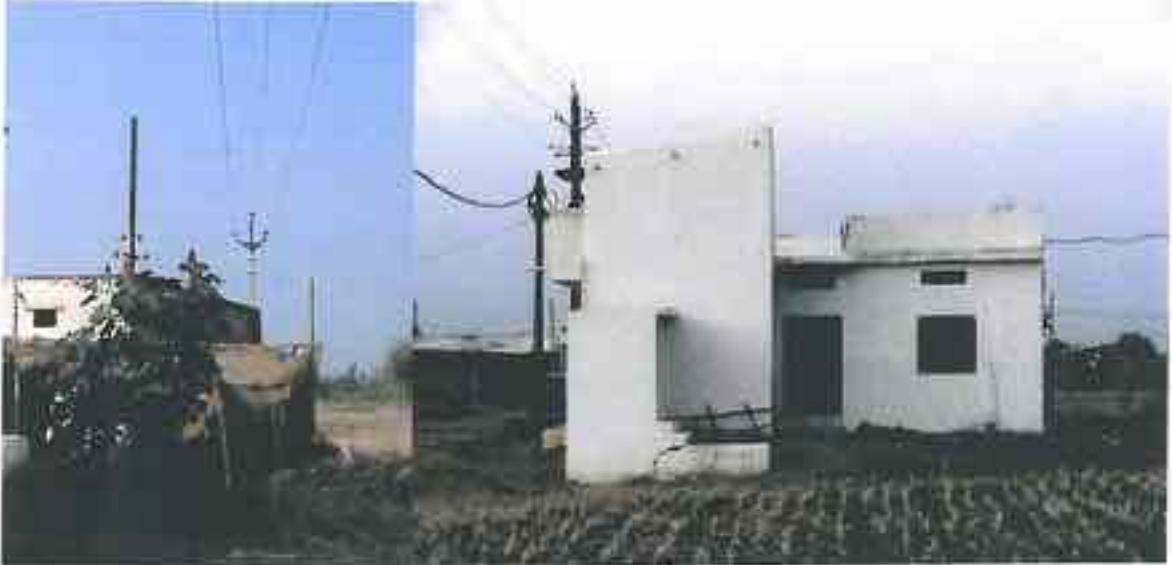
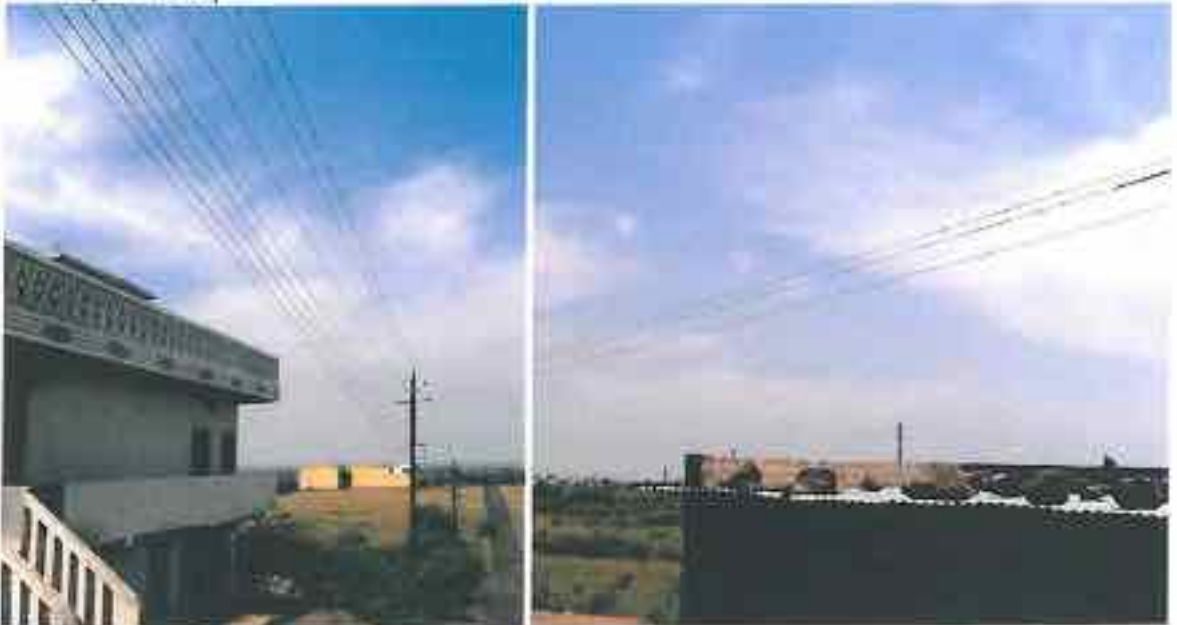
Plate 4.37. Accentuated safety Risks for R&R Inhabitants due to Electric Lines in close proximity unable to maintain prescribed minimum Clearances.

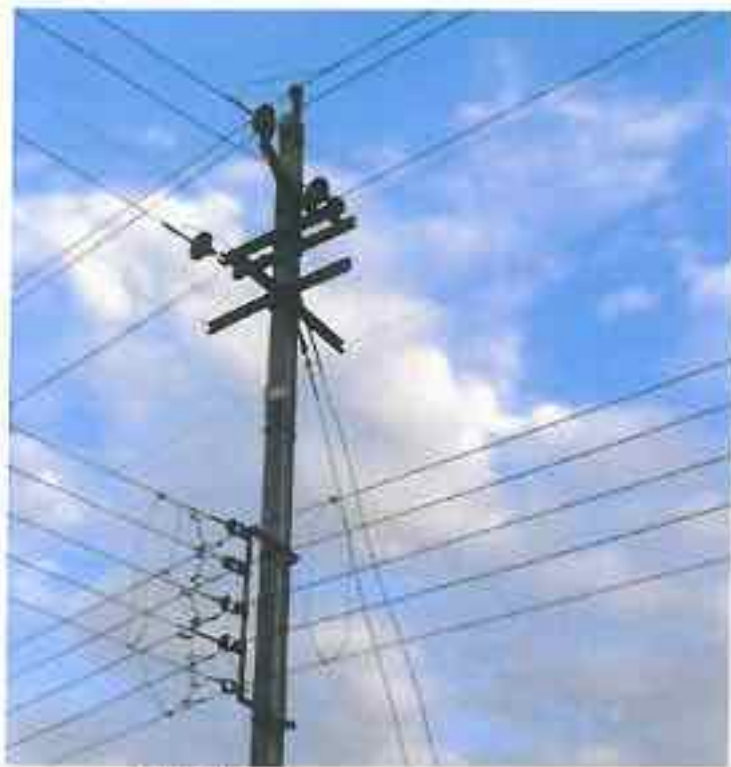
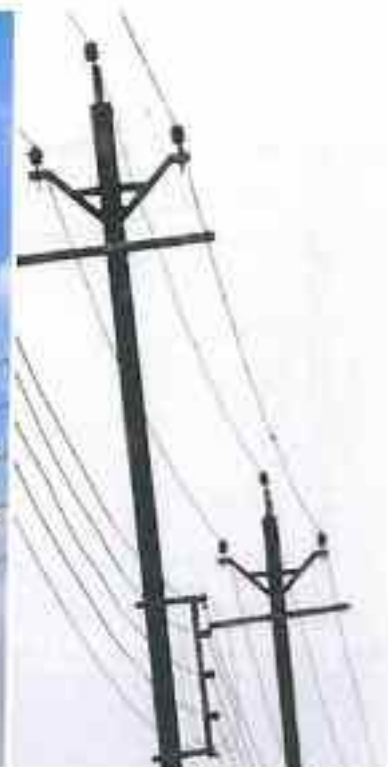
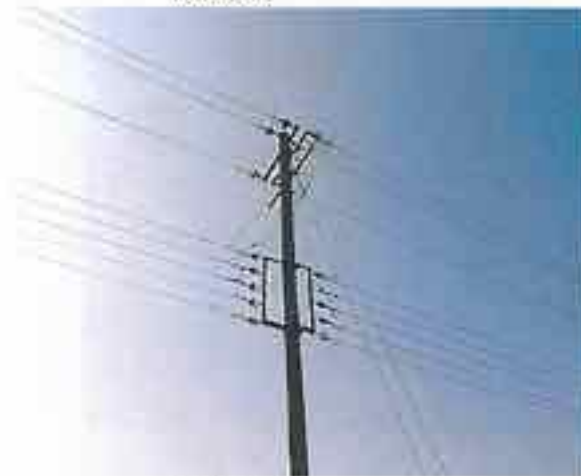
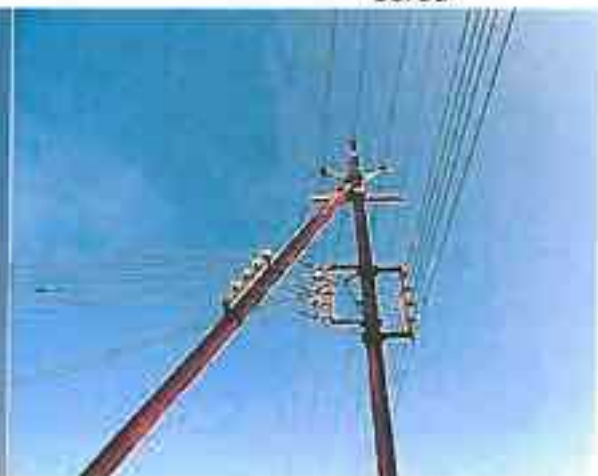
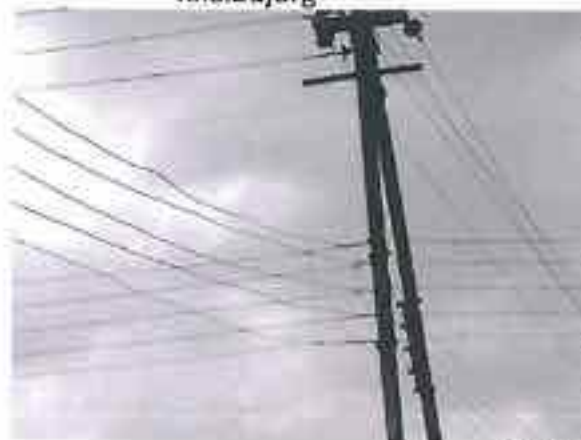
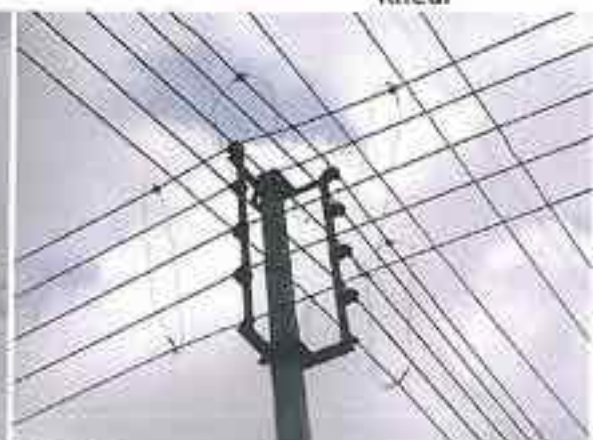
100. There were also safety concerns regarding conductors at different voltages on the same support (Plate 4.38). There were numerous instances at large numbers of sites where sets of High Tension and Low Tension wires were seen located on the same Pole. The Indian Electric Rules, 1956 as per provision 77 read out as follows: "Where conductors forming parts of systems at different voltages are erected on the same supports, the owner shall make adequate provision to guard against danger to linesman and others from the lower voltage system being charged above its normal working voltage by leakage from or contact with the higher voltage system and the methods of construction and the clearances between the conductors of the two systems shall be subject to the prior approval of the Inspector". Such prior approvals of the Inspector were not found in the records submitted.

101. In several instances, where the lines were in proximity to another line, the mandatory Guarding between two lines were seen completely missing (some pictures in Plate 4.38) indicating casual attitude to observance of safety aspects. This is in violation of the rule 88 and 87 (3) of the Indian Electricity Rules 1956: "Where an overhead line crosses or is in proximity to another overhead line, guarding arrangements shall be provided so as to guard against the possibility of their coming into contact with each other".

102. Where provided, Guardings were sometimes seen damaged/broken and sometimes even touching LT lines (some pictures in Plate 4.38)).
103. There were also instances of violation of minimum clearances needed as per the provisions of the Indian Electricity Rules, 1956. Rule 77 (Clearance above ground of the lowest conductor), and Rule 87 (3) (Minimum clearances between lines crossing each other) were both violated in instances like those depicted in Plate 4.39, enhancing risks, more so as wires sagged at places. Accentuated risks exist in case the wires fall over, a likely occurrence due to inclined poles, and poor bracketing.

Plate 4.38. Multiple lines on the same Pole (Typical): Sometimes Missing/damaged Guarding between the two lines (Typical) and Loose Conductors.....cont ..

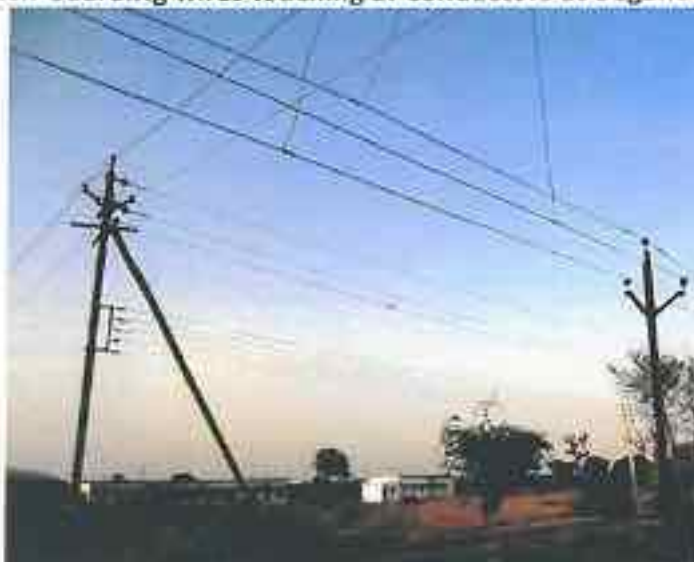
Nimbola

Plate 4.38. Multiple lines on the same Pole (Typical): Sometimes Missing/damaged Guarding between the two lines (Typical) & Loose Conductors.

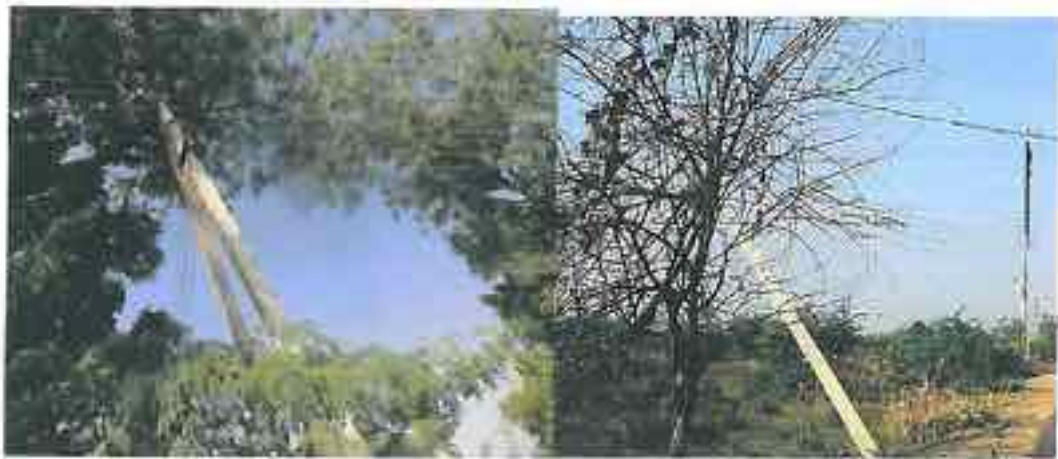
105. The State of maintenance of the Infrastructure at R&R sites is far from acceptable. It was common to find Distribution LT-Boxes fallen on ground, Transformers lying on ground, Poles lying on ground, Tree clearances are not maintained, Earthing wires broken and hanging loose in air (Some Typical cases in Plate 4.40) Missing switchboards (Plates 4.10, 4.11), Missing transformers (Plate 4.1), etc. indicating an attitude of absolute neglect and apathy towards the infrastructure.

Tree clearances not maintained: Chikalda(Left) and Khalbujurg (Right)

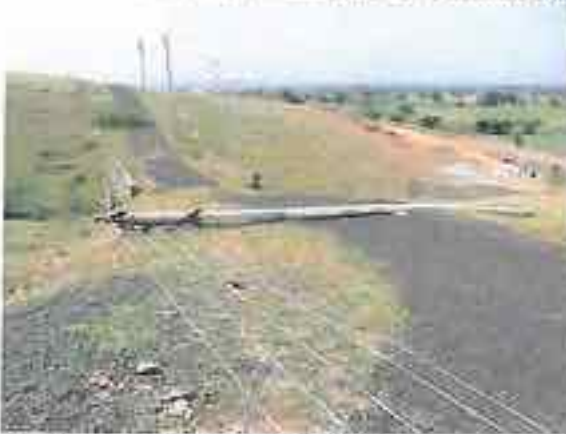
Nisarpur: Pole lying on Ground

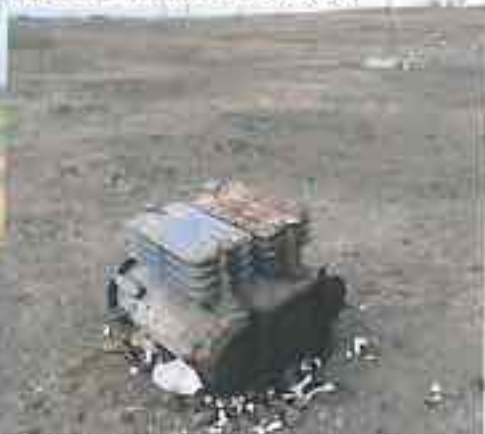
Khalkhurd (Dharampuri): Transformer lying abandoned on Ground

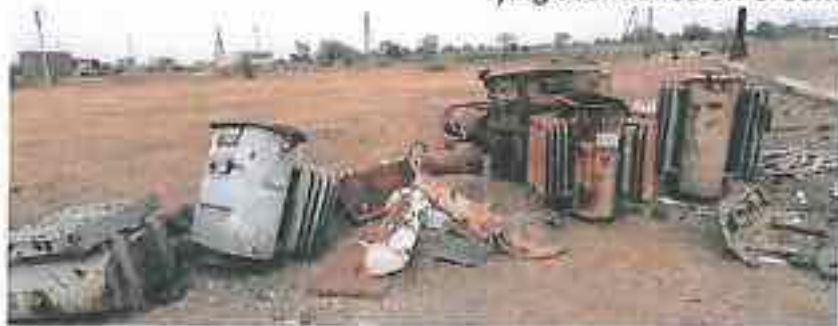
Beganda

Plate 4.40. Typical Photographs reflective of poor maintenance at R&R sites

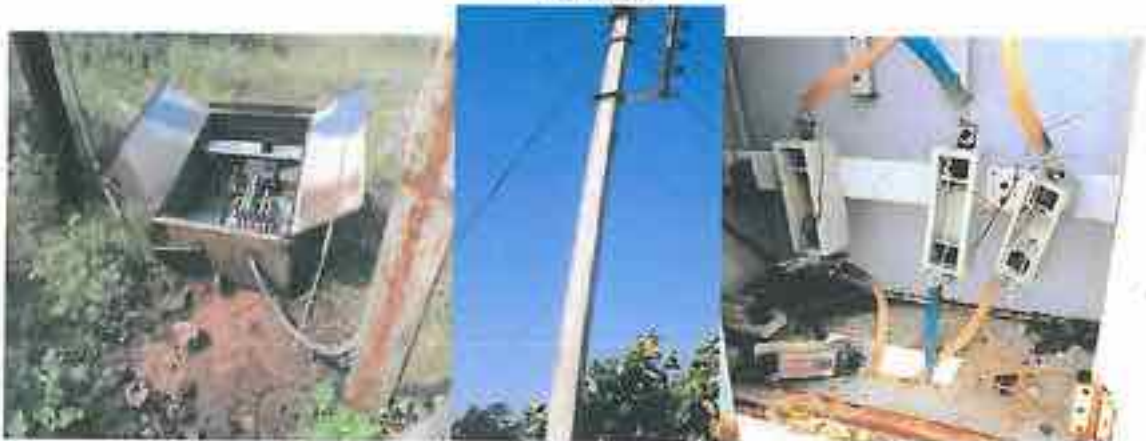
Niasarpur : LT-box on Ground Kavanthi: Broken Earthing Barda: Dangerous wiring

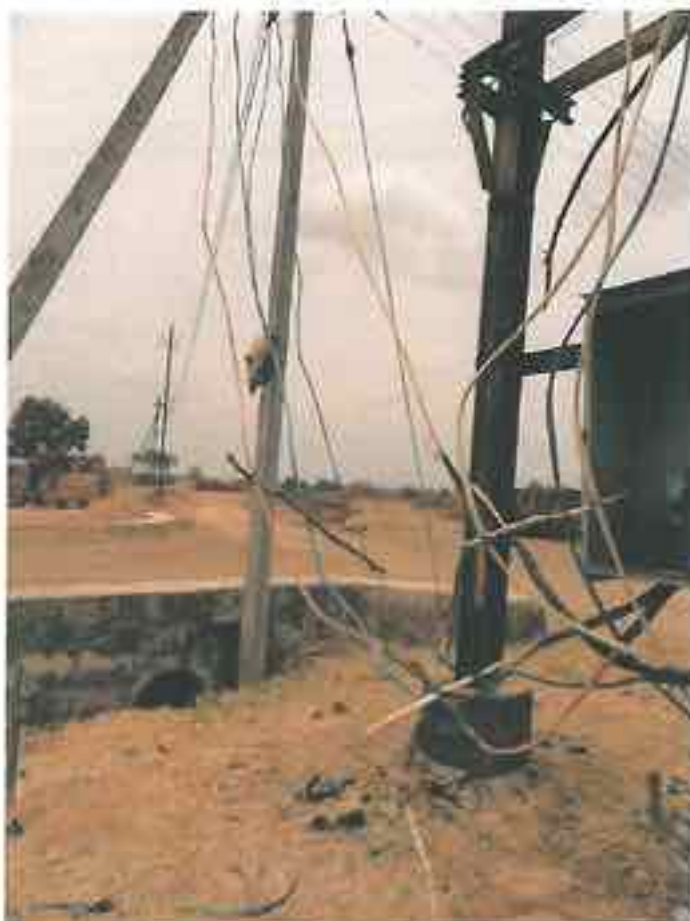
Tavlai Khurd : Poor pole location in front of culvert, Dangerous random spread of cables. Cable should be armoured and here armouring is missing. Cable found open which is dangerous to humans and animals. Poor maintenance also.

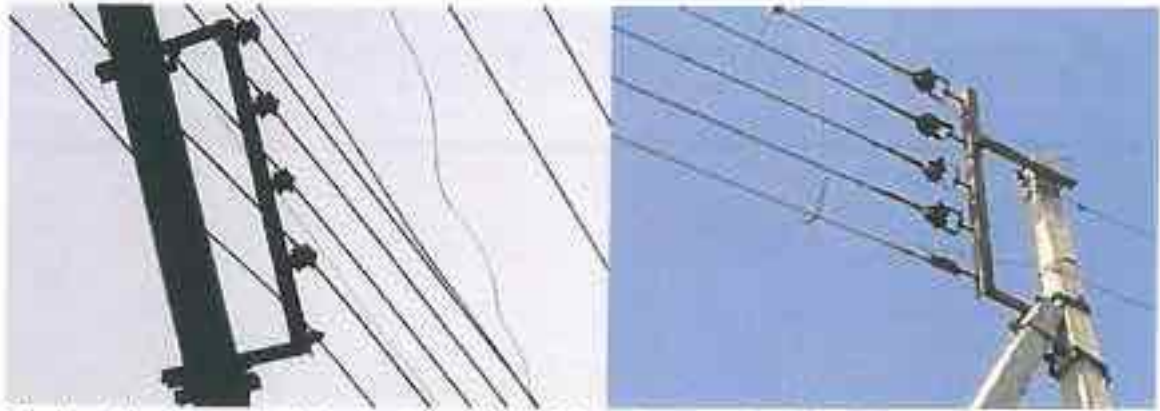
Missing Aluminium Bobbins : Nisarpur (Left) and Moreghadi (Right)

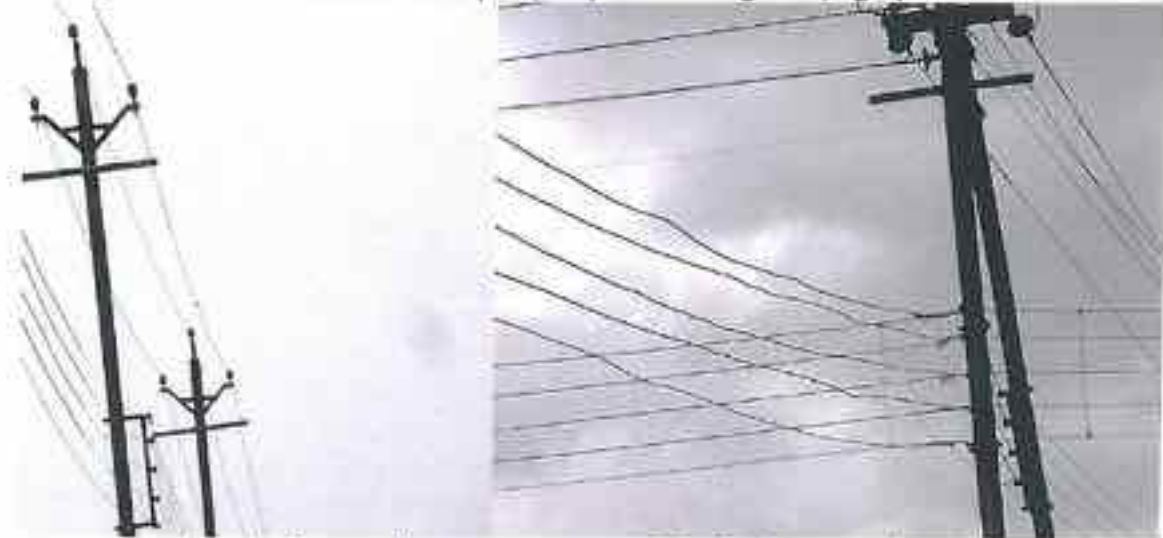
Barda: No guardings

Barda: Loose conductors

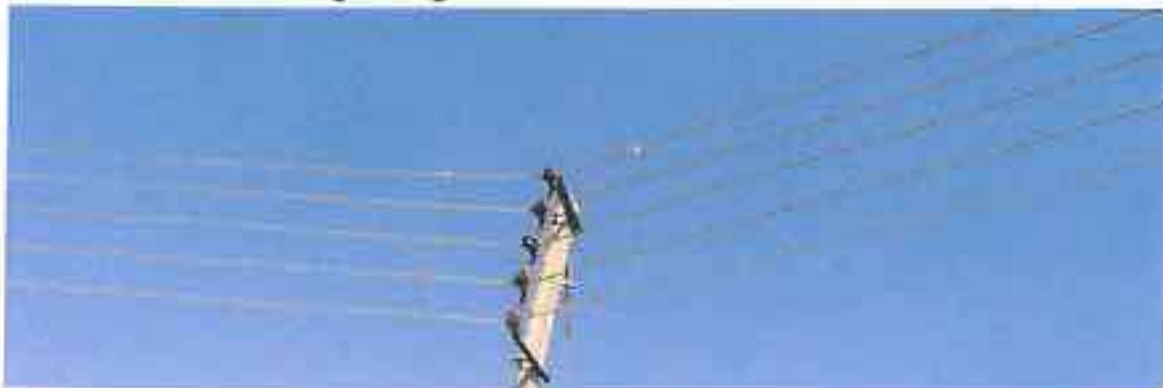
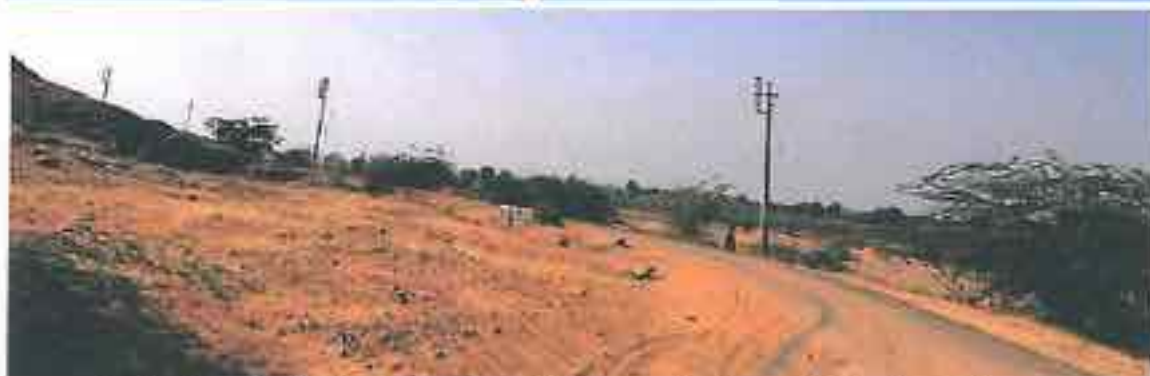
Balwada: Shackle insulators provided at turning instead of split insulators

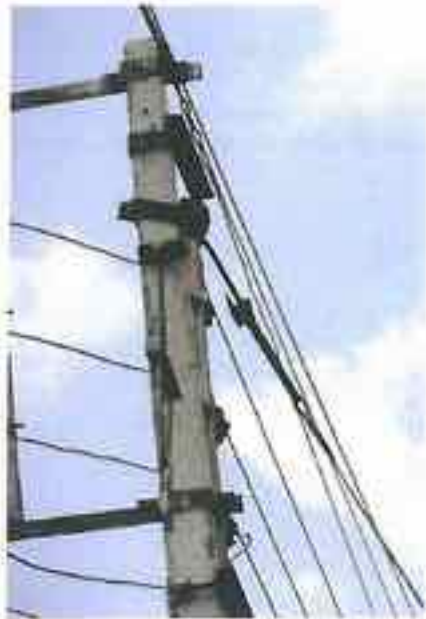
Mirzapur: Conductors directly tied

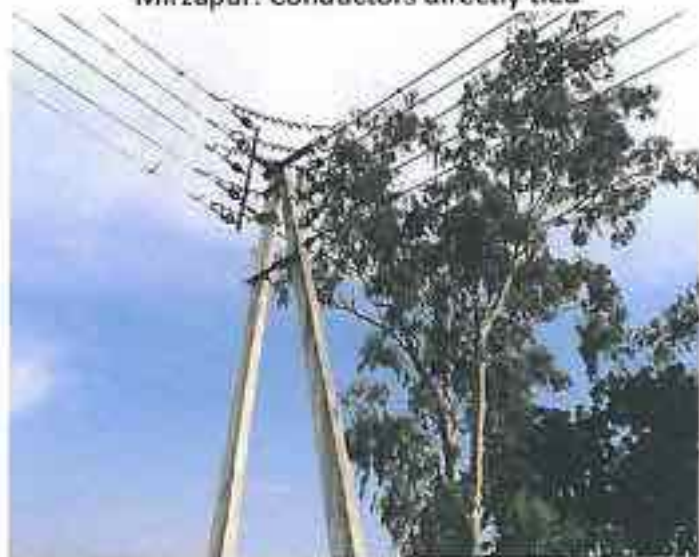
Khajuri: No earth knob (neutral directly tied to the clamp). Also note the how close line is to the tree cover

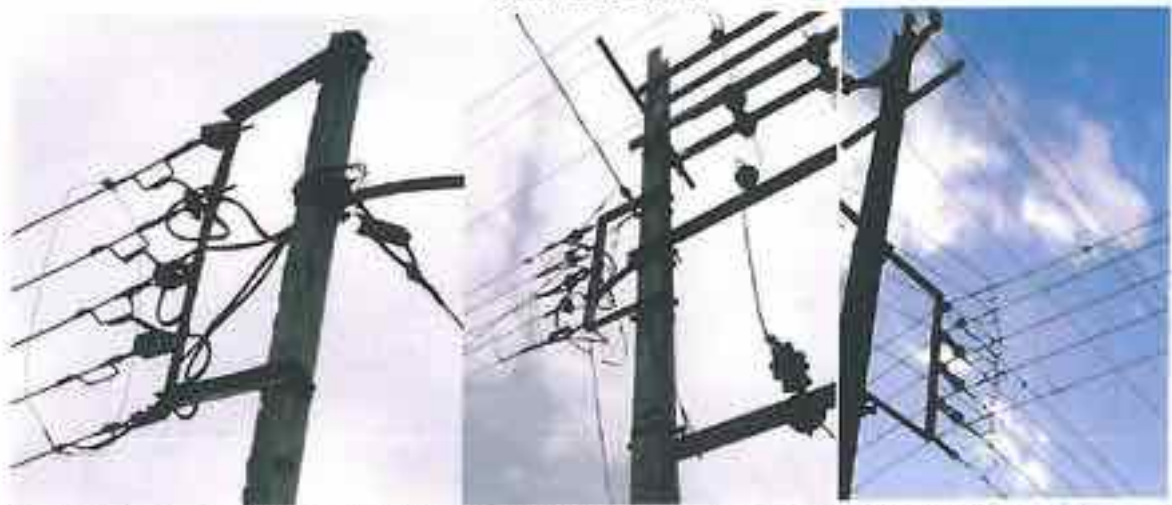
Aluminium Bobbins not used in Neutral Conductor at Urdana (Left), Dharampuri (Centre) and Moregadhi (Right). No Earthing arrangement for pole and its metallic part found.
Plate 4.41. Poor Work Execution and Supervision (Typical).....cont..

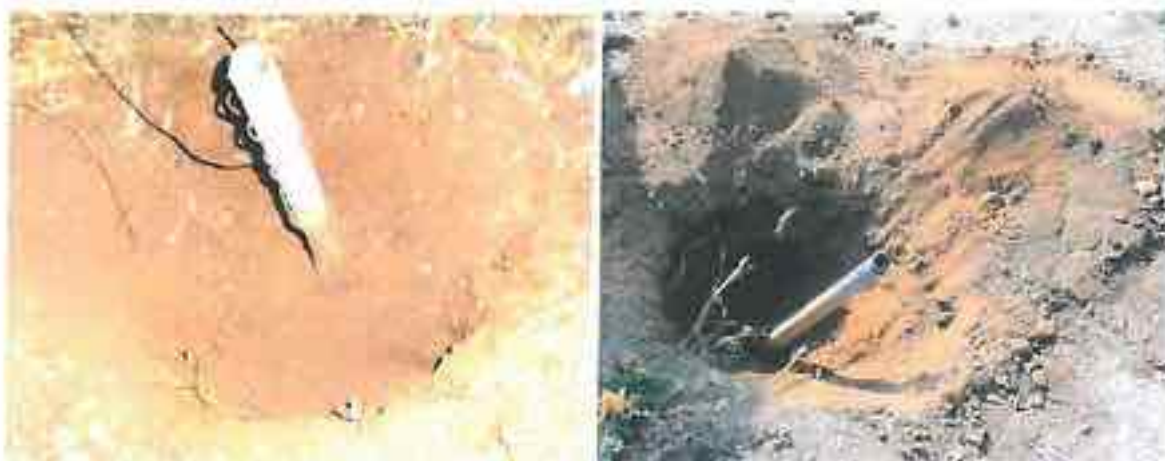
108. Similarly, the quality of something as important as Earthing was often inappropriate. Charcoal packings were often found missing, and sometimes even the GI Rods were not found present (Some pictures in Plate 4.41). As per Indian Electricity Rules 1956, the earthing systems shall be tested to ensure efficient earthing, before the electric supply lines are energised. No such test records for pre-energised state or at the time of Commissioning, including test records for mechanical strength and earthing efficiency were found available in records, indicating lack of sensitivity towards ensuring consumer safety.

No Charcoal Seen in Earthings Typically at Jamda (Left) and Dharamrai(Right). Earthing connections not made according to IS:3043-1987.

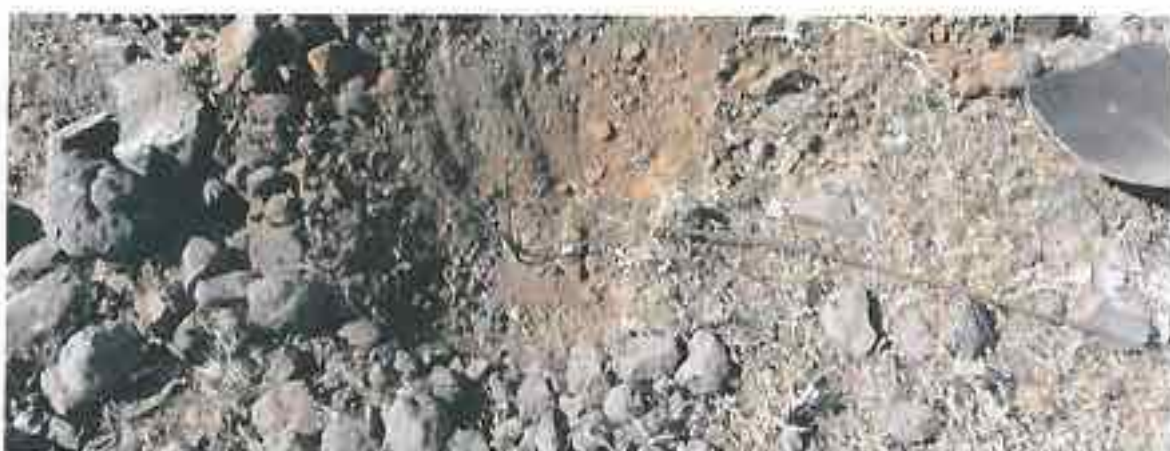
Dehar: Earthing wires without GI rod

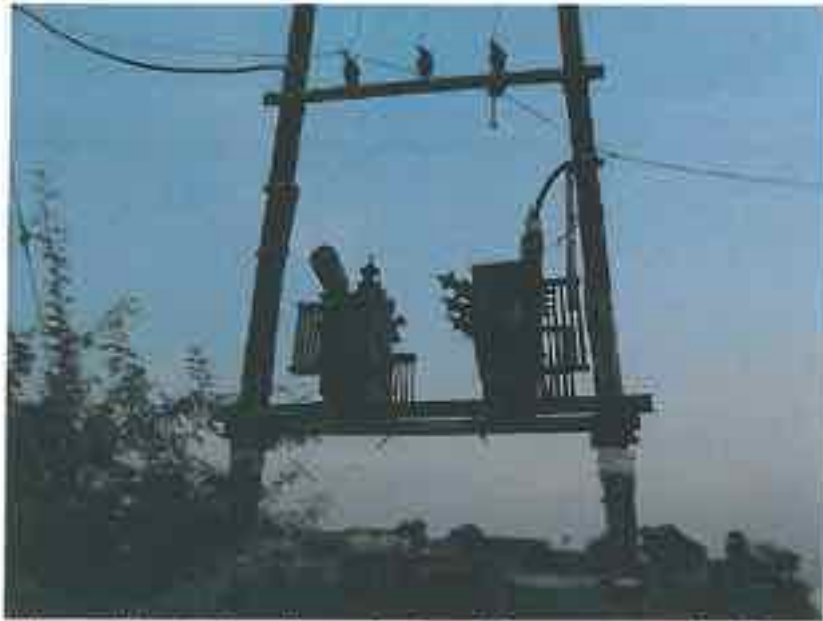
Nisarpur: One channel is missing above the Transformers, one of which is unconnected. AB Switch and Lighting Arrestors are missing. There is no LT Pole to separate out the 11 KV network from the LT Line. The cable is not seen supported by Metallic Bearer Wire.

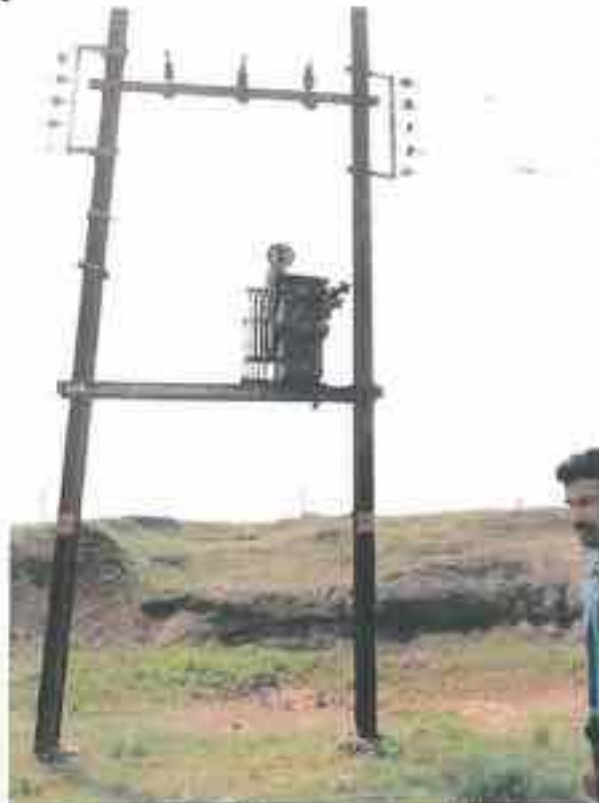
Nisarpur: LT Line taken from the 11 KV structure, which is not allowed as per safety norms. There should be separate LT pole so as to not energise the LT Circuit from the 11 KV Voltage due to leakage of current.

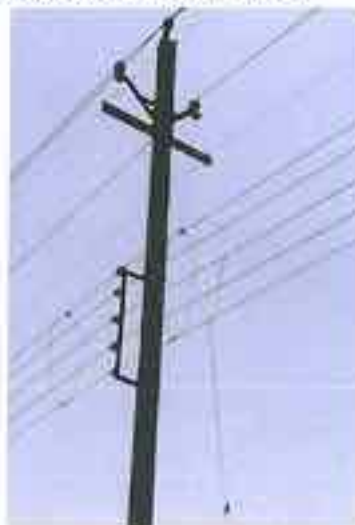
111. During the site visits, Street Lights were not seen at any of the R&R site. This is a gross violation of the provision of the NWDT Award that exclusively mentions "Electrical distribution lines and street lights" to be provided for rehabilitation in Madhya Pradesh. It is noteworthy that as per MB records, a provision for the fifth conductor exists in some, but not all, cases, and yet no street lighting has been provided, with the result that people have either to live in inconvenience or have to make personal makeshift arrangements at places (Plate 4.42).

Plate 4.42. Lakhangaon: Makeshift arrangements to get streets lighted by hanging bulb

112. Such Planning flaws at best indicate a complete lack of sensitivity to the needs of those who are located into the new and unfamiliar environs. What about the safety of residents in the changed social and cultural context which is likely to be laden with insecurity and anxiety? And safety not just from thieves or burglars, but also from insects, snakes and scorpions, who have recently lost their habitat to construction, and are lurking out in the open as was evident by our sighting of numerous snakes and scorpions at several sites even during the daytime. The absence of street lights has virtually ensured that getting emergency medical aid etc, and going to a hospital also would be tough at night-time for the habitants of R&R sites. While success stories such as provision of solar powered street lighting in off-grid Indian villages as decentralised but costlier option is fast emerging as popular options, it is a matter of regret that despite the availability of electric lines along the streets, the provisioning of street lights has not been made across the rehabilitation sites. This gross negligence on part of planners needs to be amended by making street lights available across the sites.

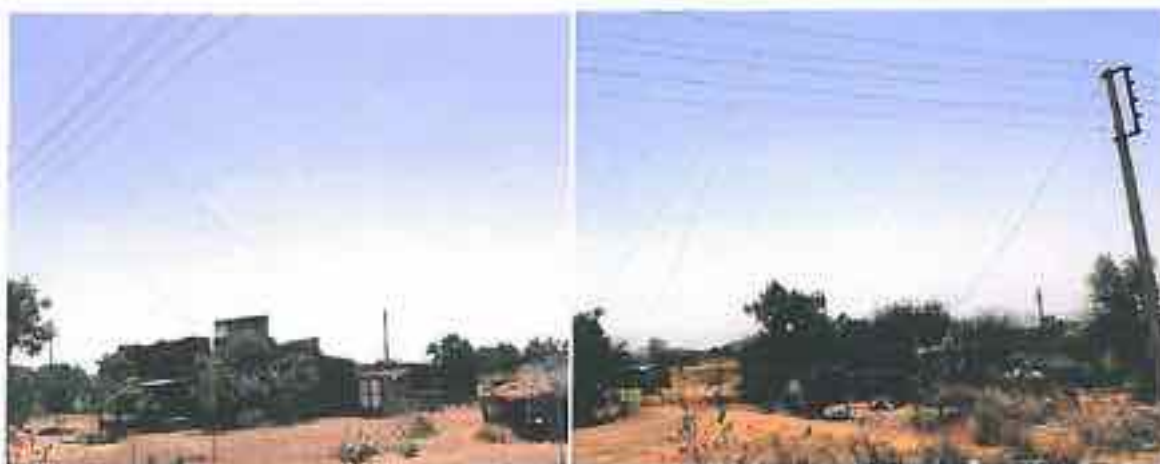
114. At a few R&R sites like Lakhangaon, large number of illegal electricity connections to houses were seen (Plate 4.43). While the behaviour of consumers is very important in maintenance and upkeep of infrastructure, the avoidance of such illegal acts is highly desirable as the same is now a punishable offense for which one can be prosecuted under the provision of Section 5.4.13 of National Electricity Policy 2005 that provides for stringent measures against theft of electricity, directing the States and distribution utilities to ensure effective implementation and permitting the State Governments to set up Special Courts as envisaged in Section 153 of the Indian Electricity Act, 2003. It may be noted that under Section 135 of the Indian Electricity Act 2003, the theft of Electricity is punishable with imprisonment for a term which may extend to three years or with fine or both with the offence being cognizable and non-bailable.

Plate 4.43. Illegal Connections thriving at Lakhangaon (Typical)

116. It is here that consumer awareness becomes necessary, and it is in such instances where NGOs active in the area can also raise their voices to educate the inhabitants on appropriate use of services at the R&R sites.

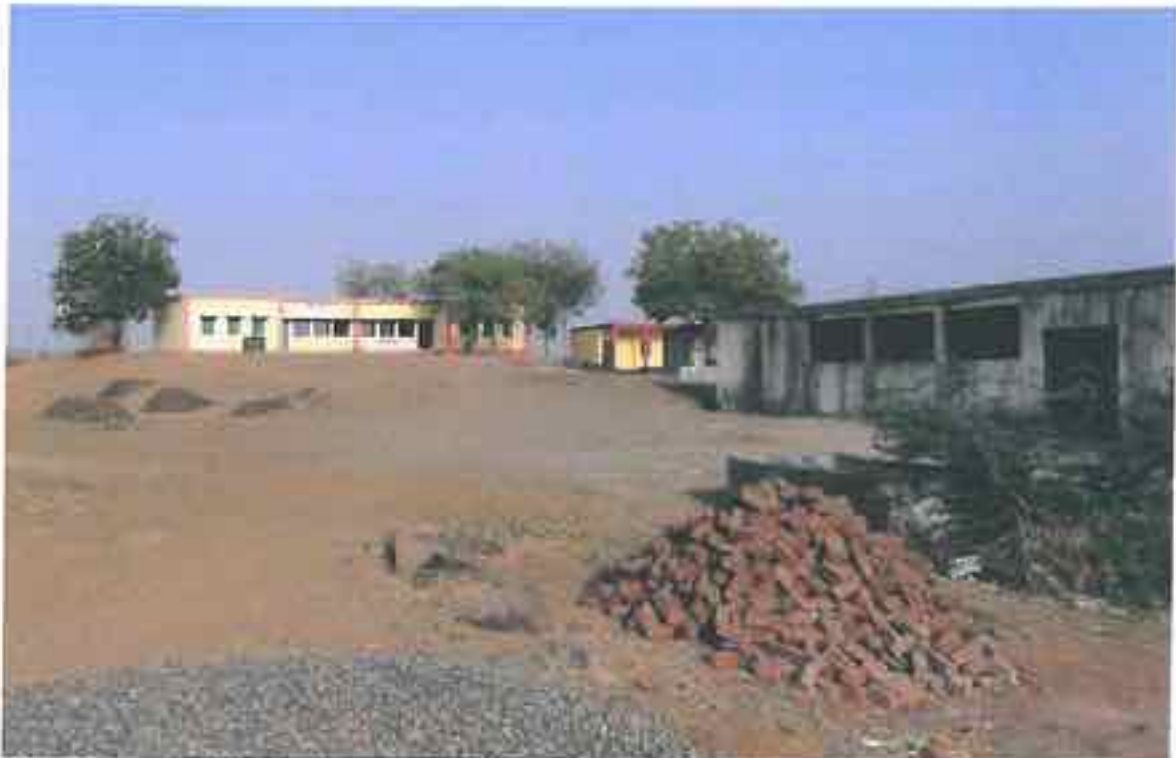
118. In odd cases such as at the R&R site Datwada, no electrical line were observed in the vicinity of Middle School etc., implying lack of electricity distribution line to the constructed public utility building (Plate 4.44). What is bizzare is that the building possesses internal electrification despite the missing distribution lines, and to provide electricity external line will have to be first laid. This is in violation to the provisions of NWDT Award, and is reflective of poor planning/execution. Clearly, the works seem to be incomplete in such instances.

Plate 4.44. No Electric lines in the near vicinity of Middle School building at Datwara. Classes expected to run without fans and lighting.

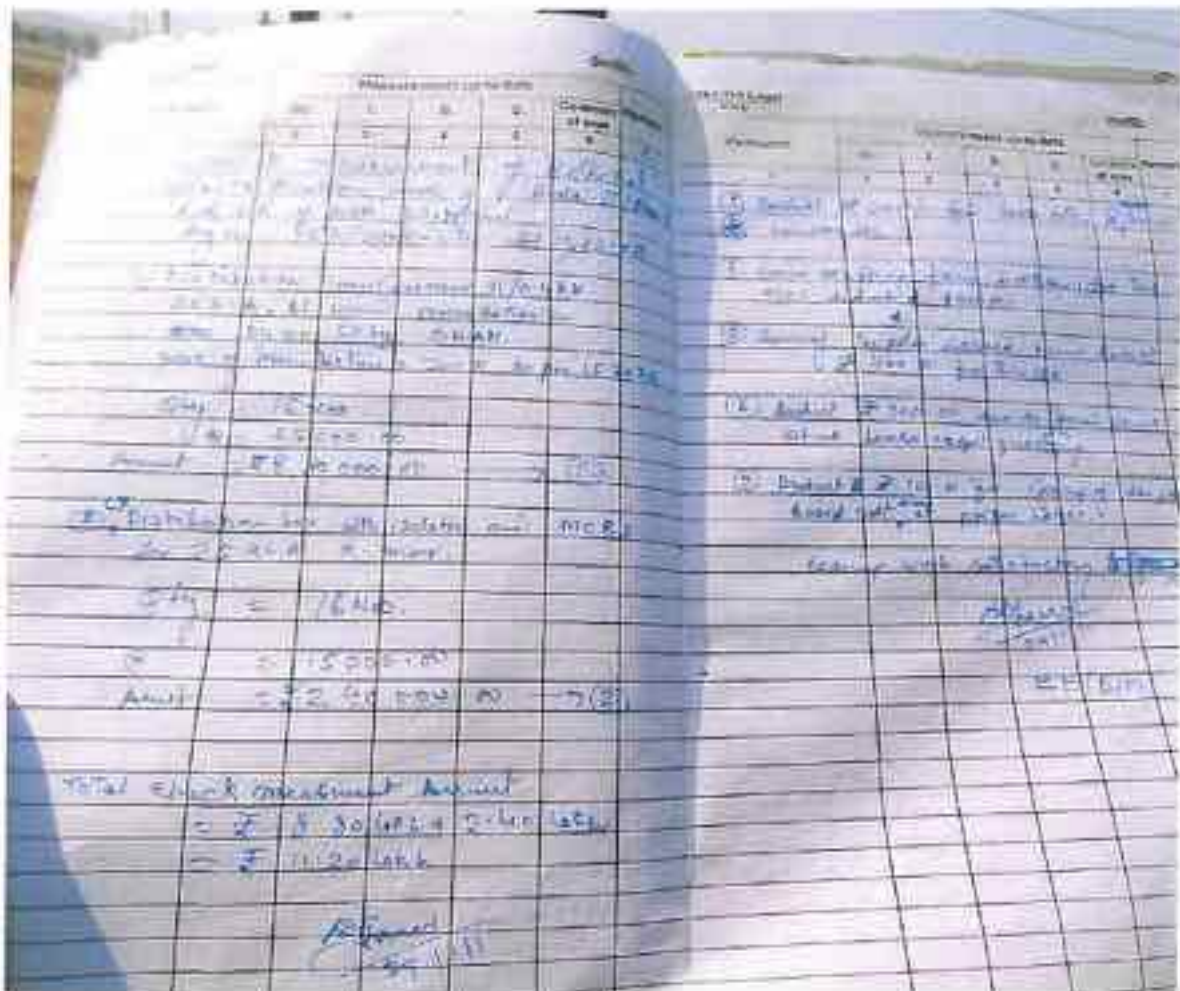
133. From Table 4.5, it also appears that in several cases large time gap exists in completion of work, and date of final payment. Thus at Sondul, the delay was as much as 3.5 years, at Anjad Barda II, the delay was more than 1 year and 8 months, at Borlai II Phase II the delay exceeded 1 year and 9 months (Plate 4.45), and at Kukra II the delay exceeded 3 years and 4 months. These delays are significant and raise suspicion.

Borlai II Phase II: Work undertaken in 2009 and billed in 2011.

Plate 4.45. The case of Borlai II, Phase II

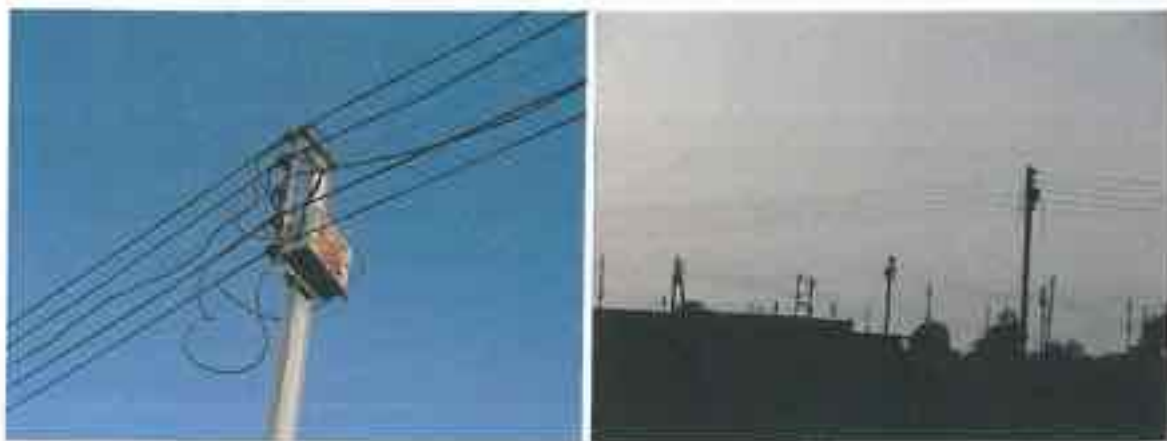
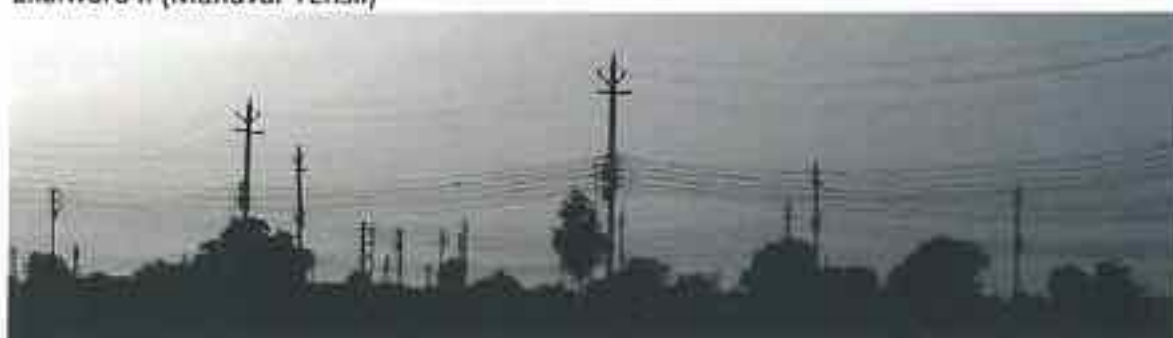
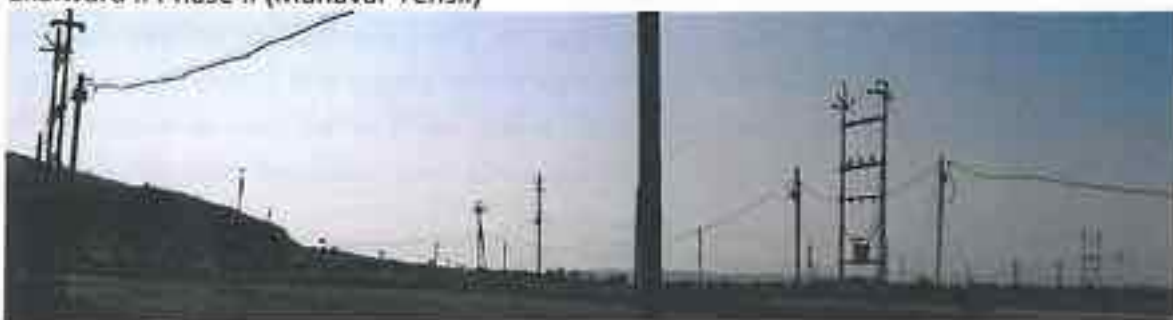
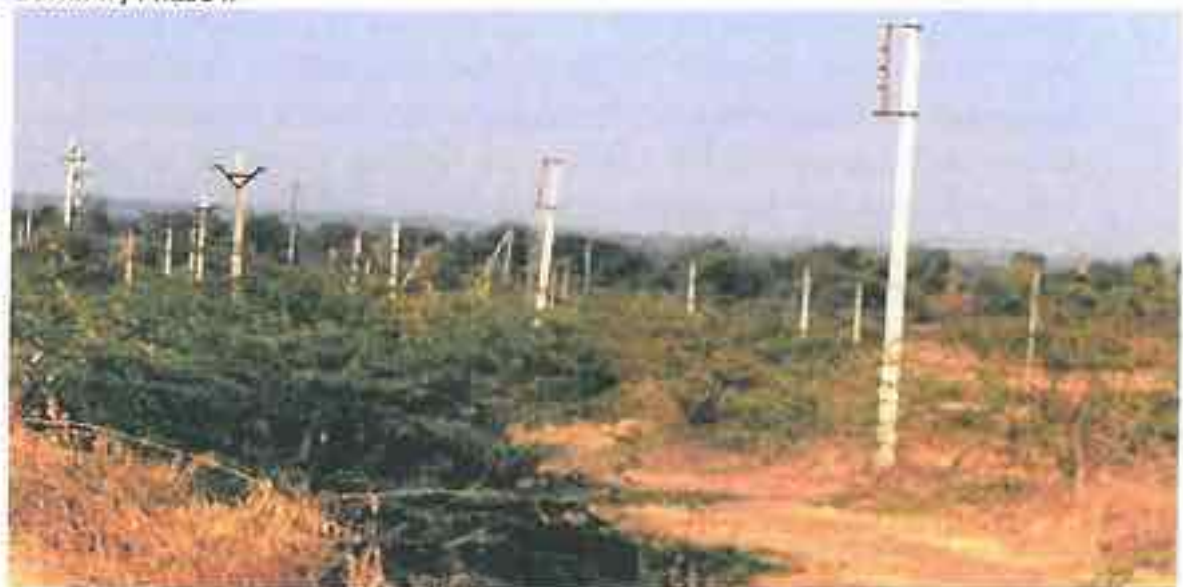
123. While Phase II sites are mostly deserted (Plate 4.46), even the main/adjoining sites along with phase II work sites show scarce habitations. As evident from Table 4.5 even at the start of year 2014, none of the overall Sites (including phase I and II works) are yet even 50% habitated, and as many as 9 sites out of 14 Main sites have habitations less than 20%, with Sondul even showing 0% habitation. Thus, even the Phase I sites were still very sparsely occupied/almost completely unoccupied, and yet the Phase II works have been undertaken in excess of the desired number of plots needed for displaced families.

Plate 4.46. Huge Capital Intensive Infrastructure in deserted Phase II works: Capital Investment for whom?

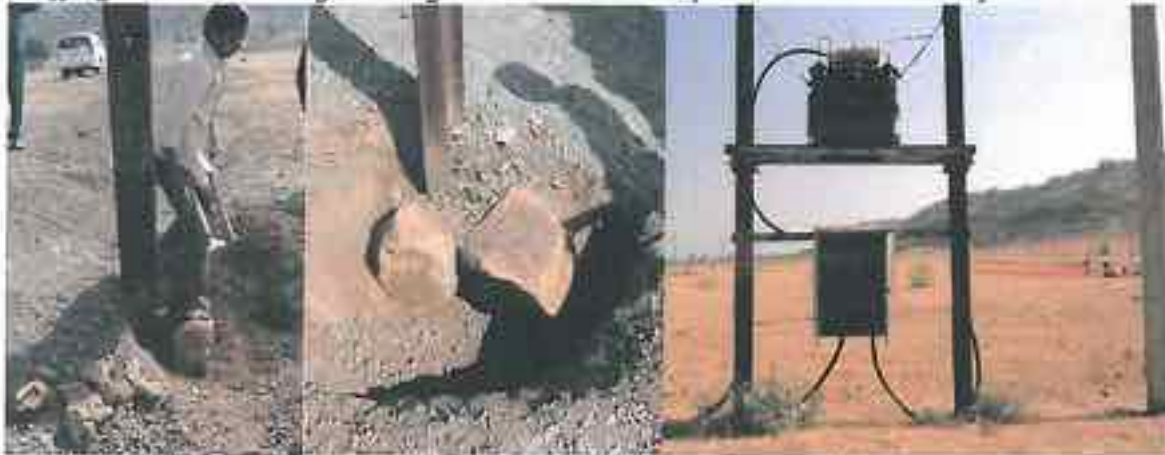
Pole inclinations not investigated, but regularised by paltry penalties.

Missing Muffings in 3 cases, 2 of which (left and middle photographs) are of HB Poles, with poor foundations. These HB Poles are recorded to have Concrete foundations as per MB Records. But even a boulder packing was missing. Just 1-2 stone pieces found as "foundation". The third photograph (Right) is of a Transformer with 3 pole configuration. Muffings again not constructed in any of the three poles. No Danger Board seen.

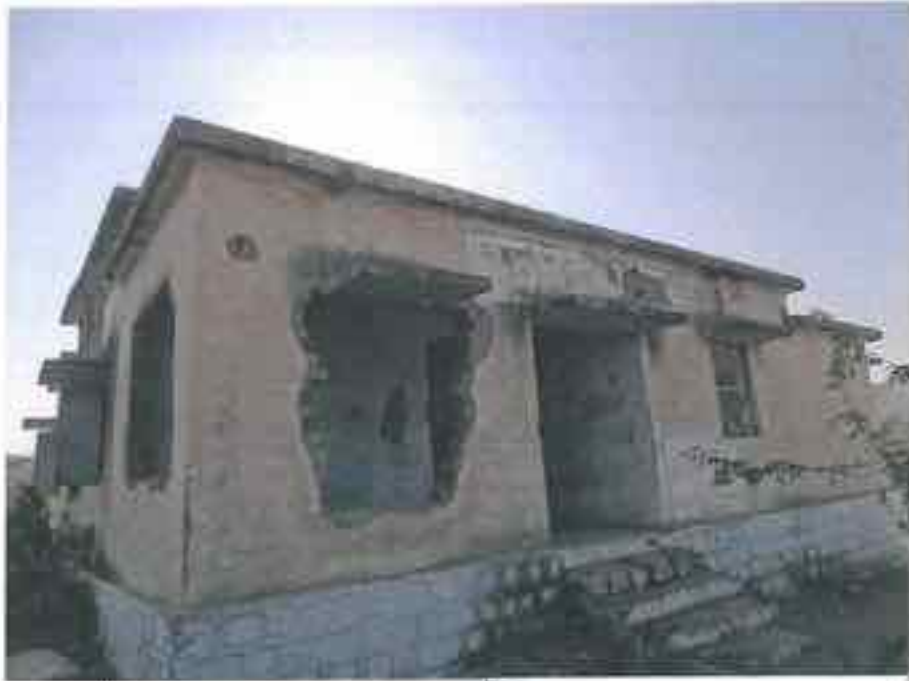
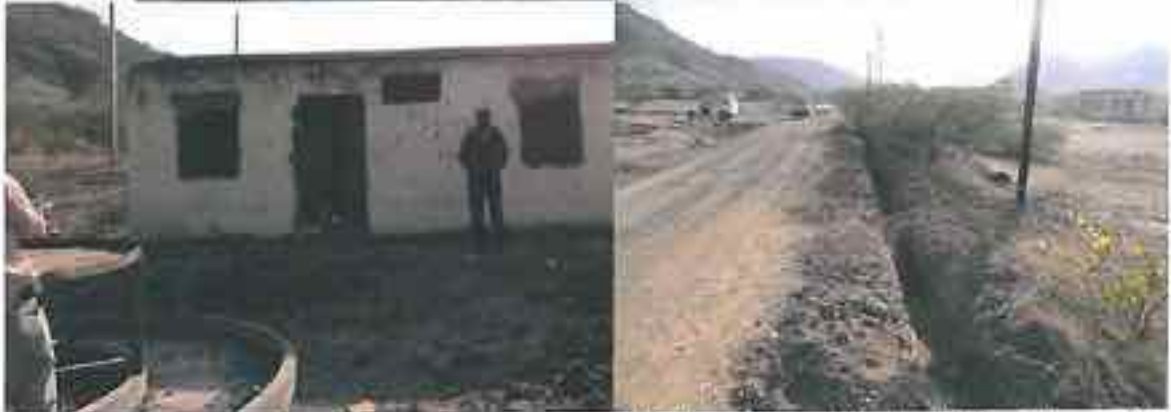
21. This has led to massive deterioration of infrastructure quality as has happened at Sondul (Plate 5.1), where even the doors and windows of the buildings are missing, and the buildings lie in shambles even as cisterns and pipes are missing. It is noteworthy that Electrical Services at Sondul even have Phase II works which is the single most costliest work under all Phase II works, costing as much as Rs 141.84 Lakhs. Unfortunately, there are no users.

Plate 5.1 Abandoned Infrastructures at Sondul. The entire site, including the capital intensive Phase II Electrical Works, appears abandoned.

23. Under all such cases, irrespective of the reasons for which the sites stand abandoned, significant investments have been made, and hence NVDA needs to identify all such sites, and revive the sites and its infrastructure to make it usable if appropriate, so that public money does not go waste. In case, the oustees are not going to occupy R&R sites, NVDA needs to find out ways to put the R&R sites to some productive alternative use.
